Inspection Report

Re: Ash/Refuse Disposal Site – Annual CCR Unit Inspection Report No. 1

Inspection Date: October 12, 2015

Report Date: January 12, 2016

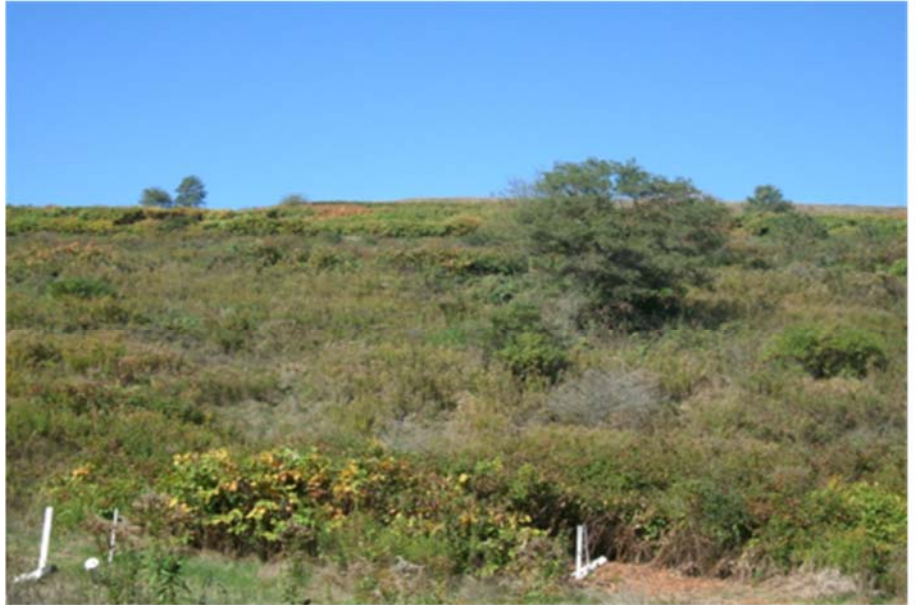
Photograph No. 1

South-central perimeter of Stage II
just north of the leachate discharge
feature

Stage II south slope and leachate
collection clean-out piping; no
evidence of tensile cracking or
slumping at toe of slope.

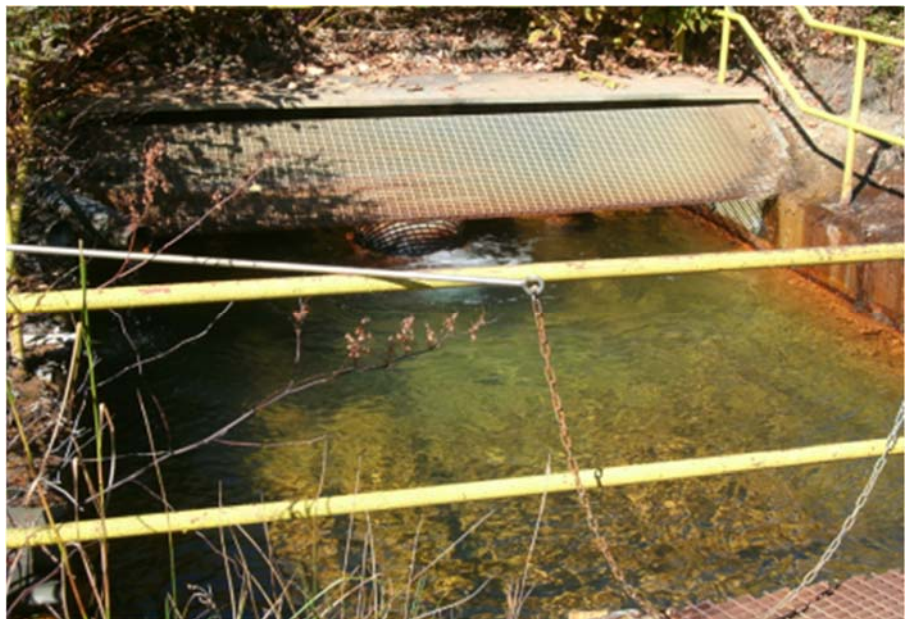
Photograph No. 2

South-central perimeter of Stage II

Surface discharge location of below
grade leachate piping; clear
evidence of unrestricted leachate
flow.

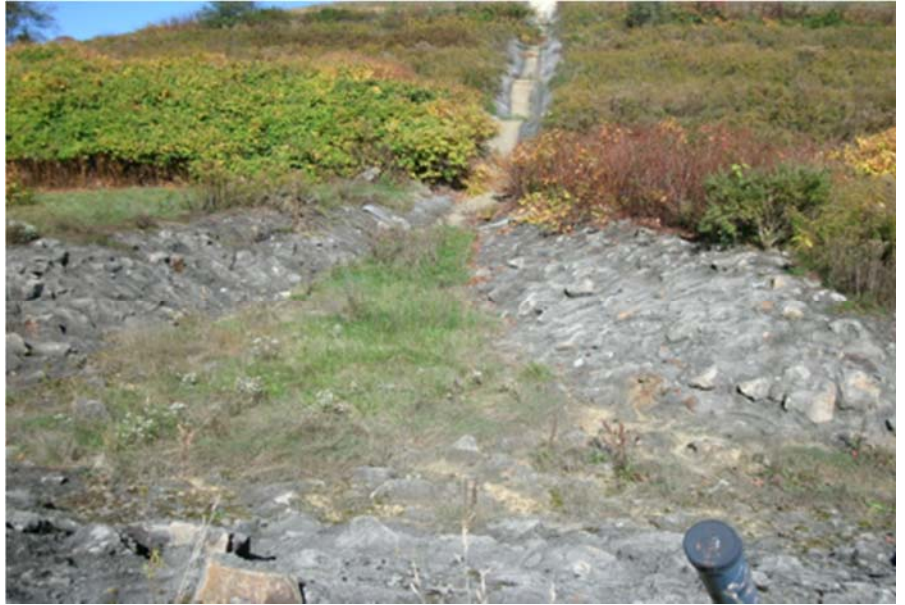
Photograph No. 3

South-central perimeter of Stage II

Internal "contact" stormwater ditch and energy dissipater basin.

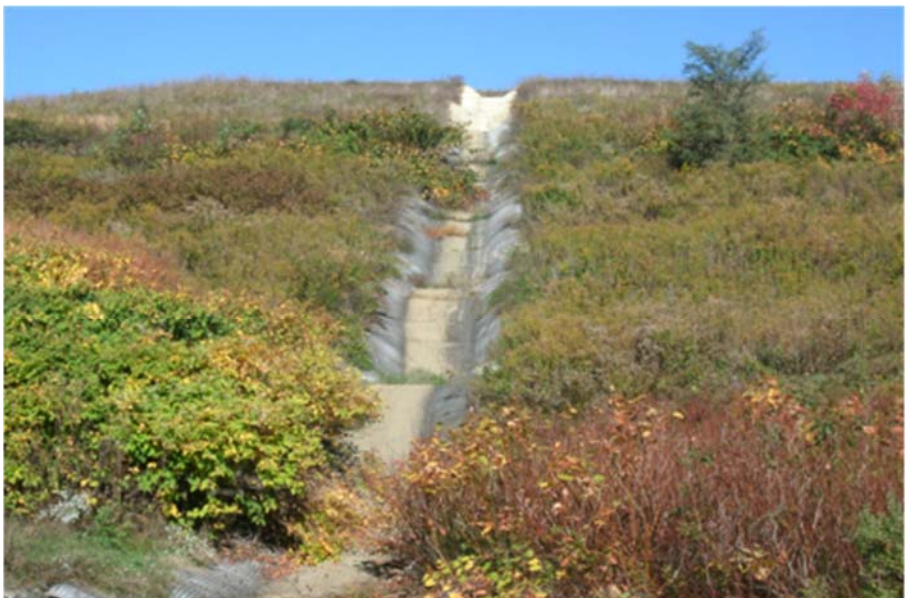
Photograph No. 4

Western perimeter of Stage II

Closed landfill slopes with vegetation and permanent stormwater downslope ditch.

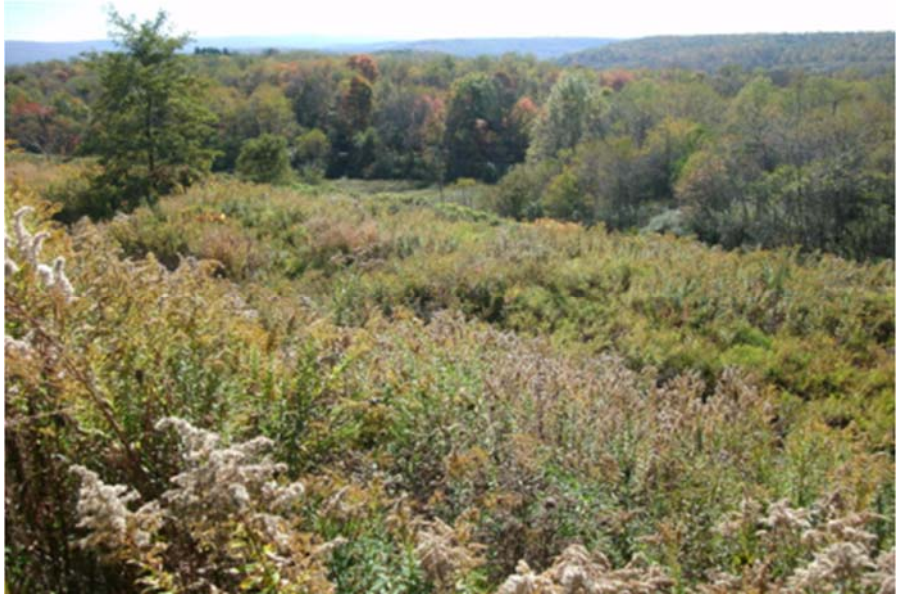
Photograph No. 5

Western perimeter of Stage II on
bench of capped slopes

Standing on bench within western
slope; no visual evidence of
slumping or tensile cracking on
surface or evidence of soil
movement via vegetation.

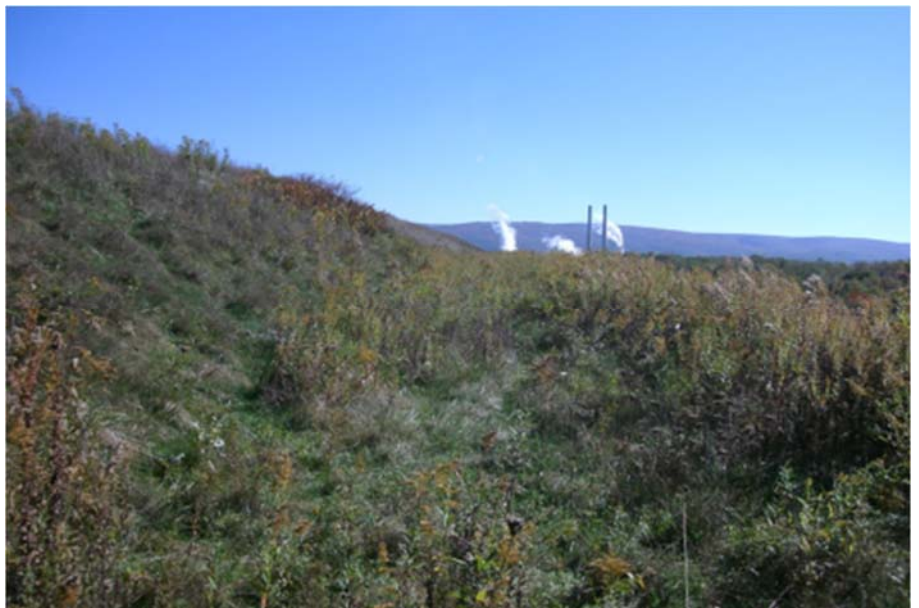
Photograph No. 6

Western perimeter of Stage II on
bench of capped western slopes,
looking south

Standing on bench along western
slope; no visual evidence of
slumping or tensile cracking on
surface or evidence of soil
movement via vegetation.

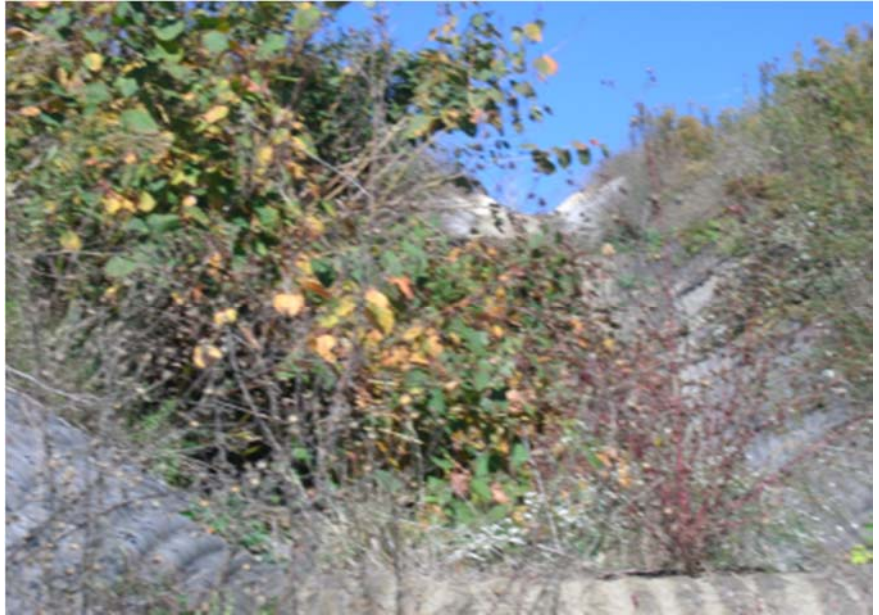
Western perimeter of Stage II within
downslope ditch

Potential stormwater blockage due
to significant vegetative growth
around perimeter of downslope
ditch.

1. Clean out vegetation on western downslope ditch (see Photograph No. 7 in Attachment 2).
2. Fill in and compact erosion gullies on internal CCR slopes (see Photograph No. 14 in Attachment 2).
3. Establish an all-weather access to western and southern toe of slope or equivalent method to inspect.

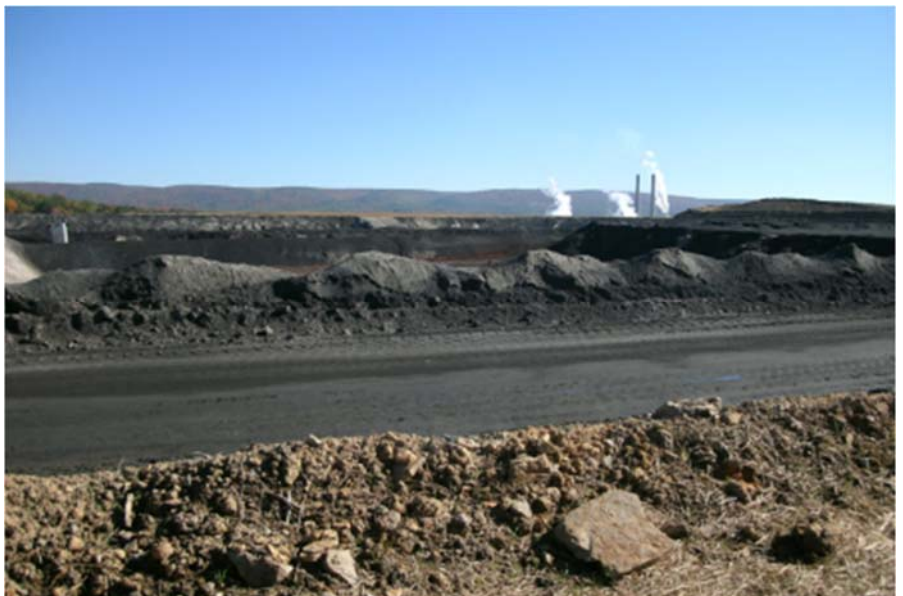
Photograph No. 8

North side perimeter of active Stage
II area

Looking south at the active filling
operations.

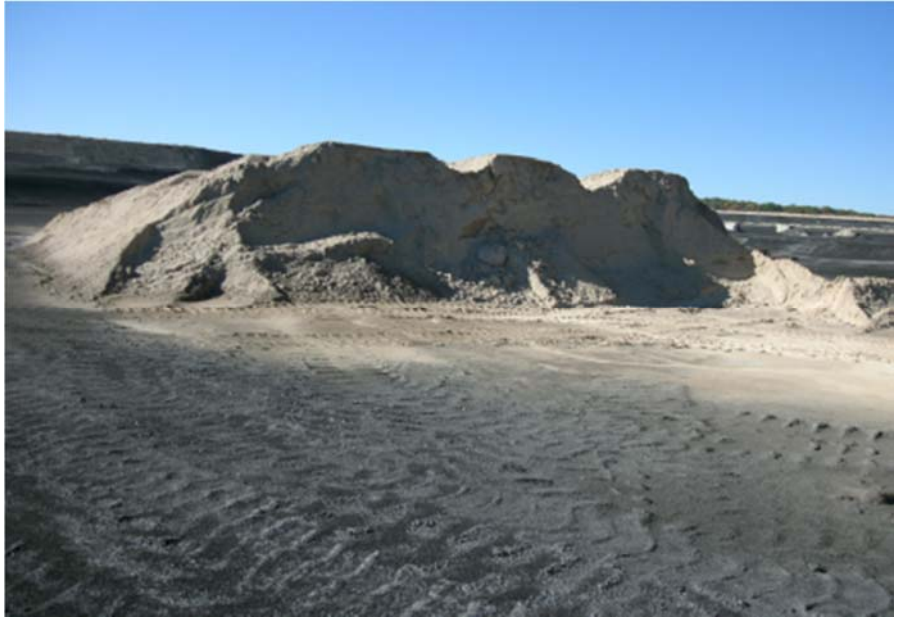
Photograph No. 9

Southeast corner of the active Stage II area

Gypsum materials in active filling operations area.

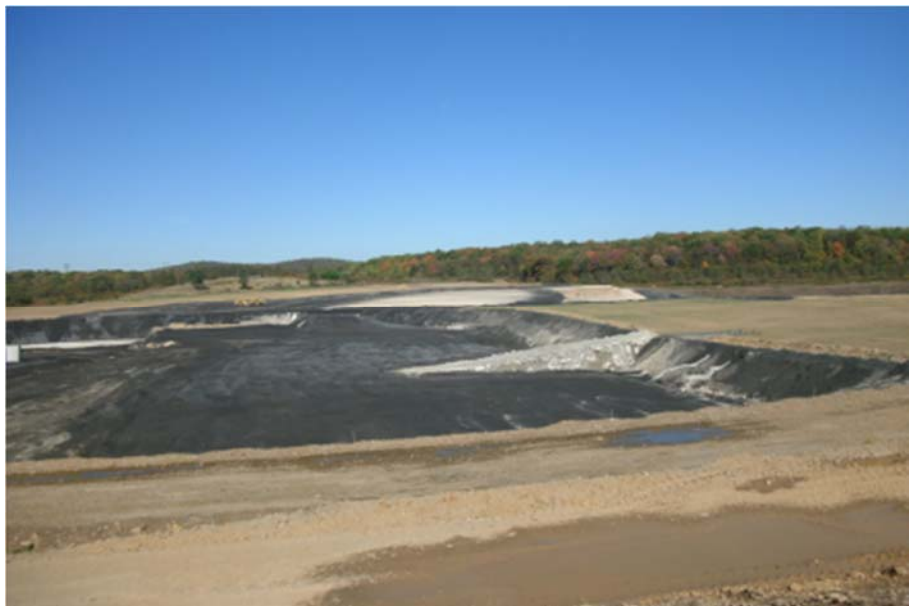
Photograph No. 10

South of the active Stage II area looking north

Active fill operations.

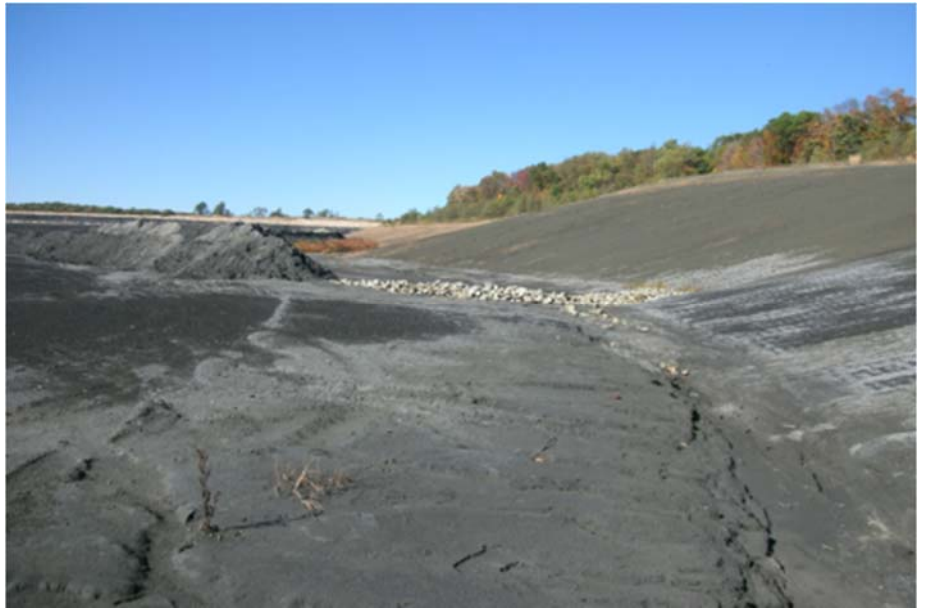
Photograph No. 11

West perimeter of the active Stage II area

Temporary "contact" stormwater runoff ditch.

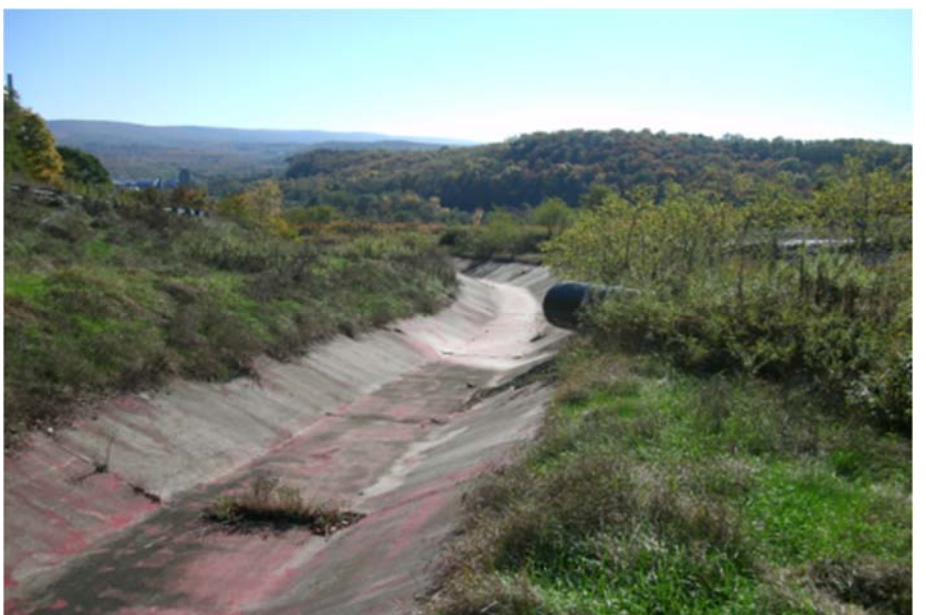
Photograph No. 12

Western perimeter of Stage II fill area

Perimeter stormwater ditch.

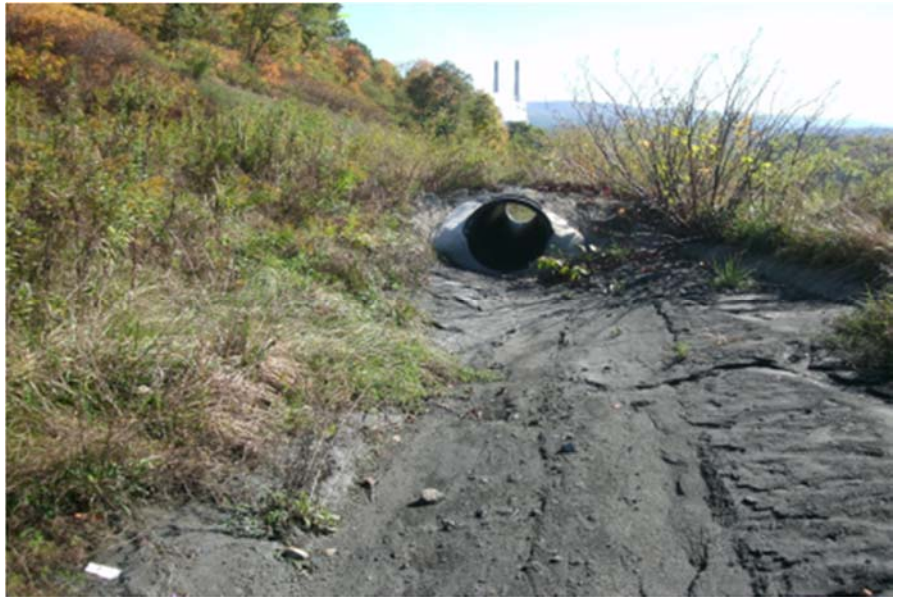
Photograph No. 13

Western perimeter of Stage II filling operations

Internal "contact" stormwater ditch.

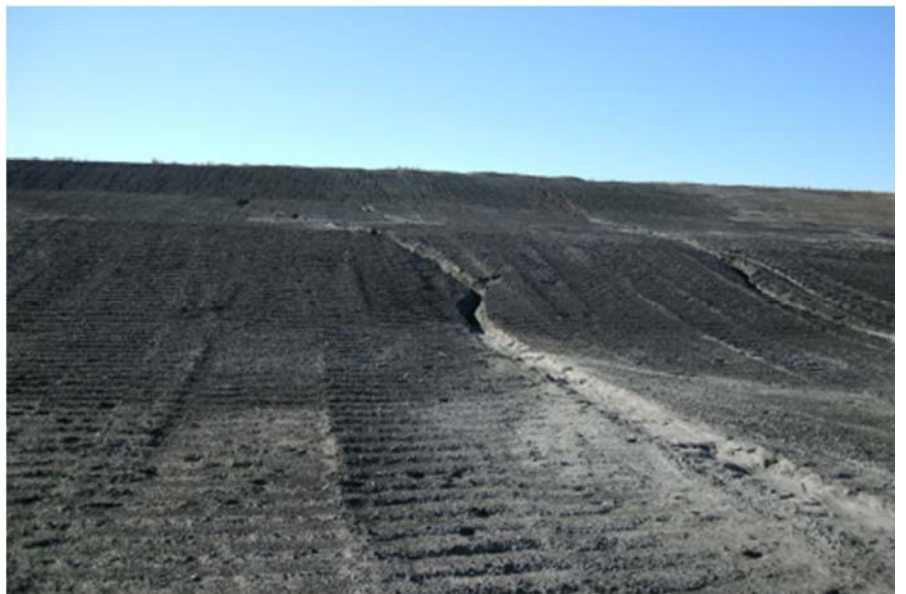
Photograph No. 14

- i. Stage II temporary interior slopes have formed water-eroded drainage paths/gullies within certain areas of active CCR placement. No other visual signs of distress or malfunction were observed for stormwater drainage features, leachate conveyance mechanisms, or overall site conditions.

- i. At the time of inspection, it was noted that stormwater run-on from the Stage II internal CCR slopes has formed water eroded paths/gullies.

Western edge of active Stage II fill area

Erosion gully forming within temporary slope/benches of active fill area.
