Inspection Report

To: James Brunson (Conemaugh Generating Station)

Re: Ash/Refuse Disposal Site – Annual CCR Unit Inspection Report No. 2

Inspection Date: November 16, 2016

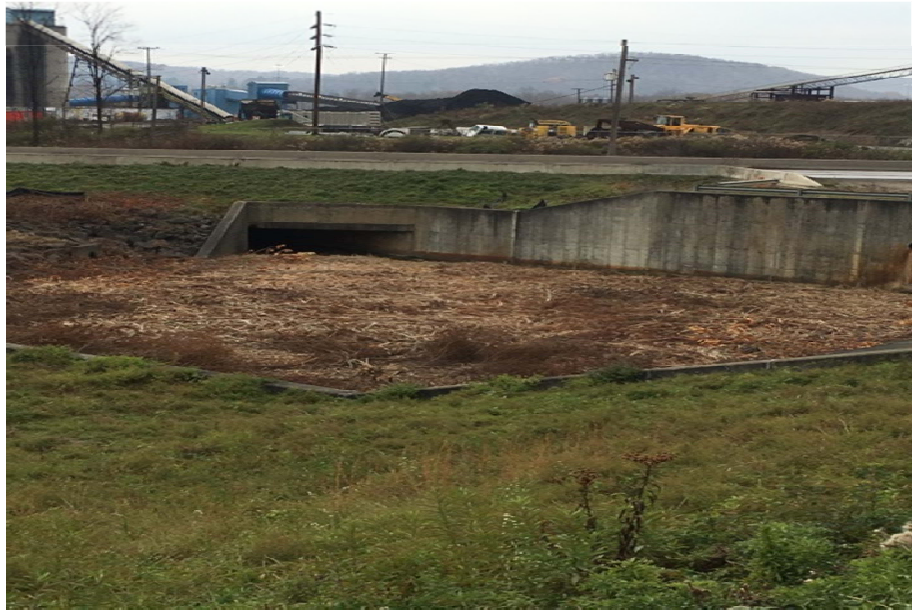
Photograph No. 1

Outlet downstream from leachate surge pond. Clear of obstructions.

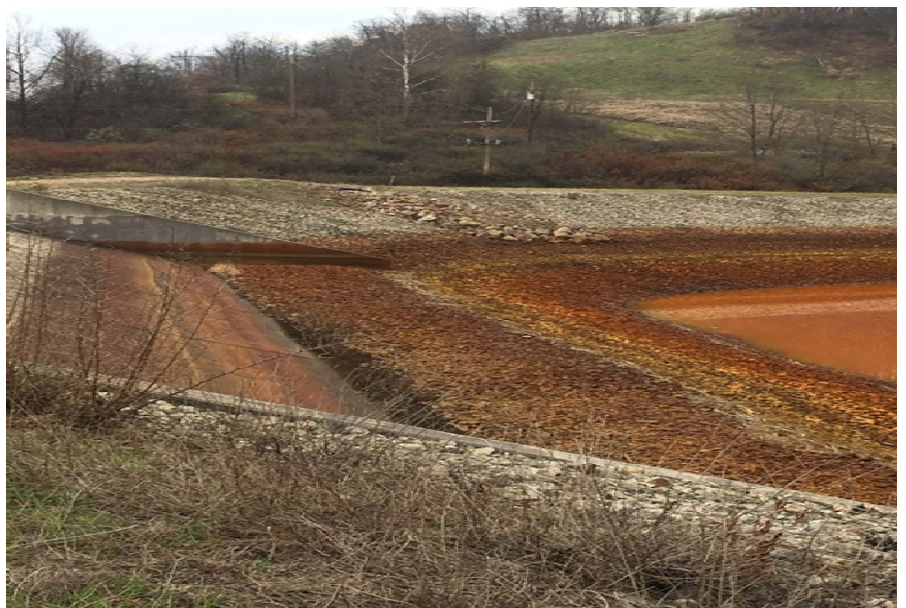
Photograph No. 2

Close-up view of broad-crested weir at leachate surge pond. Staining shows high liquid level to be below crest.

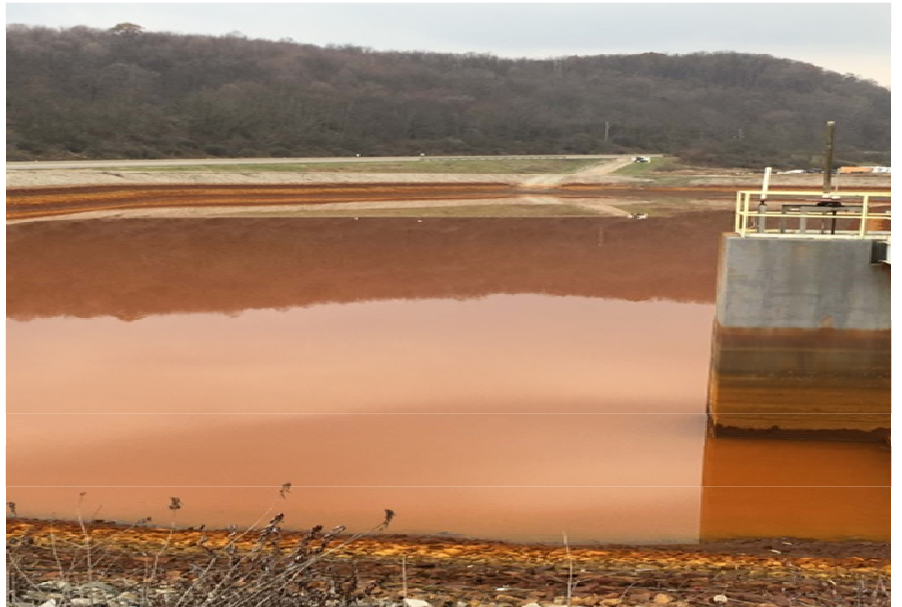
Photograph No. 3

Leachate surge pond. No evidence of overtopping or malfunction.

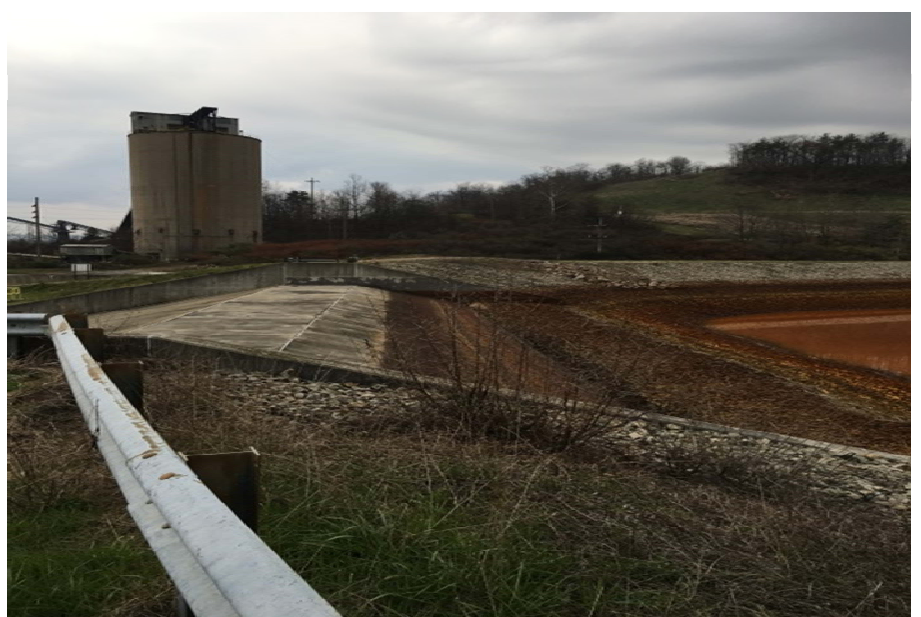
Photograph No. 4

Broad-crested weir at surge pond. Staining shows high liquid level to be below crest. No evidence of release.

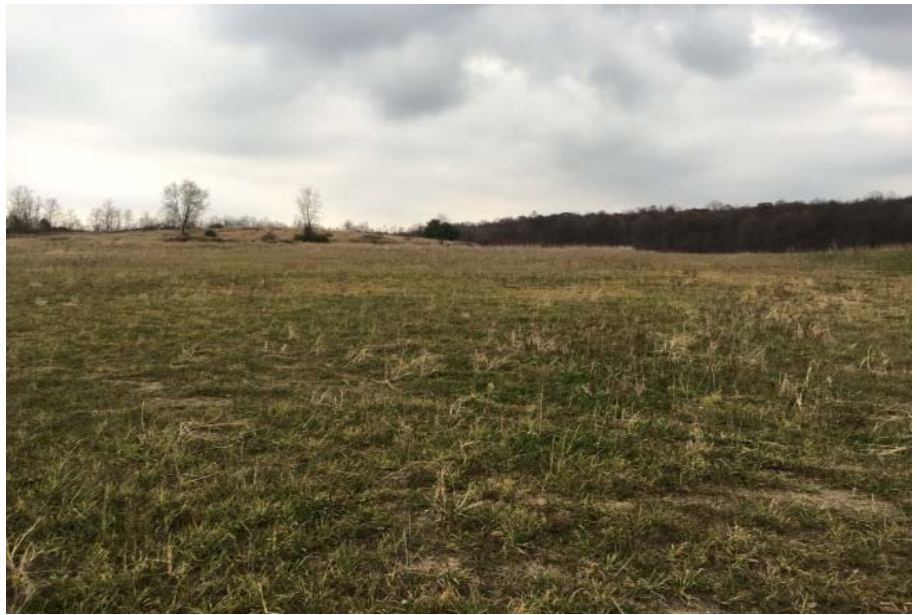
Photograph No. 5

Final cover on the southern portion of the closed Stage I disposal area. Vegetation is well established and maintained. No evidence of erosion or sloughing.

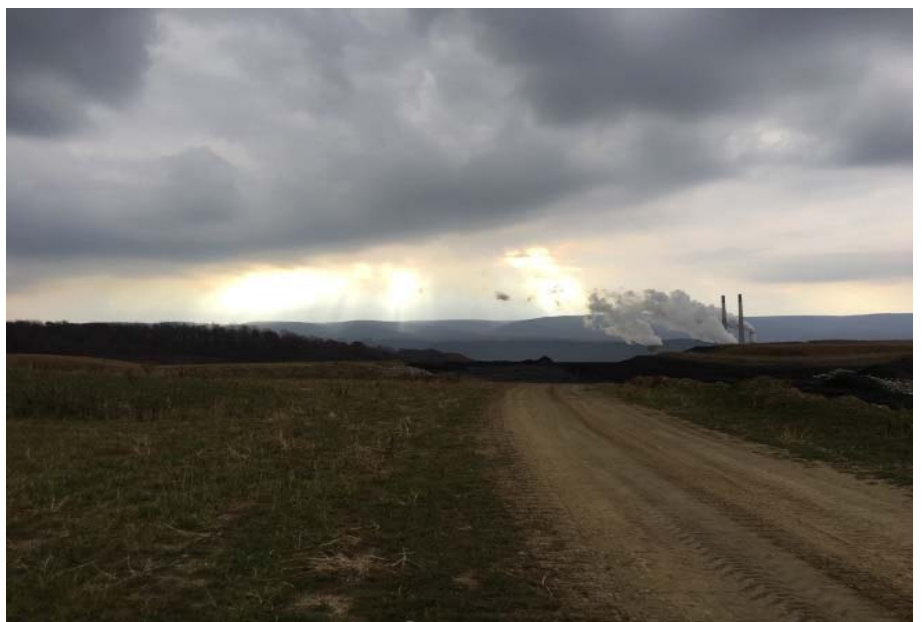
Photograph No. 6

Final cover on the southern portion of the closed Stage 1 disposal area with generating station in background. Vegetation is well established and maintained.

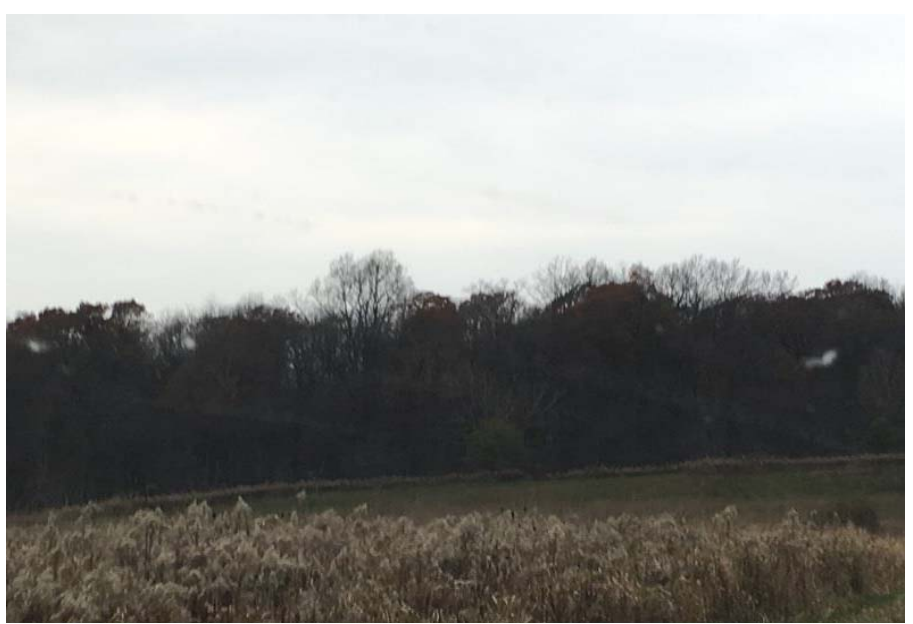
Photograph No. 7

Final cover on the northern portion of the closed Stage I disposal area. Vegetation is well established and maintained. No evidence of erosion or sloughing.

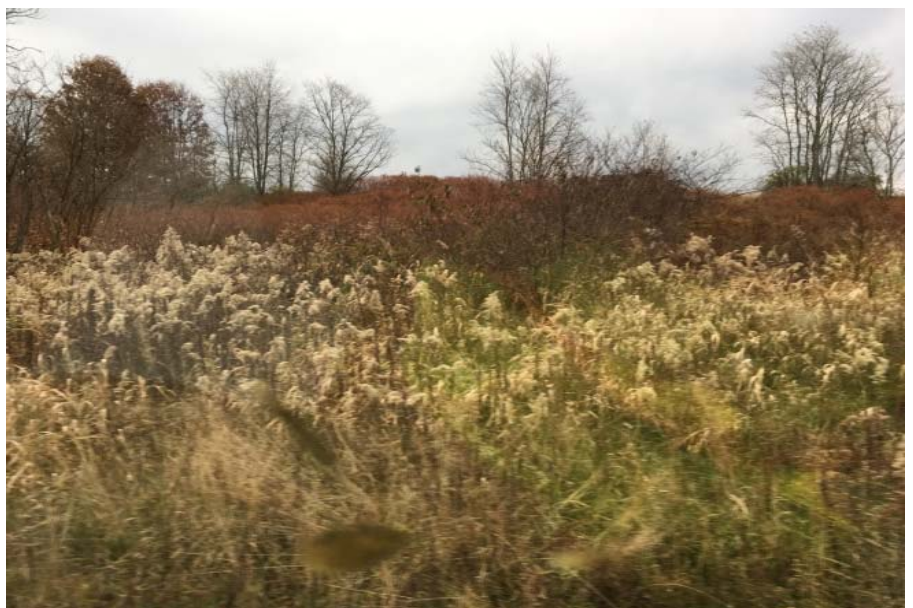
Photograph No. 8

Final cover on the northern portion of the closed Stage I disposal area. Vegetation is well established. No evidence of erosion or sloughing.

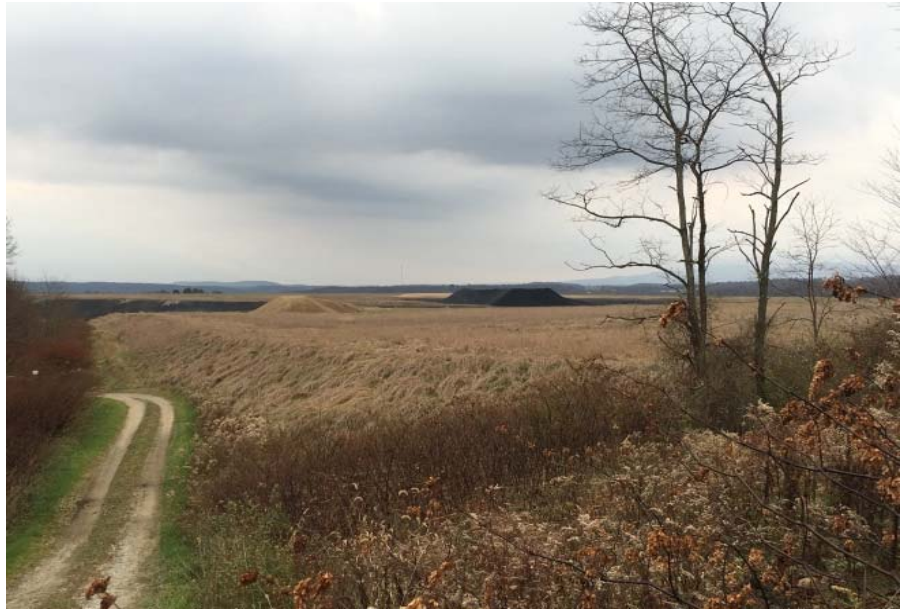
Photograph No. 9

Completed side slopes of the Stage II disposal area. No evidence of erosion or sloughing.

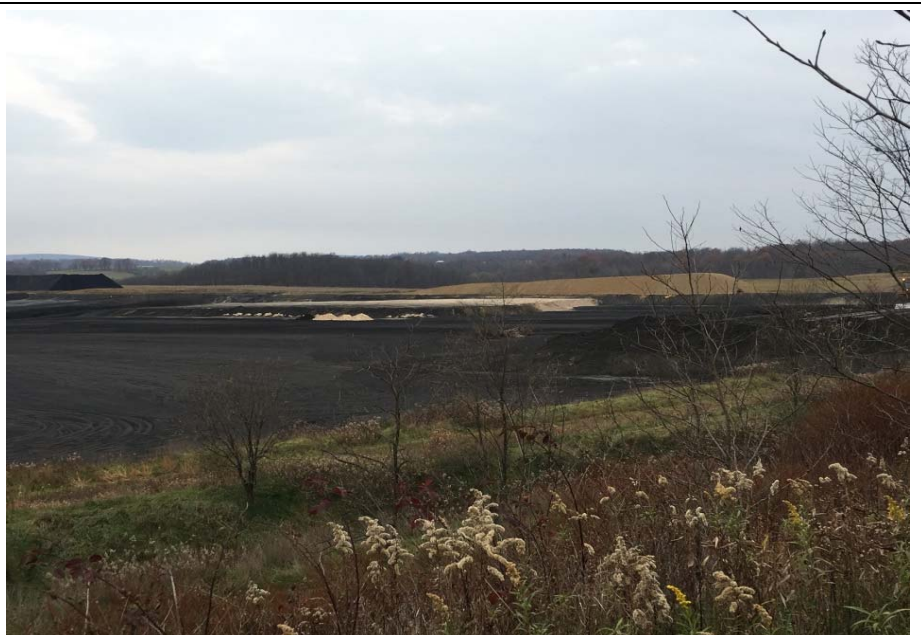
Photograph No. 10

Active filling within the Stage II disposal area. No evidence of erosion or airborne dust.

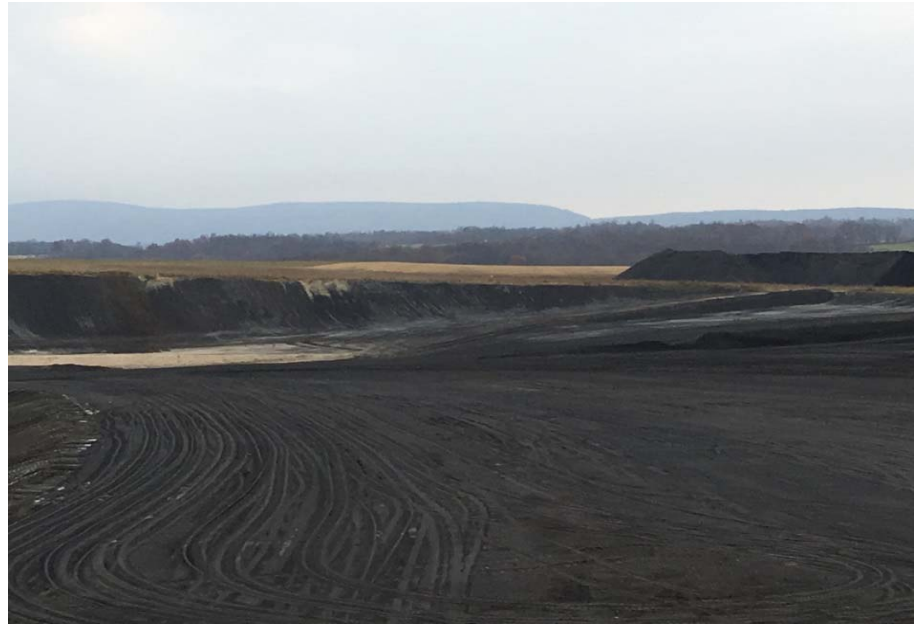
Photograph No. 11

Active filling within the Stage II disposal area. No evidence of erosion or airborne dust. Active operations area is well maintained.

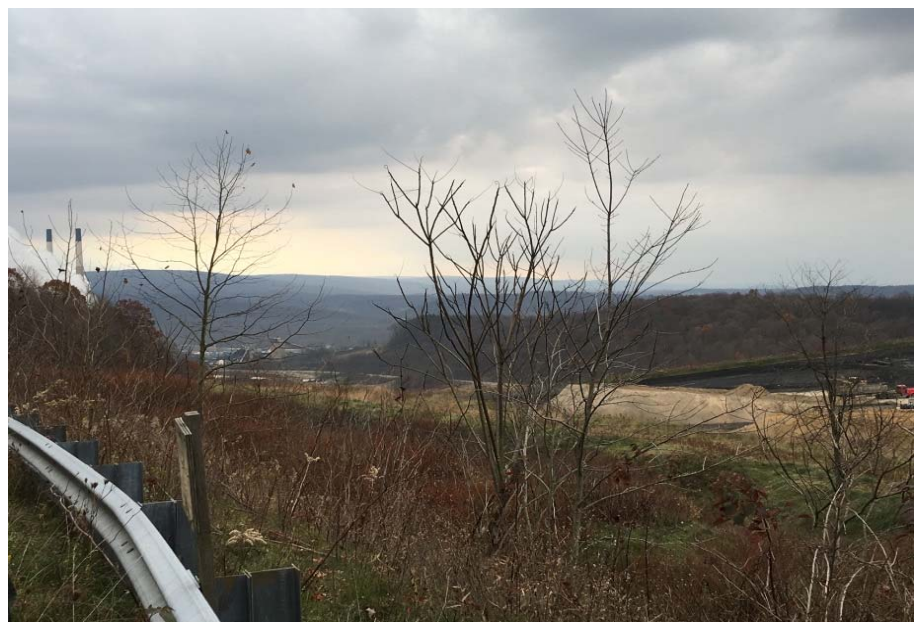
Photograph No. 12

View of the Stage III construction area from perimeter road.

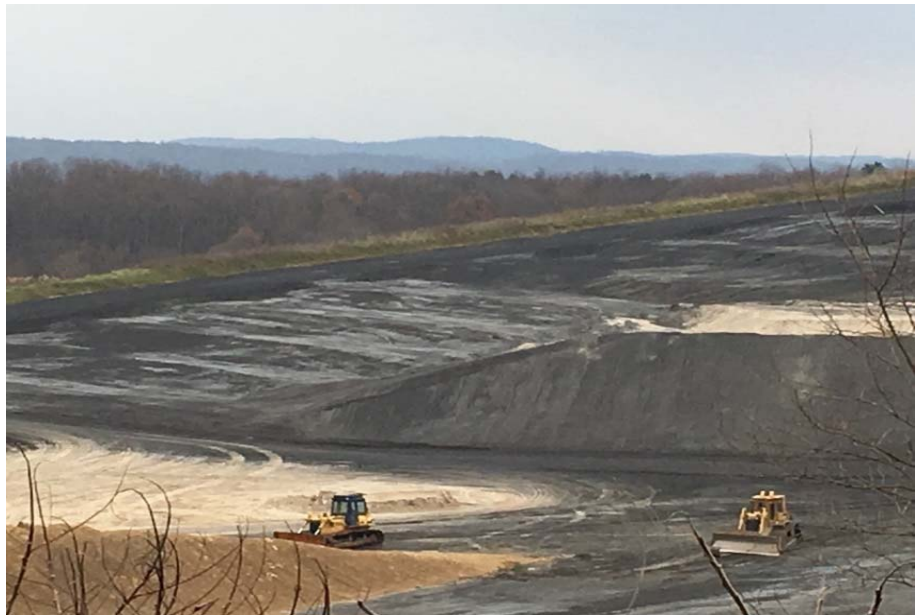
Photograph No. 13

Active filling within the Stage II disposal area. No evidence of erosion or airborne dust.

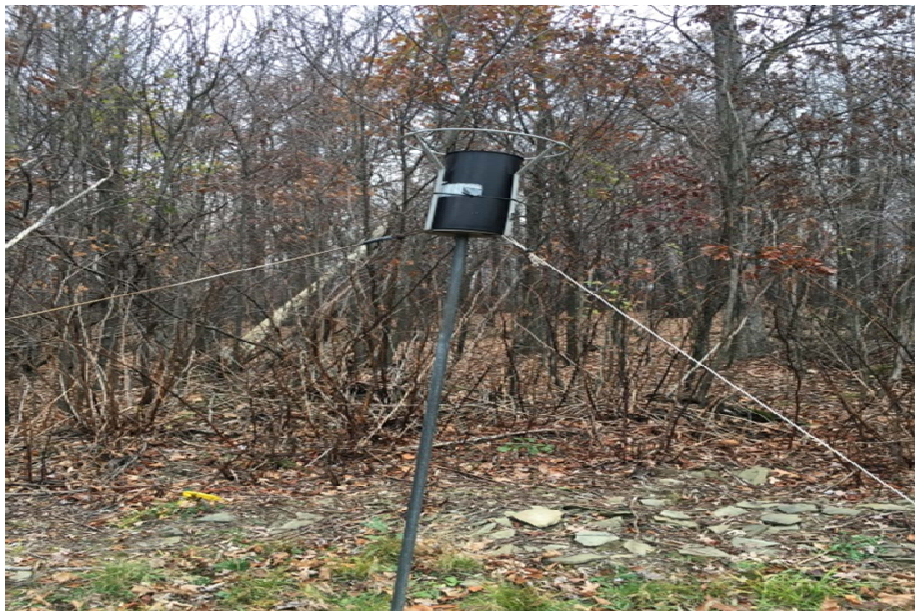
Photograph No. 14

Dust-fall monitor utilized to assess potential fugitive emissions.

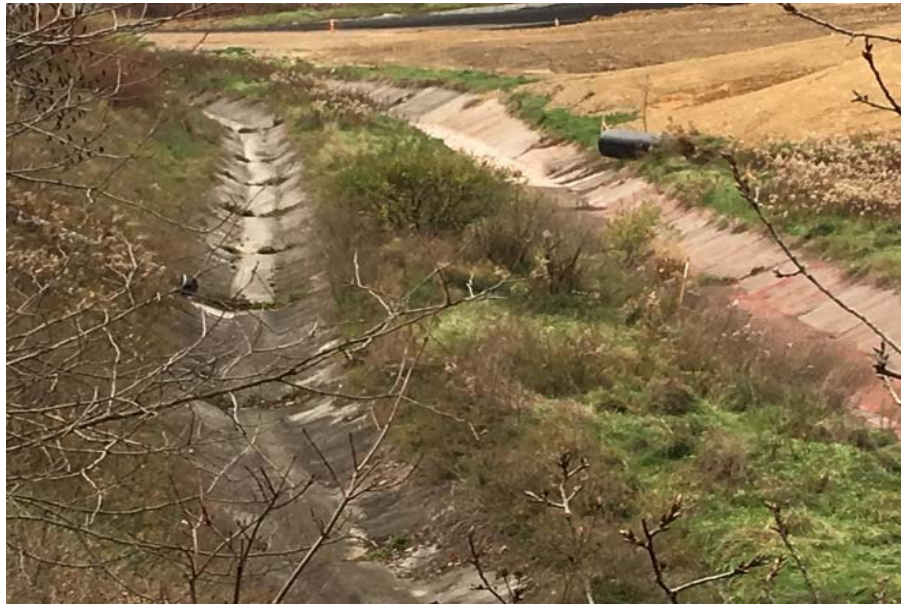
Photograph No. 15

Perimeter stormwater drainage channels along eastern limits of Stage II disposal area. "Non-contact" channel shown on left. "Contact" channel (painted red) shown on right.

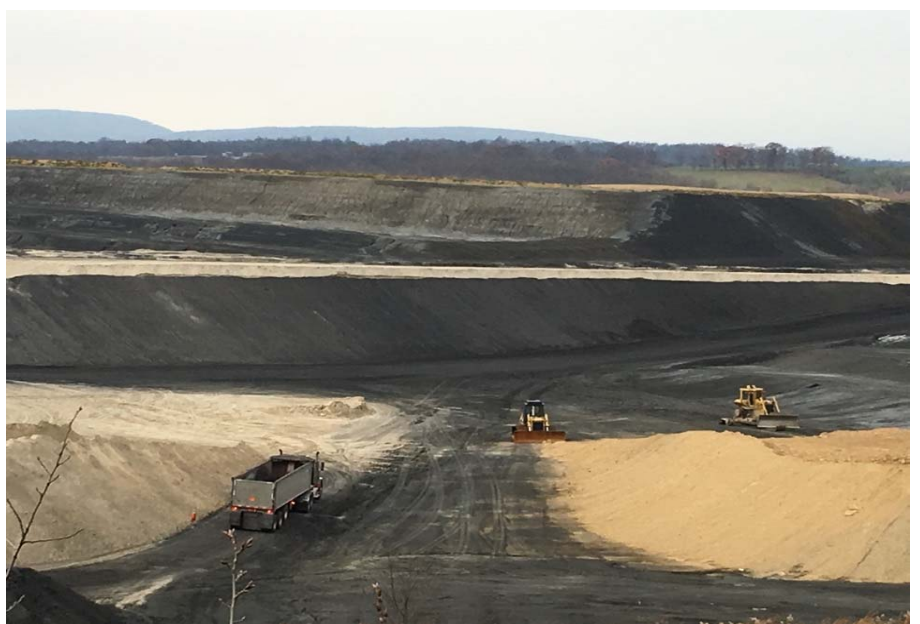
Photograph No. 16

Designated gypsum staging in active filling area of Stage II. No evidence of erosion or airborne dust.

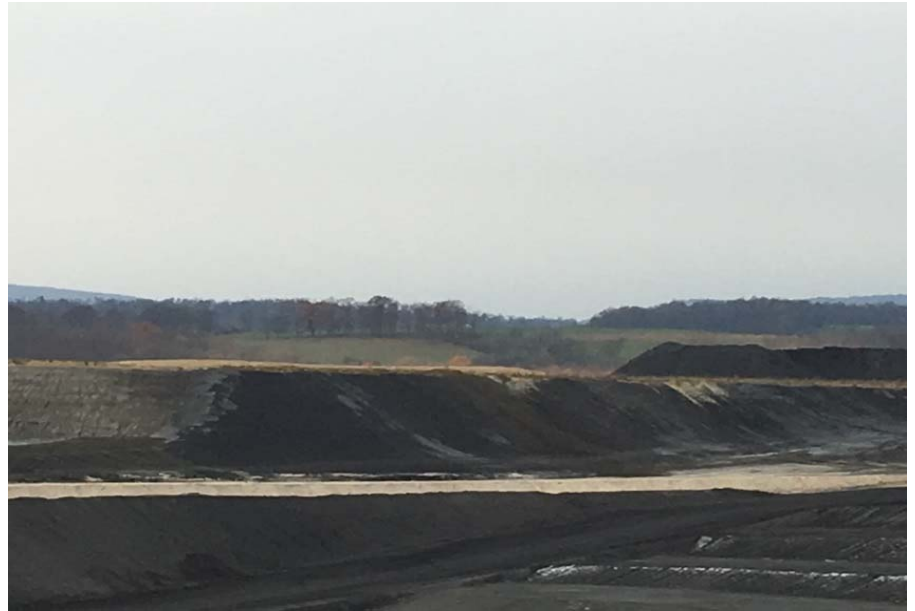
Photograph No. 17

Active filling operations within Stage II showing coal ash bench. No evidence of erosion or airborne dust.

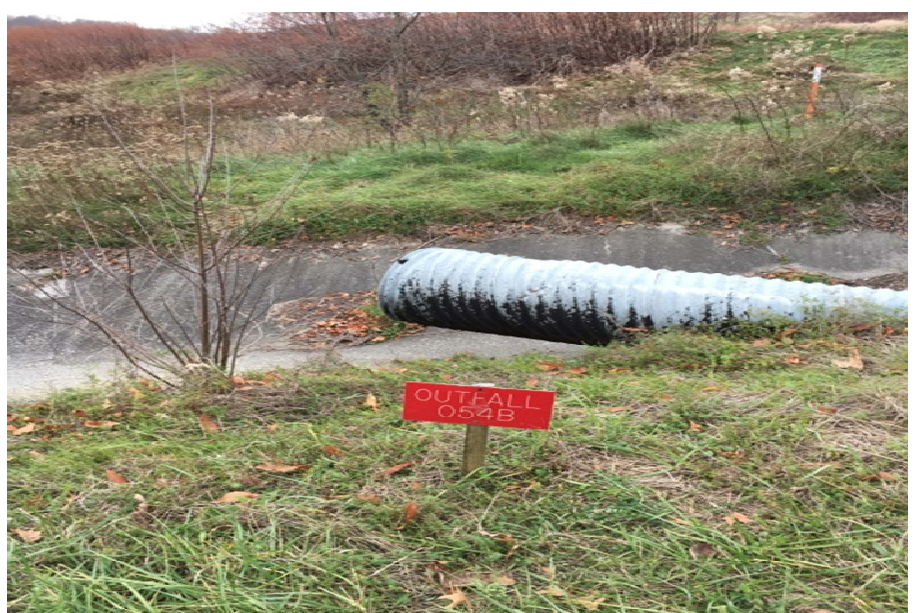
Photograph No. 18

"Non-contact" stormwater outfall into perimeter channel. No evidence of erosion or flow obstruction.

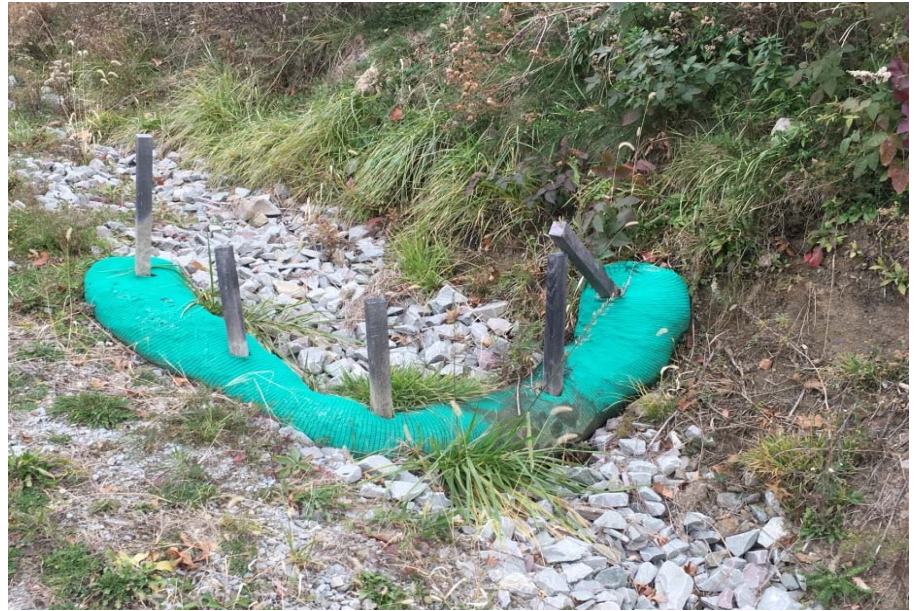
Photograph No. 19

Stormwater BMP in non-contact perimeter drainage channel. No evidence of erosion or malfunction.

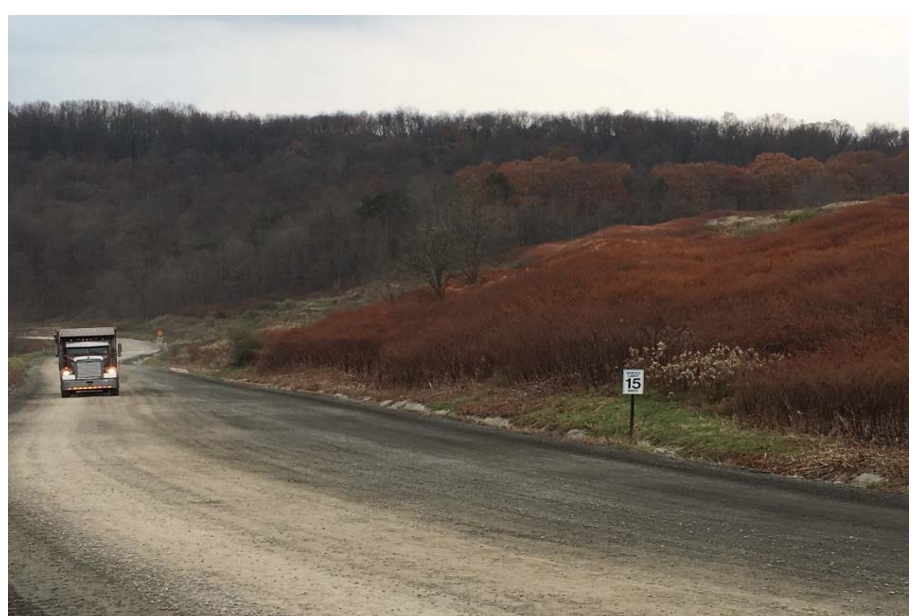
Photograph No. 20

View from southern side of haul road into Stage II disposal area. Well maintained with speed limit enforced.

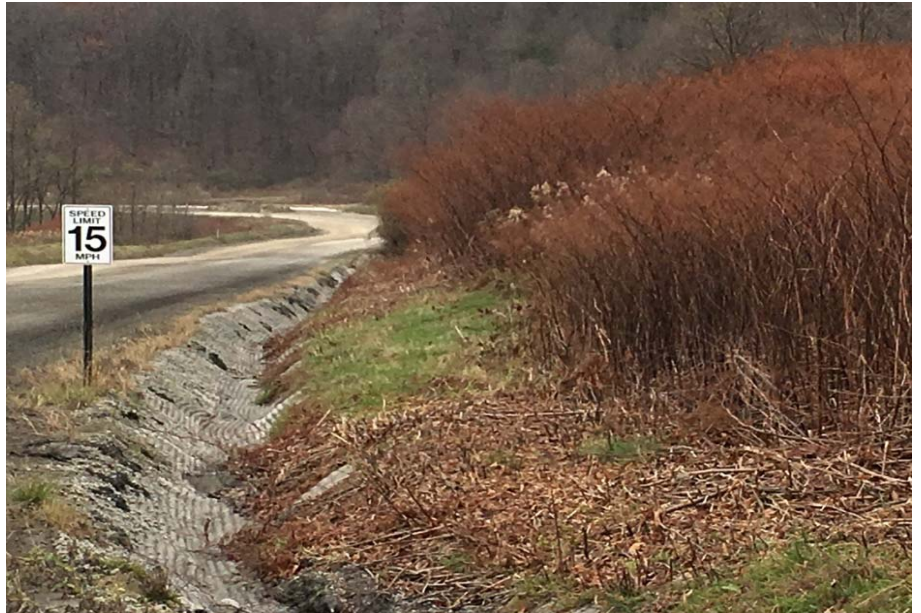
Photograph No. 21

“Contact” stormwater channel along northern side of Stage II haul road, lined with fabric-formed concrete. No evidence of erosion or obstructions.

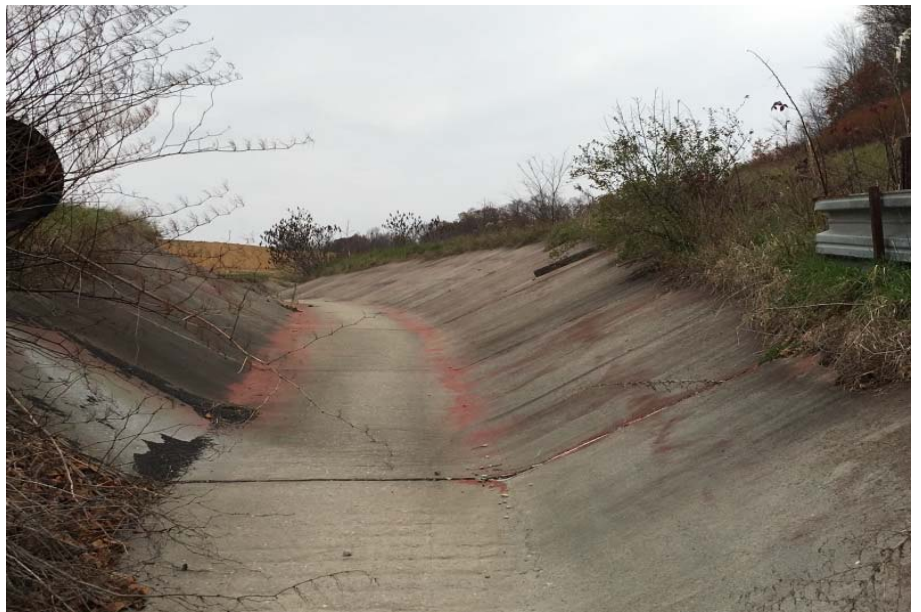
Photograph No. 22

Concrete-lined “contact” stormwater channel, painted red for identification. No evidence of obstructions.

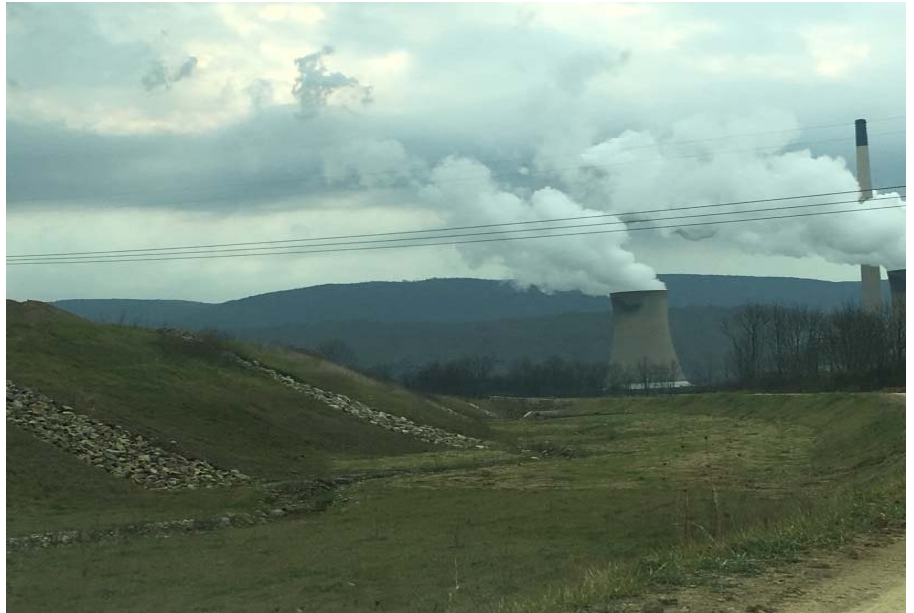
Photograph No. 23

Stream relocation to support ongoing Stage III development; rip-rap channels provide outlet from the newly constructed wetland mitigation area. No evidence of erosion or malfunction.

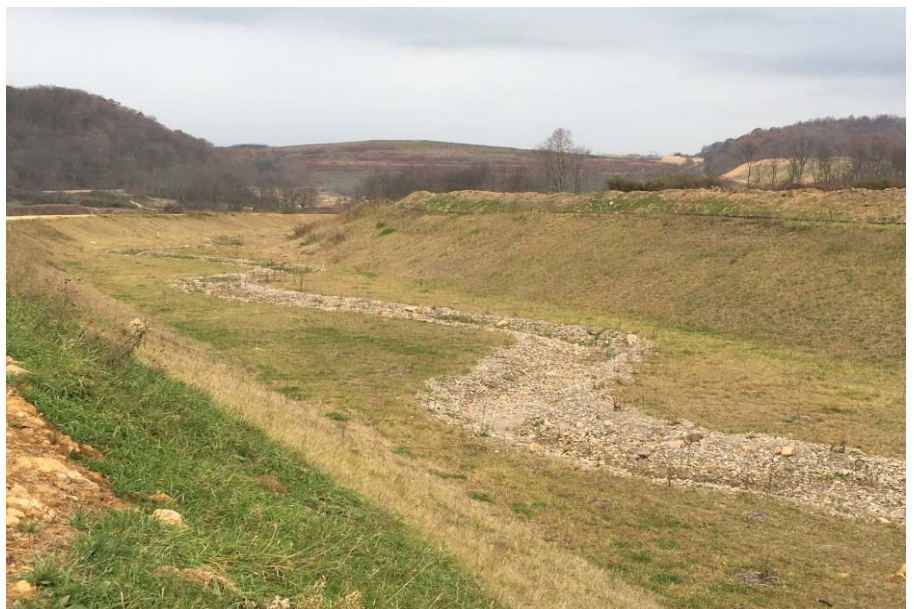
Photograph No. 24

Stream relocation to support Stage III development. No evidence of erosion or obstruction.

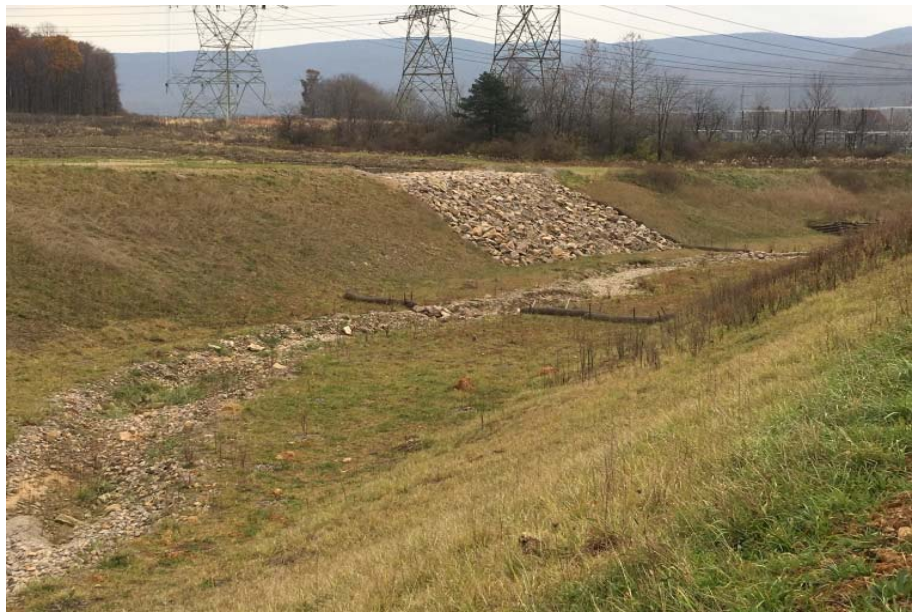
Photograph No. 25

Stream relocation to support Stage III development. No evidence of erosion or obstruction.
