## Inspection Report

**To:** Paul Orban (Conemaugh Generating Station)  
**From:** Richard Southorn, P.E., P.G., CPSWQ  
**Re:** Ash/Refuse Disposal Site – Annual CCR Unit Inspection Report  
**Inspection Date:** October 18, 2017  
**Report Date:** January 16, 2018

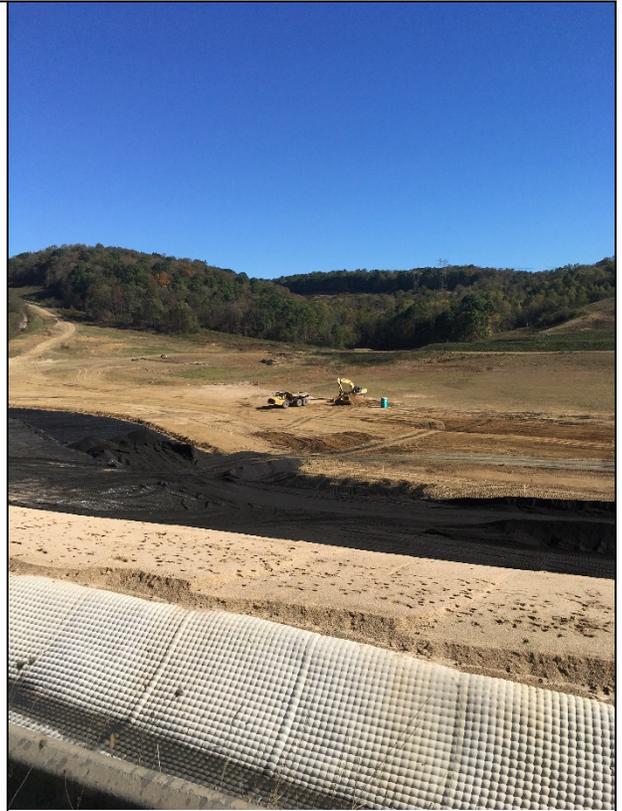
**Photograph No. 1**

Overview of Stage III construction area. In background, soil excavation is occurring in advance of base liner construction that will take place in 2018. An excavator is loading an off-road haul truck with excavated soils. In the midground, bottom ash is being placed over the composite liner system that was installed as part of 2017 construction. A lined non-contact stormwater channel is shown in the foreground.

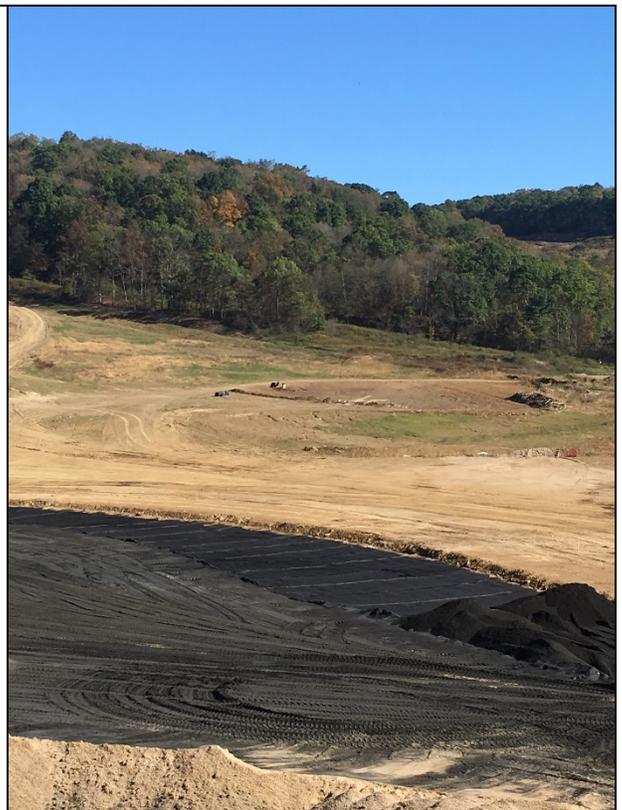
**Photograph No. 2**

Overview of Stage III area showing bottom ash being installed over the footprint of the composite liner system that was constructed in 2017.

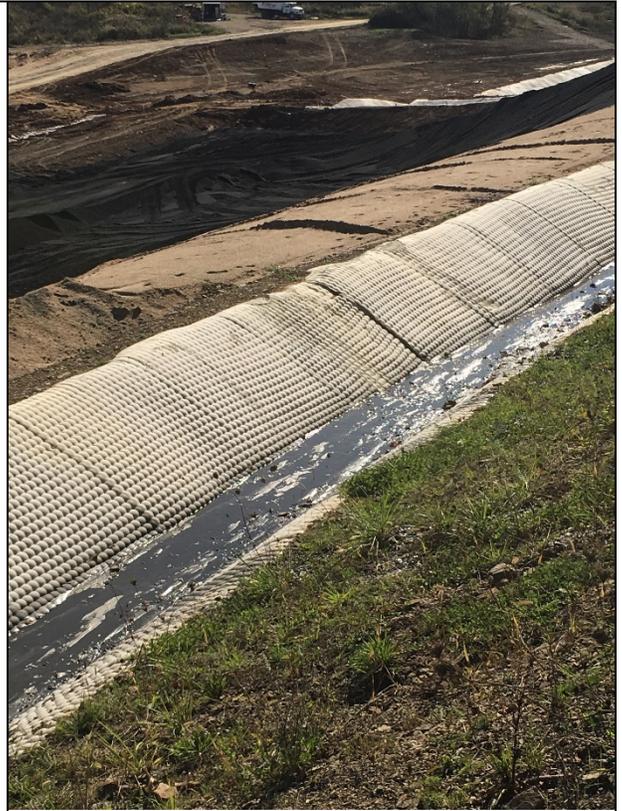
**Photograph No. 3**

Non-Contact stormwater channel. The channel is lined with revetment mat and is free of obstruction.

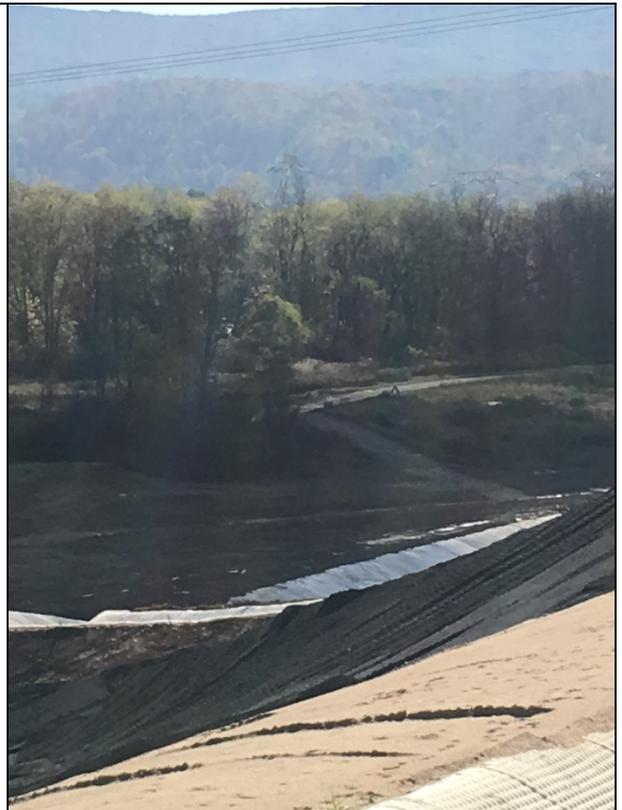
**Photograph No. 4**

Overlooking contact stormwater channel surrounded by bottom ash (channel has a white revetment lining).

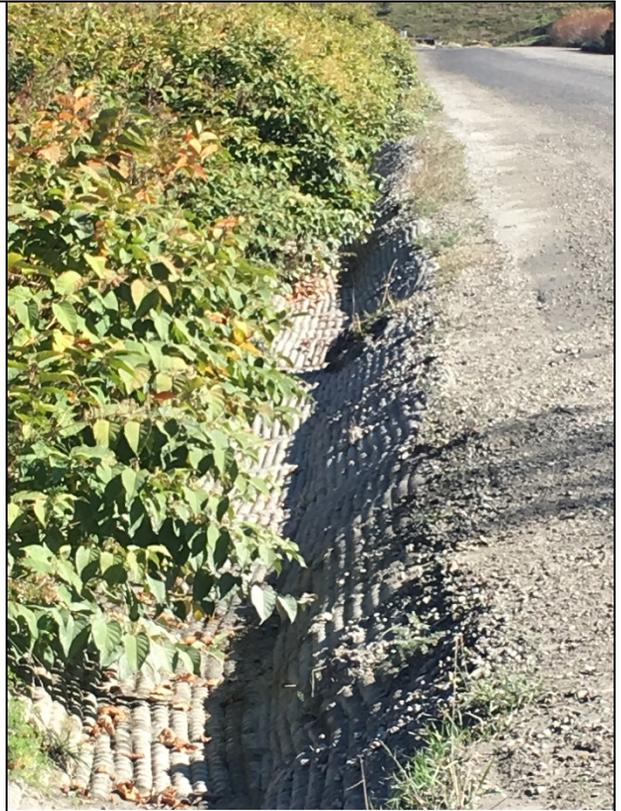
**Photograph No. 5**

Non-contact stormwater channel located on inside toe of access road that runs through the southern portion of the Stage II area. Channel is free of obstruction and in good condition.

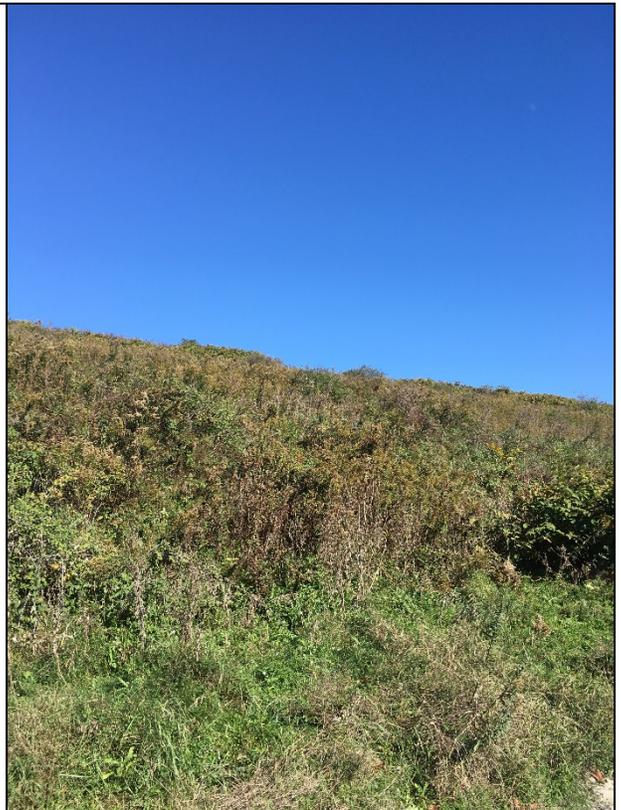
**Photograph No. 6**

Vegetation on Stage II intermediate cover area. Vegetation is well established. Slopes show no evidence of erosion, sloughing, or other signs of instability.

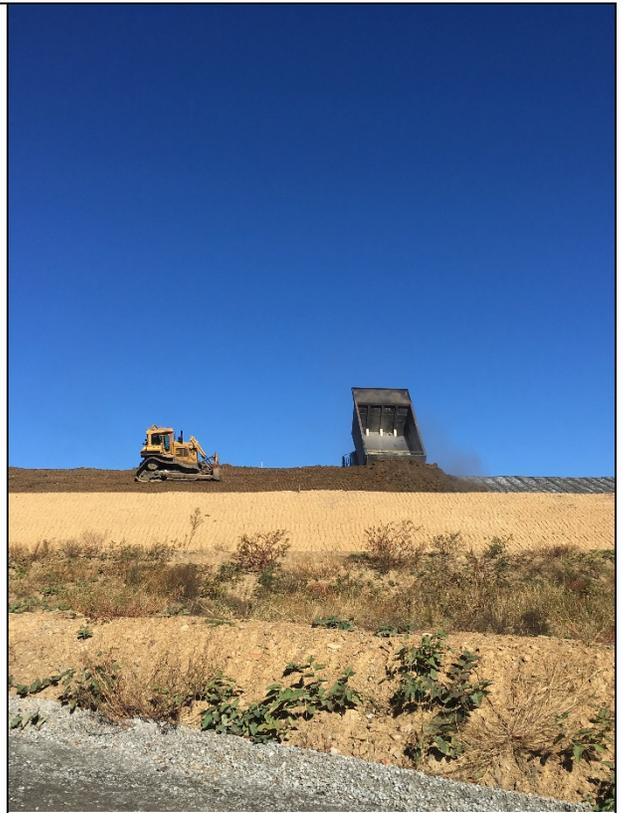
**Photograph No. 7**

Stage II cover placement. Photo shows geosynthetics, protective soils, and topsoil being placed. Material is stable and appropriately placed. No erosion rills or rutting are observed.

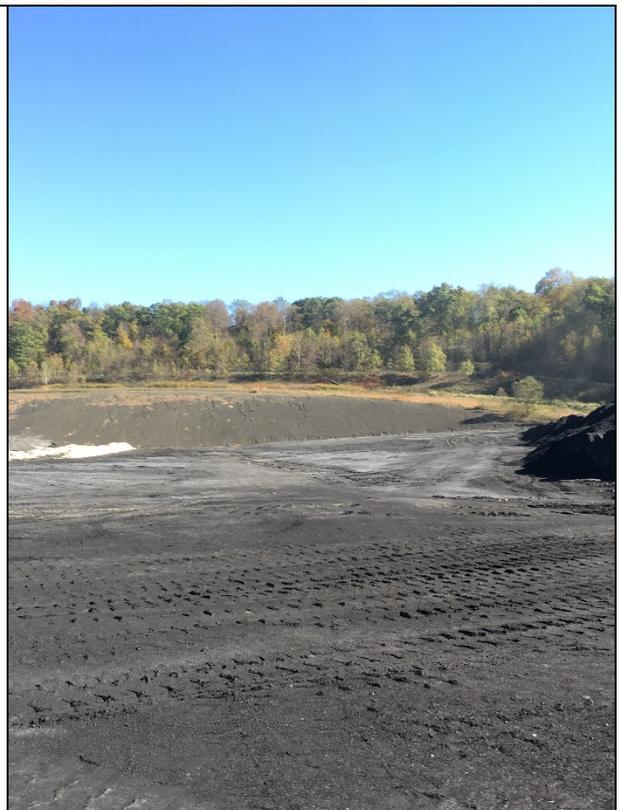
**Photograph No. 8**

Stage II active area. Material is placed in uniform lifts with no ponding water or areas showing potential for future stability issues.

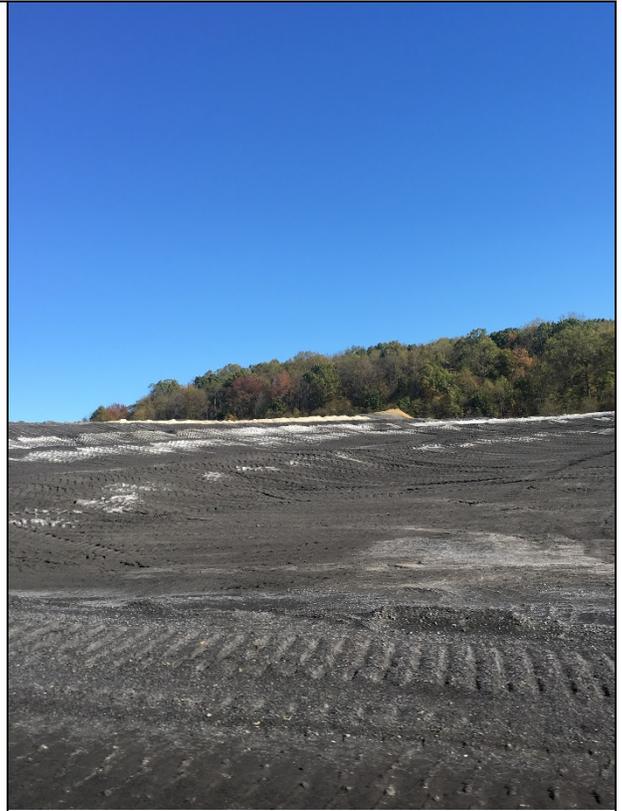
**Photograph No. 9**

Stage II active area. Area is well maintained with no evidence of ponding water or stability concerns.

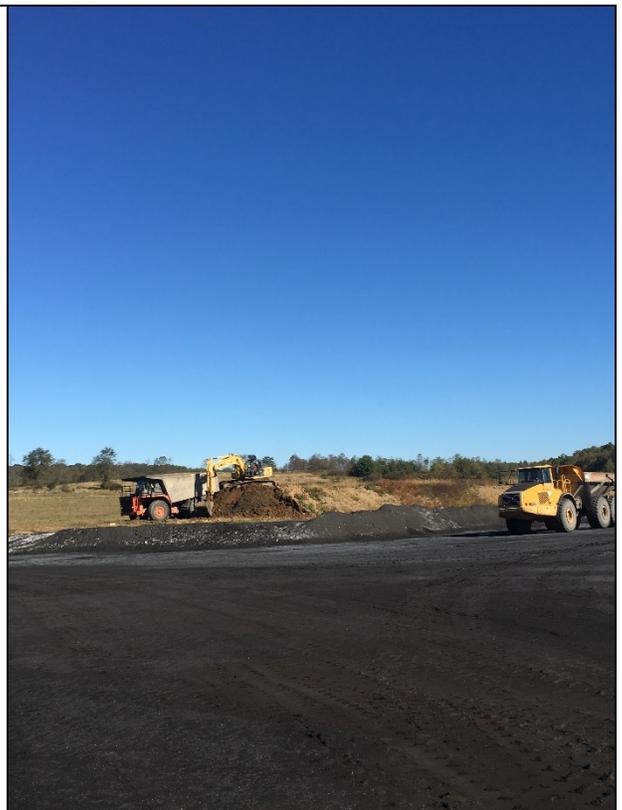
**Photograph No. 10**

Stage II active area in foreground. Area is well maintained with no evidence of ponding water or stability concerns.

Soil stockpile area shown in background that is being used for intermediate cover construction.

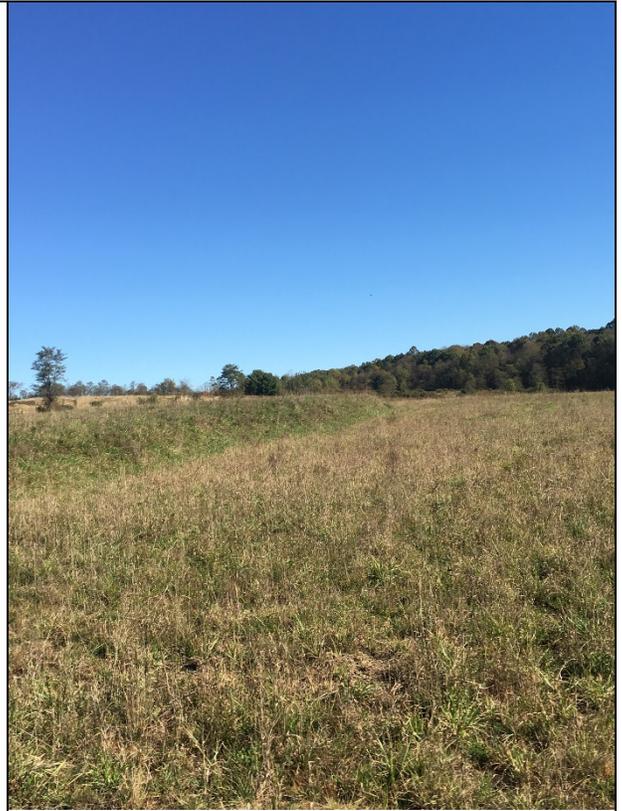
**Photograph No. 11**

Stage II intermediate cover area. Vegetation is healthy with no bare areas. No evidence of instability or erosion.

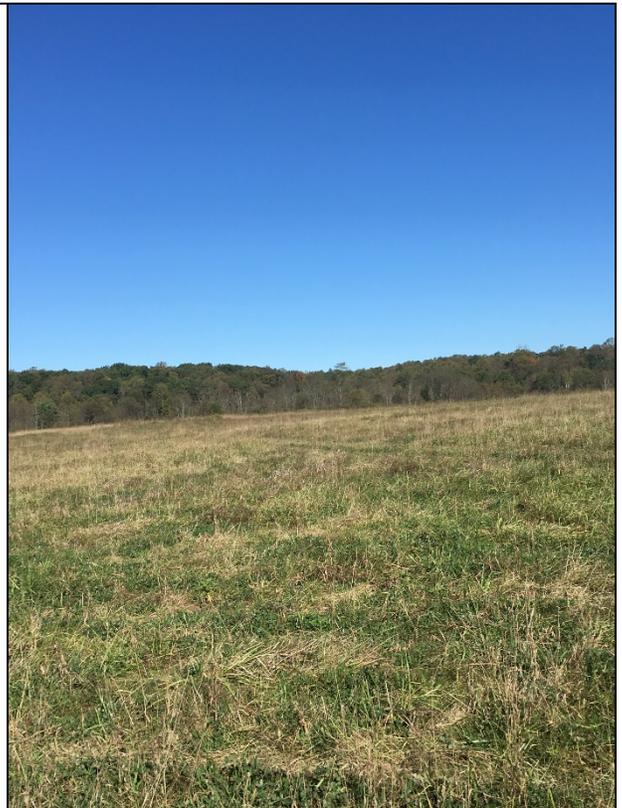
**Photograph No. 12**

Stage II intermediate cover area. Vegetation is healthy with no bare areas. No evidence of instability or erosion.

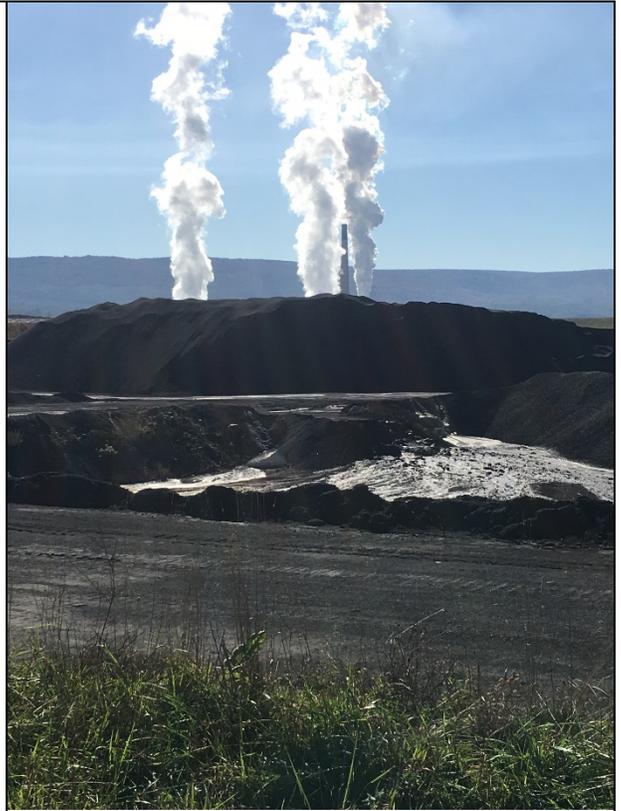
**Photograph No. 13**

Bottom ash stockpile that will be placed on the composite liner system of Stage III.

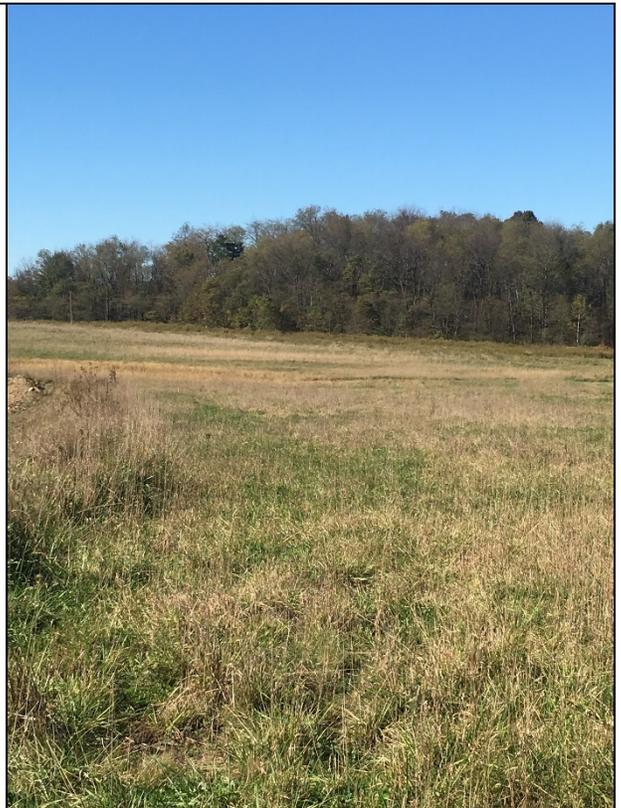
**Photograph No. 14**

Stage II intermediate cover area. Vegetation is healthy with no bare areas. No evidence of instability or erosion.

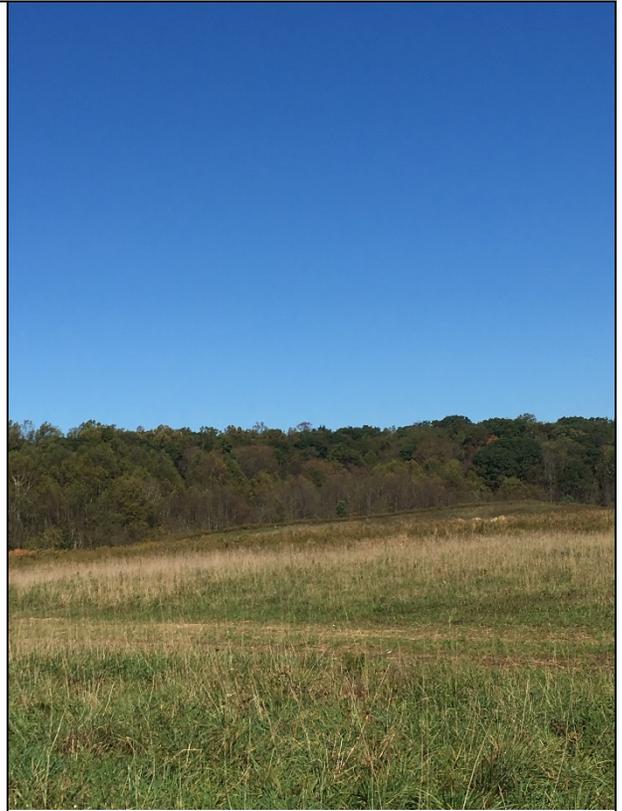
**Photograph No. 15**

Stage II intermediate cover area. Vegetation is healthy with no bare areas. No evidence of instability or erosion.

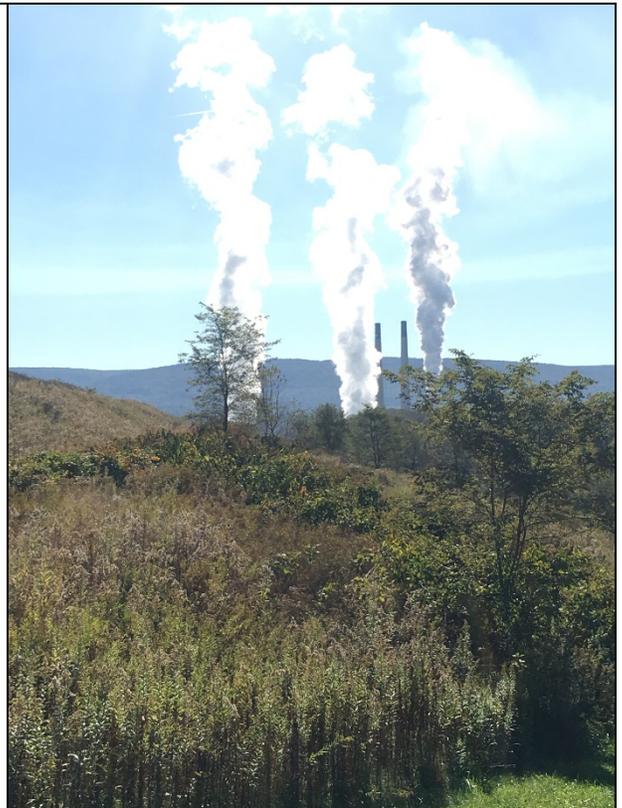
**Photograph No. 16**

Stage II intermediate cover area. Vegetation is healthy with no bare areas. No evidence of instability or erosion.

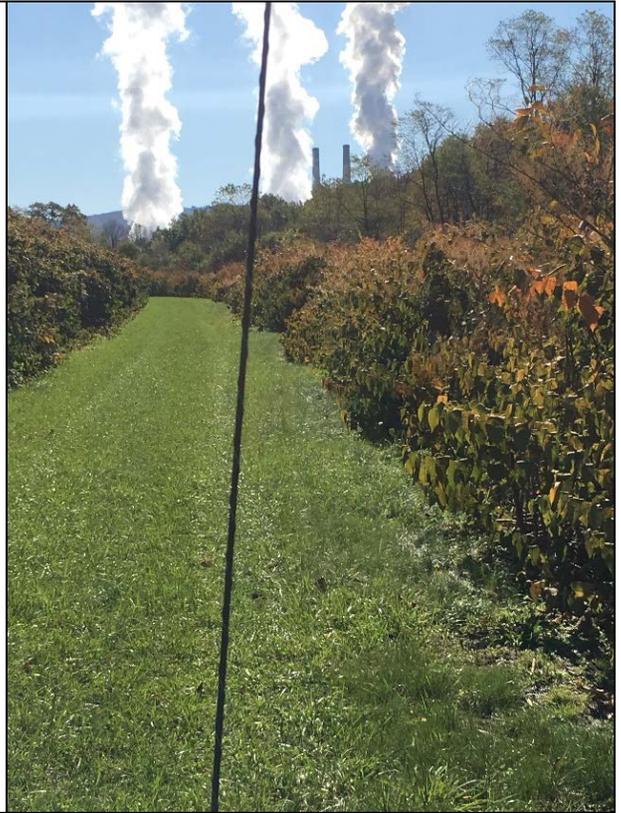
**Photograph No. 17**

Perimeter Road at base of Stage II. Road is well maintained.

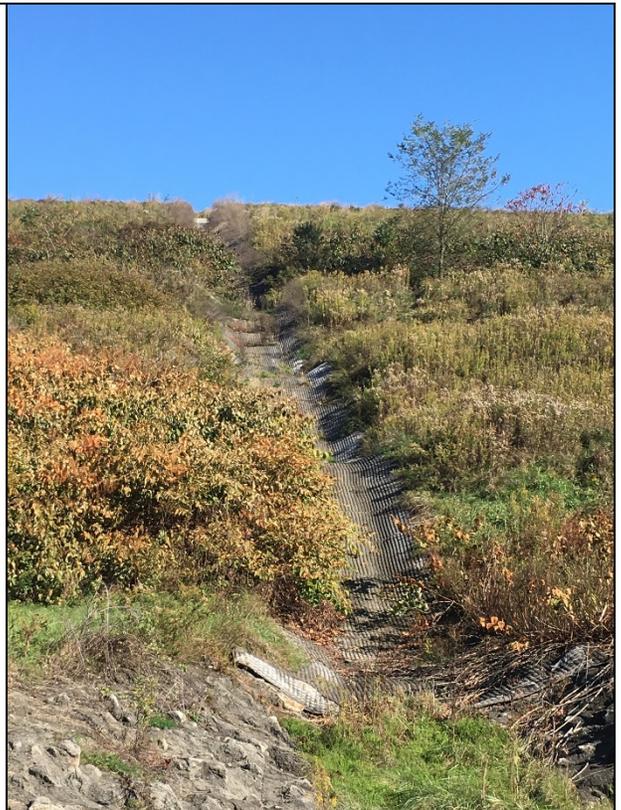
**Photograph No. 18**

Stage II downchute with revetment lining.

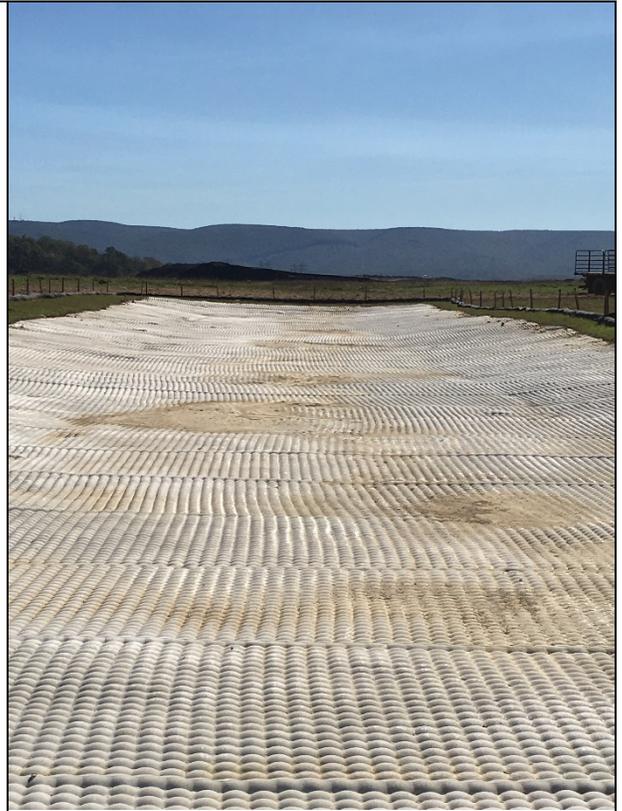
**Photograph No. 19**

Revetment mat installed on intermediate cover area of Stage I to improve drainage and eliminate water that was found to pond in this area. Construction completed in September 2017. Water is not ponding and construction appears to have effectively remediated drainage concern.

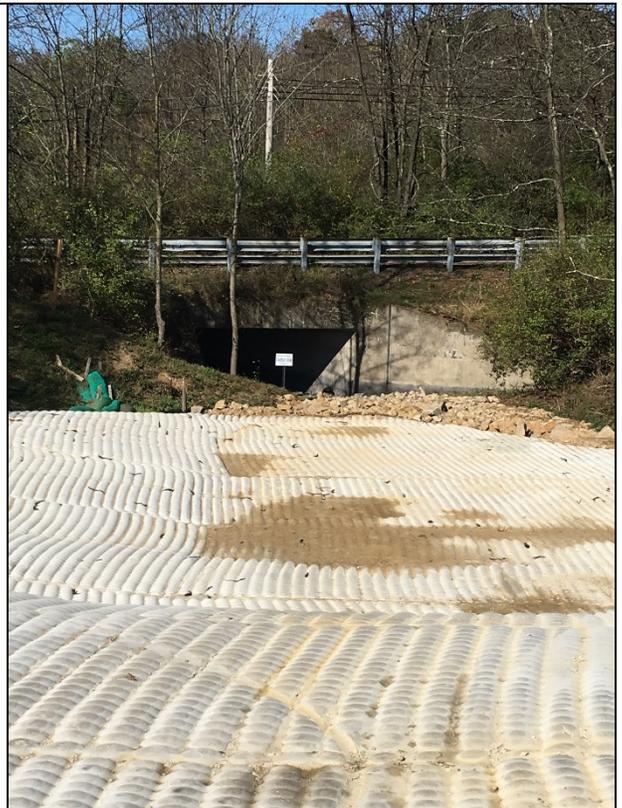
**Photograph No. 20**

Revetment mat described in Photograph No. 19 at its discharge point at Outfall 56.

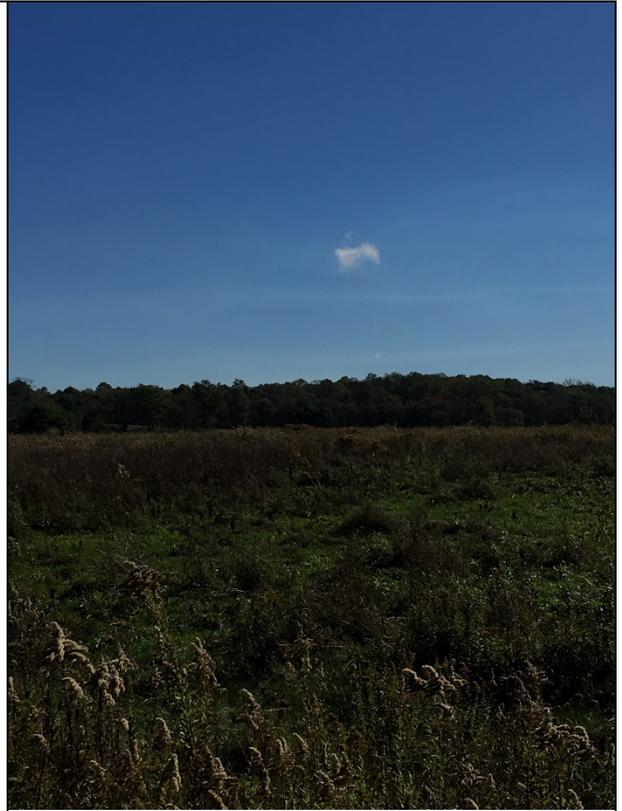
**Photograph No. 21**

Stage I cover showing healthy vegetation that has no bare spots. No evidence of erosion or signs of instability.

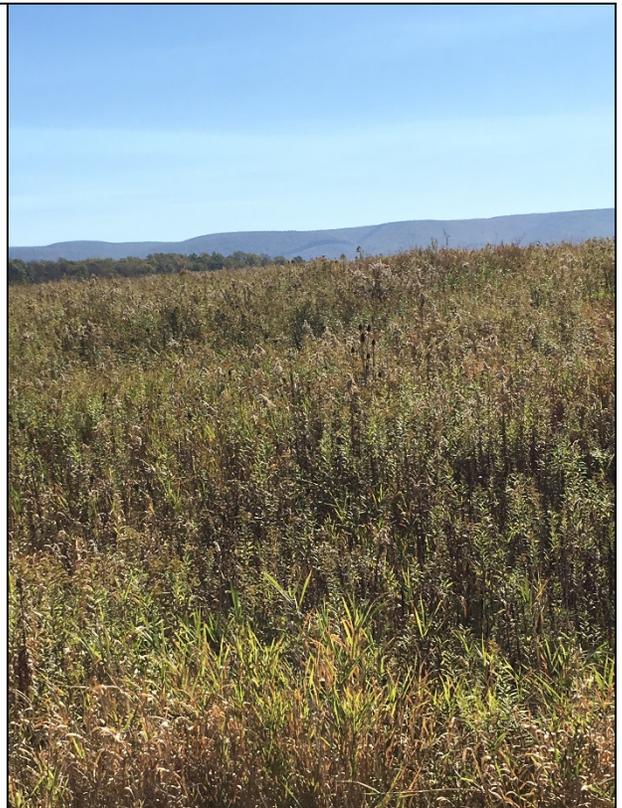
**Photograph No. 22**

Stage I cover showing healthy vegetation that has no bare spots. No evidence of erosion or signs of instability.

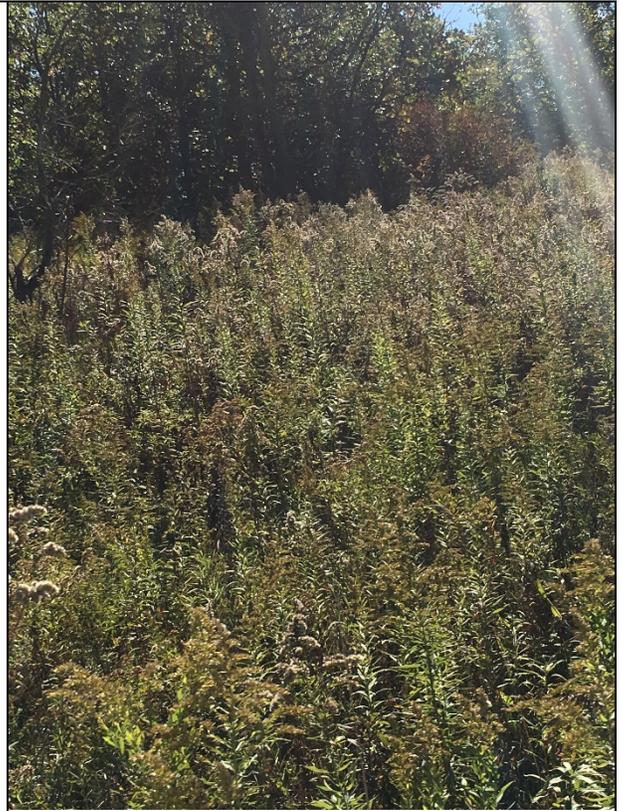
**Photograph No. 23**

Stage I cover showing healthy vegetation that has no bare spots. No evidence of erosion or signs of instability.

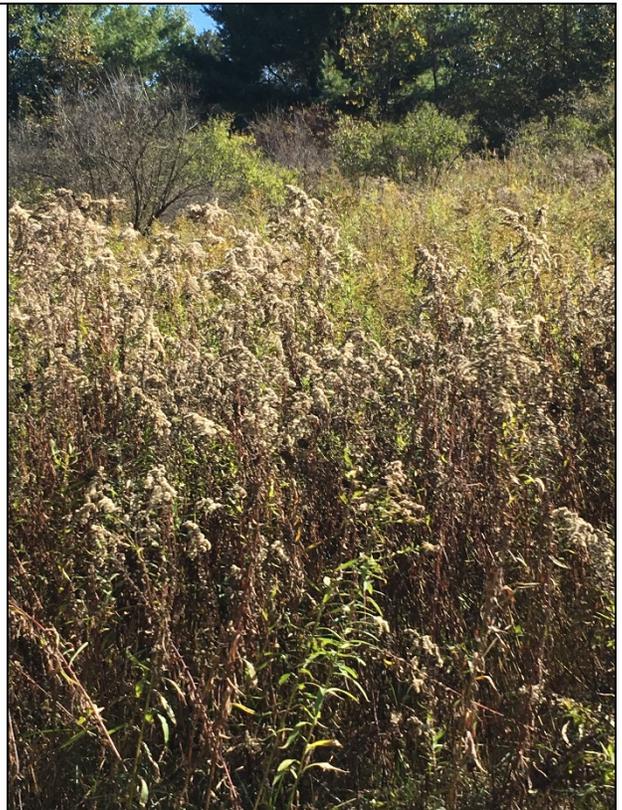
**Photograph No. 24**

Stage I cover showing healthy vegetation that has no bare spots. No evidence of erosion or signs of instability.

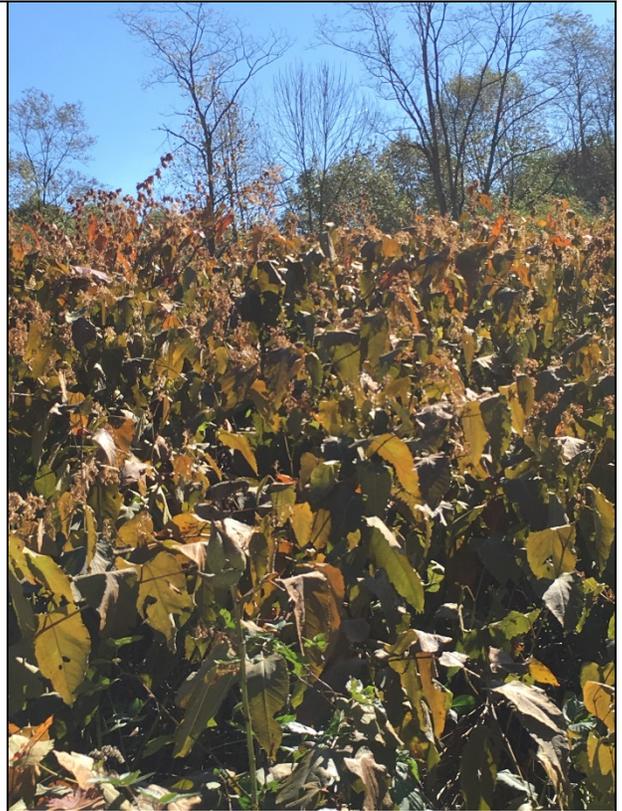
**Photograph No. 25**

Stage I cover showing healthy vegetation that has no bare spots. No evidence of erosion or signs of instability.

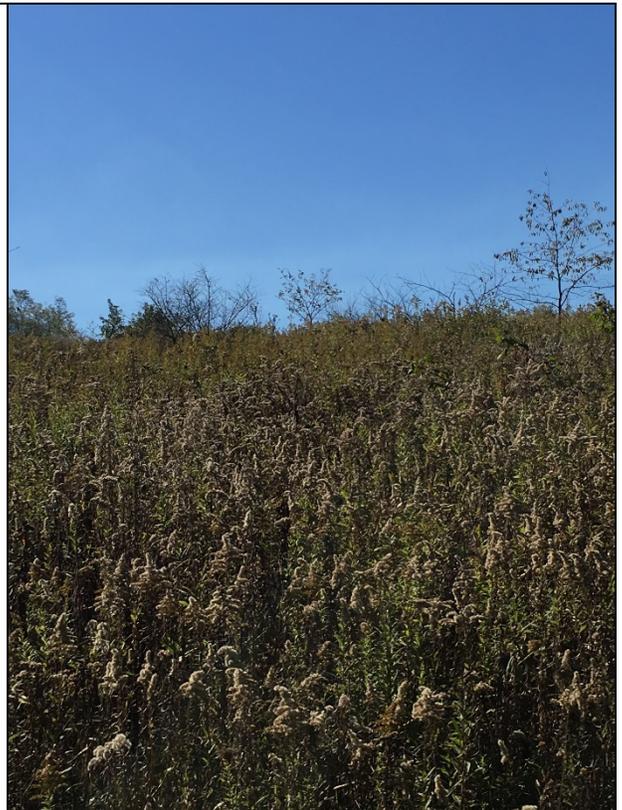
**Photograph No. 26**

Stage I cover showing healthy vegetation that has no bare spots. No evidence of erosion or signs of instability.

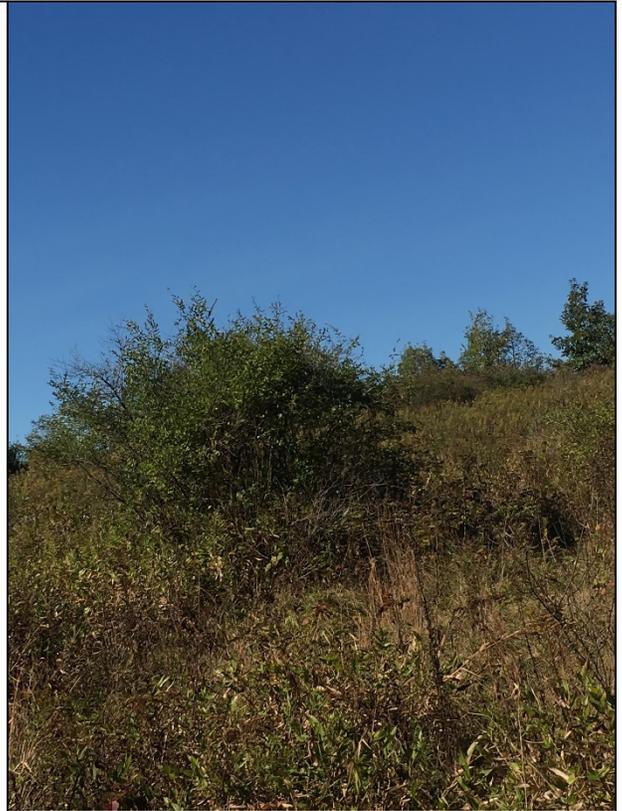
**Photograph No. 27**

Stage I cover showing healthy vegetation that has no bare spots. No evidence of erosion or signs of instability.

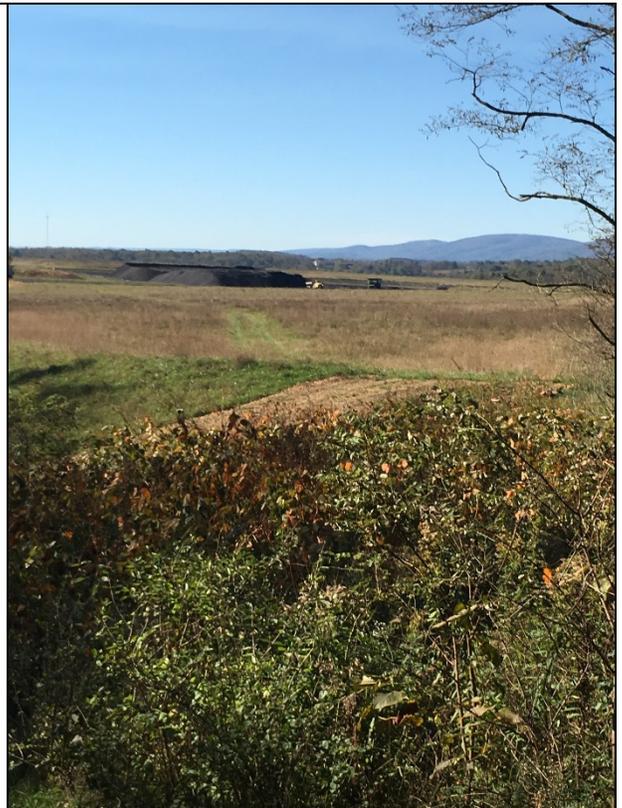
**Photograph No. 28**

Stage I cover in the foreground and Stage II intermediate cover in background. View of Stage II active area in the distance. Cover areas showing healthy vegetation that has no bare spots. No evidence of erosion or signs of instability.

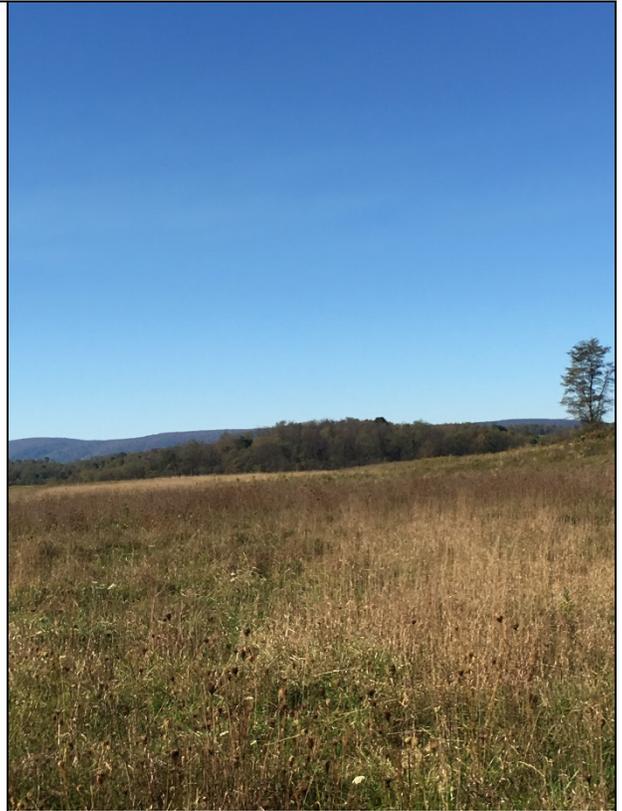
**Photograph No. 29**

Stage II intermediate cover showing healthy vegetation that has no bare spots. No evidence of erosion or signs of instability.

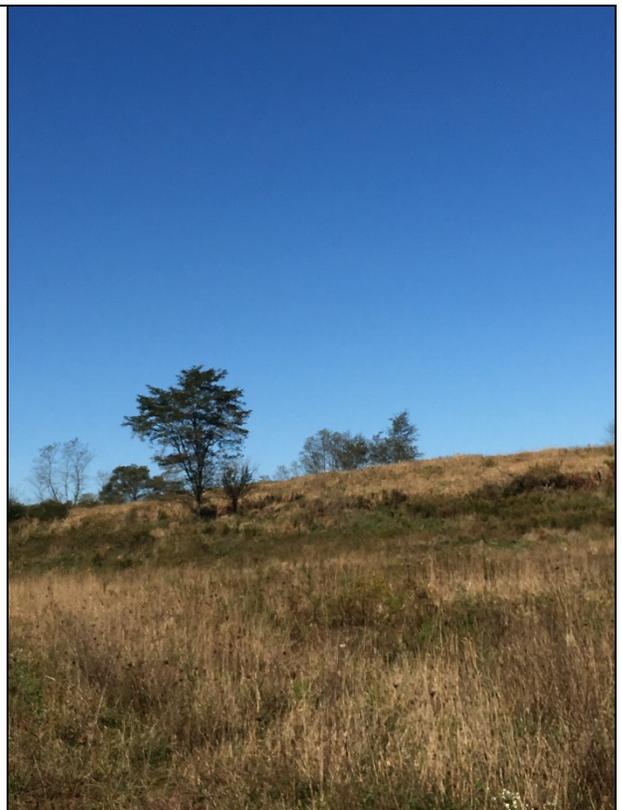
**Photograph No. 30**

Stage II intermediate cover showing healthy vegetation that has no bare spots. No evidence of erosion or signs of instability.

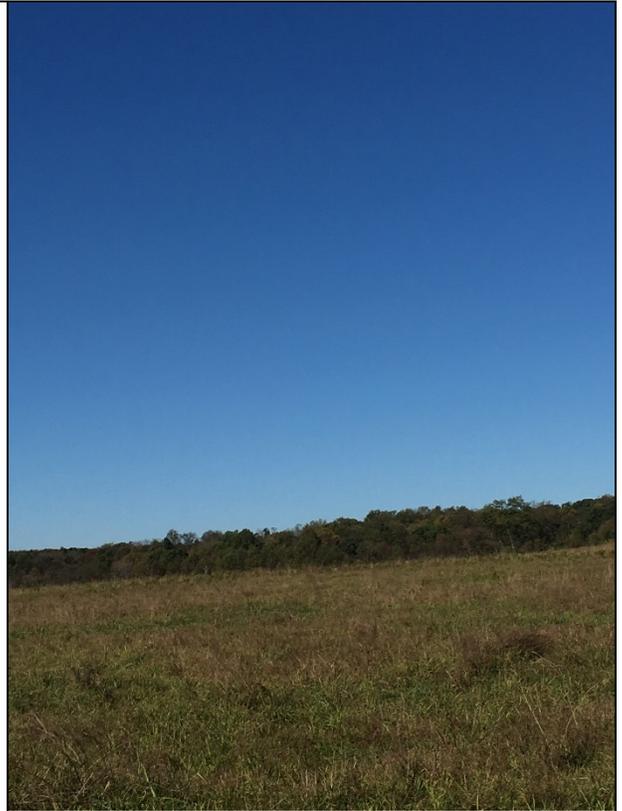
**Photograph No. 31**

Stage II intermediate cover showing healthy vegetation that has no bare spots. No evidence of erosion or signs of instability.

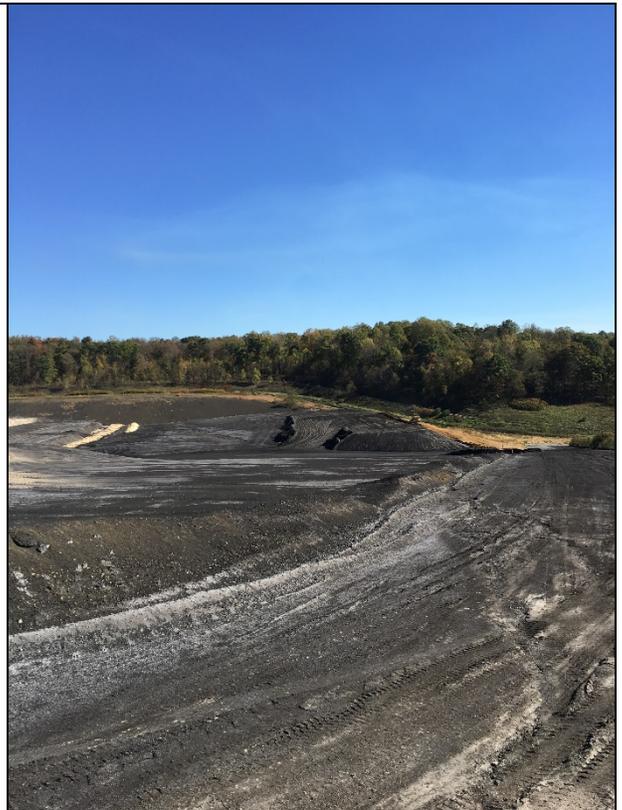
**Photograph No. 38**

Stage II active area. Well maintained. No ponding.

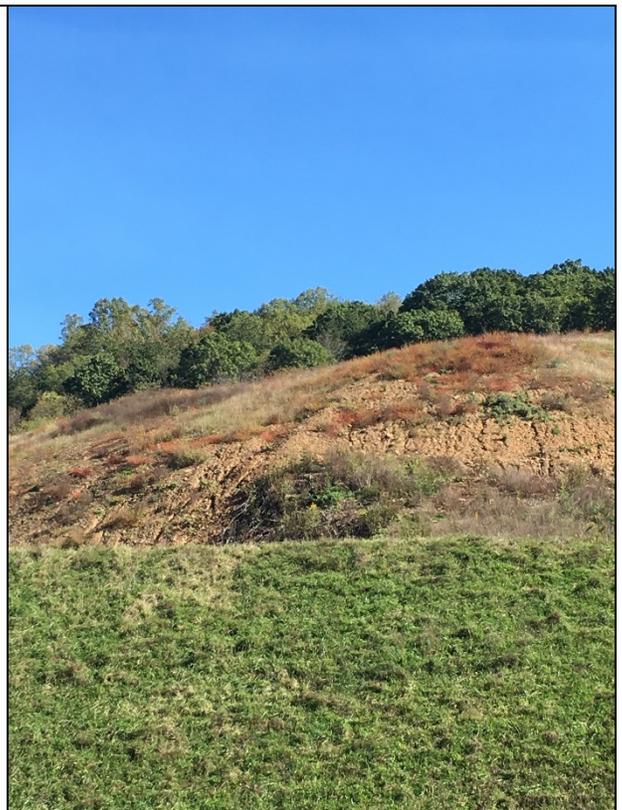
**Photograph No. 44**

Soil borrow pile. Some erosion, but does not impact landfill safety or design.

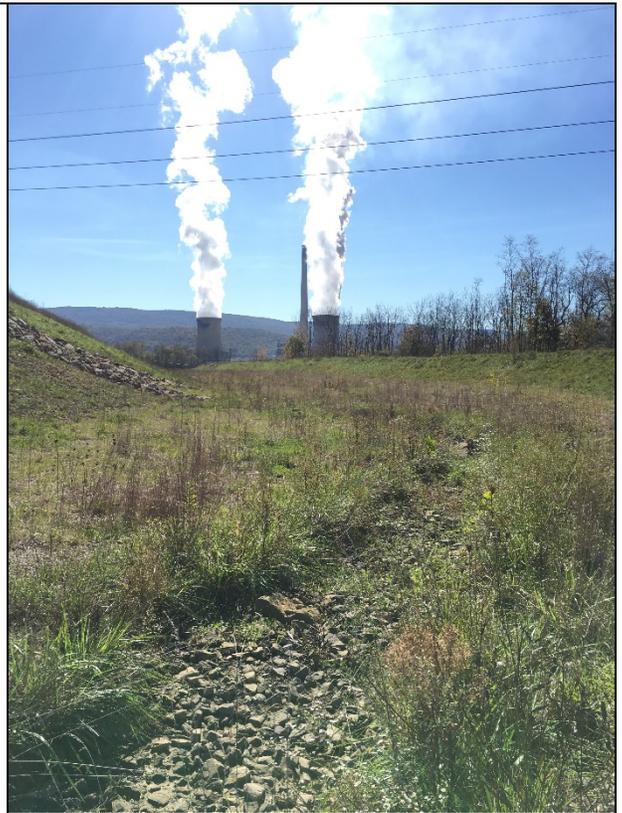
**Photograph No. 45**

Stream constructed to divert run-on into Stage III. Vegetation is well established.

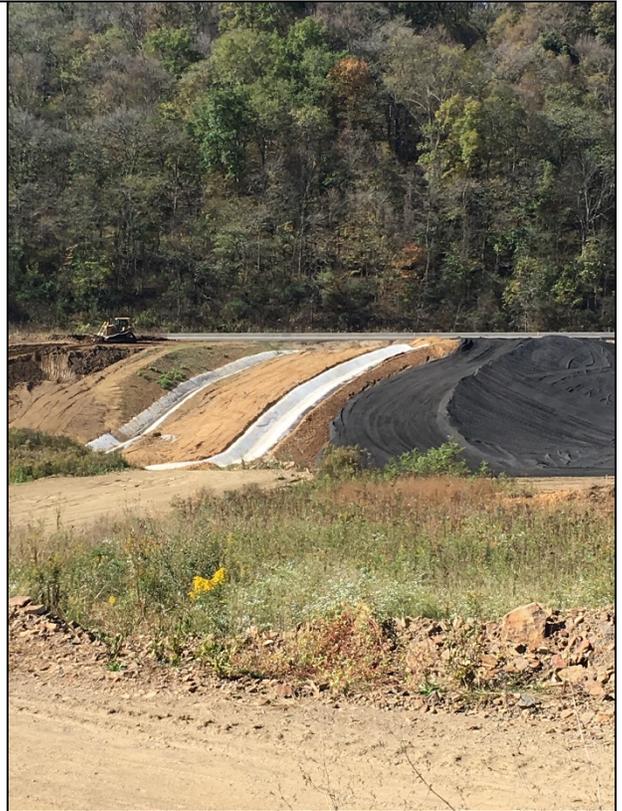
**Photograph No. 47**

Contact stormwater channel. Free of debris.

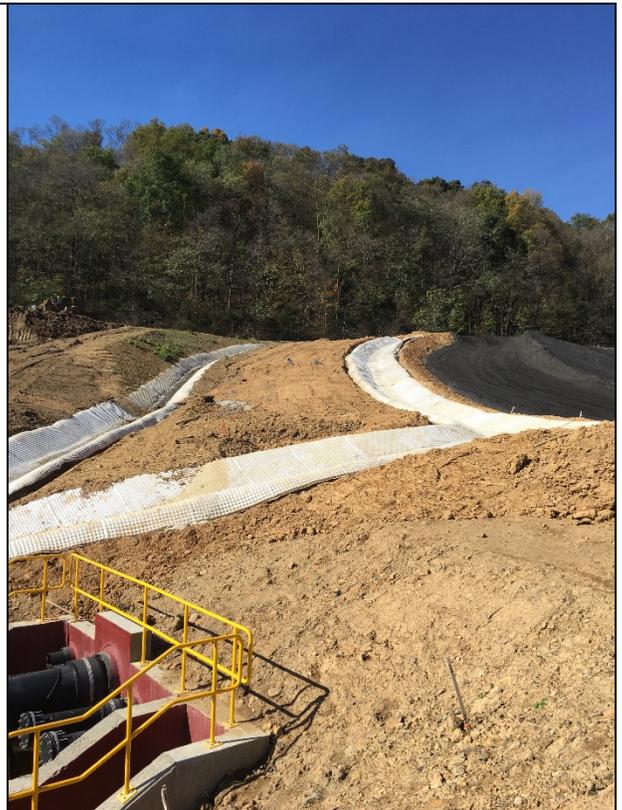
**Photograph No. 48**

Contact stormwater channels – will be toe of slope of Phase IIIA once CCR material is placed.
