Inspection Report

To: John Shimshock (Conemaugh Generating Station)
From: Richard Southorn, P.E., P.G.
Re: Ash/Refuse Disposal Site – Annual CCR Unit Inspection Report
Inspection Date: October 23, 2018
Report Date: January 16, 2019

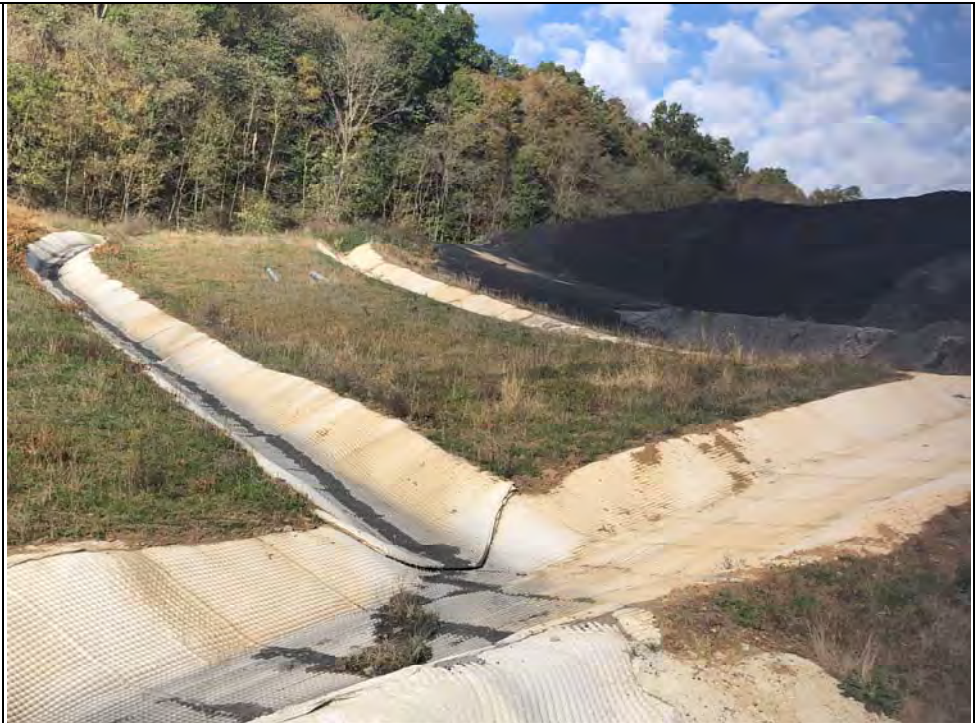
Image: 2612
Date: 10/23/2018
Time: 9:14 AM
Direction: West

Contact water channels –
at toe of slope of Phase
IIIA.

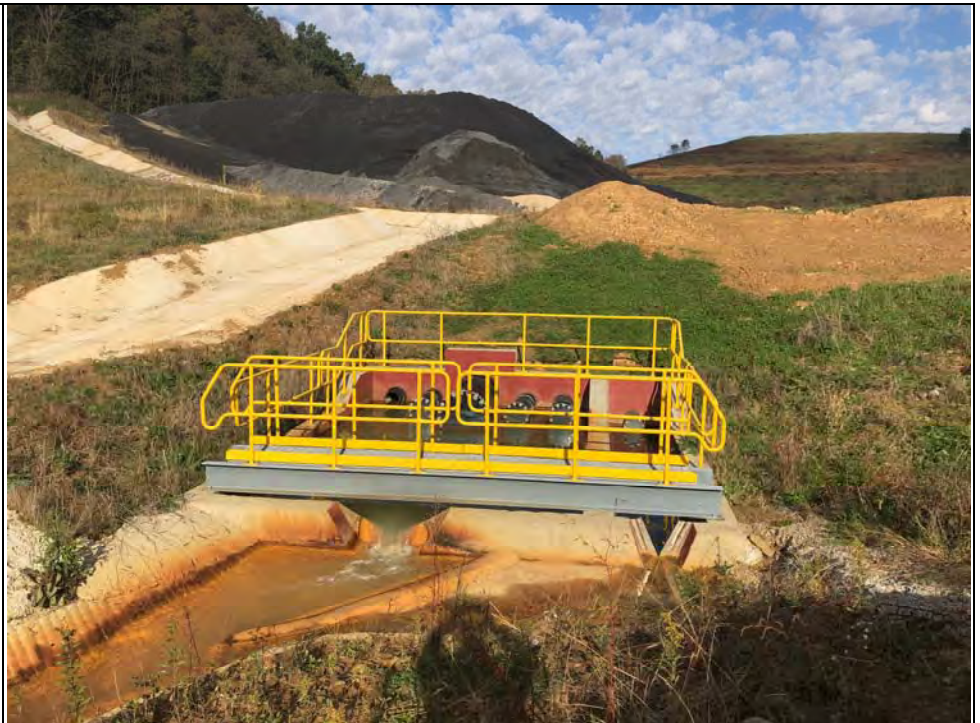
Image: 2614
Date: 10/23/2018
Time: 9:15 AM
Direction: Northwest

Leachate collection
pipes.

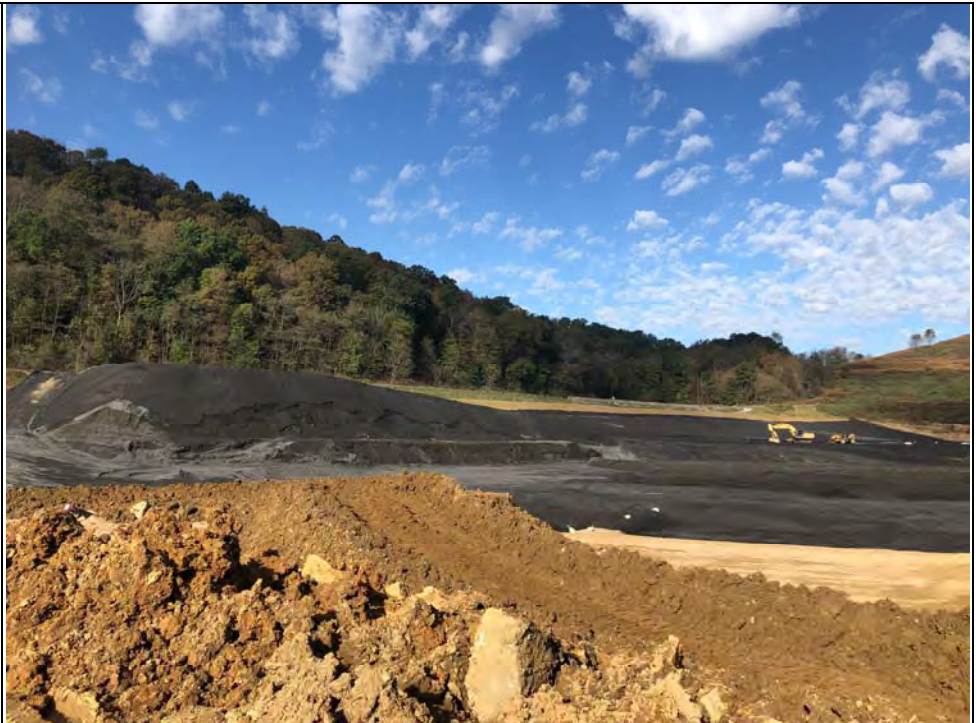
Image: 2618
Date: 10/23/2018
Time: 9:17 AM
Direction: West

Phase IIIA construction area, placing bottom ash material over the drainage layer.

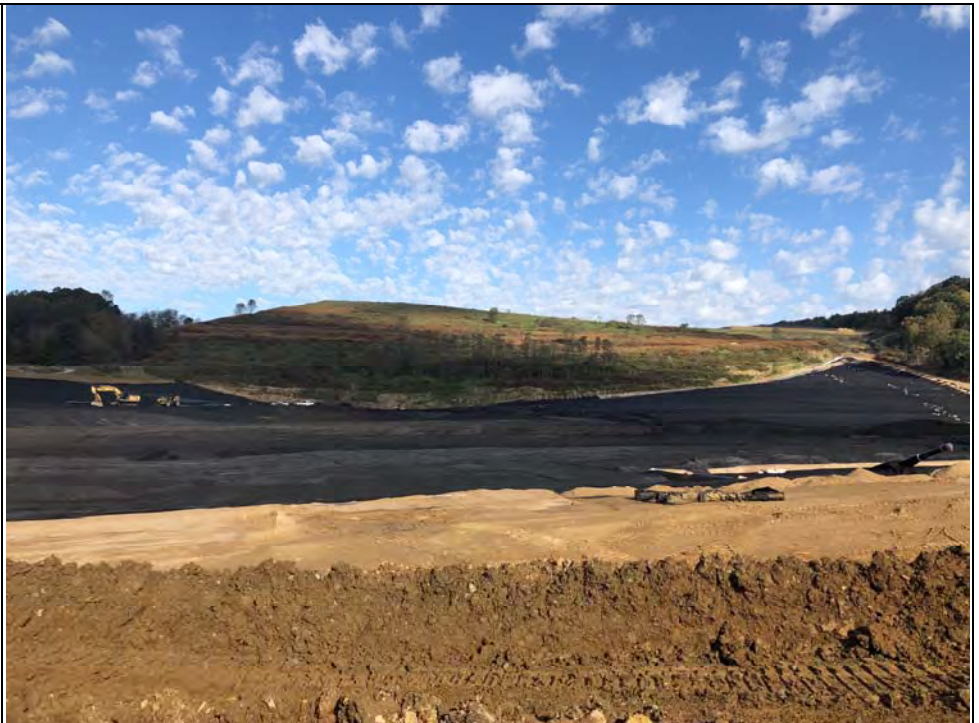
Image: 2620
Date: 10/23/2018
Time: 9:17 AM
Direction: North

Phase IIIA construction area, placing bottom ash material over the drainage layer.

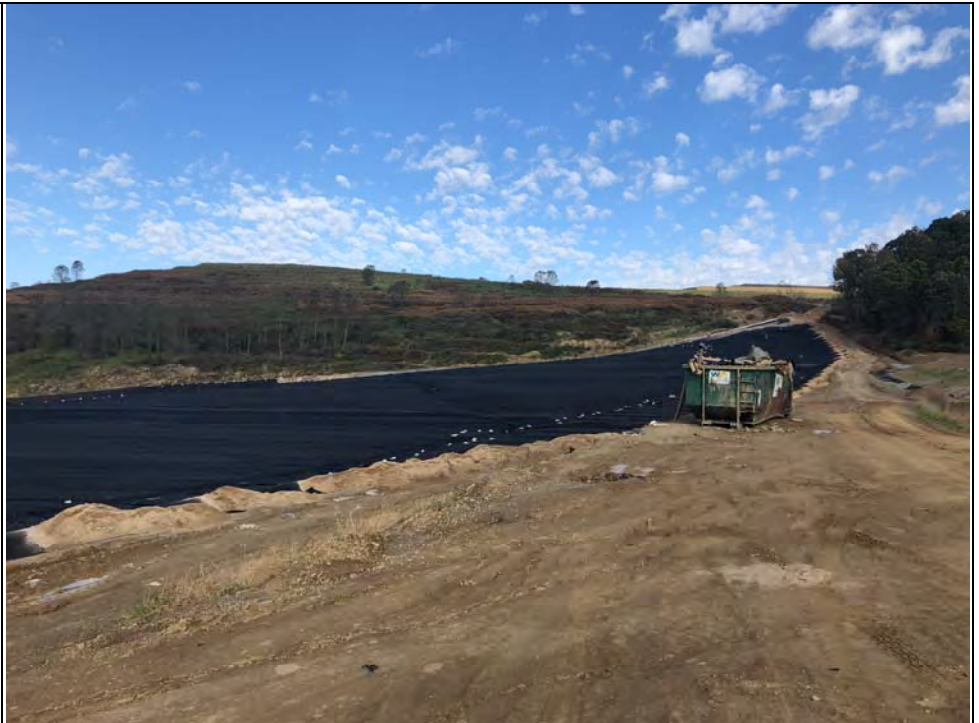
Image: 2630
Date: 10/23/2018
Time: 9:20 AM
Direction: Northwest

Western edge of Stage III construction. Geotextile component of Phase IIIA drainage layer being installed.

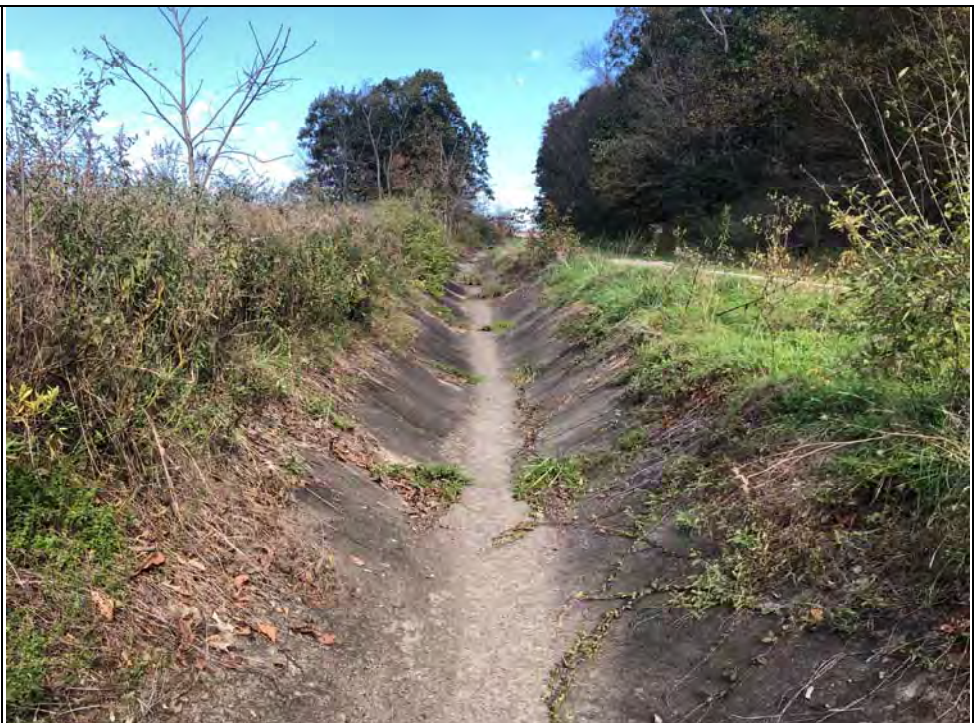
Image: 2632
Date: 10/23/2018
Time: 9:22 AM
Direction: Northwest

Stage II stormwater run-on diversion channel (non-contact water). Clear, free of obstructions.

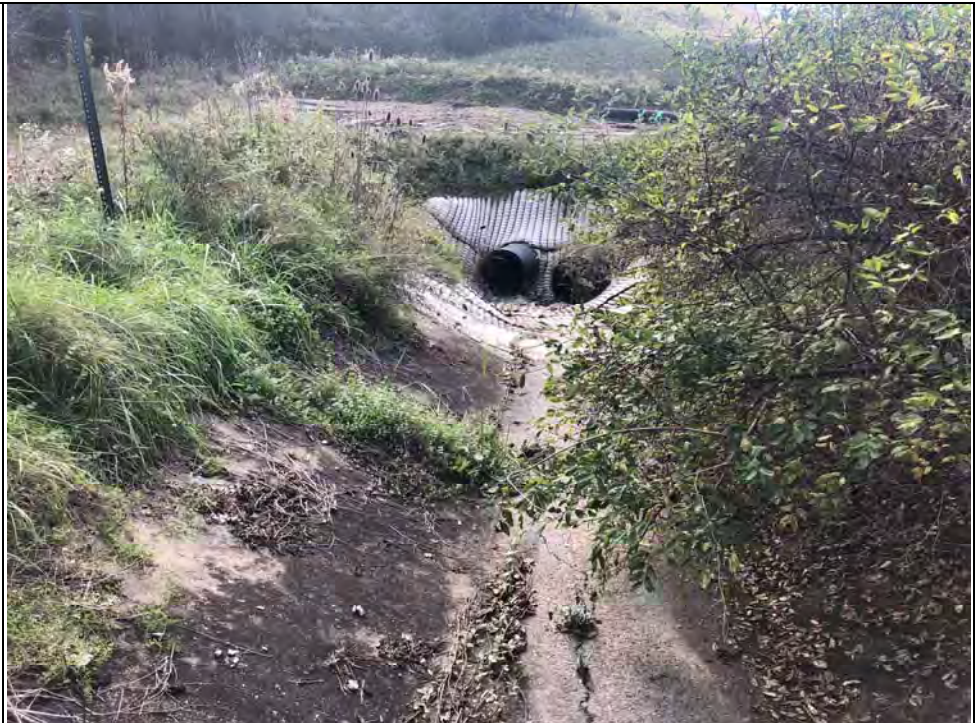
Image: 2634
Date: 10/23/2018
Time: 9:22 AM
Direction: Southeast

Stage II stormwater run-on diversion channel (non-contact water). Clear, free of obstructions.

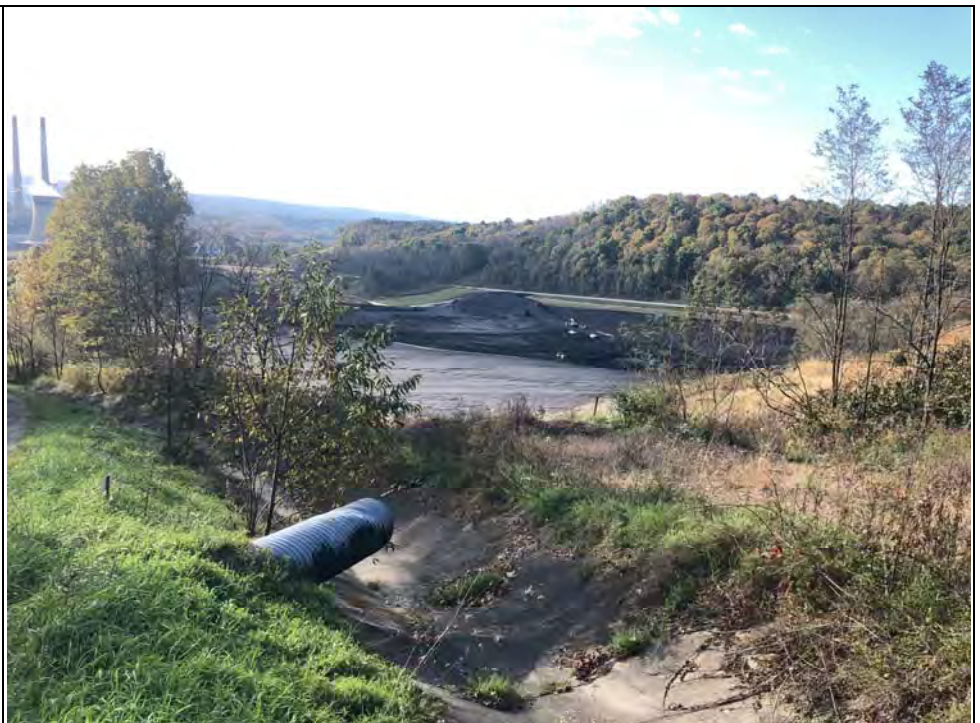
Image: 2636
Date: 10/23/2018
Time: 9:24 AM
Direction: South

Stage II stormwater run-on diversion channel (non-contact water). Clear, free of obstructions. Phase IIIA construction area in background.

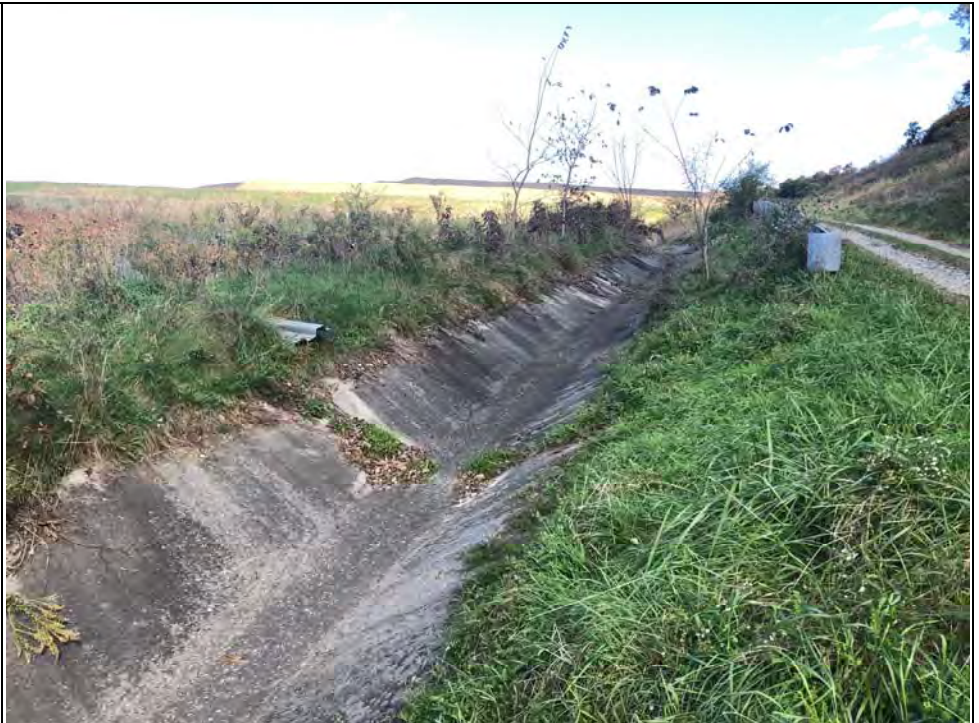
Image: 2638
Date: 10/23/2018
Time: 9:24 AM
Direction: Northwest

Stage II stormwater run-on diversion channel (non-contact water). Clear, free of obstructions.

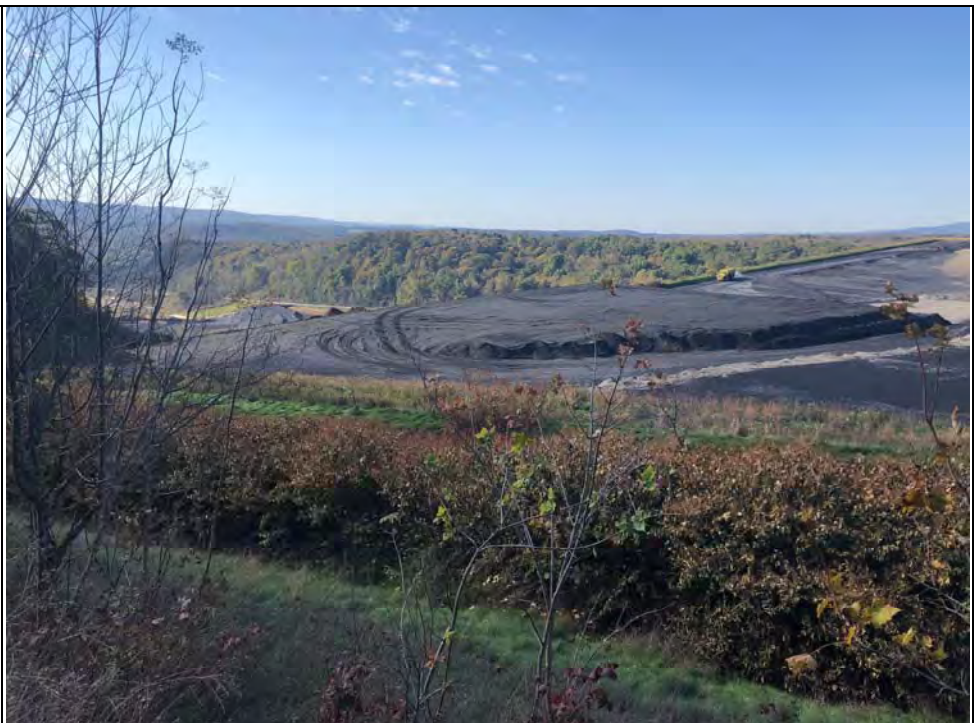
Image: 2640
Date: 10/23/2018
Time: 9:26 AM
Direction: Southwest

Stage II active area. Well maintained. No ponding water.

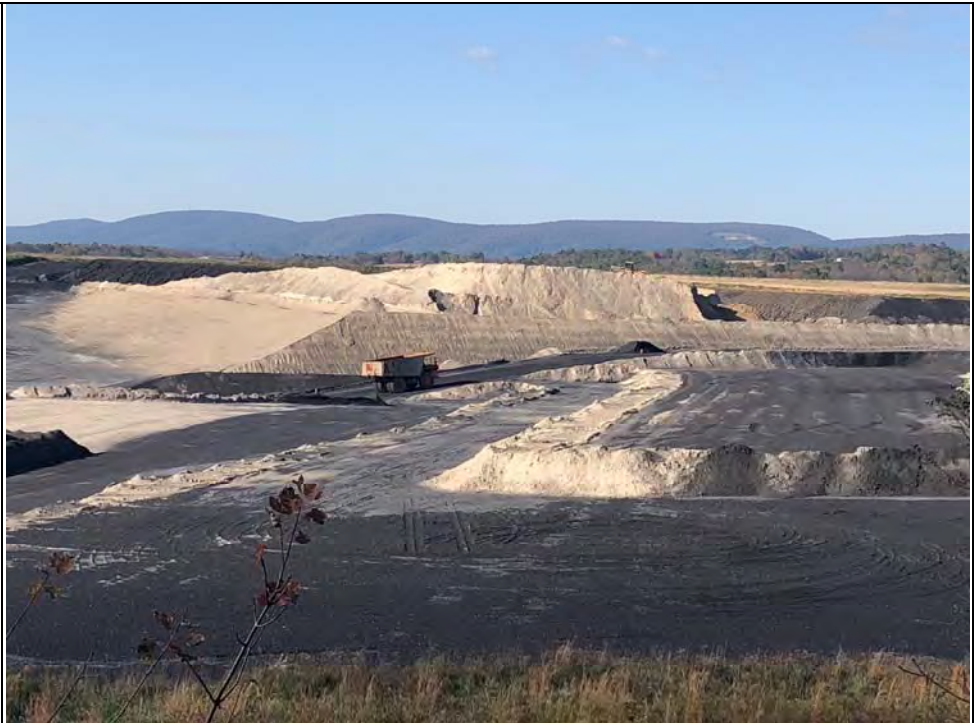
Image: 2644
Date: 10/23/2018
Time: 9:26 AM
Direction: West

Gypsum pile in Stage II active area. Well maintained and graded. No sign of washouts or erosional issues.

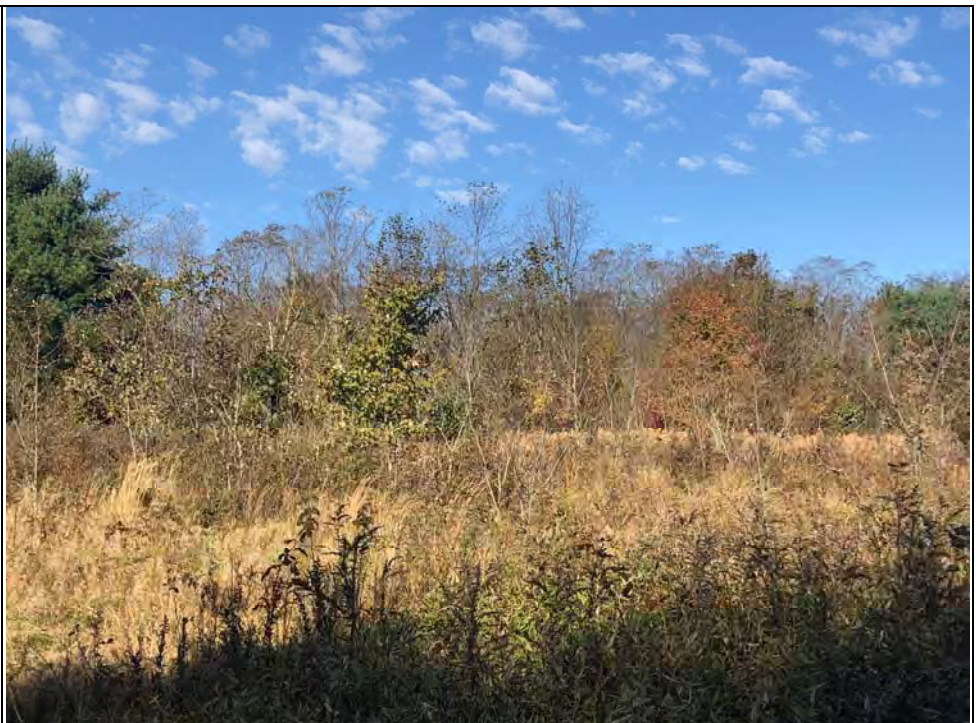
Image: 2646
Date: 10/23/2018
Time: 9:29 AM
Direction: Northwest

Stage I Final Cover showing healthy vegetation that has no bare spots. No evidence of erosion or signs of instability.

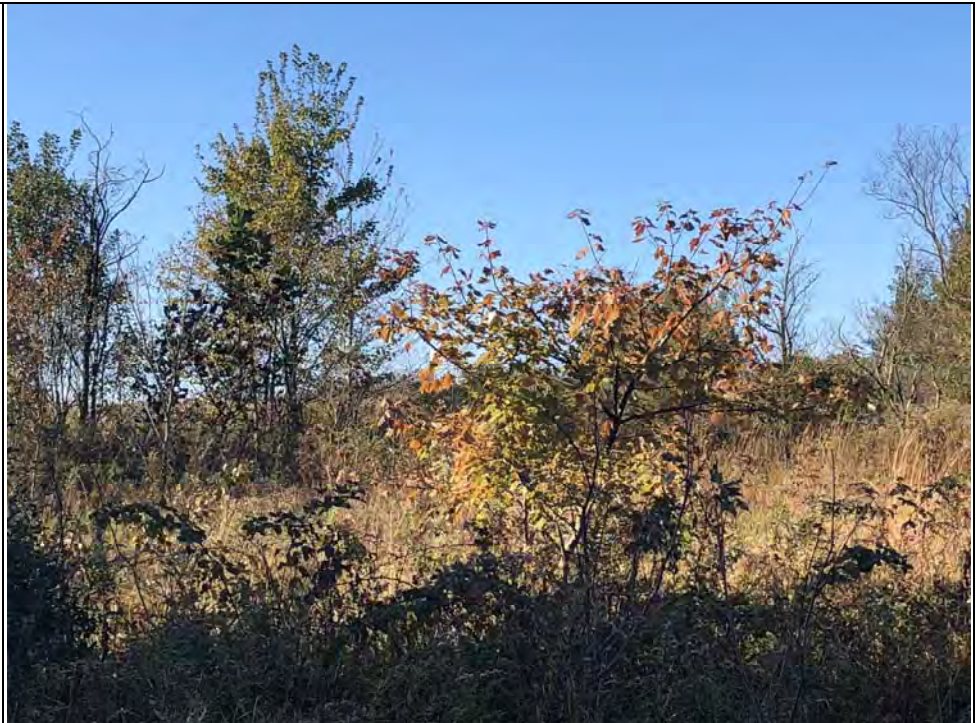
Image: 2648
Date: 10/23/2018
Time: 9:29 AM
Direction: Southwest

Stage I Final Cover showing healthy vegetation that has no bare spots. No evidence of erosion or signs of instability.

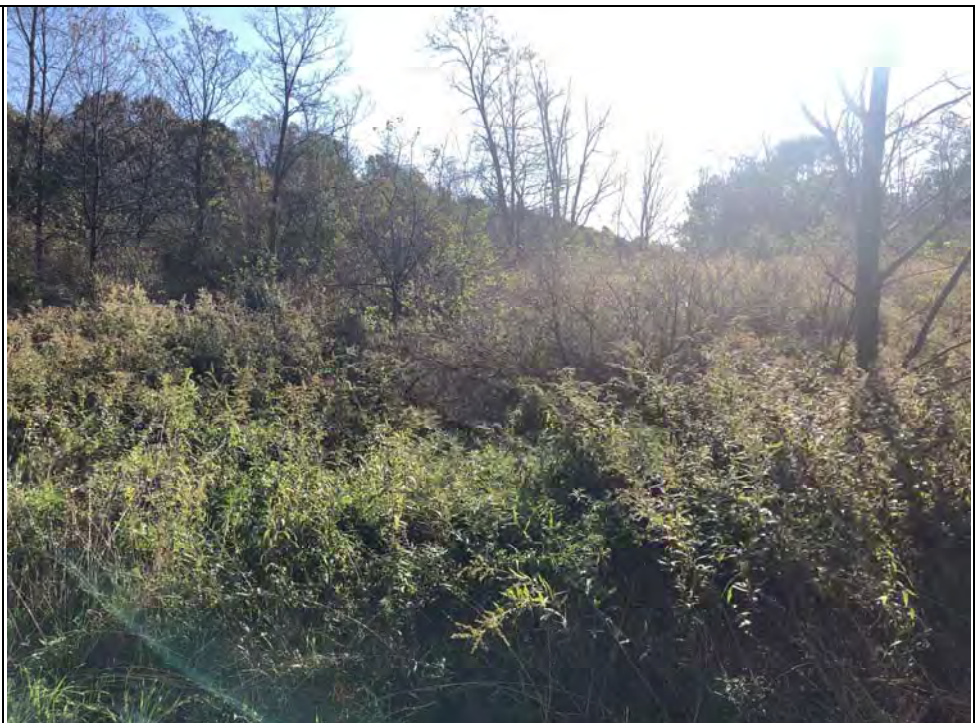
Image: 2654
Date: 10/23/2018
Time: 9:33 AM
Direction: Southeast

Stage I Final Cover showing healthy vegetation that has no bare spots. No evidence of erosion or signs of instability.

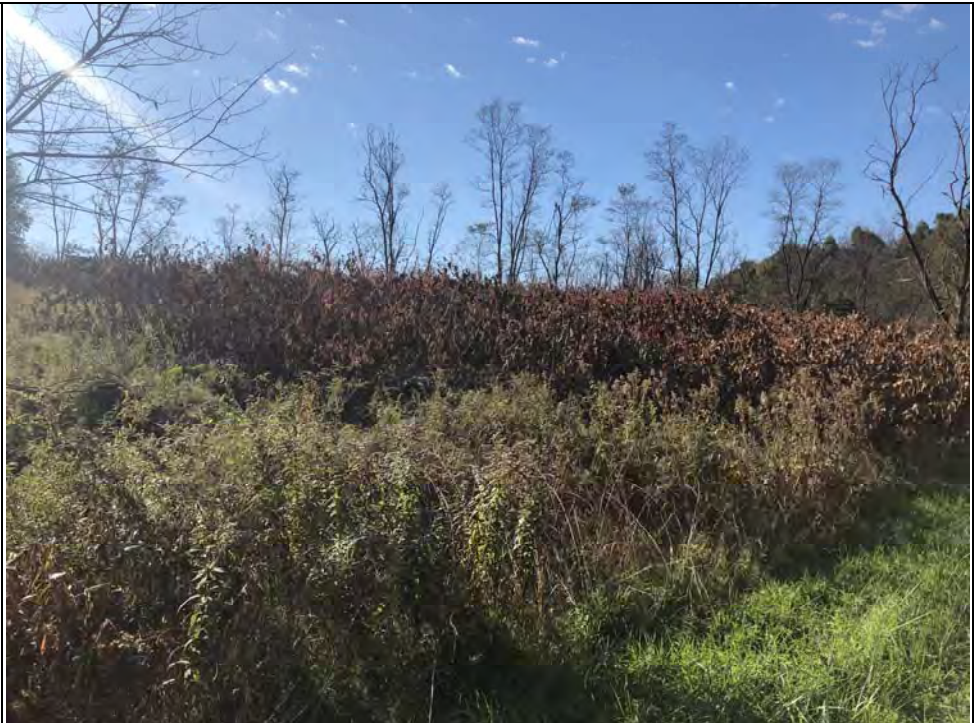
Image: 2656
Date: 10/23/2018
Time: 9:33 AM
Direction: South

Stage I Final Cover showing healthy vegetation that has no bare spots. No evidence of erosion or signs of instability.

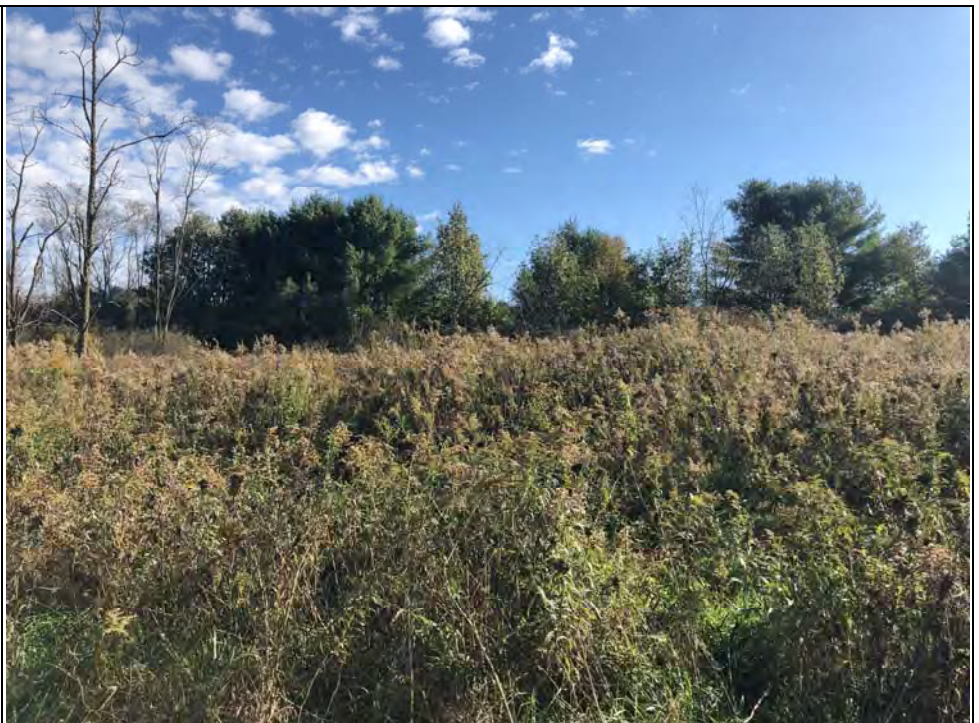
Image: 2658
Date: 10/23/2018
Time: 9:35 AM
Direction: East

Stage I Final Cover showing healthy vegetation that has no bare spots. No evidence of erosion or signs of instability.

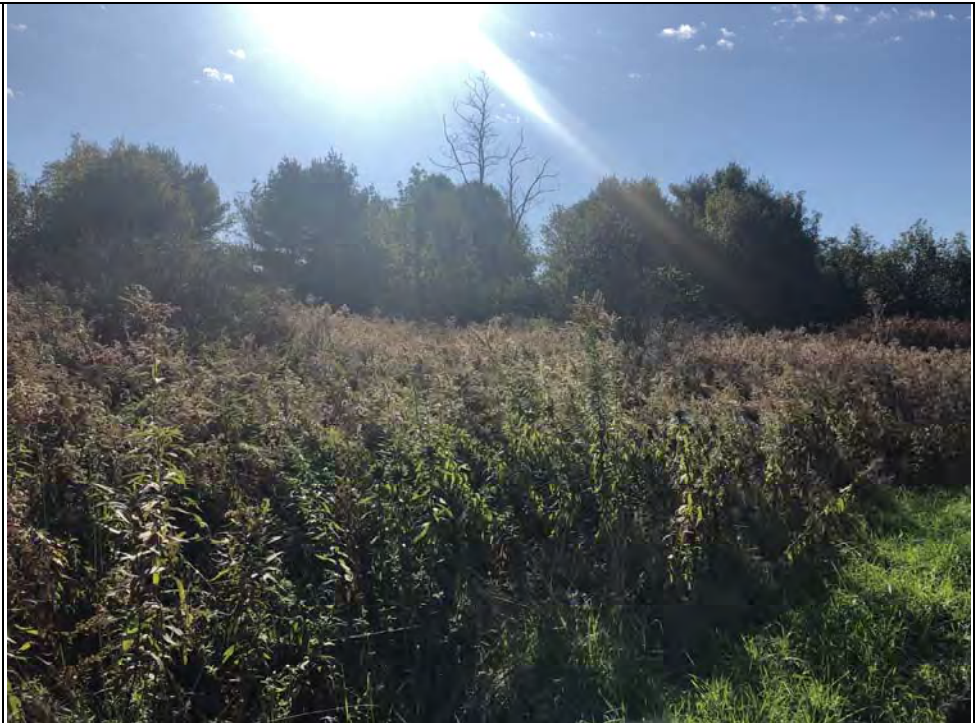
Image: 2660
Date: 10/23/2018
Time: 9:35 AM
Direction: Southeast

Stage I Final Cover showing healthy vegetation that has no bare spots. No evidence of erosion or signs of instability.

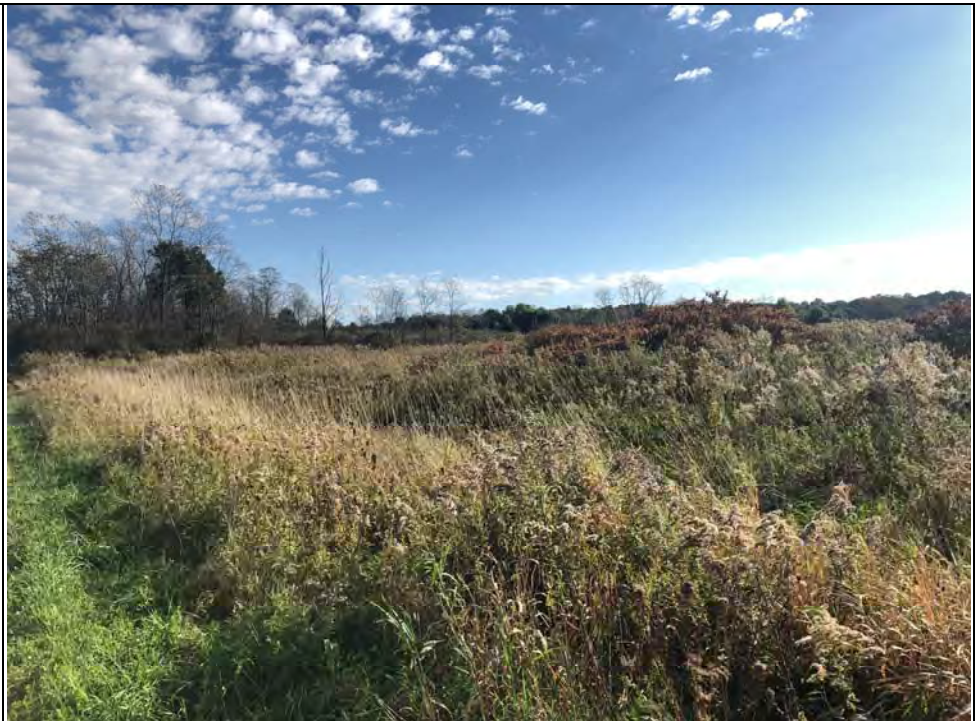
Image: 2663
Date: 10/23/2018
Time: 9:38 AM
Direction: East

Stage I Final Cover showing healthy vegetation that has no bare spots. No evidence of erosion or signs of instability.

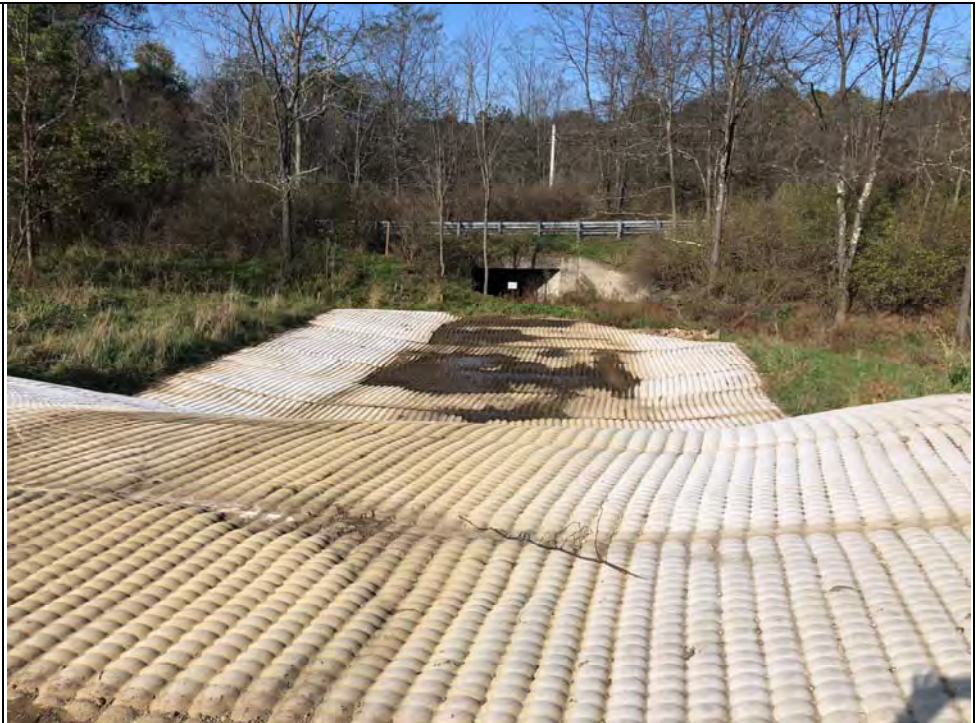
Image: 2667
Date: 10/23/2018
Time: 9:39 AM
Direction: West

Revetment mat that has been installed on final cover area of Stage I to improve drainage and eliminate water that was found to pond in this area. Water is not ponding and construction appears to have effectively remediated drainage concern.

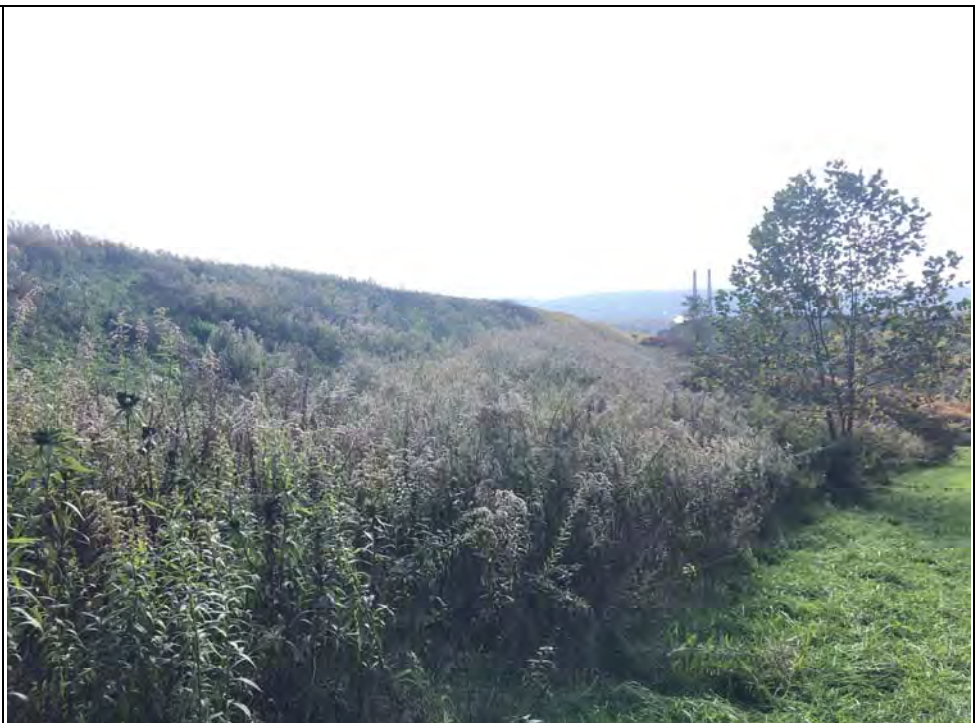
Image: 2671
Date: 10/23/2018
Time: 9:41 AM
Direction: Southeast

Stage II sideslope terraces are well maintained with healthy vegetation. No evidence of instability or erosion.

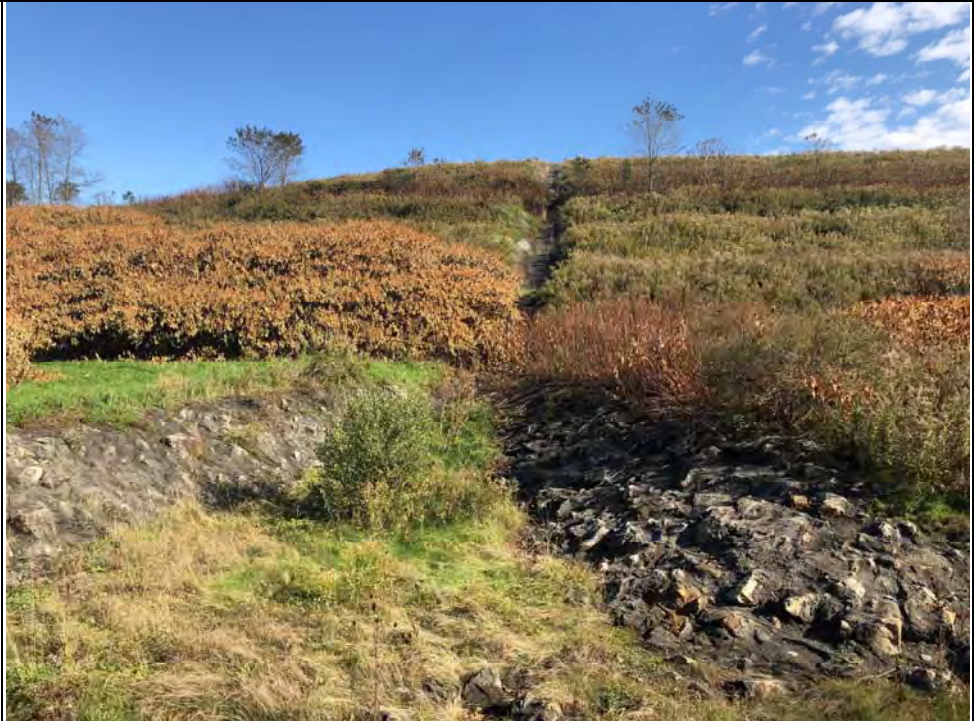
Image: 2673
Date: 10/23/2018
Time: 9:44 AM
Direction: North

Stage II final cover downchute with revetment lining. Clear of obstructions. No structural damage observed.

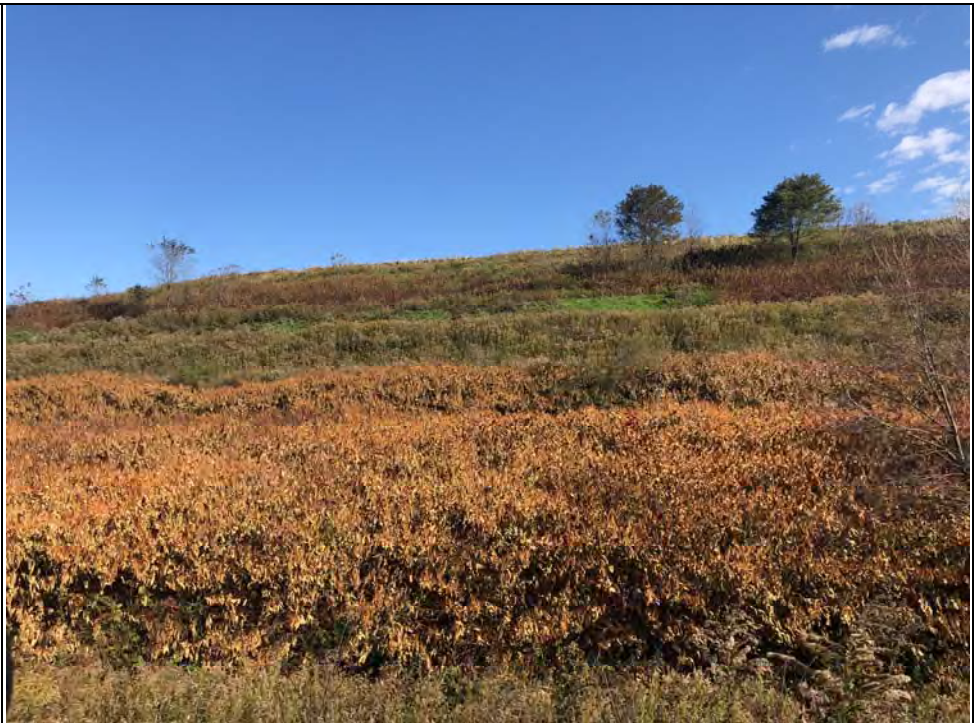
Image: 2675
Date: 10/23/2018
Time: 9:45 AM
Direction: South

Vegetation on final cover along perimeter road of Stage II. Road is well maintained. Slopes show no signs of instability.

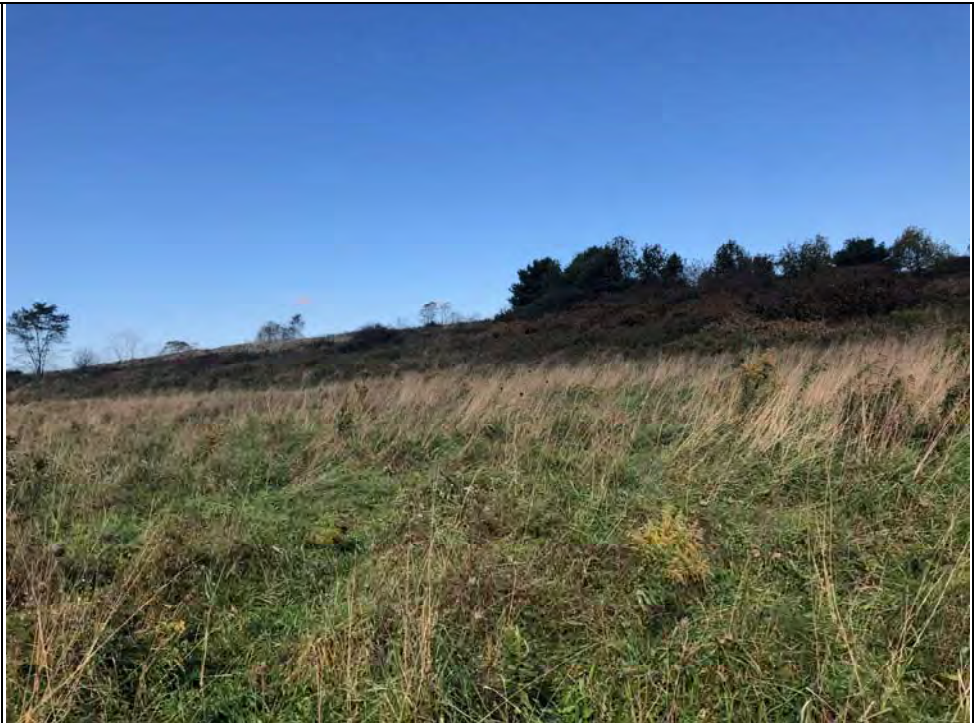
Image: 2679
Date: 10/23/2018
Time: 9:55 AM
Direction: West

Vegetation on final cover along perimeter road of Stage II. Road is well maintained. Slopes show no signs of instability.

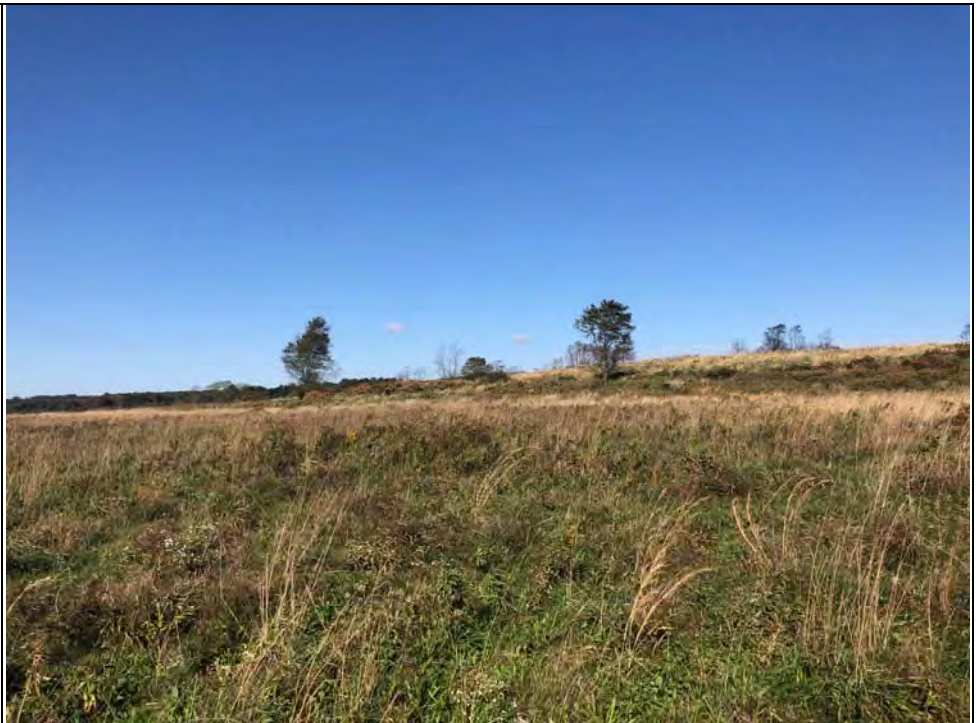
Image: 2683
Date: 10/23/2018
Time: 9:55 AM
Direction: West

Stage II Intermediate cover area. Vegetation is healthy with no bare areas. No evidence of instability or erosion.

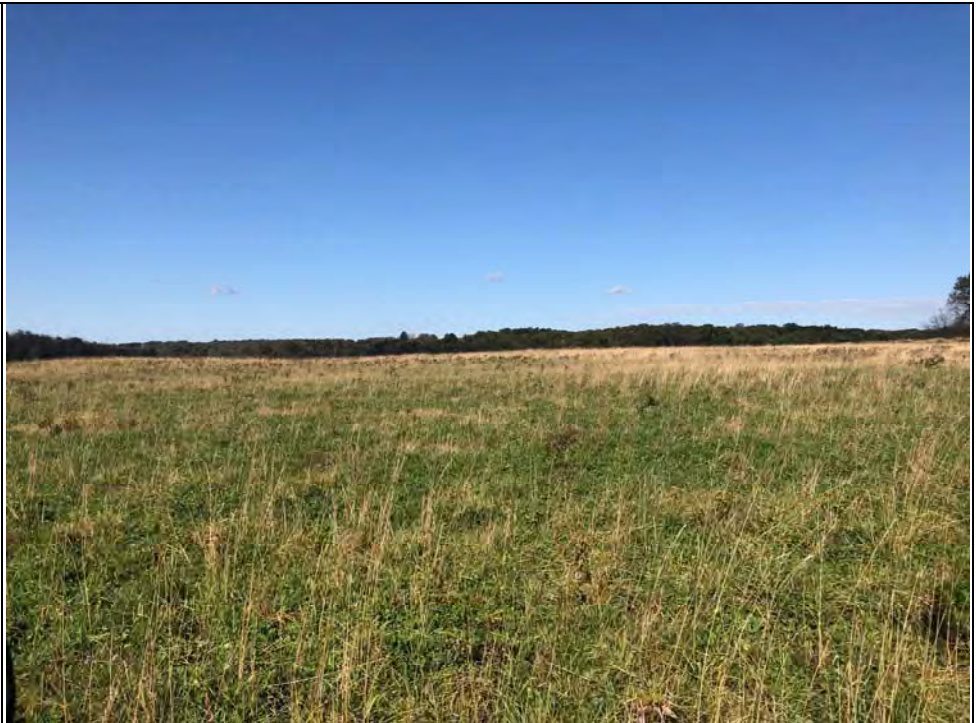
Image: 2687
Date: 10/23/2018
Time: 9:55 AM
Direction: West

Stage II Intermediate cover area. Vegetation is healthy with no bare areas. No evidence of instability or erosion.

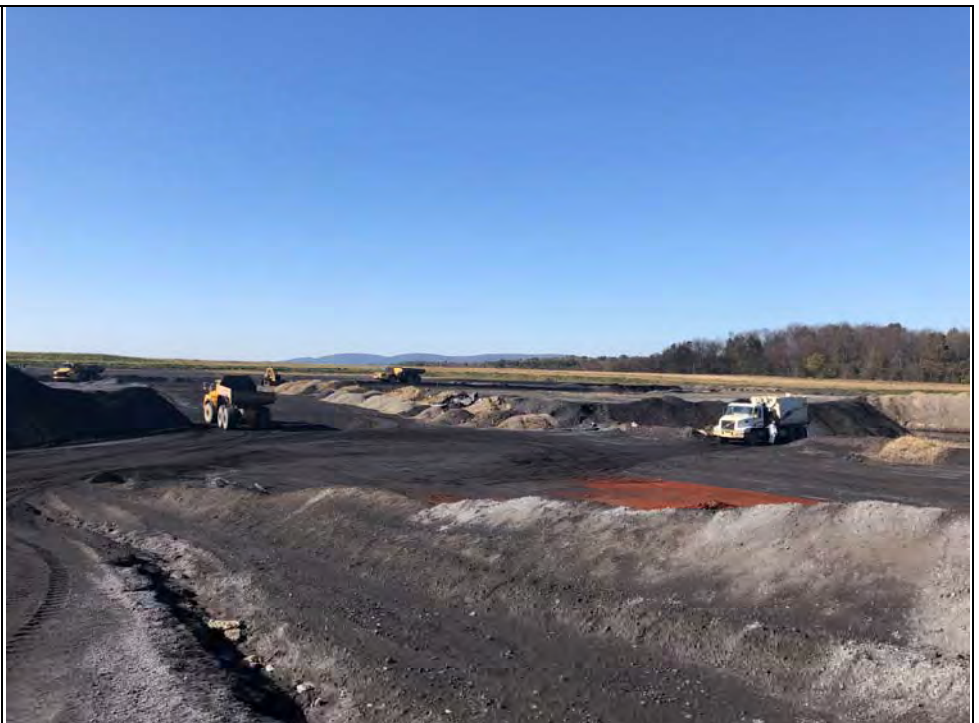
Image: 2689
Date: 10/23/2018
Time: 9:57 AM
Direction: Southwest

Stage II active area. Good housekeeping, well graded. No signs of erosion or instability.

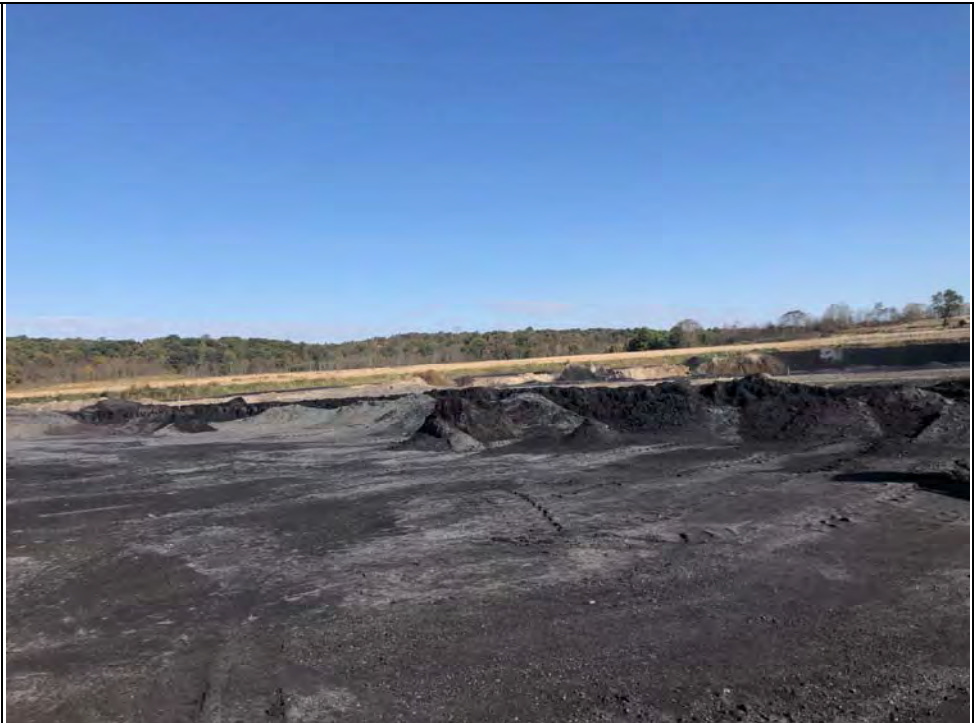
Image: 2693
Date: 10/23/2018
Time: 9:57 AM
Direction: Northwest

Stage II active area.
CCR material is
appropriately spread and
compacted.

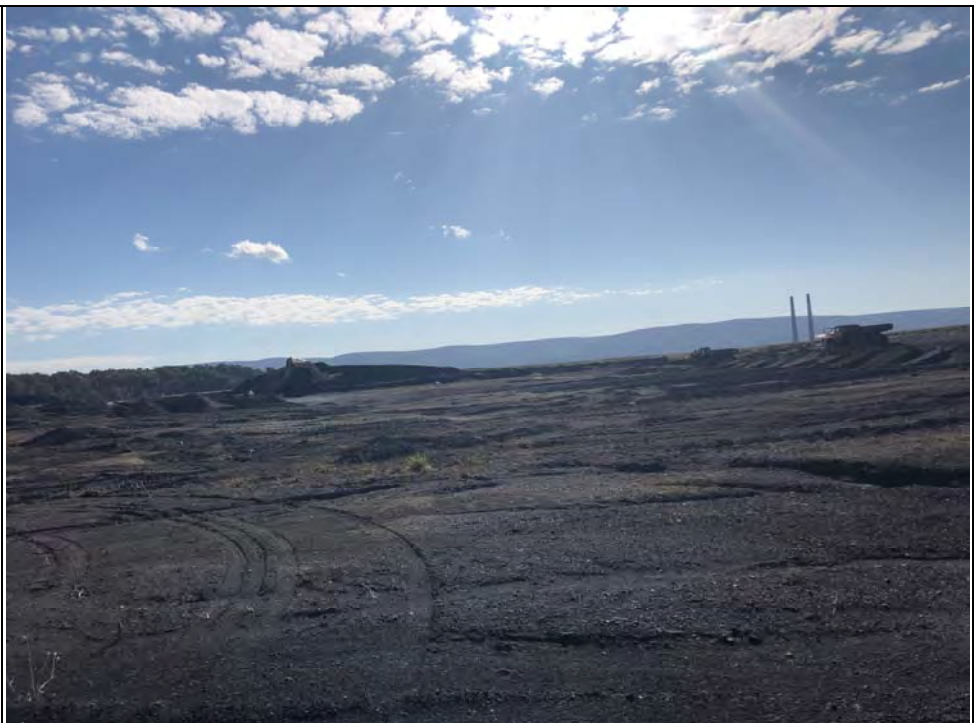
Image: 2697
Date: 10/23/2018
Time: 9:59 AM
Direction: South

Stage II active area.
CCR material is
appropriately spread and
compacted.

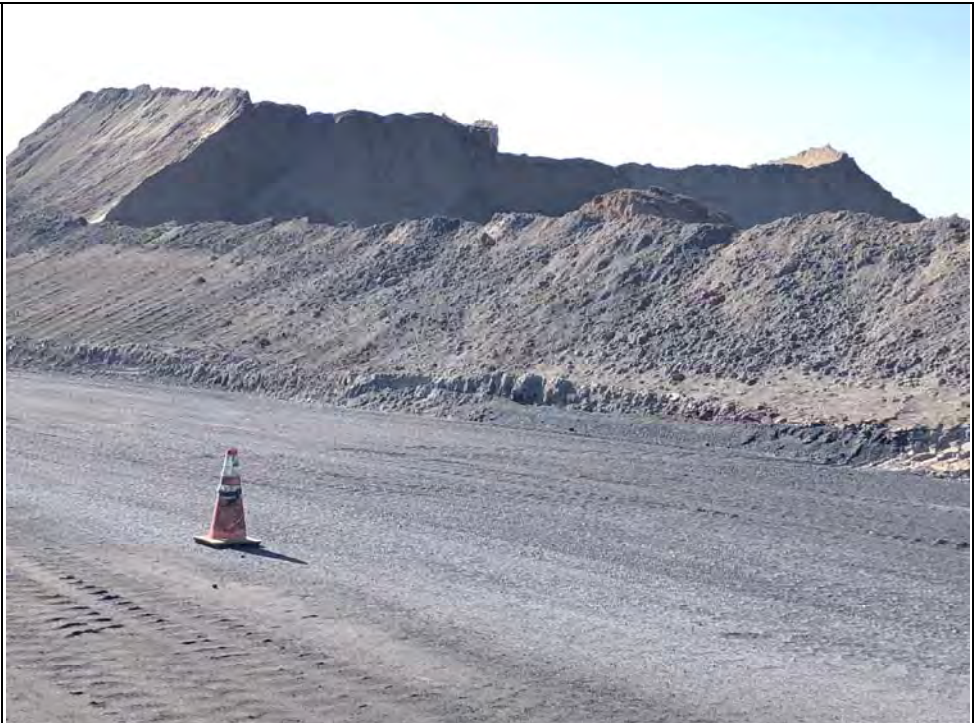
Image: 2703
Date: 10/23/2018
Time: 10:01 AM
Direction: Southwest

Gypsum pile in Stage II active area.

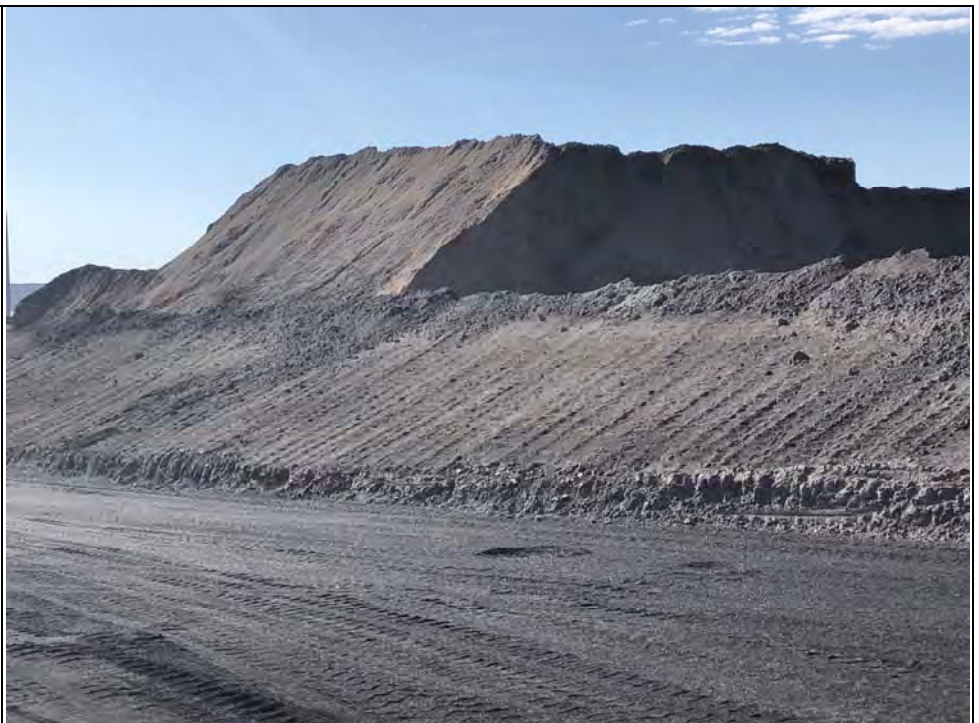
Image: 2705
Date: 10/23/2018
Time: 10:01 AM
Direction: South

Gypsum pile in Stage II active area. Slopes are maintained to prevent erosion.
