Inspection Report

To: John Shimshock (Conemaugh Generating Station)
From: Richard Southorn, P.E., P.G.
Re: Ash/Refuse Disposal Site – Annual CCR Unit Inspection Report
Inspection Date: October 23, 2018
Report Date: January 16, 2019

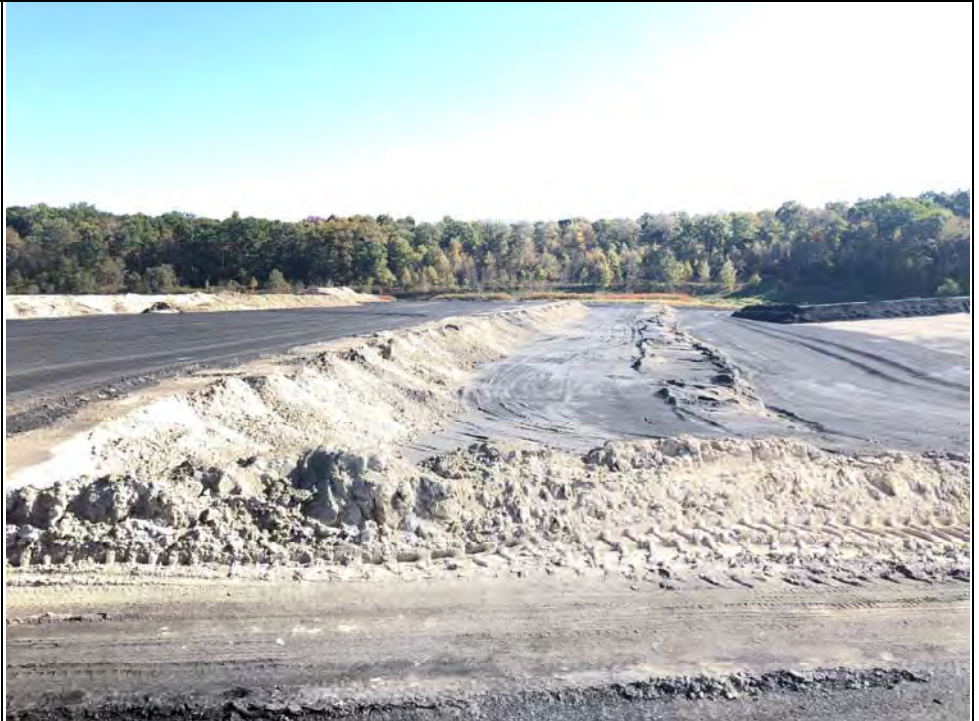
Image: 2709
Date: 10/23/2018
Time: 10:01 AM
Direction: East

A lift of CCR material placed in the active area of Stage II. Well maintained.

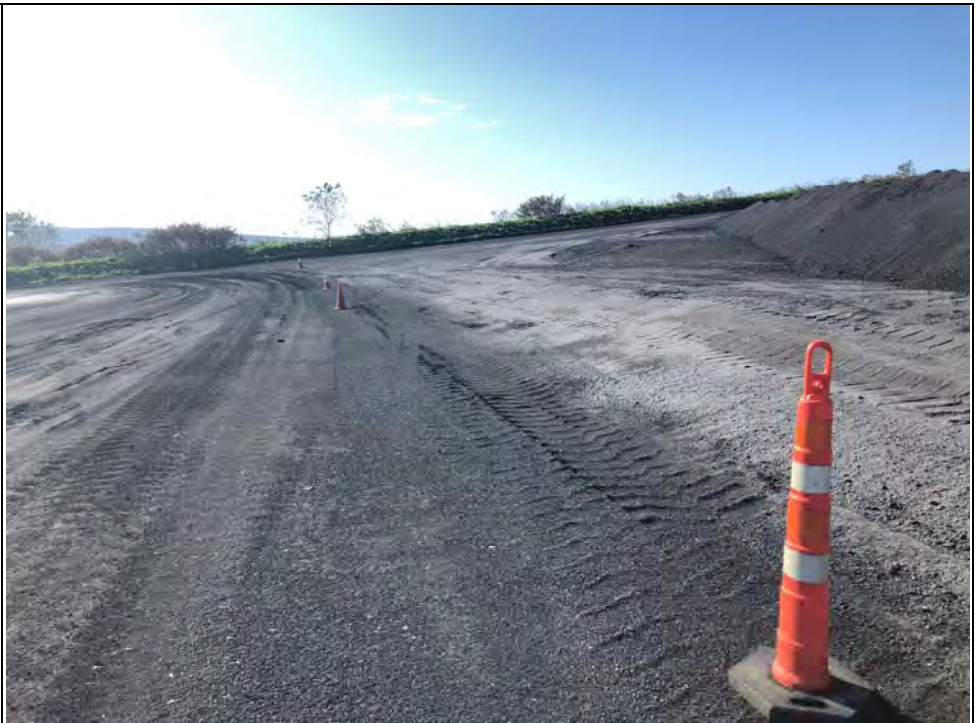
Image: 2715
Date: 10/23/2018
Time: 10:03 AM
Direction: South

Traffic control measures in the active area of Stage II.

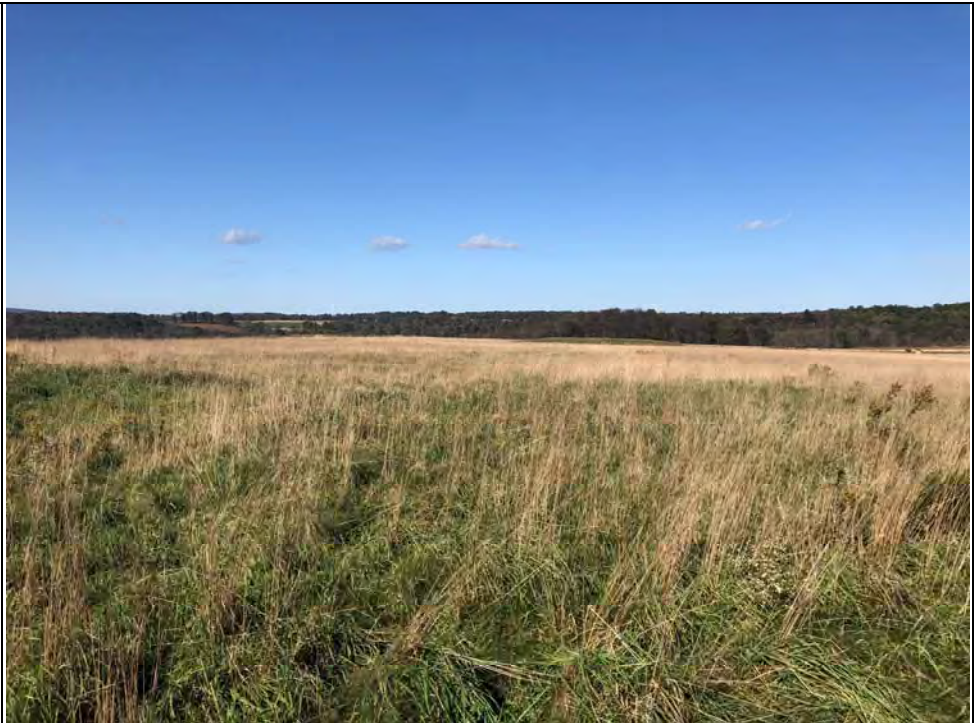
Image: 2723
Date: 10/23/2018
Time: 10:05 AM
Direction: West

Intermediate cover area of Phase II. Vegetation is healthy with full coverage.

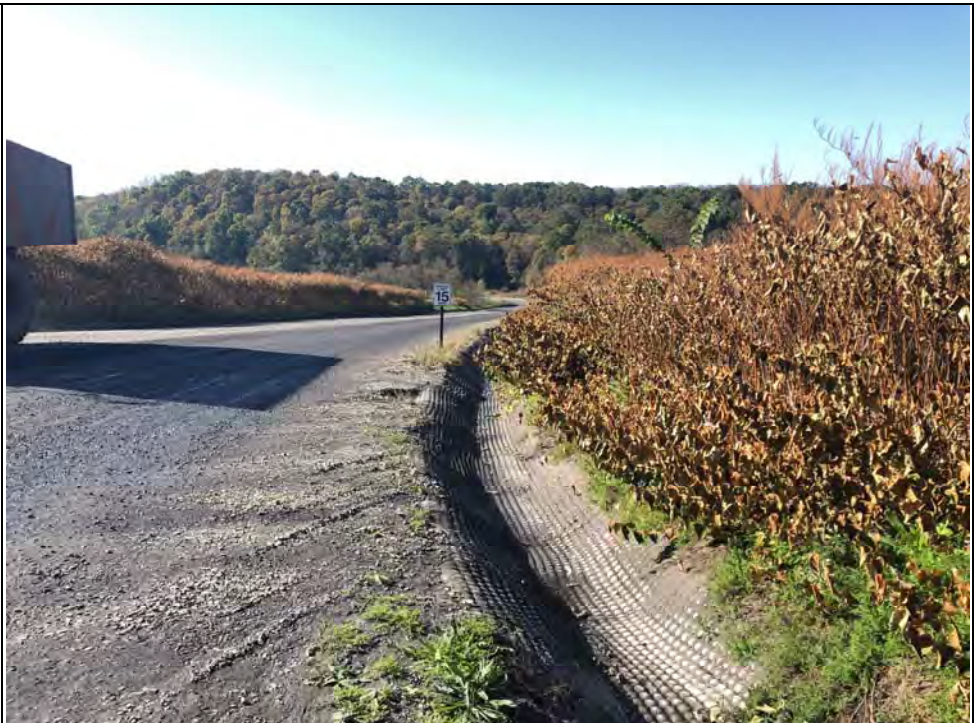
Image: 2727
Date: 10/23/2018
Time: 10:07 AM
Direction: Southwest

Contact water channel on inside toe of main haul road. Clear of debris.

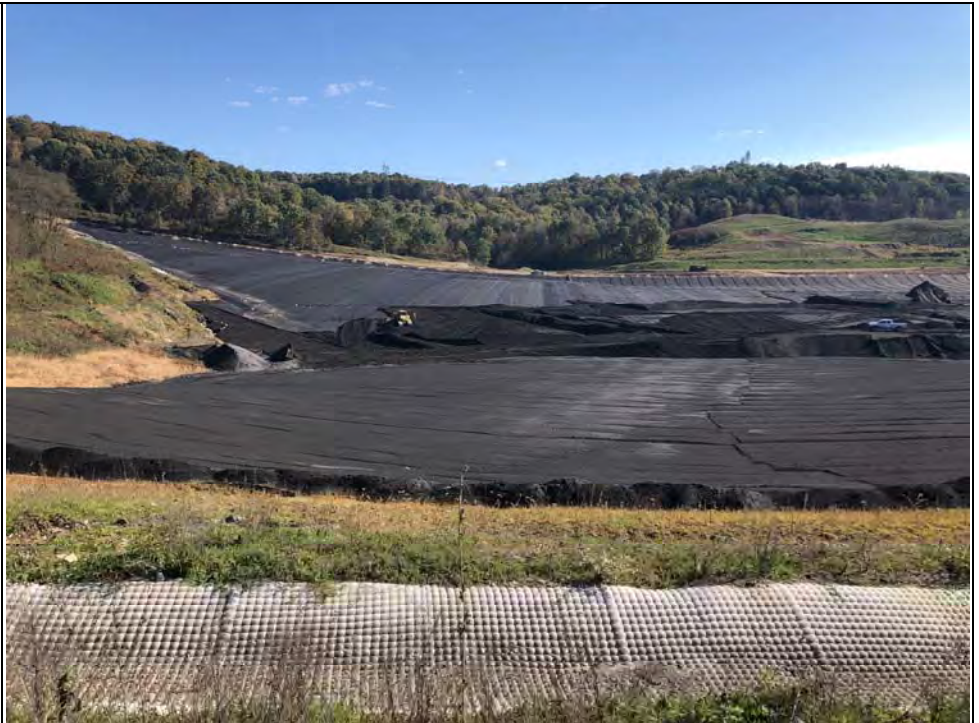
Image: 2729
Date: 10/23/2018
Time: 10:09 AM
Direction: East

Spreading bottom ash protective material on the drainage layer of Phase IIIA leachate collection layer.

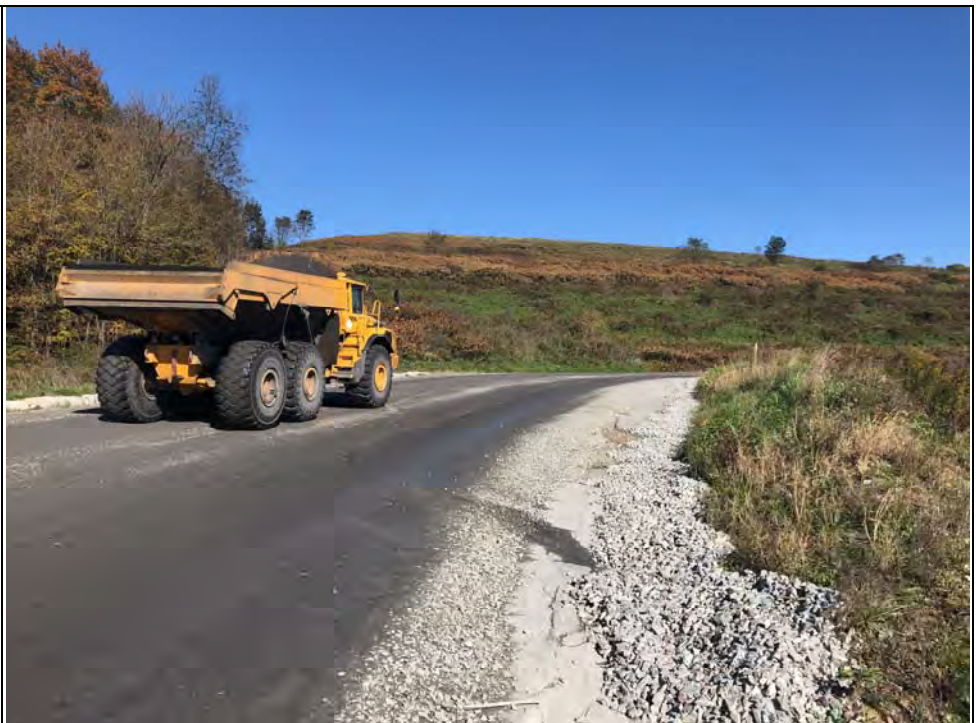
Image: 2733
Date: 10/23/2018
Time: 10:10 AM
Direction: North

Main haul road to active area. Road is well maintained.

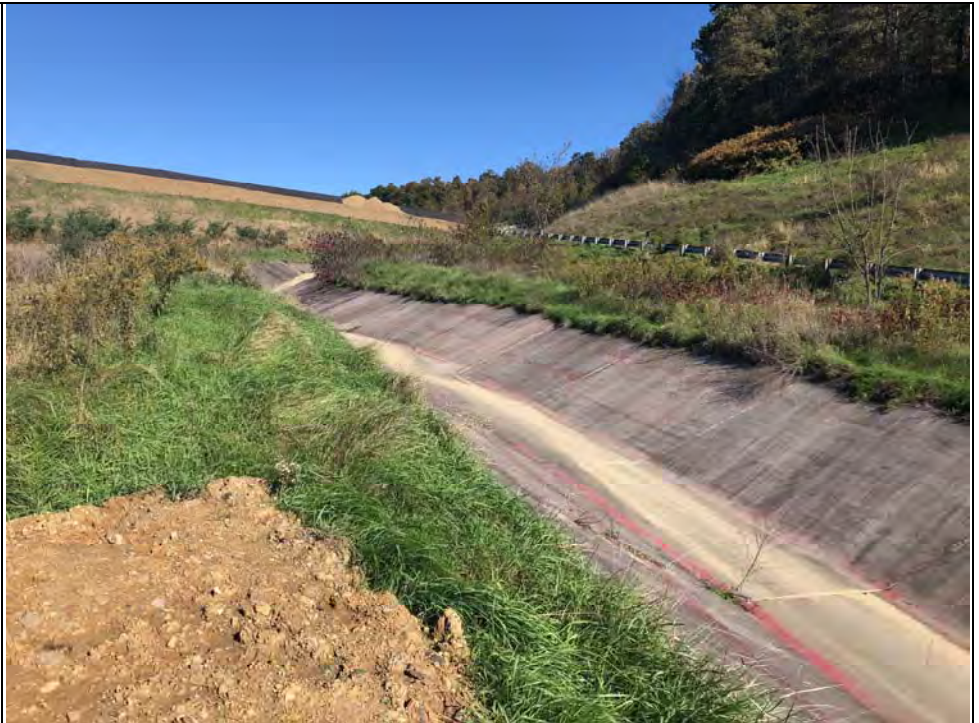
Image: 2738
Date: 10/23/2018
Time: 10:18 AM
Direction: North

Contact water channel.
Free of debris. Good
condition.

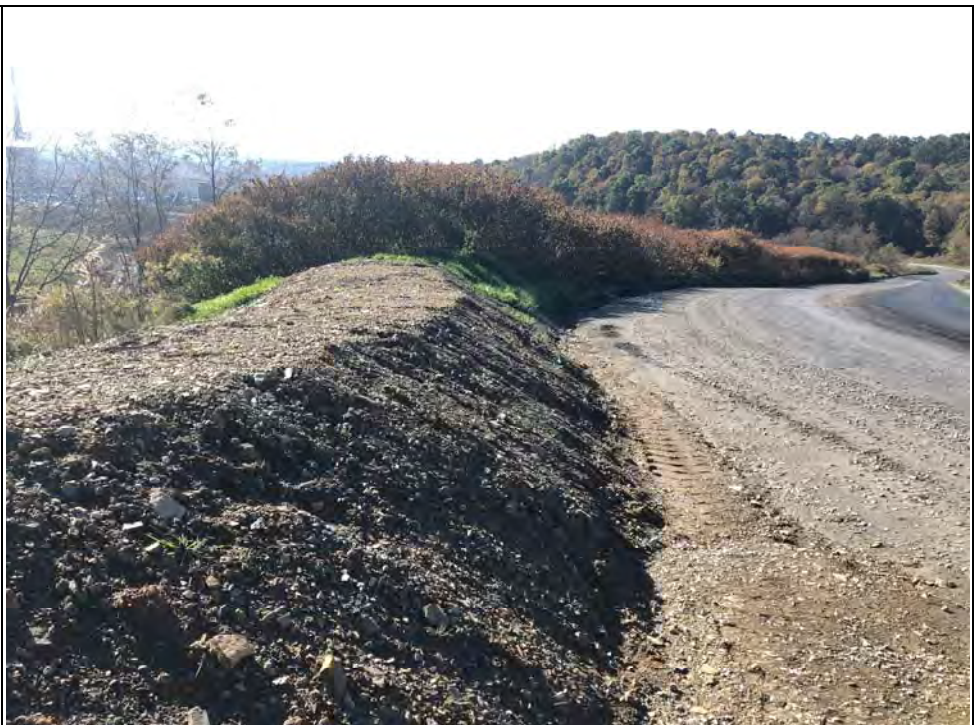
Image: 2744
Date: 10/23/2018
Time: 10:21 AM
Direction: South

As previously noted, a surficial release occurred in 2018 during a heavy rain event that resulted in stormwater conveyance and run-off controls to be overwhelmed. Contact stormwater overtopped a diversion berm that had been temporarily lowered to facilitate access to the Stage III construction area. Based on review of completed site activities, it is the initial opinion of the certifying engineer that the appropriate repairs and clean-up activities appear to have been completed. The original height of the diversion berm has been restored to minimize the potential of future releases. These actions have been fully implemented and are currently deemed appropriate. No further action is considered necessary at this time. A final determination will be provided in The Assessment of Corrective Measures Report, which will also be incorporated into the 2018 Annual CCR Groundwater Monitoring and Corrective Action Report (completed no later than January 31, 2019) as required by §257.96(a).

Newly constructed
diversion berm along
main haul road to prevent
run-off water from leaving
the landfill during
rainstorms.

Stormwater controls that were impacted during the surficial release event had been appropriately restored. The original height of the diversion berm has been restored to minimize the potential of recurrence (see Photo 2744 in attached Photo Log).
