Inspection Report

Re: Keystone Ash Disposal Site – Annual CCR Unit Inspection Report No. 2

Inspection Date: November 15, 2016

Report Date: January 16, 2017

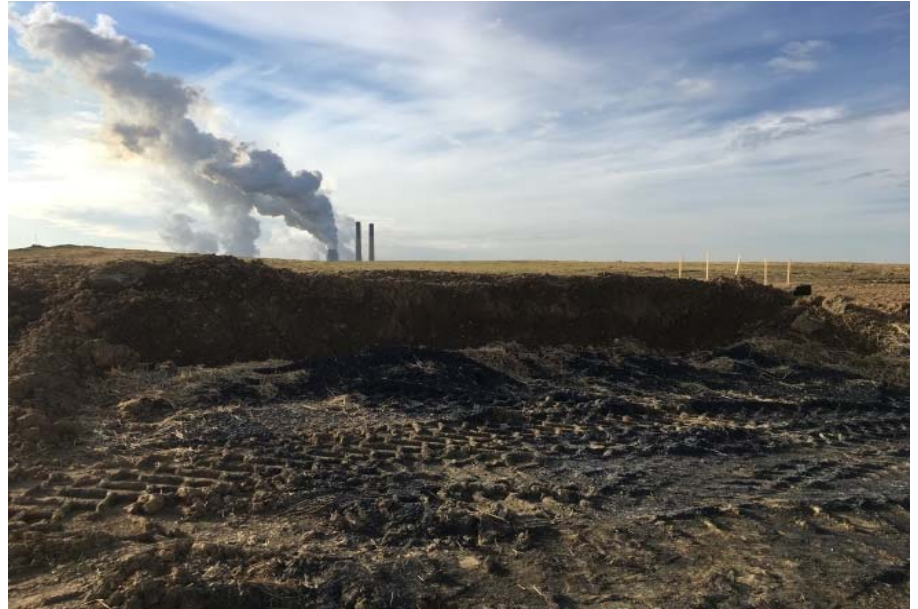
Photograph No. 1

Southern end of installed final cover in the East Valley disposal area. No evidence of erosion or sloughing.

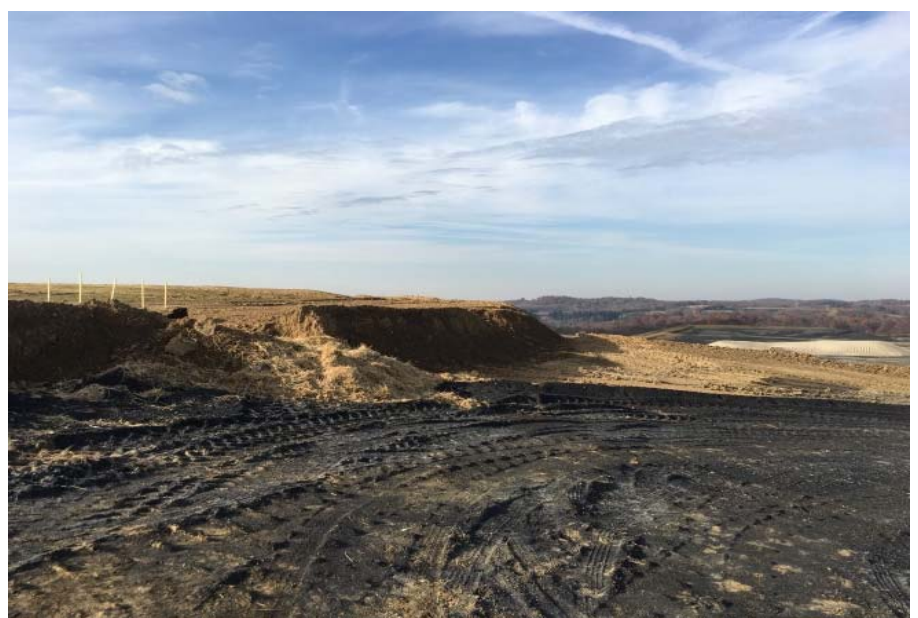
Photograph No. 2

Continuing view of installed final cover in the East Valley disposal area. No evidence of erosion or sloughing.

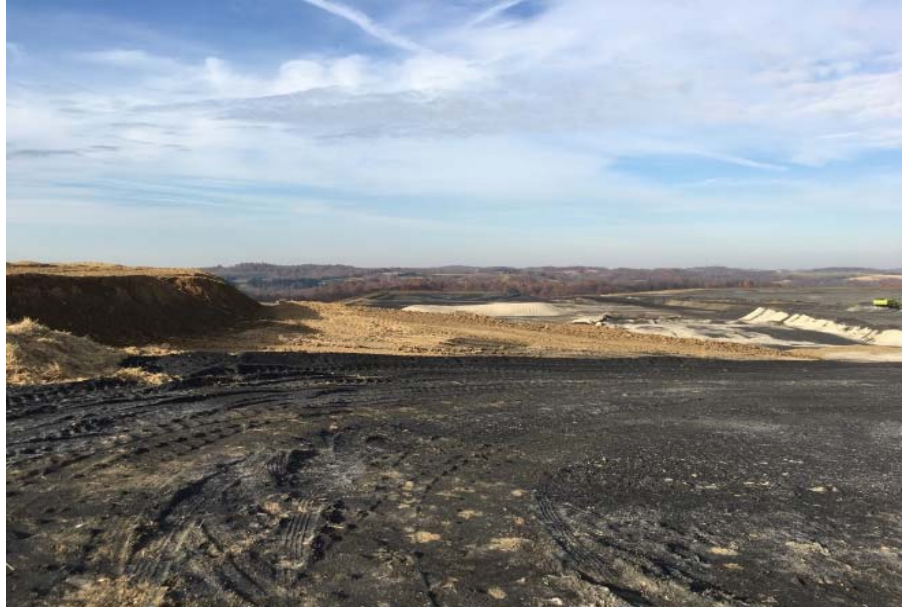
Photograph No. 3

Continuing view of installed final cover in the East Valley disposal area (West Valley disposal area in the background). No evidence of erosion or sloughing.

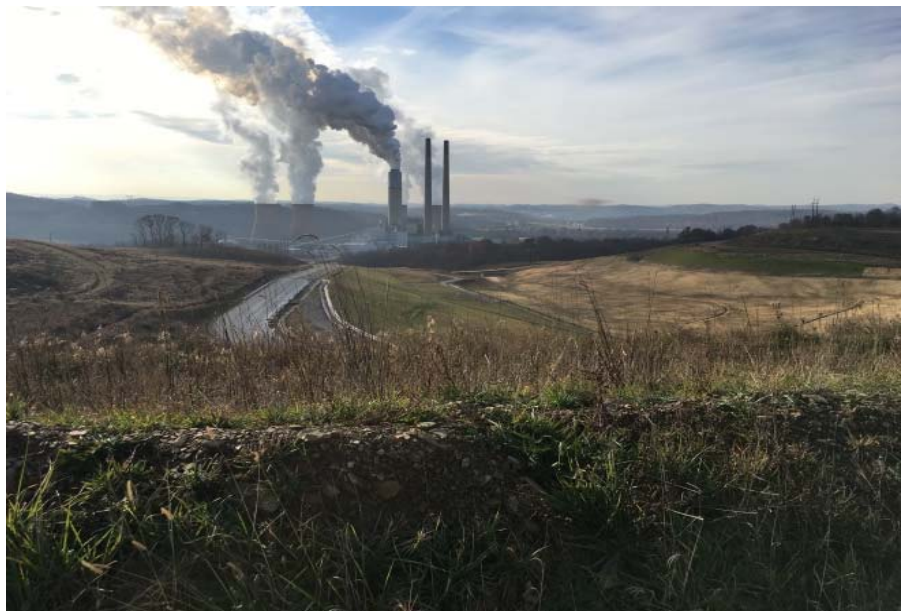
Photograph No. 4

Overview of ongoing Stage IV expansion at West Valley.

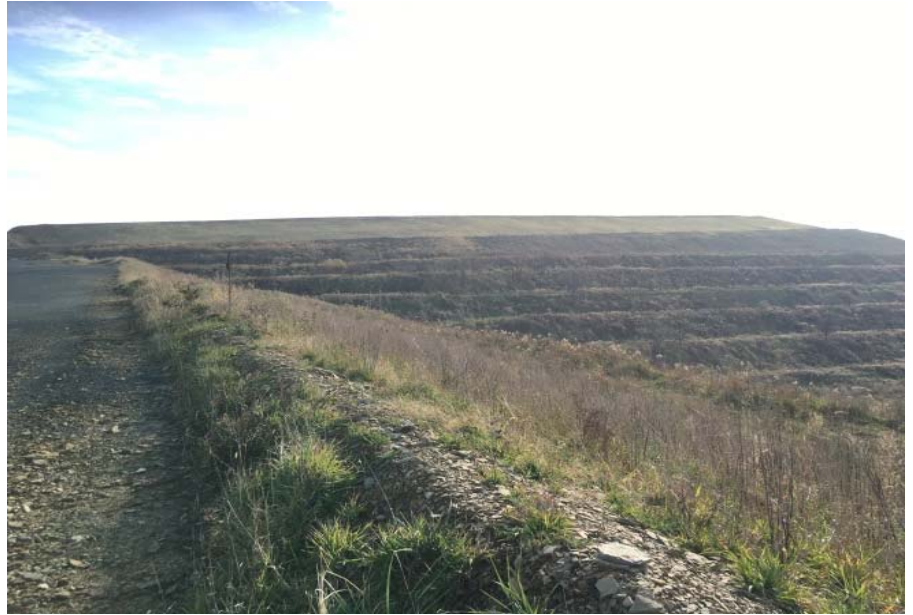
Photograph No. 5

Closed side slopes and terrace benches of the East Valley disposal area. Vegetation is well established. No evidence of erosion or sloughing.

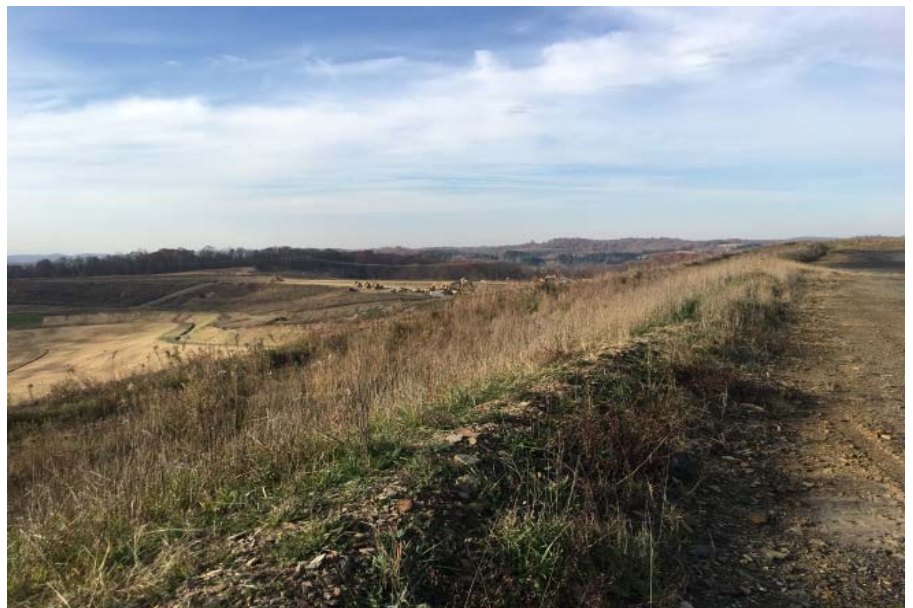
Photograph No. 6

Active filling operations in West Valley disposal area and landfill side slopes. No evidence of erosion or sloughing.

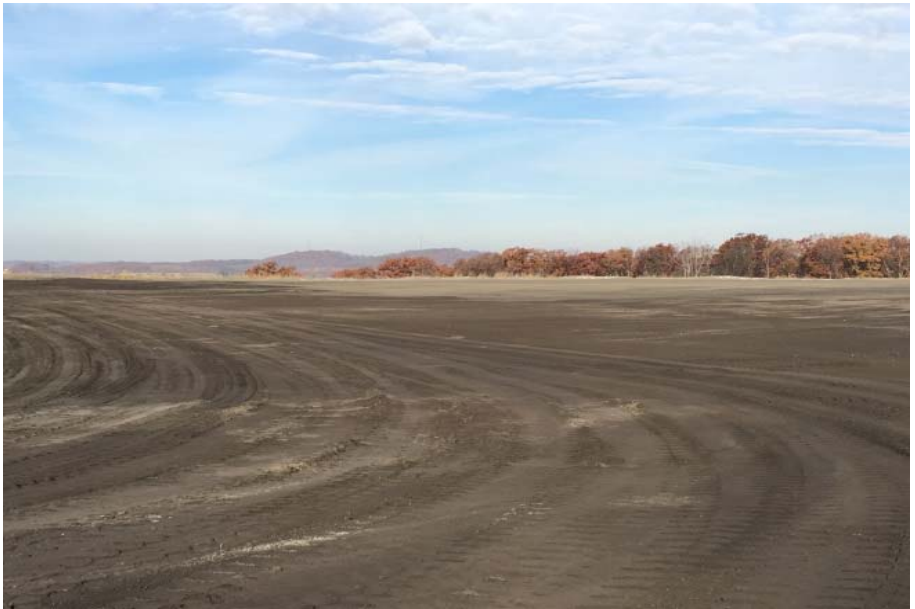
<p>Photograph No. 8</p> <p>Date: November 15, 2016</p> <p>Direction: Northwest</p>

A photograph of a large, flat, dark brown area, which appears to be a landfill disposal area. The surface is smooth and well-compacted, with some faint tire tracks visible. In the background, there is a line of trees with autumn-colored foliage (yellows and oranges) against a blue sky with light clouds.
<p>Description: Active filling in West Valley disposal area. Area is flat and well compacted. No evidence of erosion or airborne dust.</p>

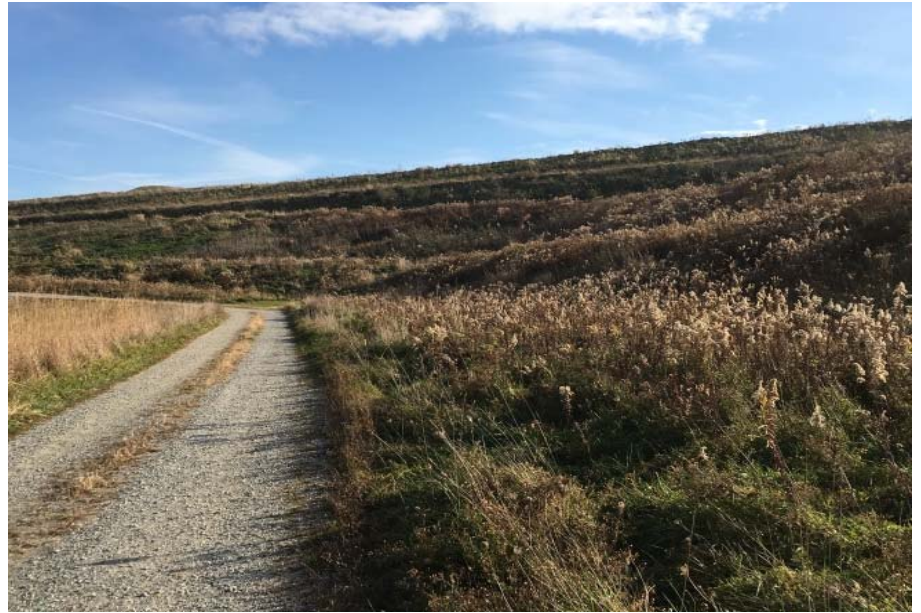
Photograph No. 9

Closed side slopes and terrace benches of the West Valley disposal area. Vegetation is well established. No evidence of erosion or sloughing.

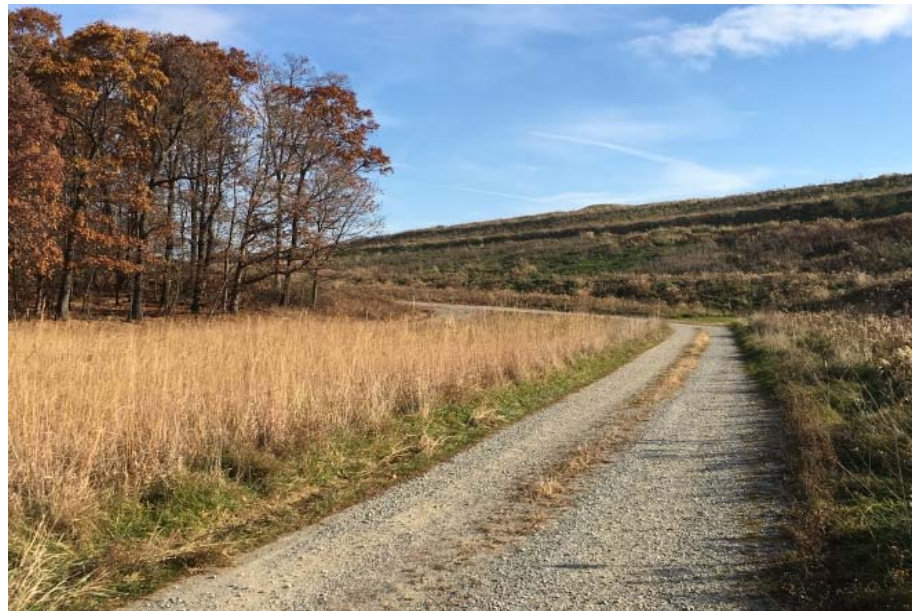
Photograph No. 10

Closed side slopes and terrace benches of the West Valley disposal area. Vegetation is well established. No evidence of erosion or sloughing.

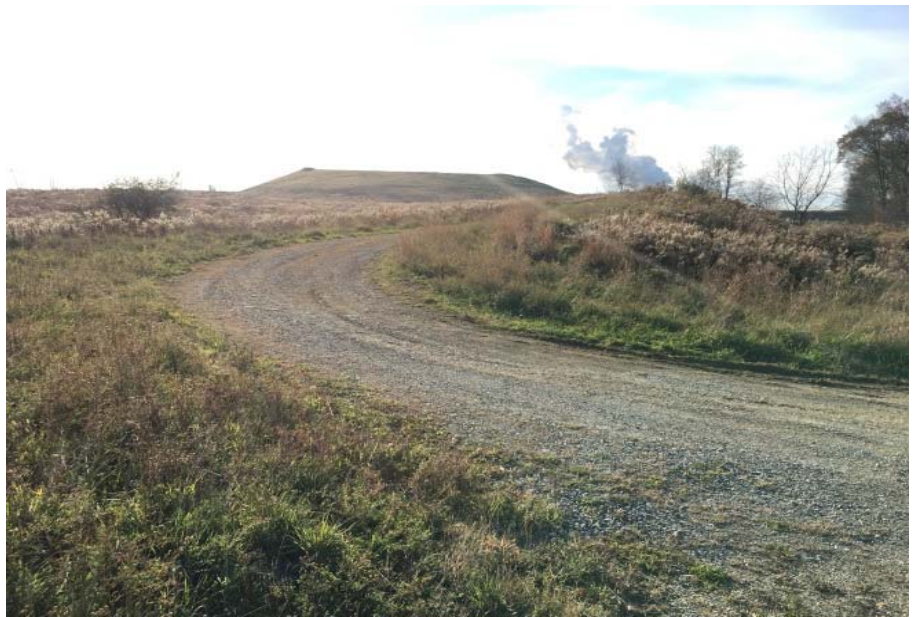
Photograph No. 11

Closed portion of the East Valley disposal area with active filling operations in background.

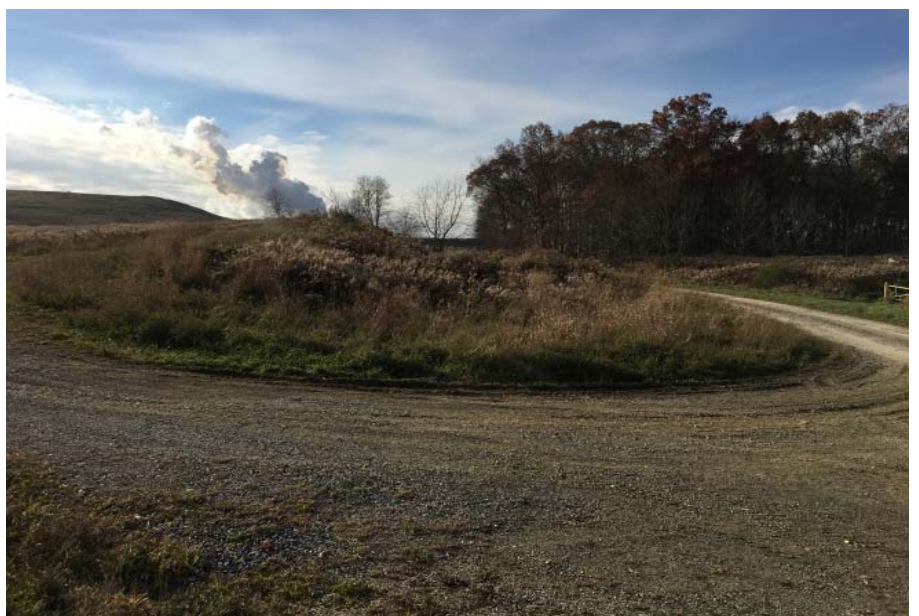
Photograph No. 12

Closed portion of the East Valley disposal area with active filling operations in background.

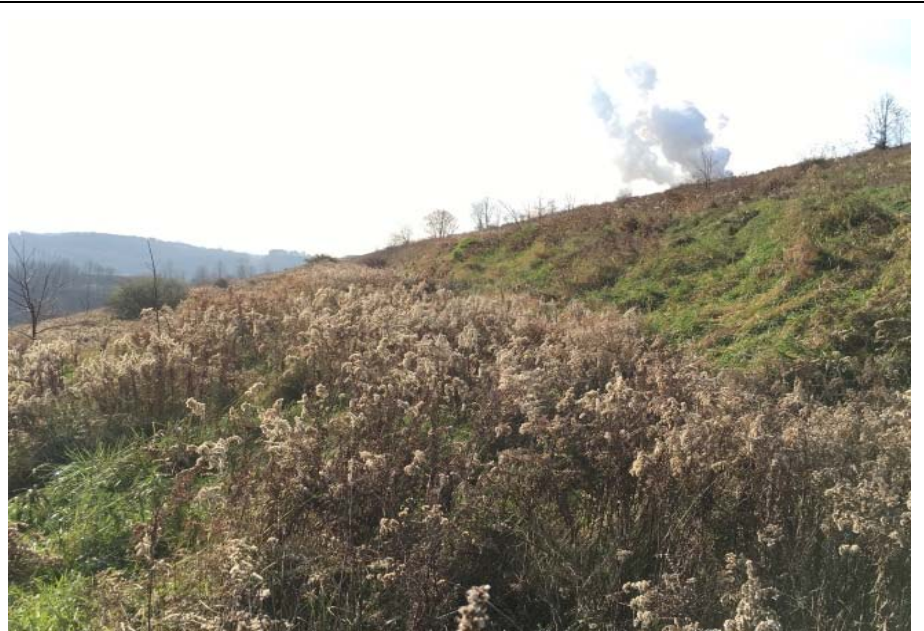
Photograph No. 15

Continued view of terrace benching along closed portion of the East Valley disposal area. No evidence of erosion or sloughing.

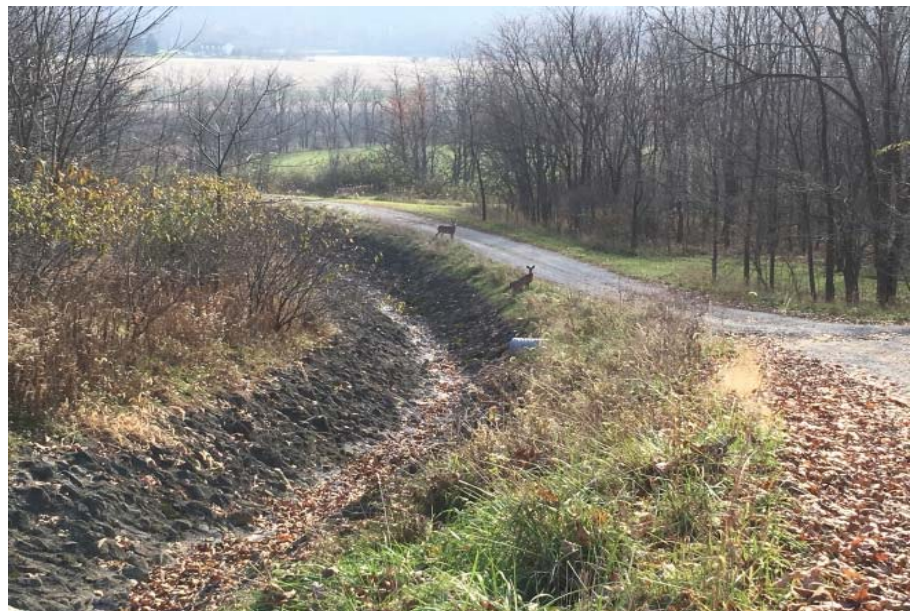
Photograph No. 16

"Non-contact" stormwater drainage channel along eastern perimeter of East Valley disposal area. No evidence of erosion or obstruction.

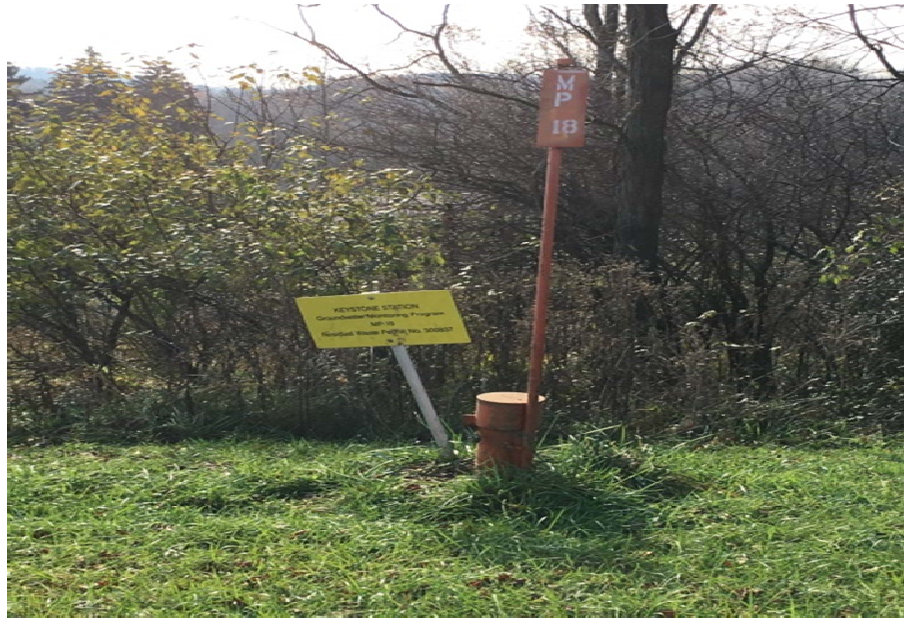
Photograph No. 17

Monitoring Well MP-18 along eastern perimeter of East Valley disposal area. Clear designation and signage.

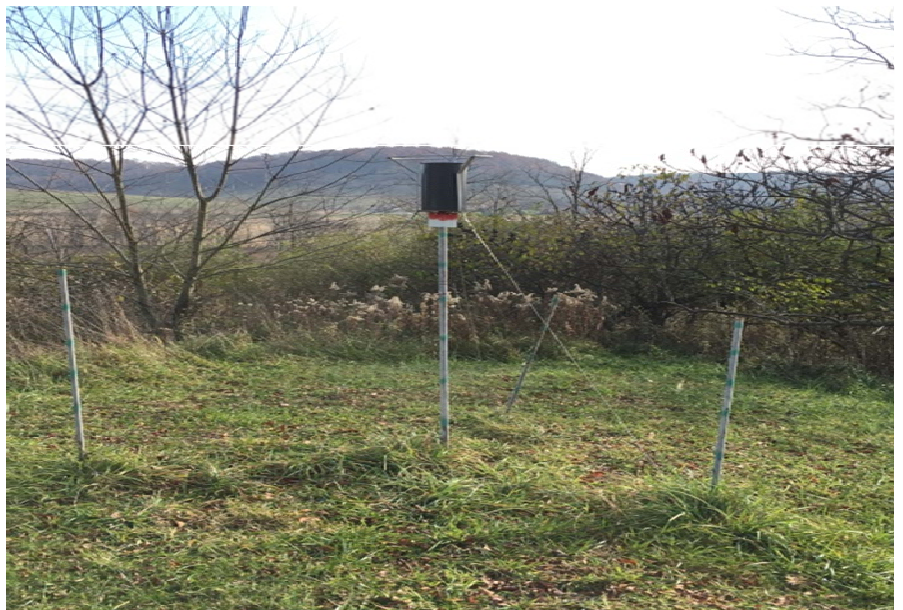
Photograph No. 18

Dust-fall monitor utilized to assess potential fugitive emissions.

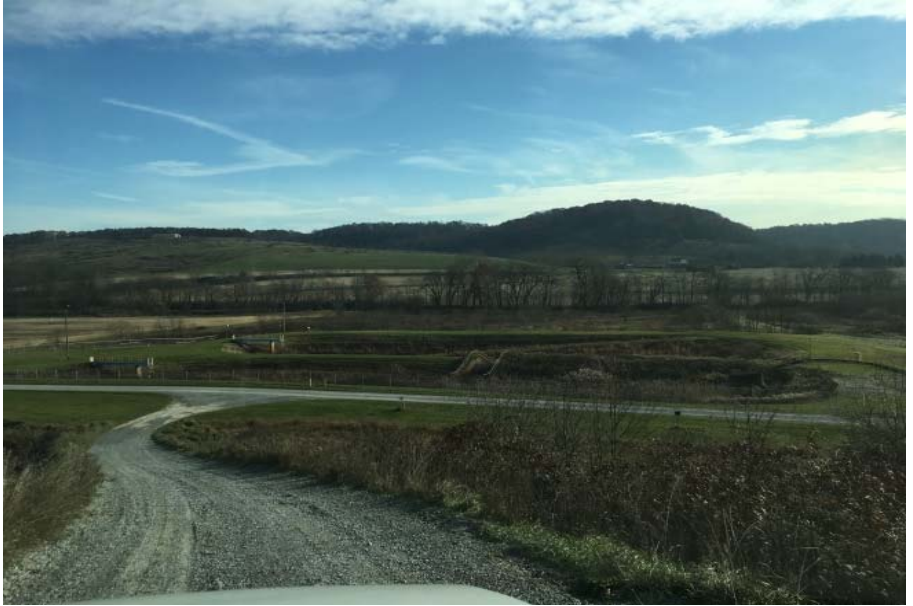
<p>Photograph No. 19</p> <p>Date: November 15, 2016</p> <p>Direction: East</p>

<p>Description: Leachate ponds formerly associated with East Valley operations.</p>

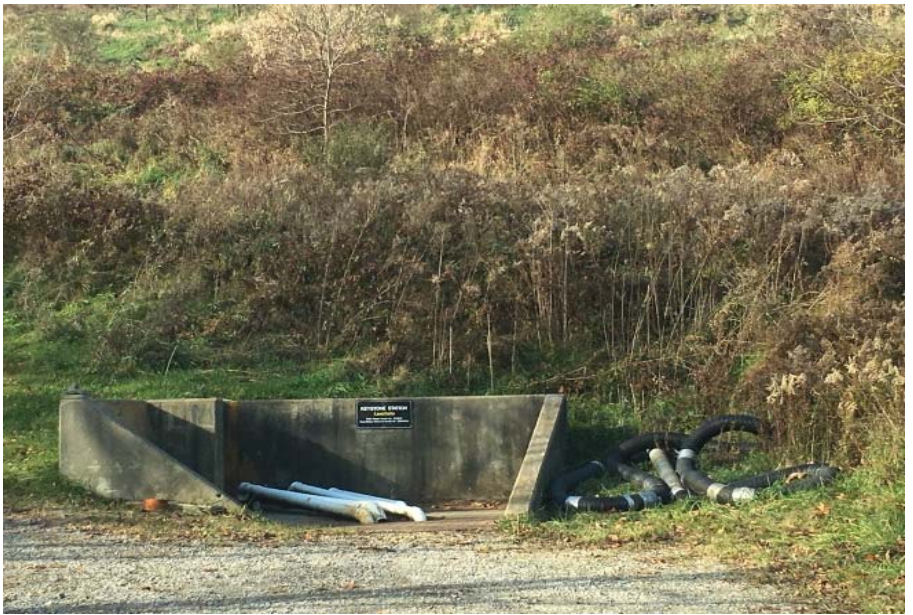
<p>Photograph No. 20</p> <p>Date: November 15, 2016</p> <p>Direction: East</p>

<p>Description: East Valley leachate collection structure (routes to Pump Station and then to IWT facility).</p>

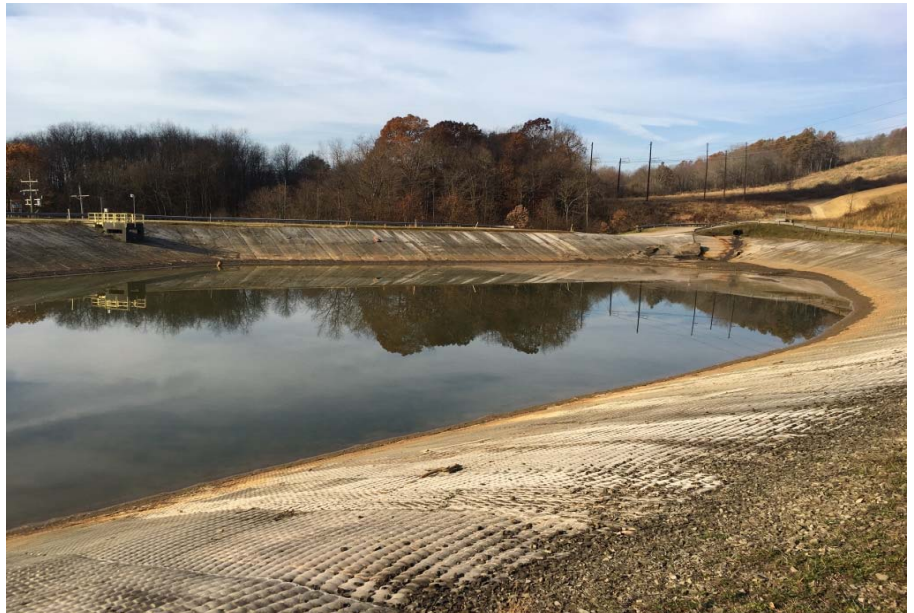
Photograph No. 21

West Valley equalization pond. No evidence of erosion or malfunction.

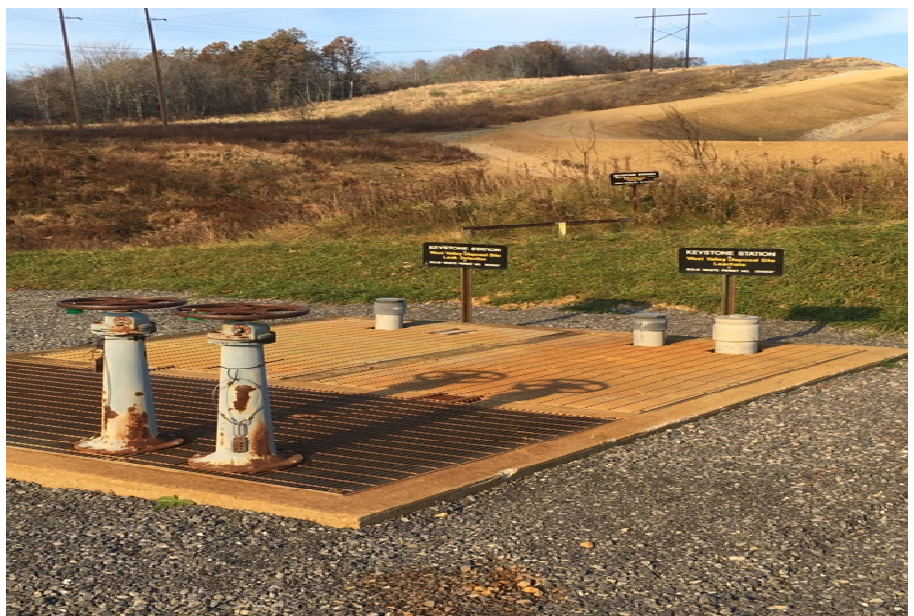
Photograph No. 22

Leachate collection box and valve station for the West Valley equalization pond. No evidence of malfunction.

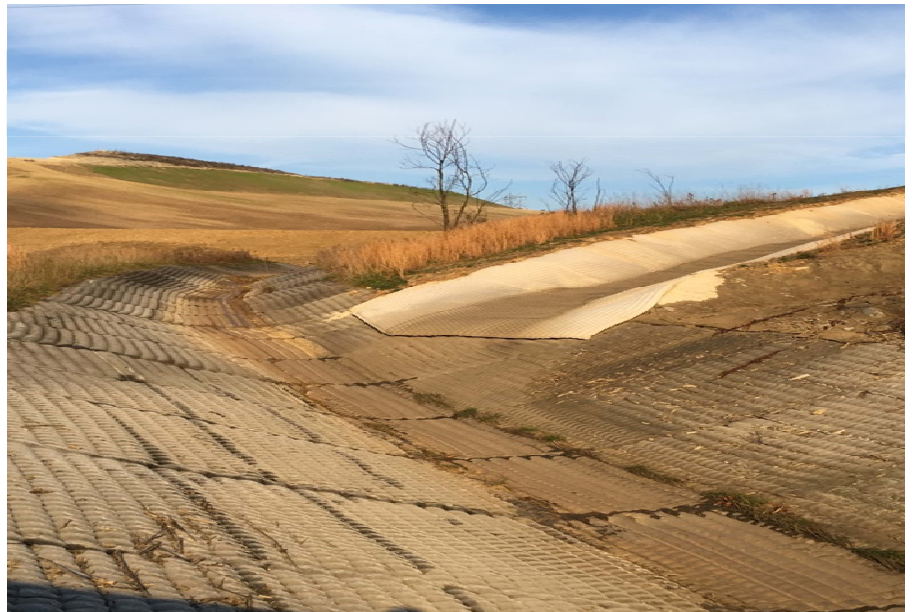
Photograph No. 23

"Contact" stormwater drainage channel. No evidence of erosion or obstruction.

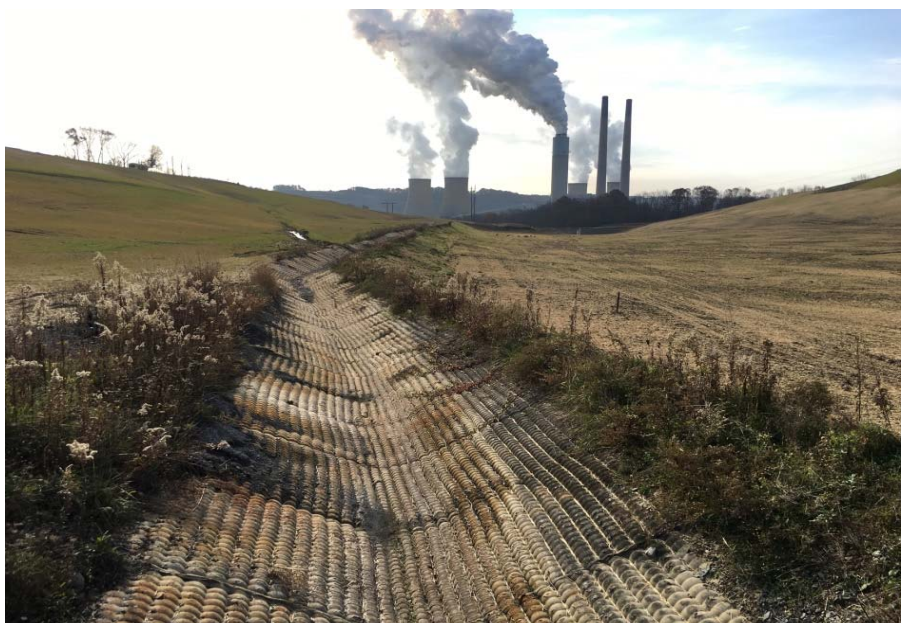
Photograph No. 24

"Non-contact" stormwater drainage channel between valley areas. No evidence of erosion or obstruction.

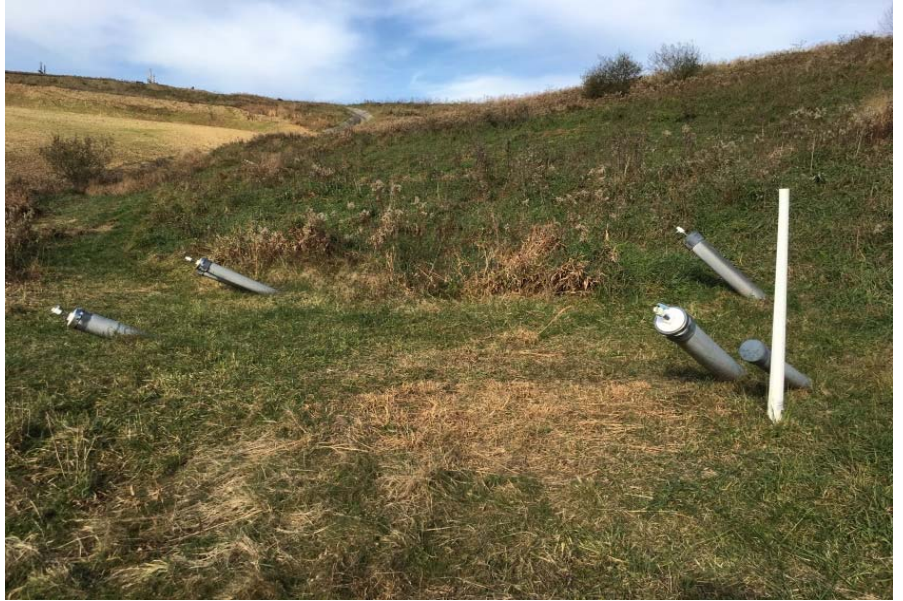
Photograph No. 25

Leachate collection system
cleanouts along interim toe of West
Valley disposal area southern slope.

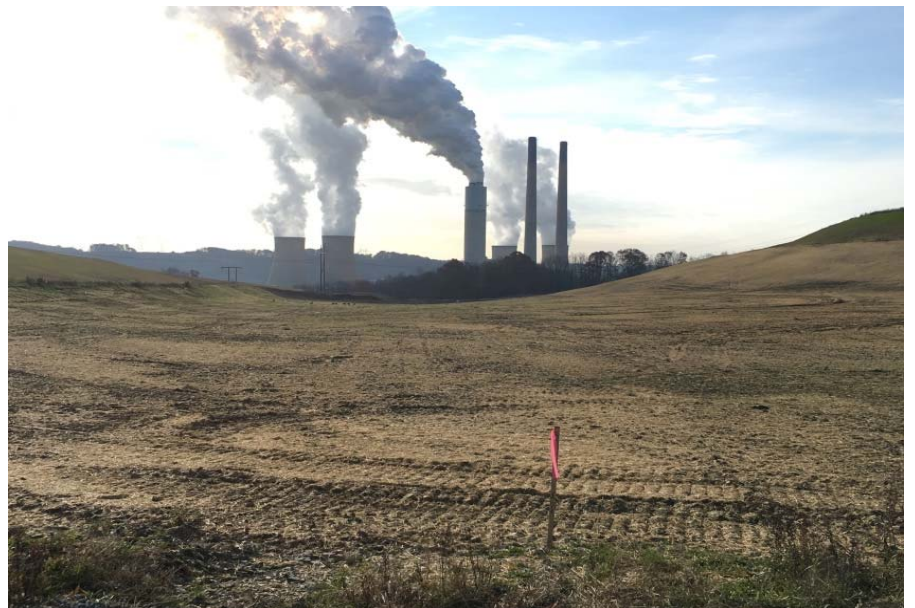
Photograph No. 26

Regraded and seeded area of the
West Valley Stage IV expansion. No
evidence of erosion.

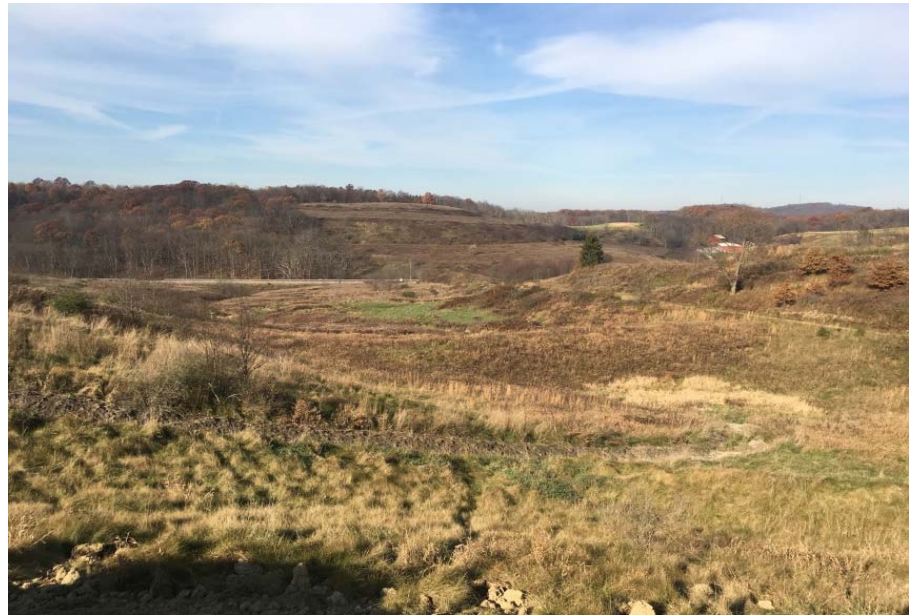
Photograph No. 27

Closed portion along the northwest perimeter of the West Valley disposal area. Vegetation is well established. No evidence of erosion or sloughing.

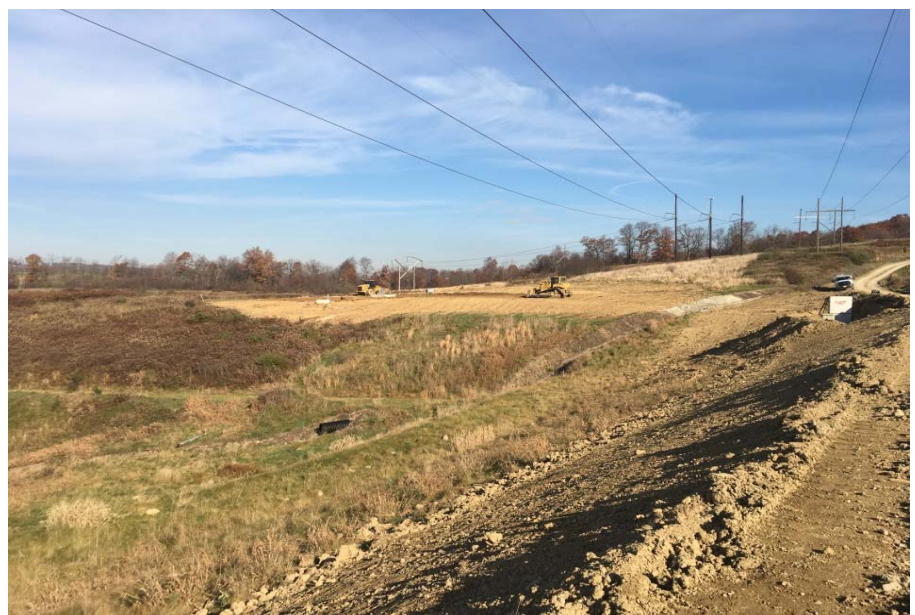
Photograph No. 28

Continued view of closed portion along the northwest perimeter of the West Valley disposal area. Vegetation is well established. No evidence of erosion or sloughing.
