## **Inspection Report**

**To:** Mark Jacklin (Keystone Generating Station)  
**From:** Richard Southorn, P.E., P.G.  
**Re:** Keystone Ash Disposal Site – Annual CCR Unit Inspection Report  
**Inspection Date:** October 22, 2018  
**Report Date:** January 16, 2019

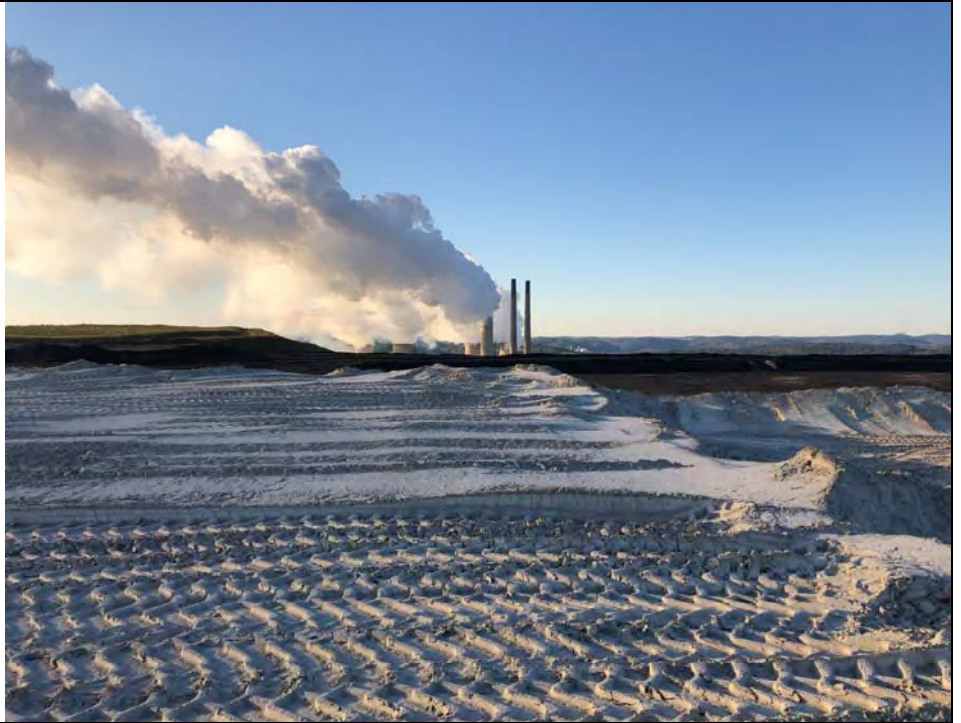
Image: 2284  
Date: 10/22/2018  
Time: 7:45 AM  
Direction: South

Gypsum in West Valley active area that has been recently spread prior to compaction.

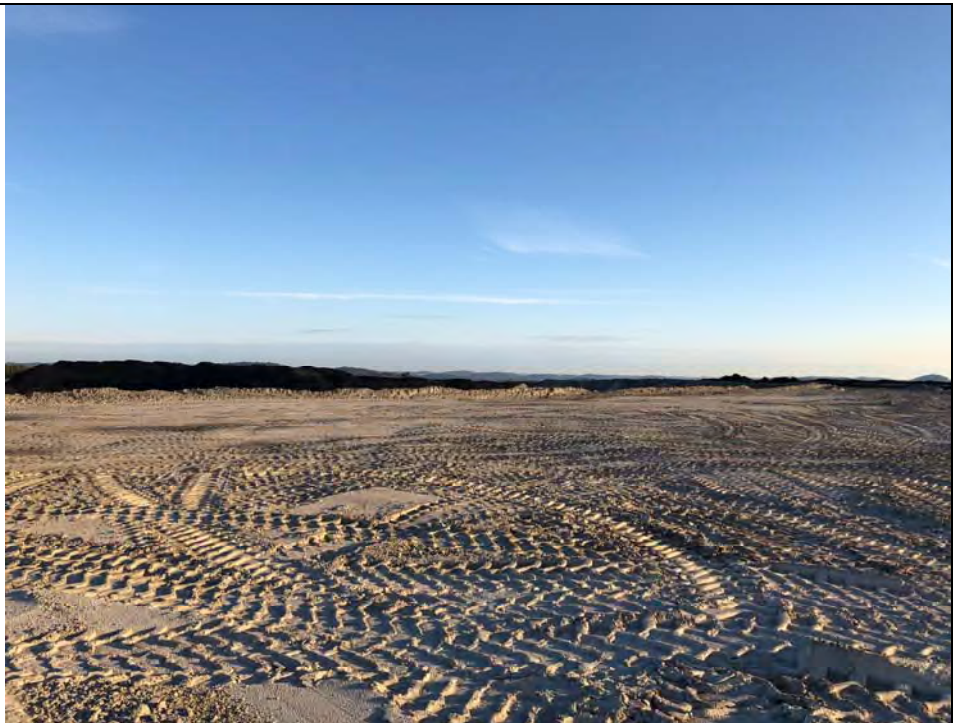
Image: 2286  
Date: 10/22/2018  
Time: 7:45 AM  
Direction: North

Gypsum in West Valley active area.

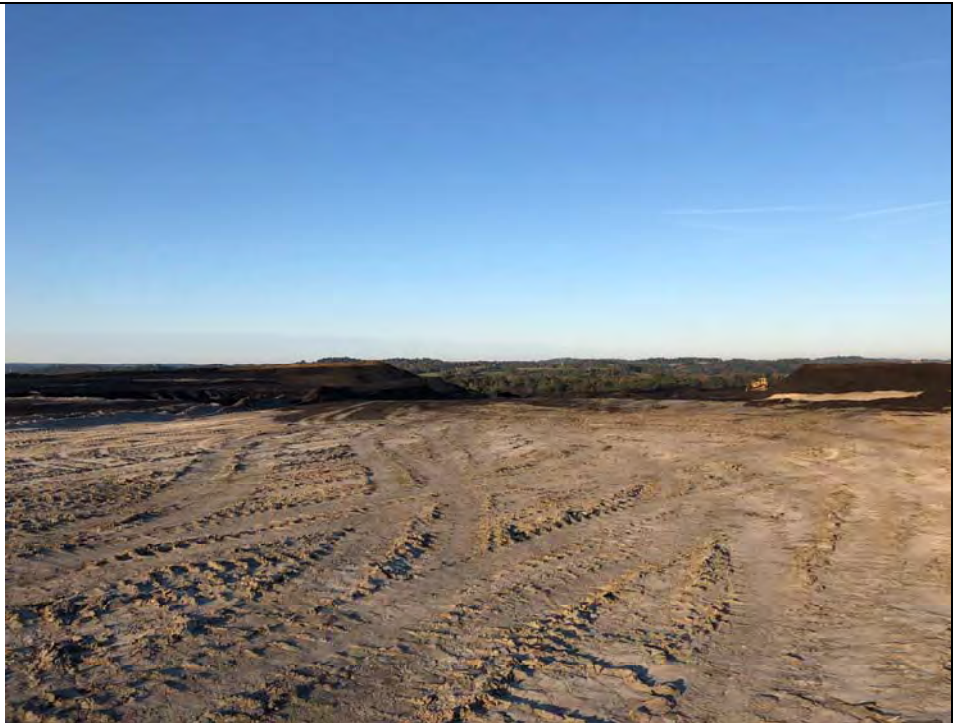
Image: 2288  
Date: 10/22/2018  
Time: 7:46 AM  
Direction: West

West Valley active area.  
Compacted and graded to  
prevent ponding water.

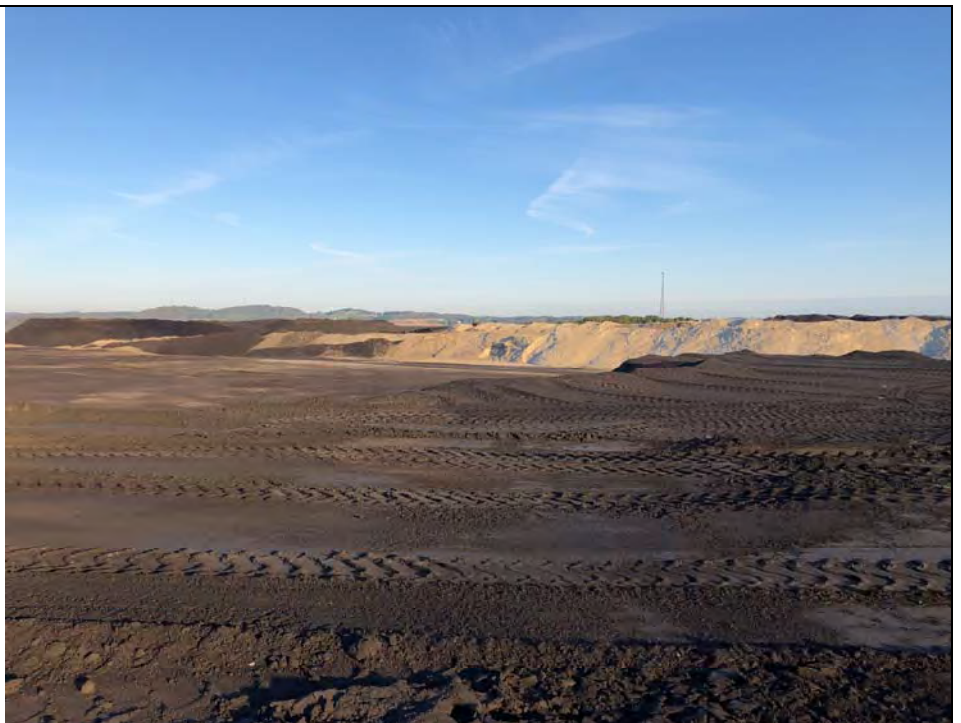
Image: 2290  
Date: 10/22/2018  
Time: 7:48 AM  
Direction: North

West Valley active area  
after being sprayed by  
water truck to prevent  
fugitive dust.

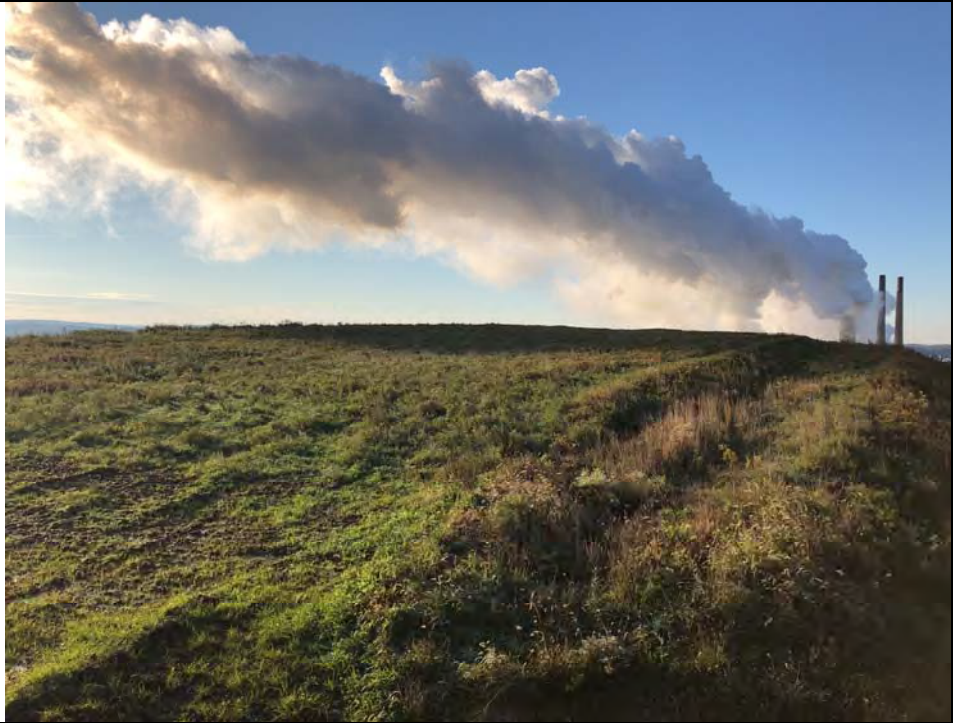
Image: 2292  
Date: 10/22/2018  
Time: 7:49 AM  
Direction: South

Final cover placed on East Valley. Vegetation is well established with uniform coverage. No observed erosion, animal burrows, or visual indications of instability.

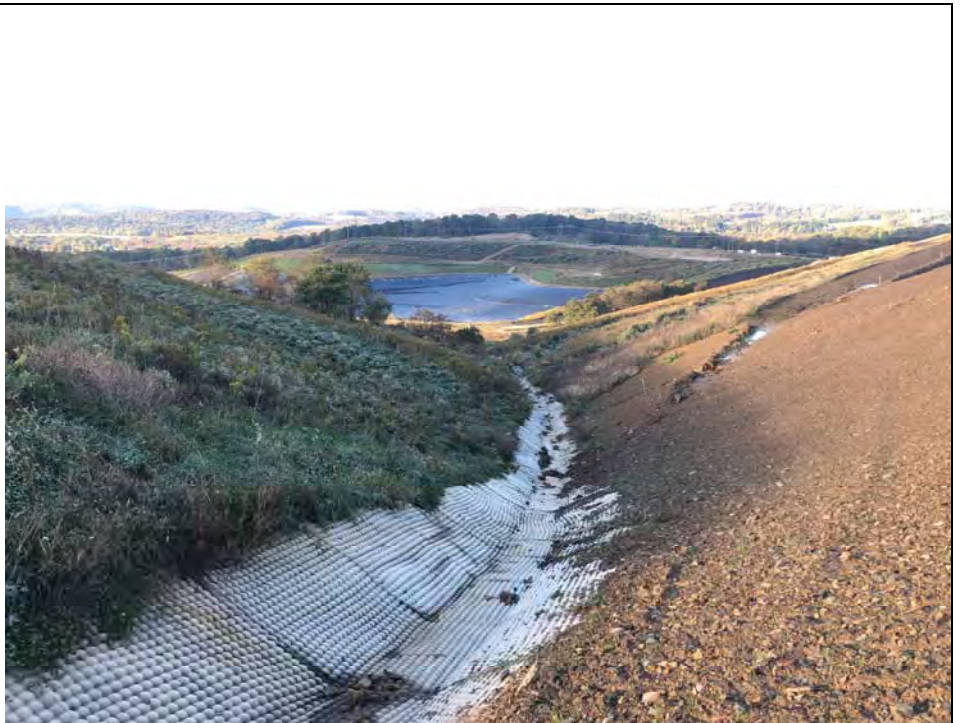
Image: 2294  
Date: 10/22/2018  
Time: 7:49 AM  
Direction: Southwest

A non-contact stormwater channel that is lined with revetment mat. The channel is free of obstructions and appears in good condition.

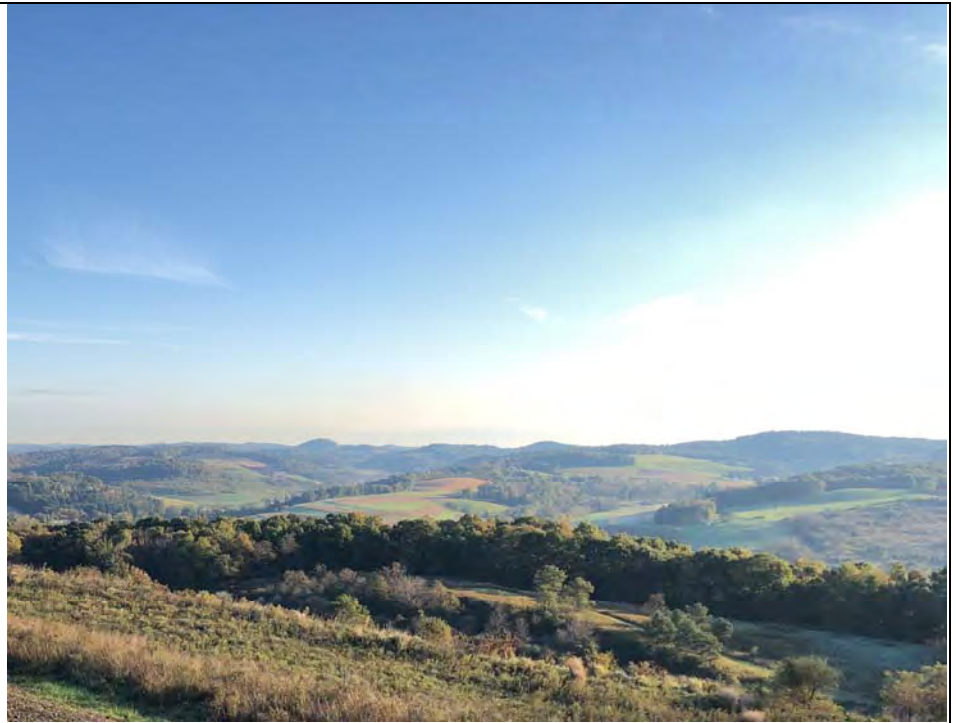
Image: 2296  
Date: 10/22/2018  
Time: 7:51 AM  
Direction: Northeast

Final cover on sideslopes of East Valley. The vegetation is dense, healthy, and uniformly distributed. The final cover slopes show no evidence of erosion, animal burrows, or failure (e.g. sloughing or sliding).

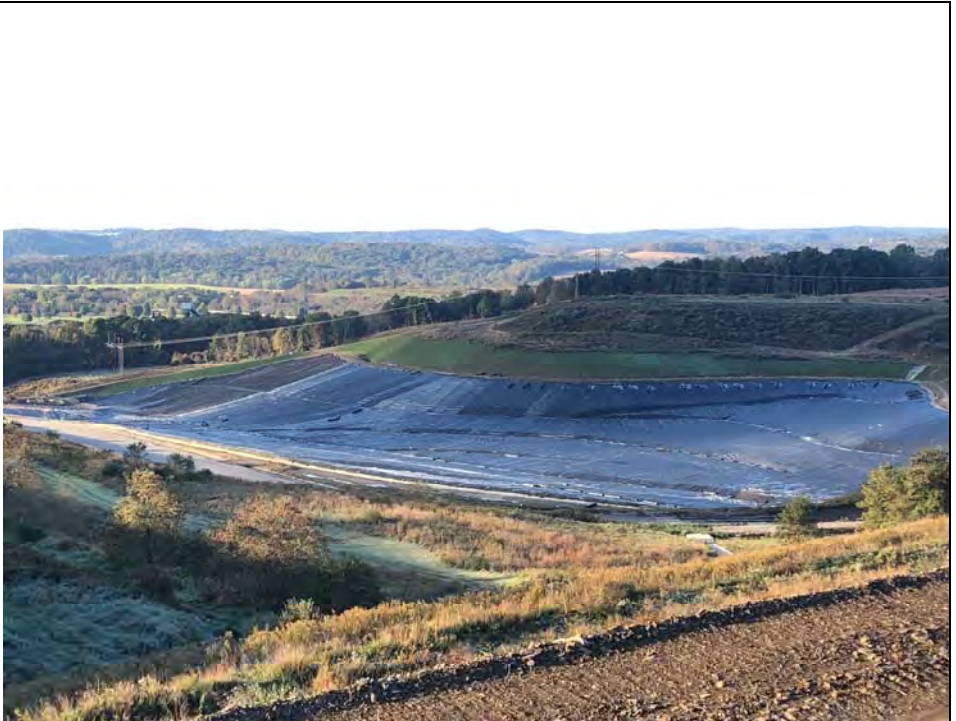
Image: 2298  
Date: 10/22/2018  
Time: 7:53 AM  
Direction: Southwest

Recently installed geomembrane in West Valley Expansion Area.

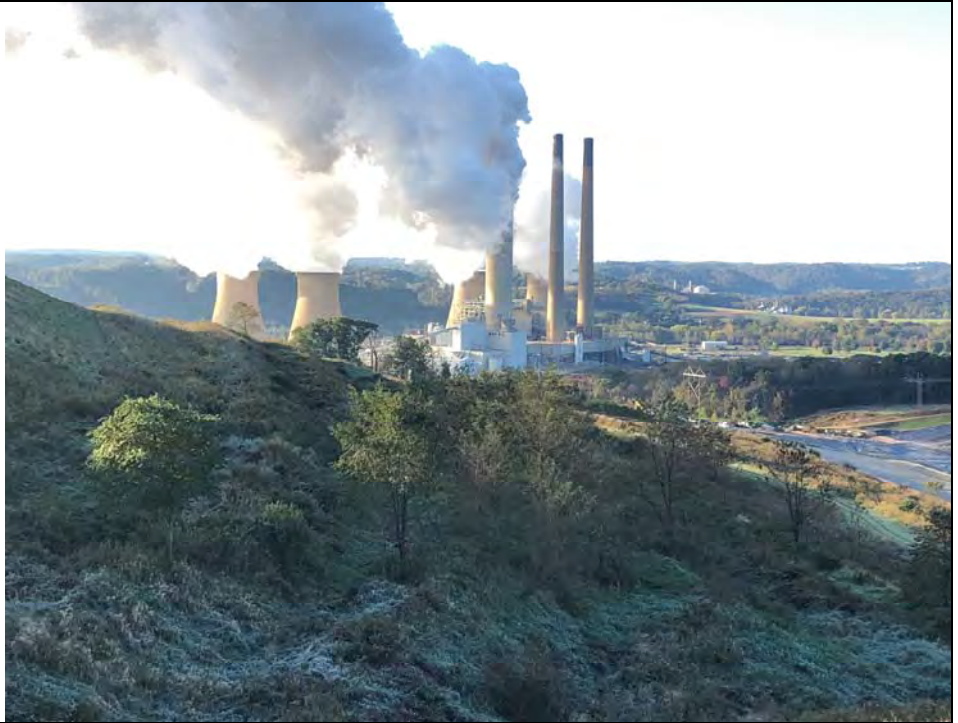
Image: 2300  
Date: 10/22/2018  
Time: 7:53 AM  
Direction: South

Final cover on sideslopes of East Valley. The vegetation is dense and healthy. The final cover slopes show no evidence of erosion, animal burrows, or failure (e.g. sloughing or sliding).

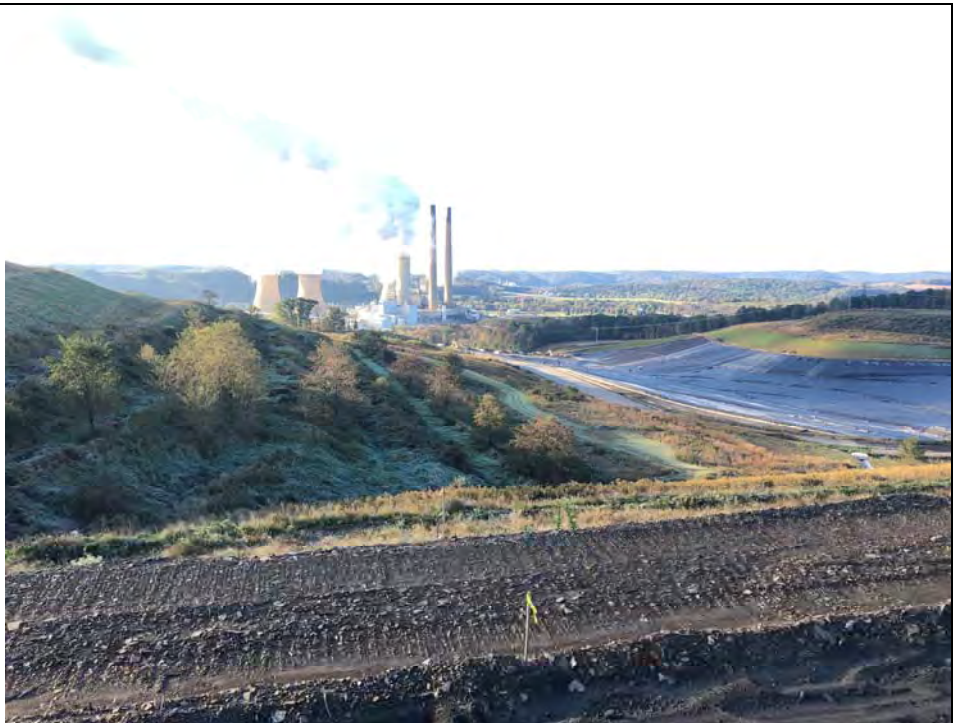
Image: 2302  
Date: 10/22/2018  
Time: 7:53 AM  
Direction: South

Southern view between East and West Valley Expansion Area from active area.

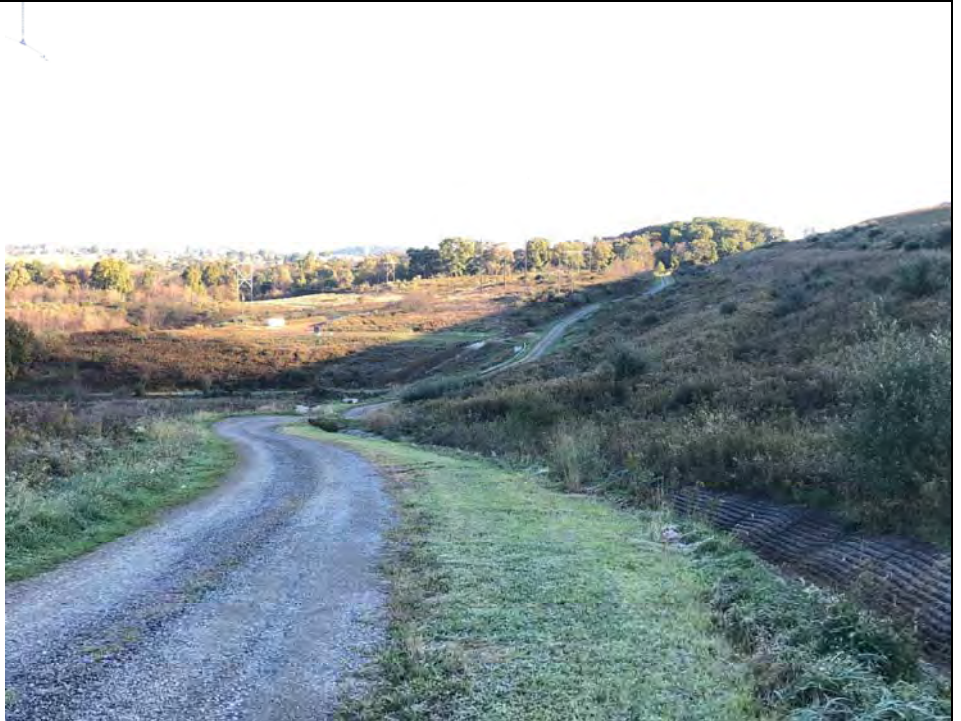
Image: 2311  
Date: 10/22/2018  
Time: 8:02 AM  
Direction: Northeast

Perimeter road on western side of West Valley.  
Revetment lined run-off ditch on interior side of road (right, in photograph).

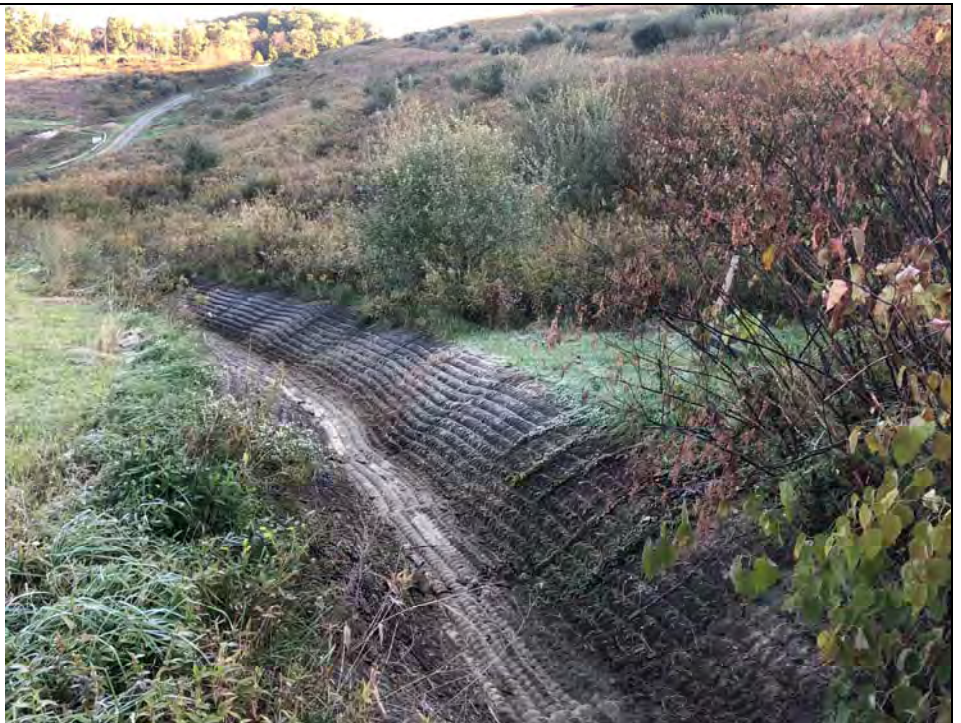
Image: 2313  
Date: 10/22/2018  
Time: 8:02 AM  
Direction: Northeast

A non-contact stormwater channel that is lined with revetment mat. The channel is free of obstructions and appears in good condition.

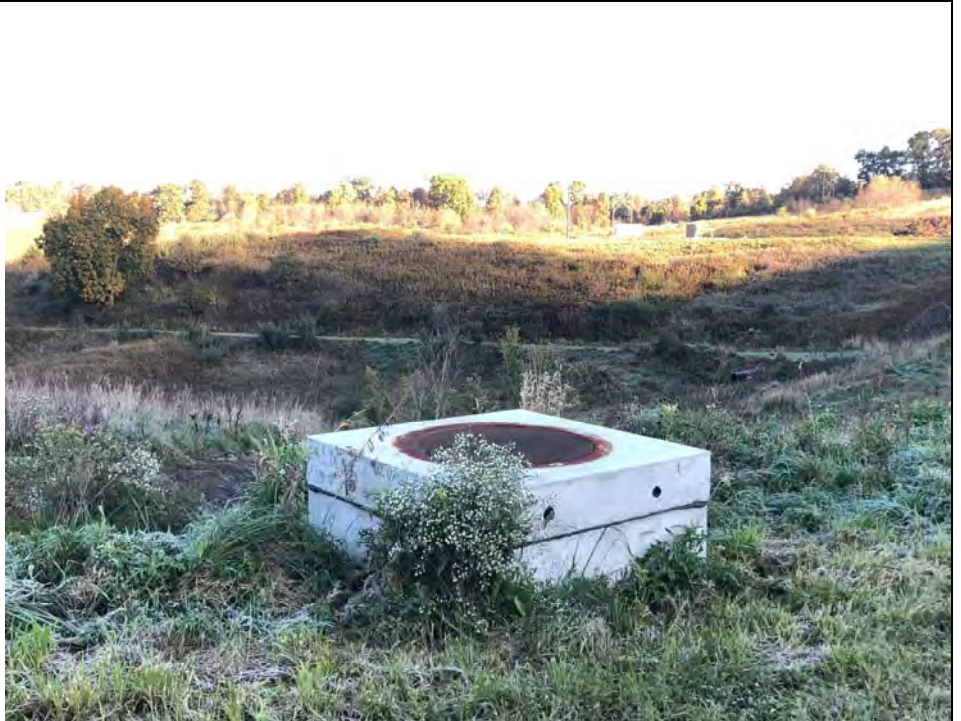
Image: 2317  
Date: 10/22/2018  
Time: 8:03 AM  
Direction: North

Cleanout access point for new pump station.

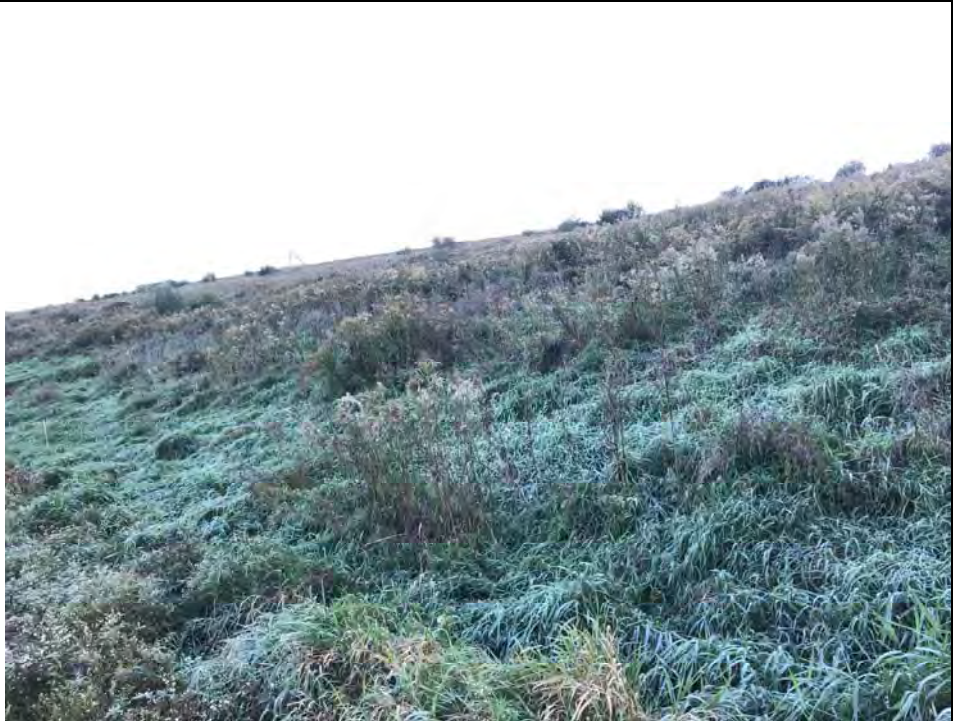
Image: 2321  
Date: 10/22/2018  
Time: 8:04 AM  
Direction: Northeast

Final cover on sideslopes of West Valley. The vegetation is dense, healthy, and uniformly distributed. The final cover slopes show no evidence of erosion, animal burrows, or failure (e.g. sloughing or sliding).

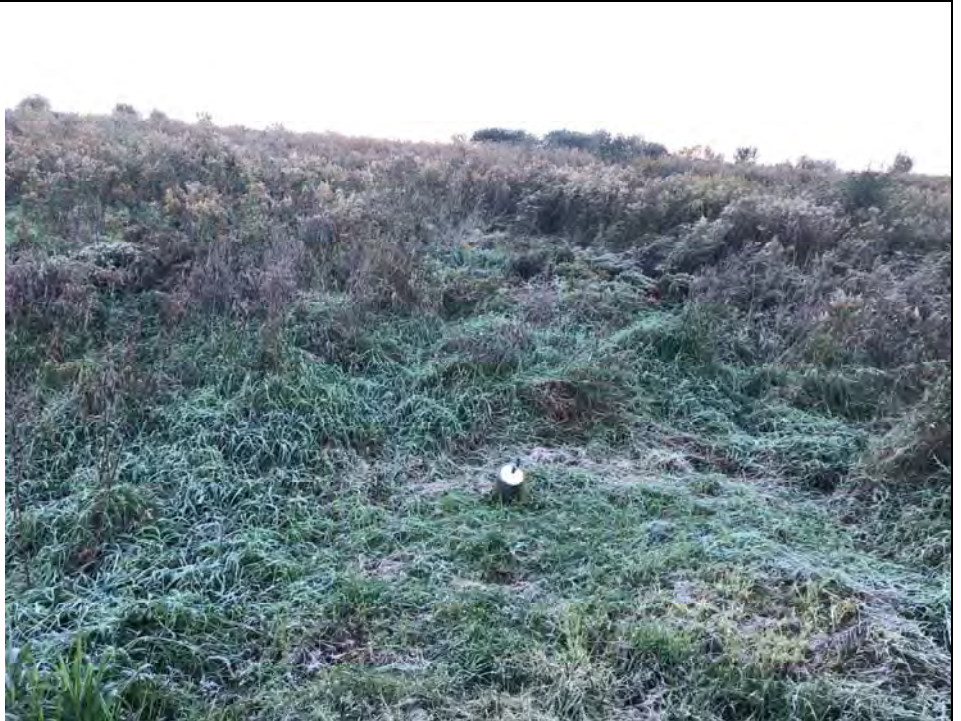
Image: 2323  
Date: 10/22/2018  
Time: 8:04 AM  
Direction: Southeast

A leachate cleanout present within the West Valley final cover.

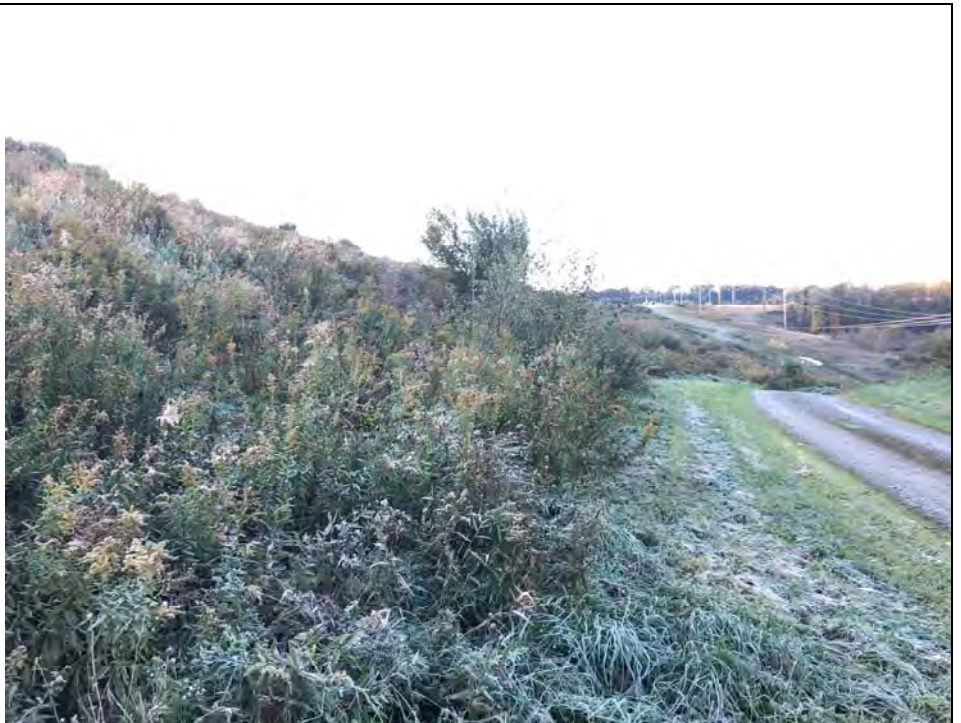
Image: 2325  
Date: 10/22/2018  
Time: 8:07 AM  
Direction: Southwest

Final cover on sideslopes of West Valley. The vegetation is dense, healthy, and uniformly distributed. The final cover slopes show no evidence of erosion, animal burrows, or failure (e.g. sloughing or sliding).

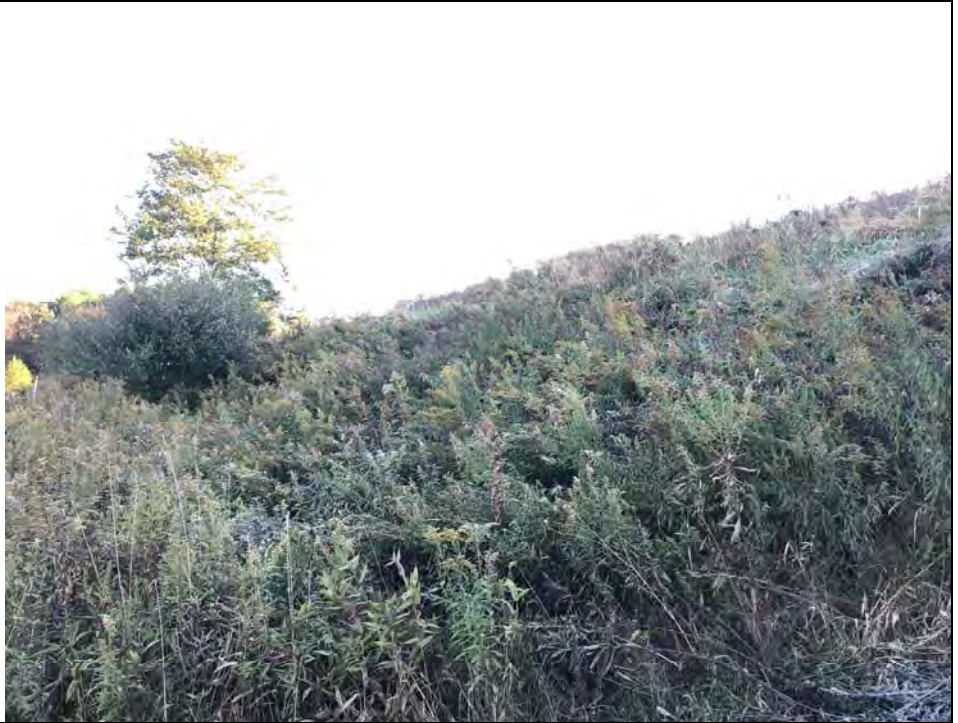
Image: 2327  
Date: 10/22/2018  
Time: 8:08 AM  
Direction: Northeast

Final cover on sideslopes of West Valley. The vegetation is dense, healthy, and uniformly distributed. The final cover slopes show no evidence of erosion, animal burrows, or failure (e.g. sloughing or sliding).

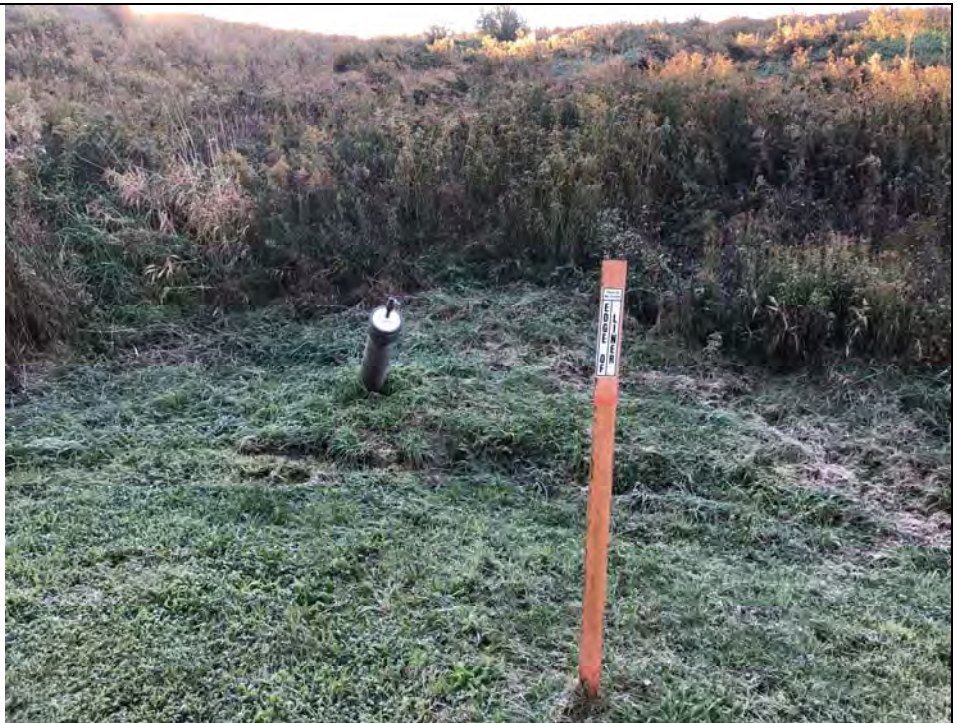
Image: 2329  
Date: 10/22/2018  
Time: 8:09 AM  
Direction: Southeast

West Valley edge-of-Liner marker in foreground and leachate cleanout riser in background.

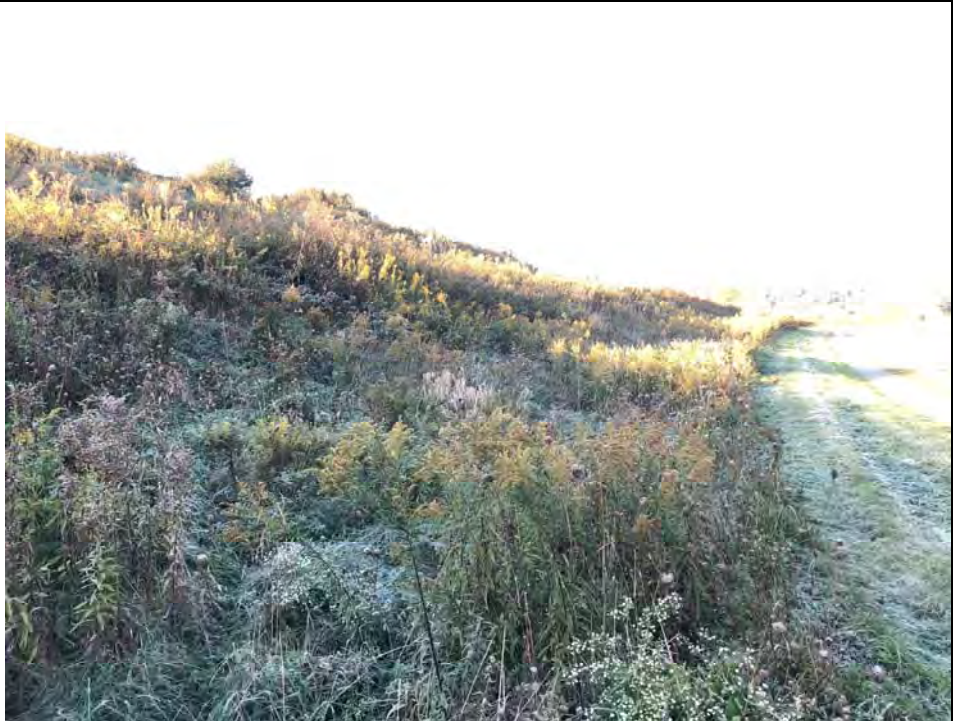
Image: 2331  
Date: 10/22/2018  
Time: 8:09 AM  
Direction: Southwest

Final cover on sideslopes of West Valley. The vegetation is dense, healthy, and uniformly distributed. The final cover slopes show no evidence of erosion, animal burrows, or failure (e.g. sloughing or sliding).

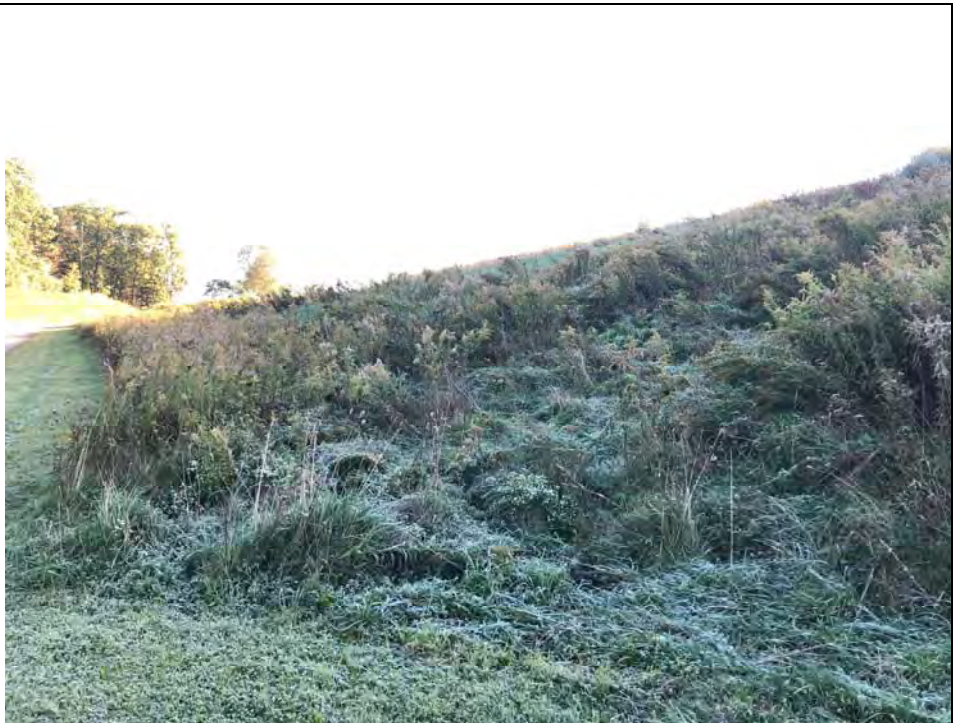
Image: 2333  
Date: 10/22/2018  
Time: 8:09 AM  
Direction: Northeast

Final cover on sideslopes of West Valley. The vegetation is dense, healthy, and uniformly distributed. The final cover slopes show no evidence of erosion, animal burrows, or failure (e.g. sloughing or sliding).

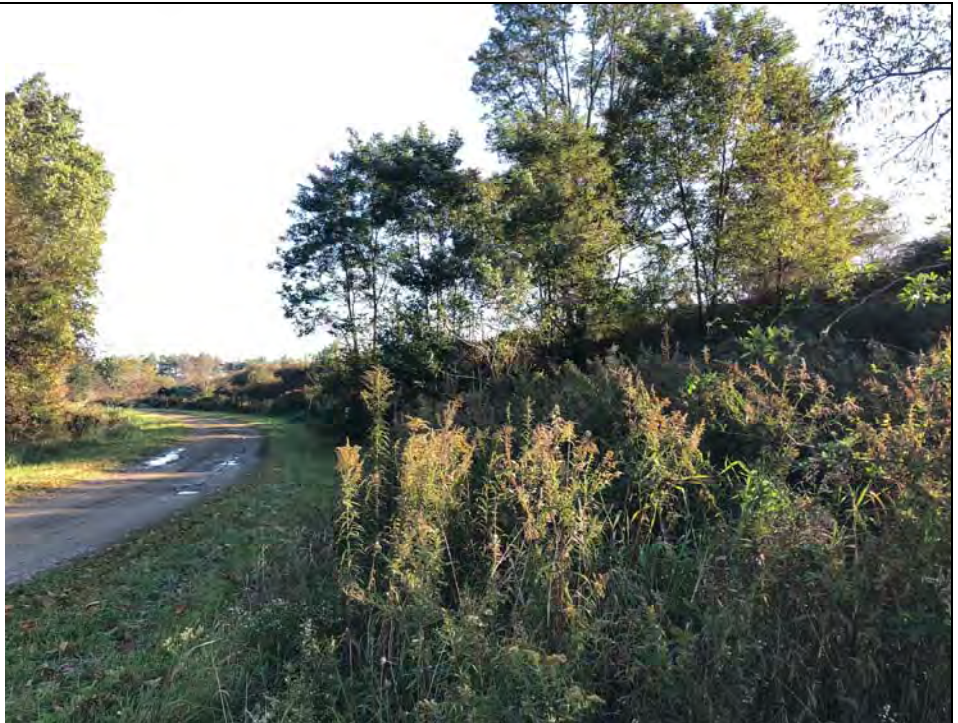
Image: 2337  
Date: 10/22/2018  
Time: 8:11 AM  
Direction: Northeast

Final cover on sideslopes of West Valley. The vegetation is dense, healthy, and uniformly distributed. The final cover slopes show no evidence of erosion, animal burrows, or failure (e.g. sloughing or sliding).

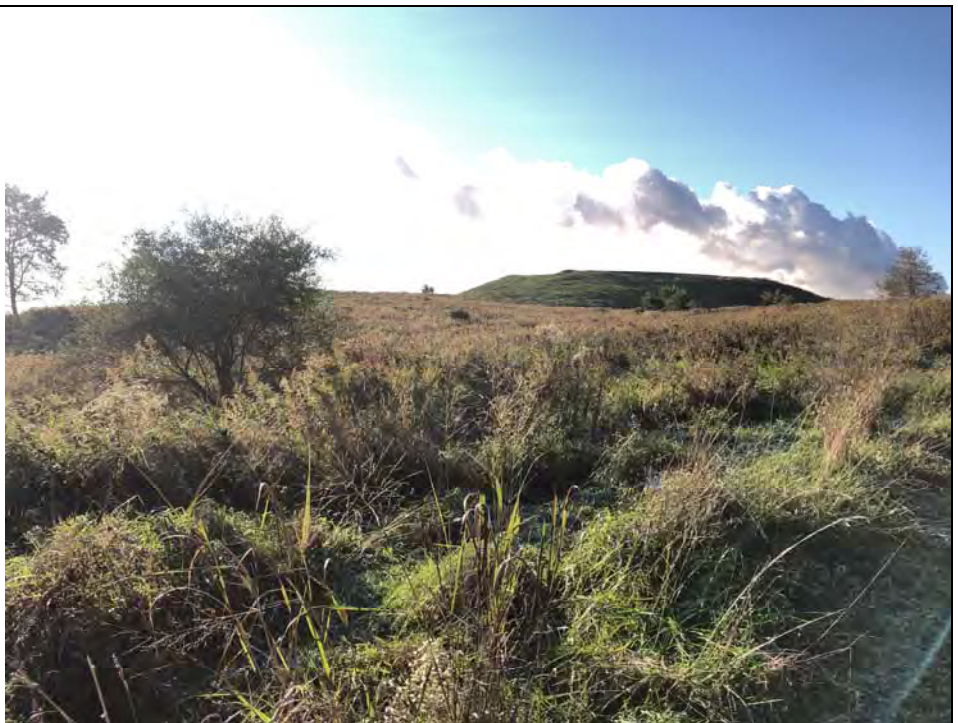
Image: 2339  
Date: 10/22/2018  
Time: 8:14 AM  
Direction: South

Final cover on topslopes of West Valley. The vegetation is dense, healthy, and uniformly distributed. The final cover slopes show no evidence of erosion, animal burrows, or failure (e.g. sloughing or sliding).

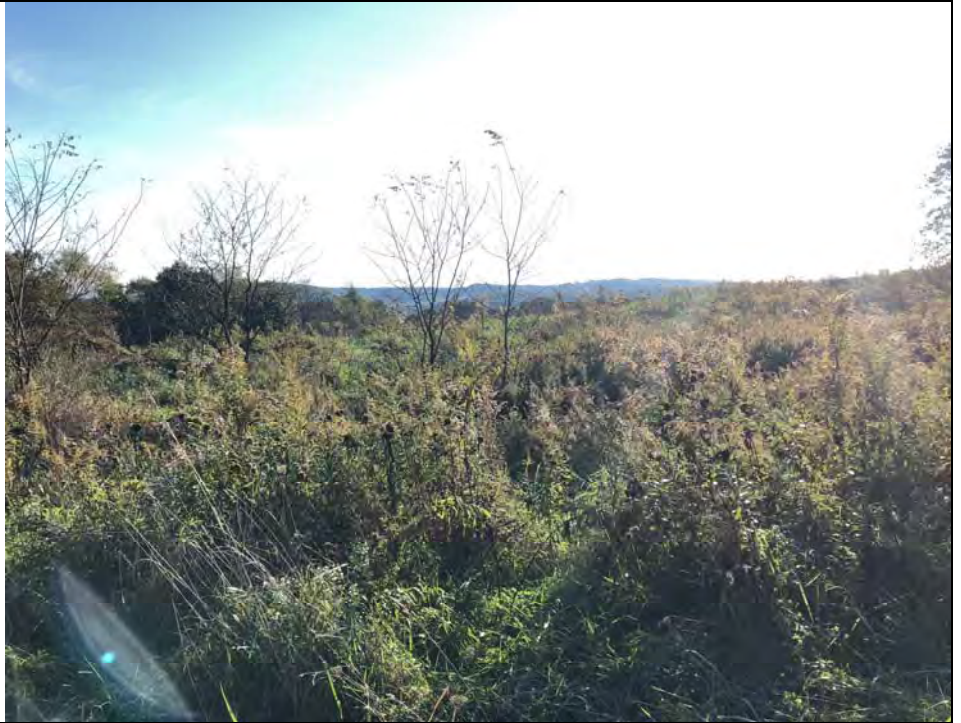
Image: 2341  
Date: 10/22/2018  
Time: 8:14 AM  
Direction: East

Final cover on sideslopes of East Valley. The vegetation is dense, healthy, and uniformly distributed. The final cover slopes show no evidence of erosion, animal burrows, or failure (e.g. sloughing or sliding).

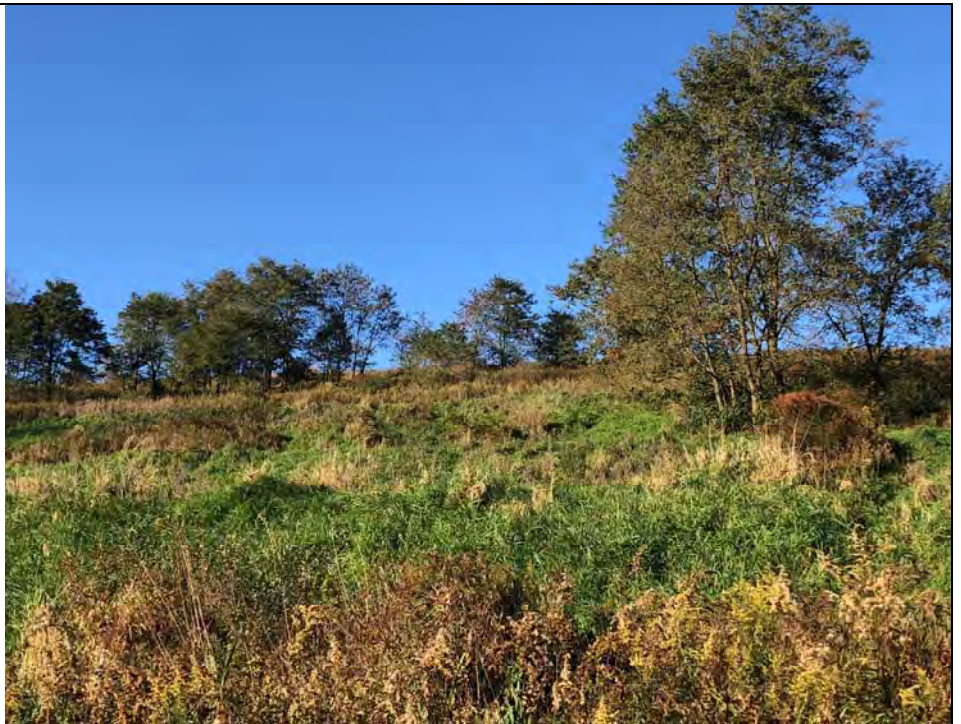
Image: 2347  
Date: 10/22/2018  
Time: 8:17 AM  
Direction: Southwest

Final cover on sideslopes of East Valley. The vegetation is dense, healthy, and uniformly distributed. The final cover slopes show no evidence of erosion, animal burrows, or failure (e.g. sloughing or sliding).

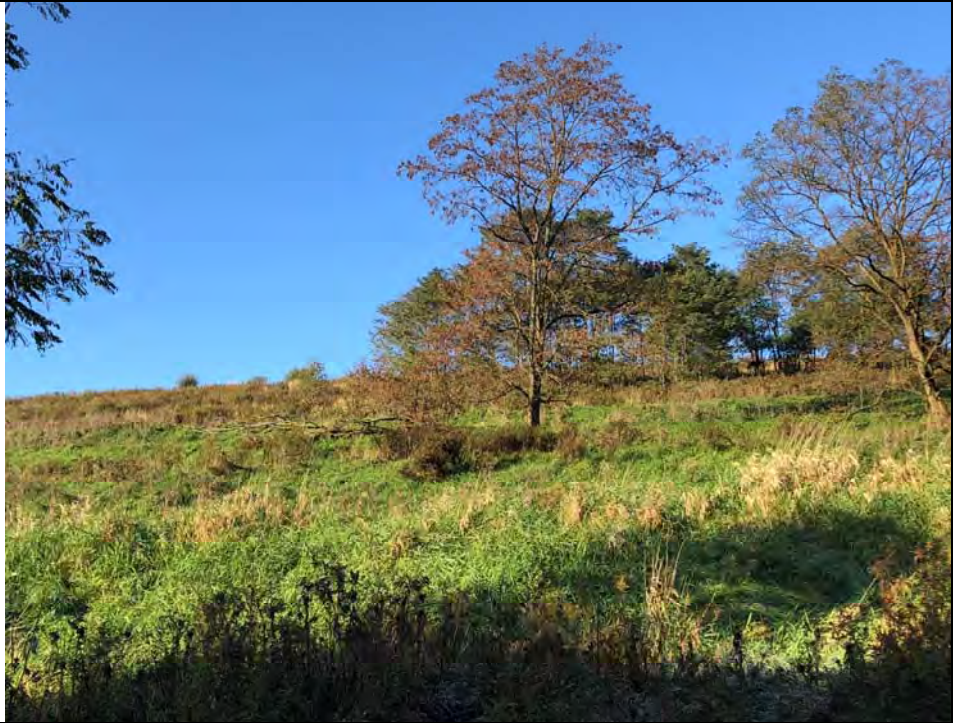
Image: 2349  
Date: 10/22/2018  
Time: 8:17 AM  
Direction: Southwest

Final cover on sideslopes of East Valley. The vegetation is dense, healthy, and uniformly distributed. The final cover slopes show no evidence of erosion, animal burrows, or failure (e.g. sloughing or sliding).

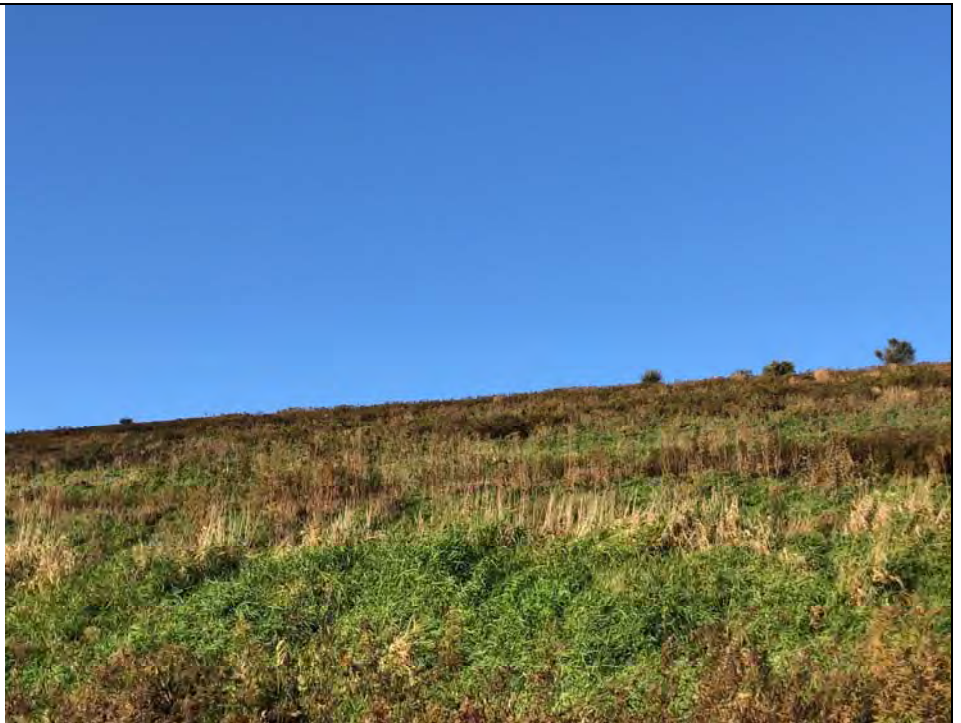
Image: 2351  
Date: 10/22/2018  
Time: 8:17 AM  
Direction: Southwest

Final cover on sideslopes of East Valley. The vegetation is dense, healthy, and uniformly distributed. The final cover slopes show no evidence of erosion, animal burrows, or failure (e.g. sloughing or sliding).

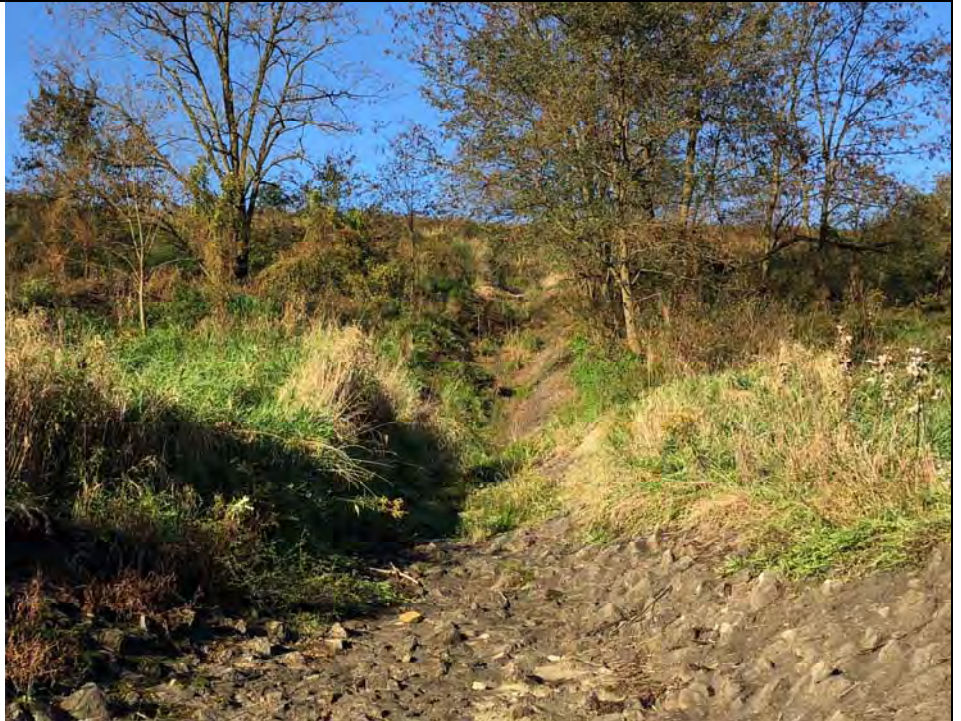
Image: 2353  
Date: 10/22/2018  
Time: 8:19 AM  
Direction: West

Downchute on final cover at East Valley. The downchute is armored and free of obstruction. Functioning as intended.

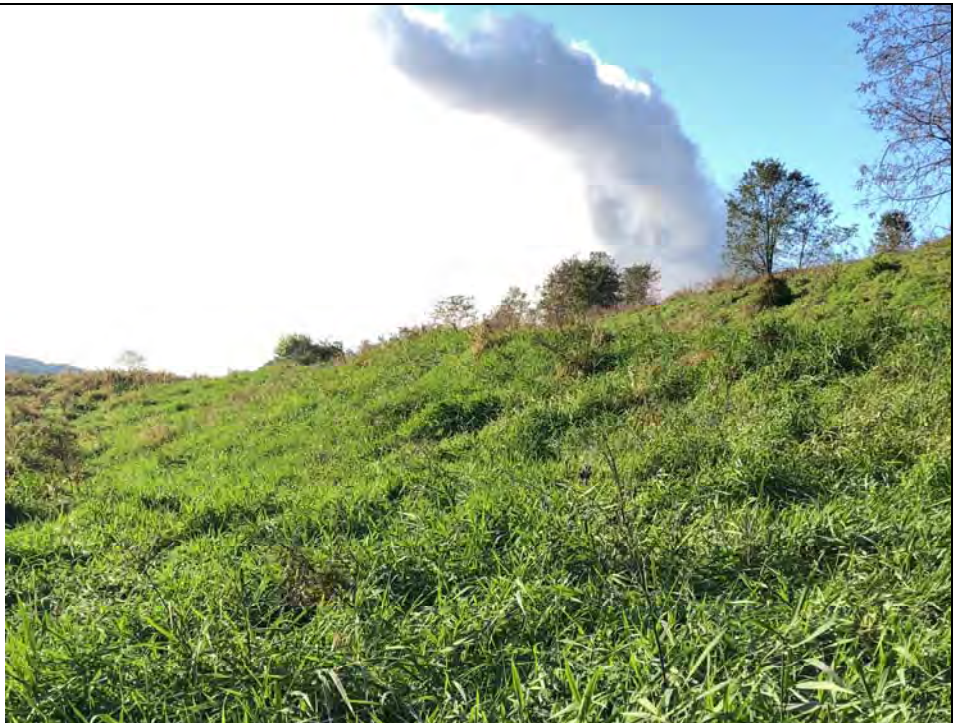
Image: 2357  
Date: 10/22/2018  
Time: 8:19 AM  
Direction: South

Final cover on sideslopes of East Valley. The vegetation is dense, healthy, and uniformly distributed. The final cover slopes show no evidence of erosion, animal burrows, or failure (e.g. sloughing or sliding).

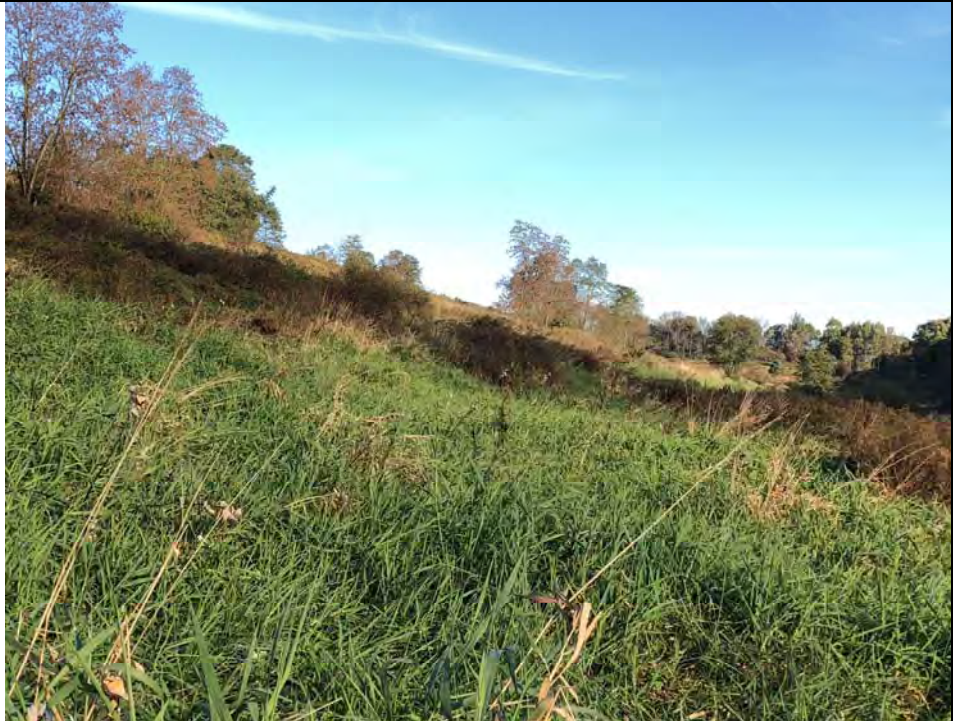
Image: 2359  
Date: 10/22/2018  
Time: 8:19 AM  
Direction: North

Final cover on sideslopes of East Valley. The vegetation is dense, healthy, and uniformly distributed. The final cover slopes show no evidence of erosion, animal burrows, or failure (e.g. sloughing or sliding).

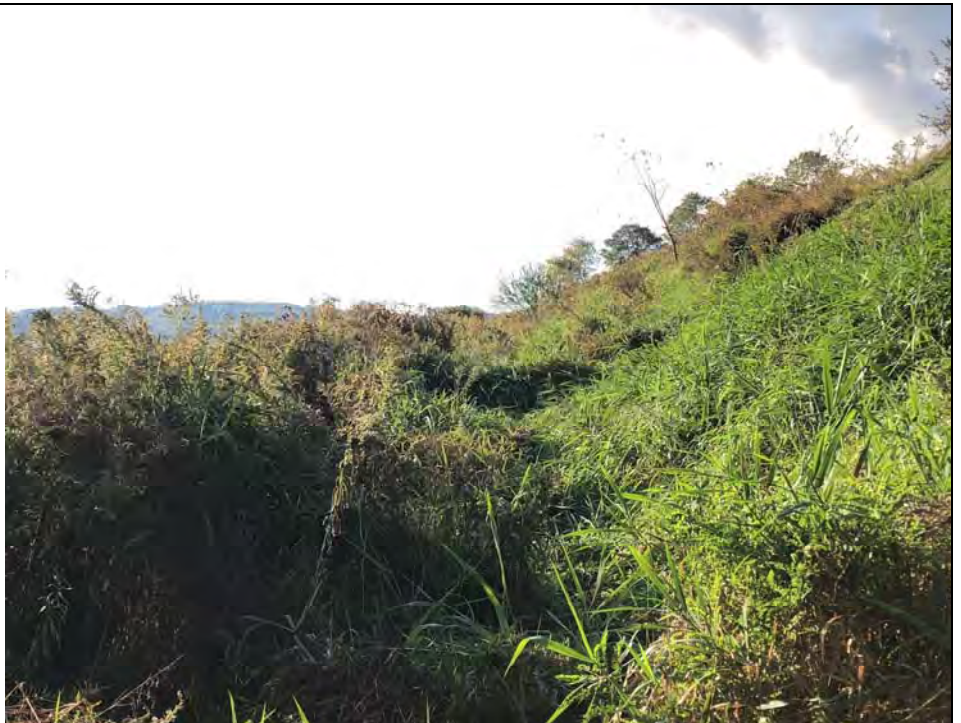
Image: 2361  
Date: 10/22/2018  
Time: 8:22 AM  
Direction: South

Final cover terrace on sideslopes of East Valley. The vegetation is dense, healthy, and uniformly distributed. The final cover slopes show no evidence of erosion, animal burrows, or failure (e.g. sloughing or sliding).
