## **Inspection Report**

**To:** Mark Jacklin (Keystone Generating Station)  
**From:** Richard Southorn, P.E., P.G.  
**Re:** Keystone Ash Disposal Site – Annual CCR Unit Inspection Report  
**Inspection Date:** October 22, 2018  
**Report Date:** January 16, 2019

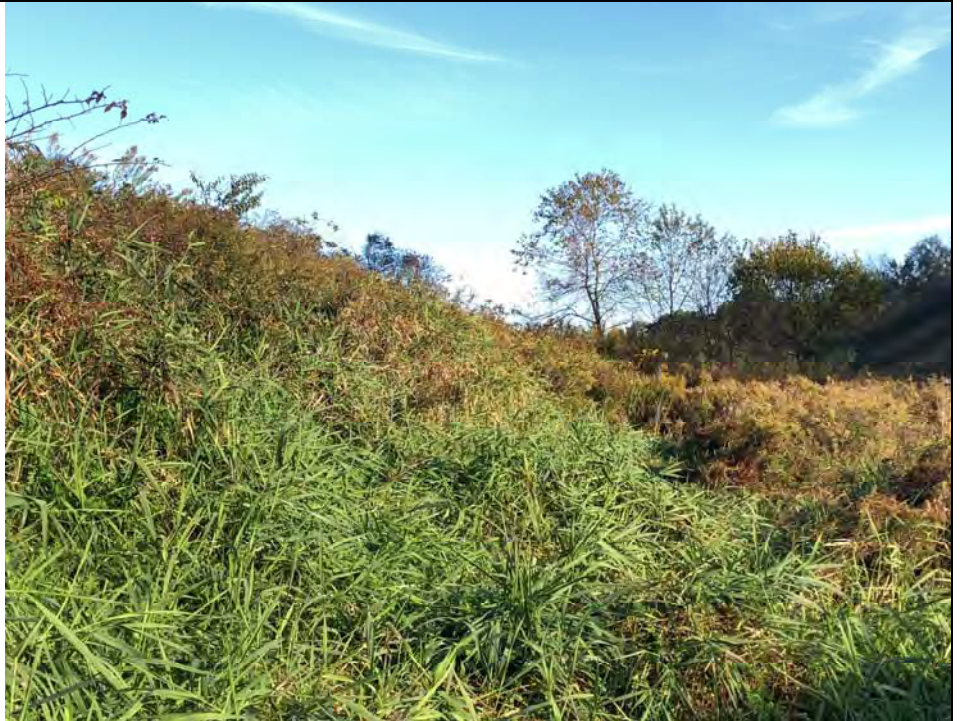
Image: 2363  
Date: 10/22/2018  
Time: 8:22 AM  
Direction: North

Final cover terrace on sideslopes of East Valley. The vegetation is dense, healthy, and uniformly distributed. The final cover slopes show no evidence of erosion, animal burrows, or failure (e.g. sloughing or sliding).

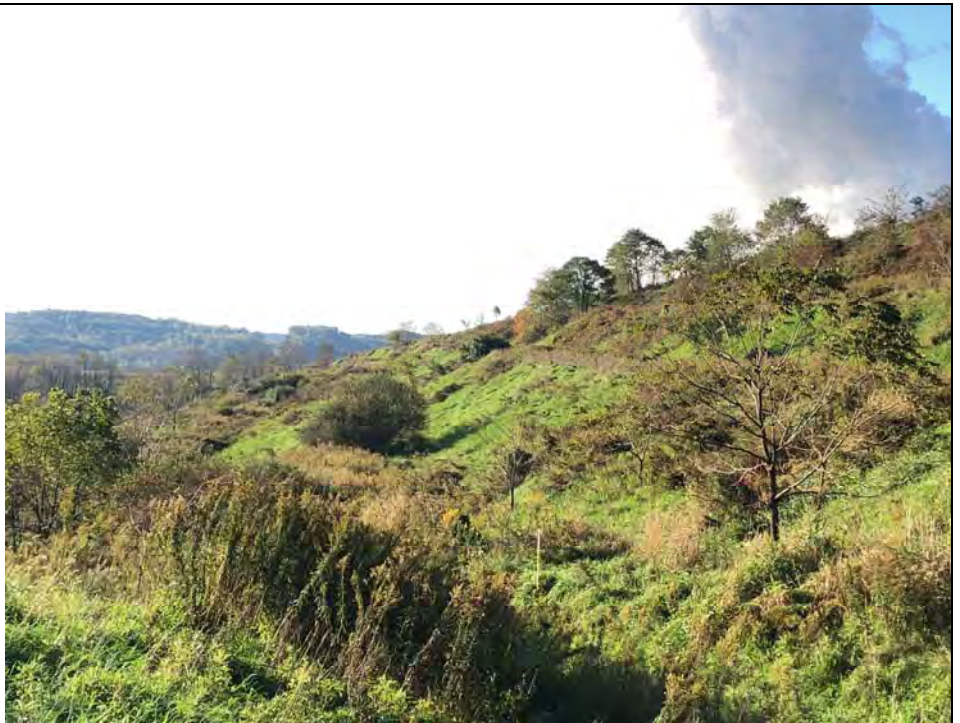
Image: 2365  
Date: 10/22/2018  
Time: 8:23 AM  
Direction: South

Final cover terrace on sideslopes of East Valley. The vegetation is dense, healthy, and uniformly distributed. The final cover slopes show no evidence of erosion, animal burrows, or failure (e.g. sloughing or sliding).

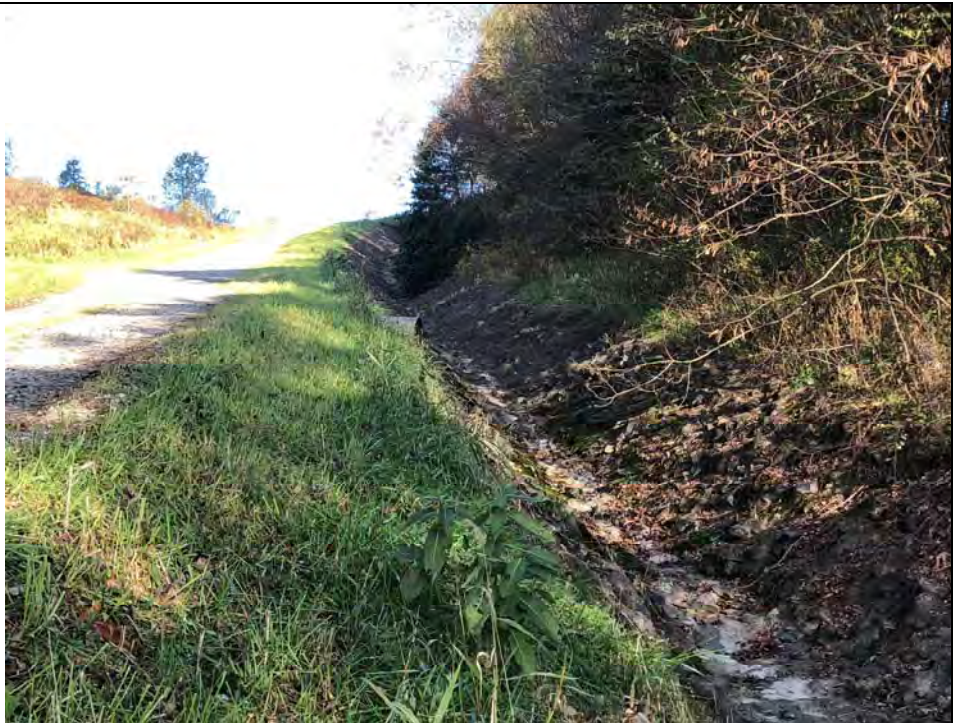
Image: 2368  
Date: 10/22/2018  
Time: 8:25 AM  
Direction: Northwest

Non-contact stormwater channel looking upslope at East Valley. Armored and functioning as intended.

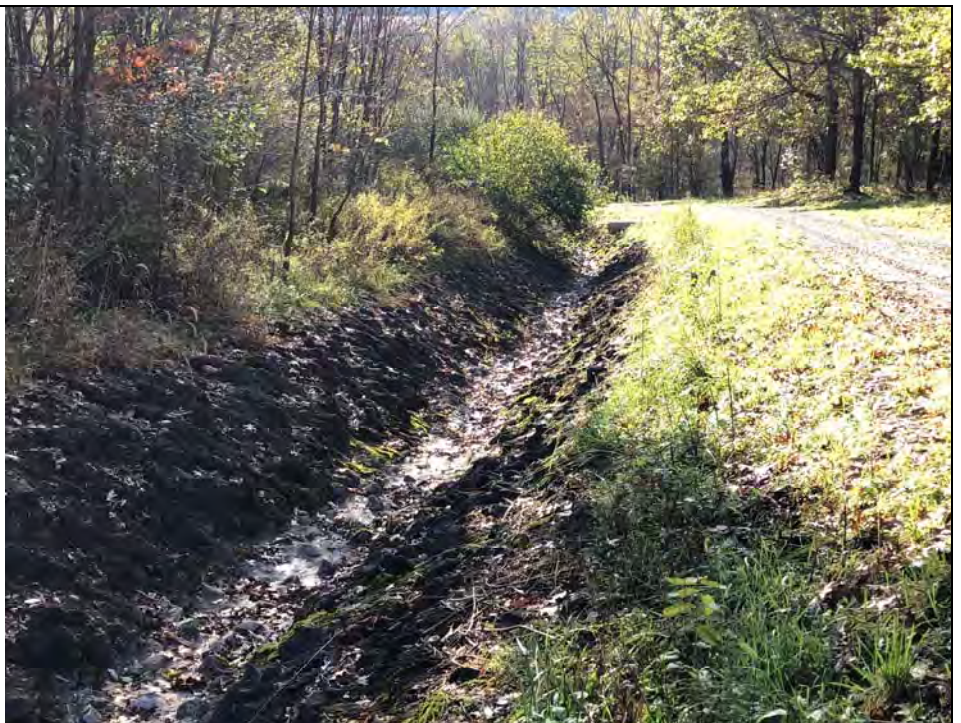
Image: 2372  
Date: 10/22/2018  
Time: 8:25 AM  
Direction: Southeast

Non-contact stormwater channel looking downslope at East Valley. Armored and functioning as intended.

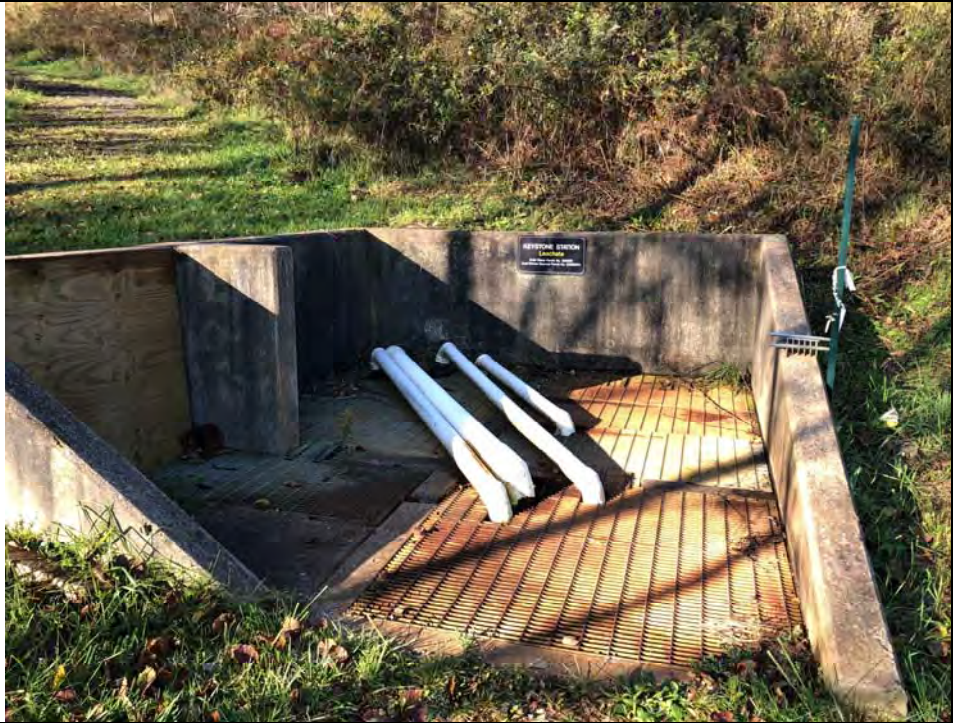
Image: 2374  
Date: 10/22/2018  
Time: 8:29 AM  
Direction: West

East Valley leachate collection structure (routes to Pump Station and then to IWT facility).

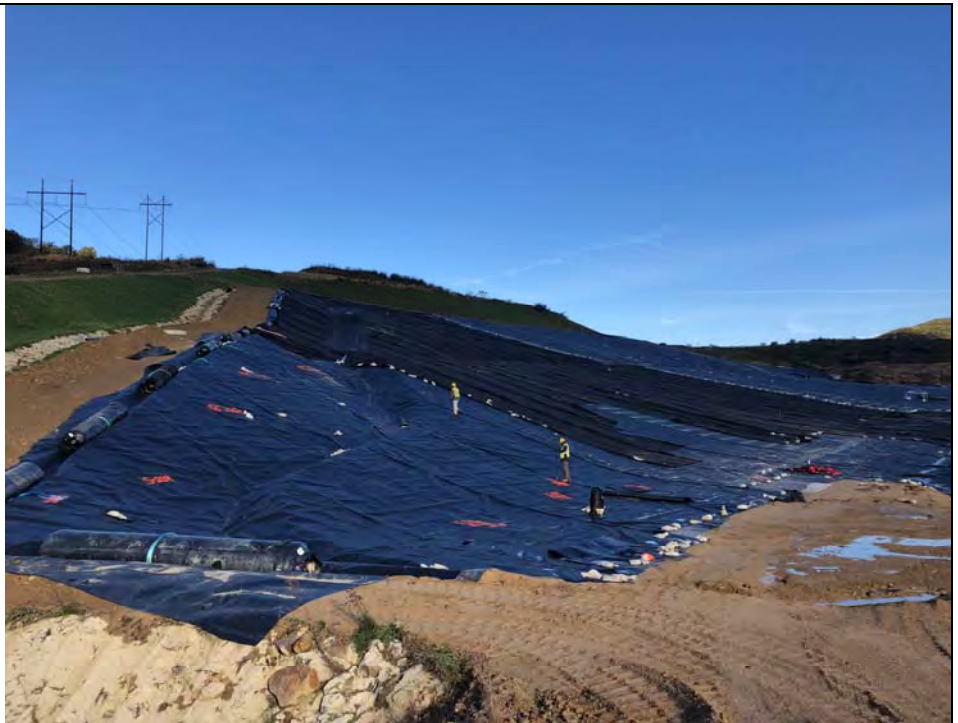
Image: 2376  
Date: 10/22/2018  
Time: 8:35 AM  
Direction: Northwest

Liner construction to support filling between valleys. Geomembrane is being installed over compacted clay liner. Panel seaming actively being completed.

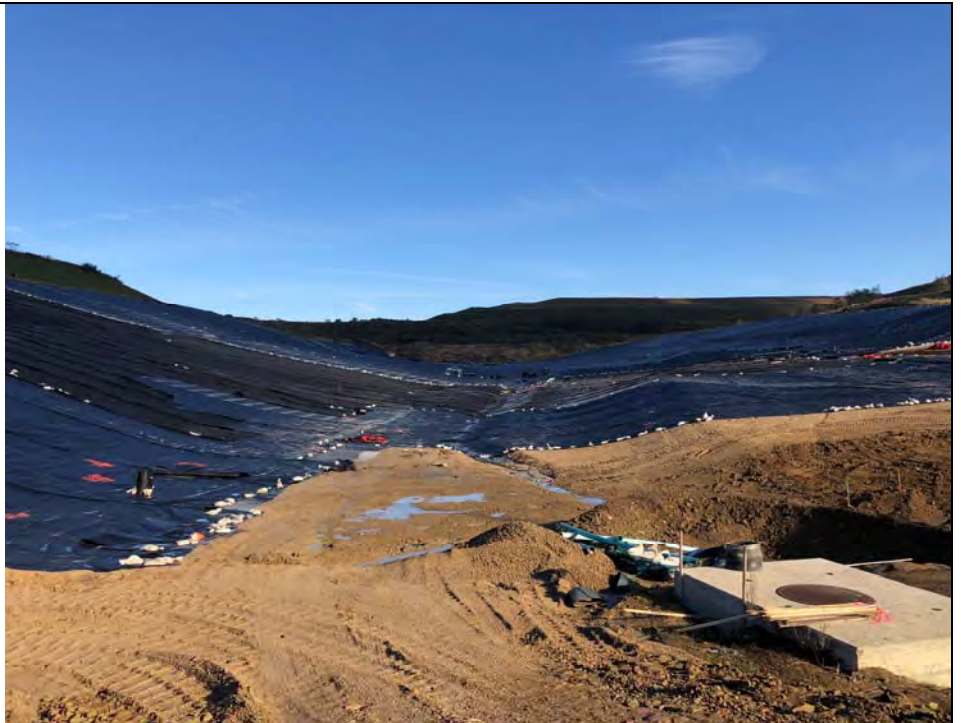
Image: 2378  
Date: 10/22/2018  
Time: 8:36 AM  
Direction: North

Liner construction to support filling between valleys. Geomembrane is being installed over compacted clay liner. Panel seaming actively being completed.

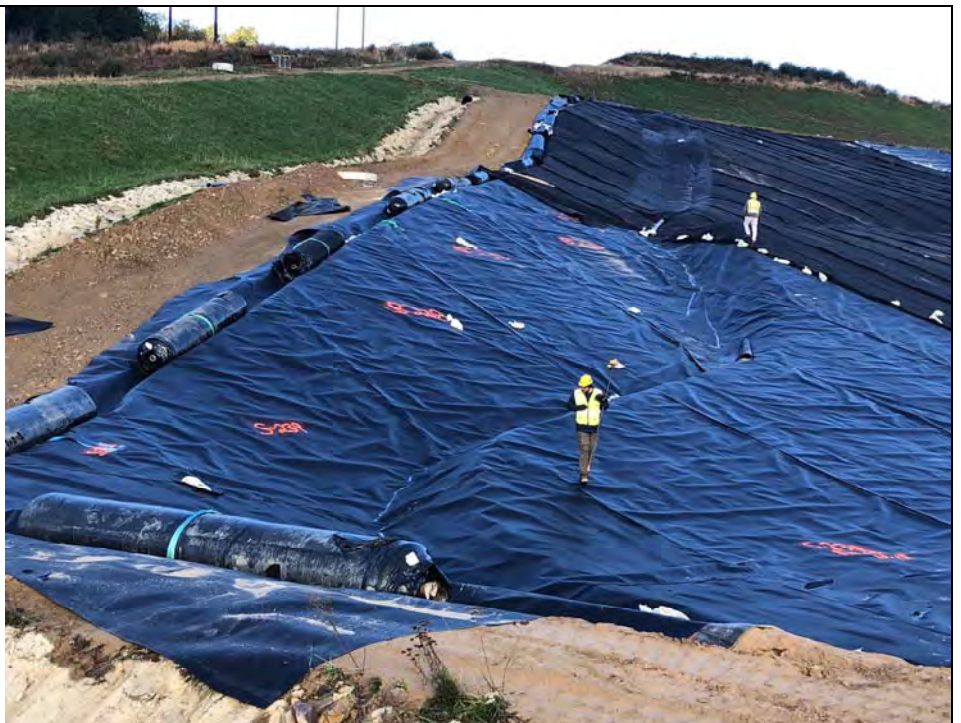
Image: 2382  
Date: 10/22/2018  
Time: 8:36 AM  
Direction: Northwest

Geomembrane is being installed over compacted clay liner in West Valley Expansion Area.

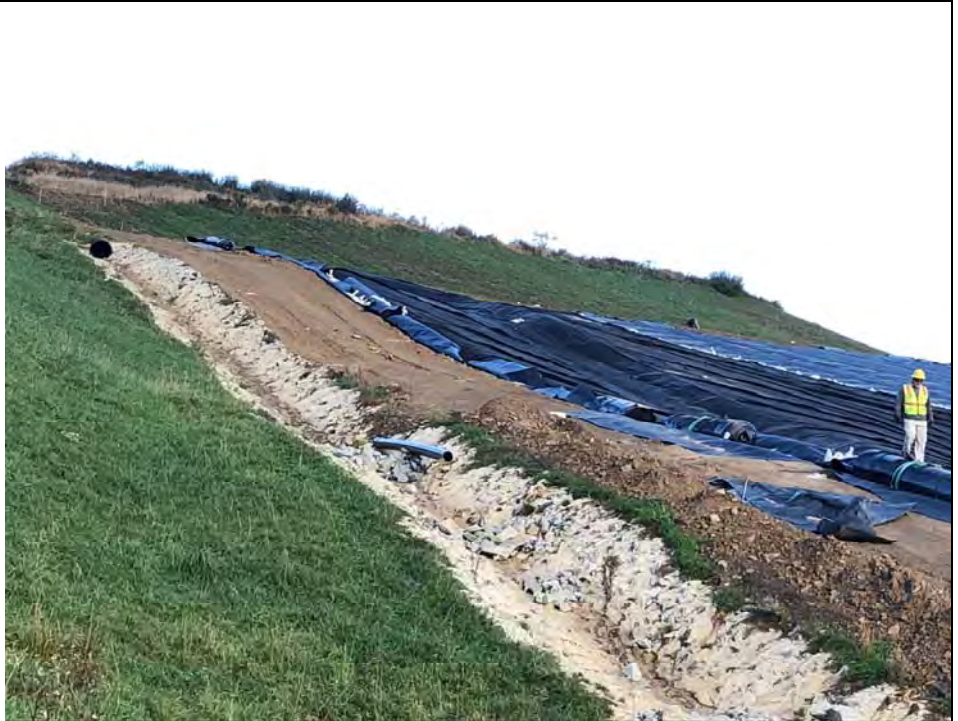
Image: 2384  
Date: 10/22/2018  
Time: 8:37 AM  
Direction: West

Stormwater run-on control ditch near limits of construction in West Valley Expansion Area.

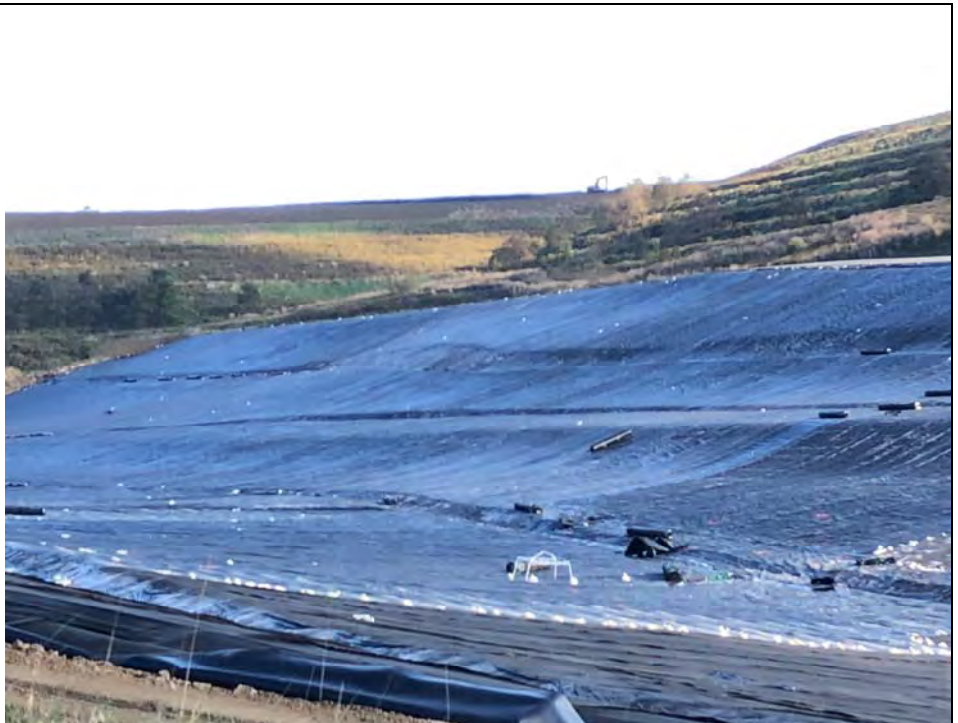
Image: 2386  
Date: 10/22/2018  
Time: 8:37 AM  
Direction: Northwest

Geomembrane installation in West Valley Expansion Area.

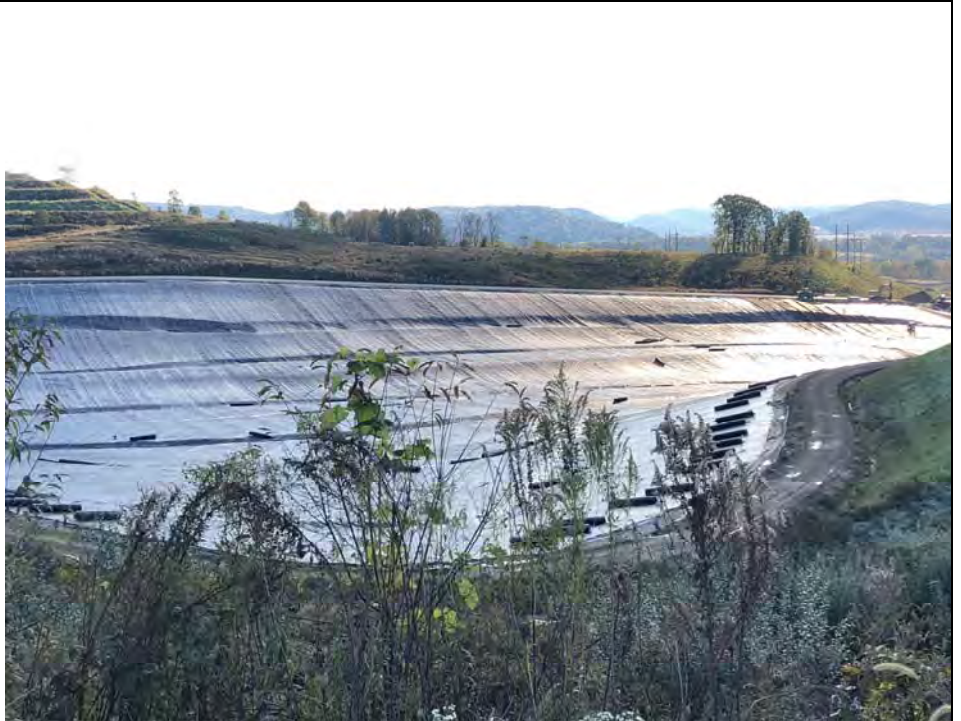
Image: 2388  
Date: 10/22/2018  
Time: 8:39 AM  
Direction: Southeast

Geomembrane installation  
in West Valley Expansion  
Area.

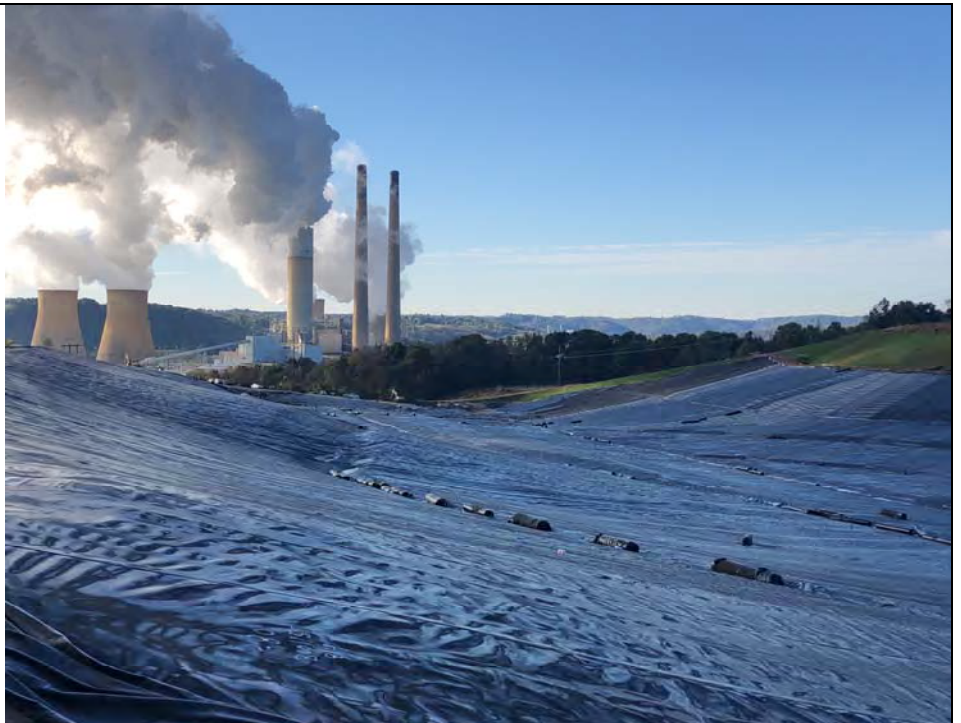
Image: 2390  
Date: 10/22/2018  
Time: 8:42 AM  
Direction: South

Geomembrane installation  
in West Valley Expansion  
Area.

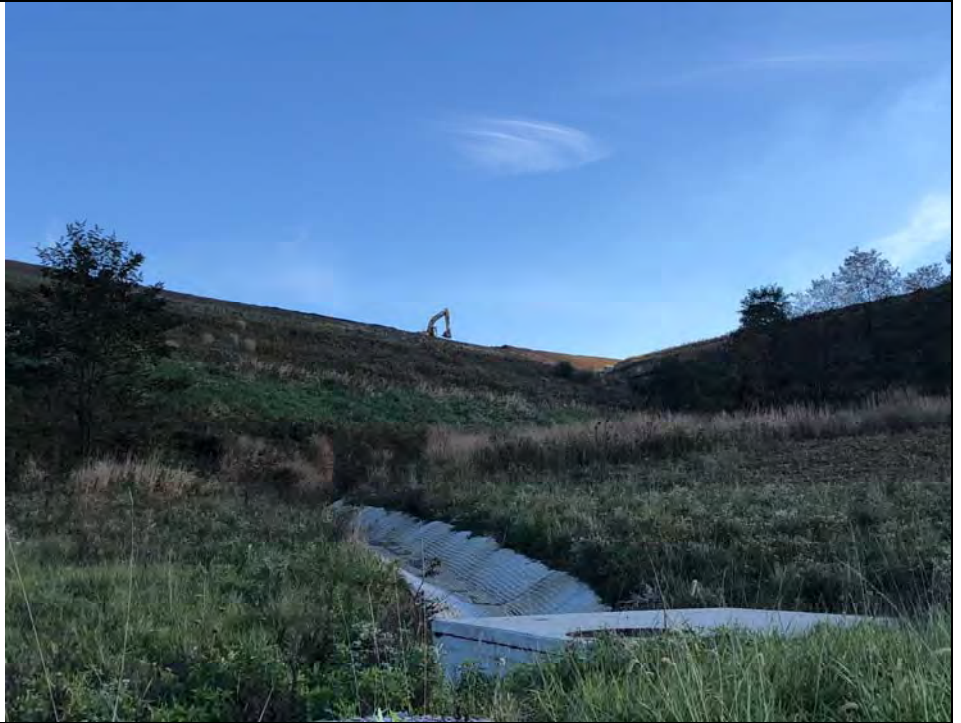
Image: 2392  
Date: 10/22/2018  
Time: 8:42 AM  
Direction: Northeast

Contact stormwater  
ditches that flow to the  
West Valley Equalization  
Pond.
