Inspection Report

Re: Keystone Ash Disposal Site – Annual CCR Unit Inspection Report No. 1

Inspection Date: October 15, 2015

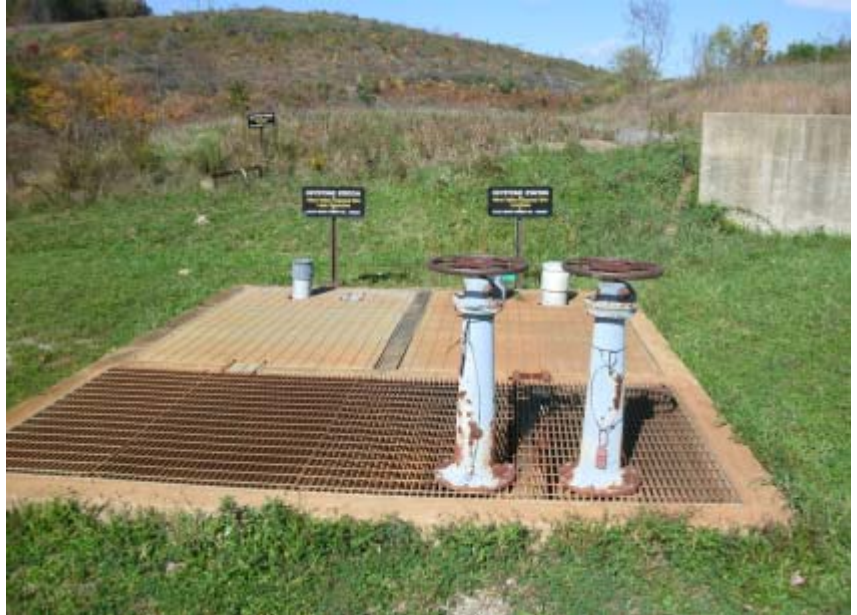
Photograph No. 1

Leachate Weir Box and Valving Station at West Valley Equalization Pond.

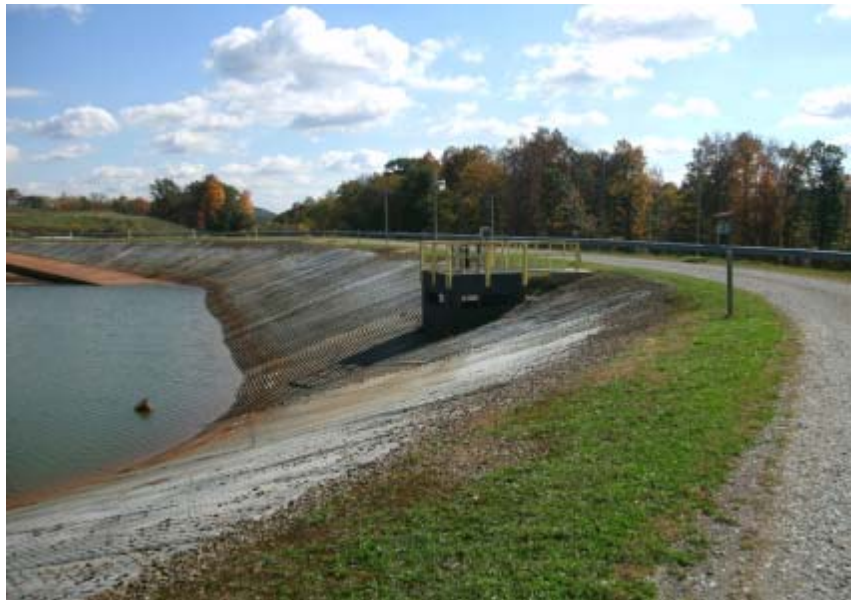
Photograph No. 2

West Valley Equalization Pond principal discharge structure.

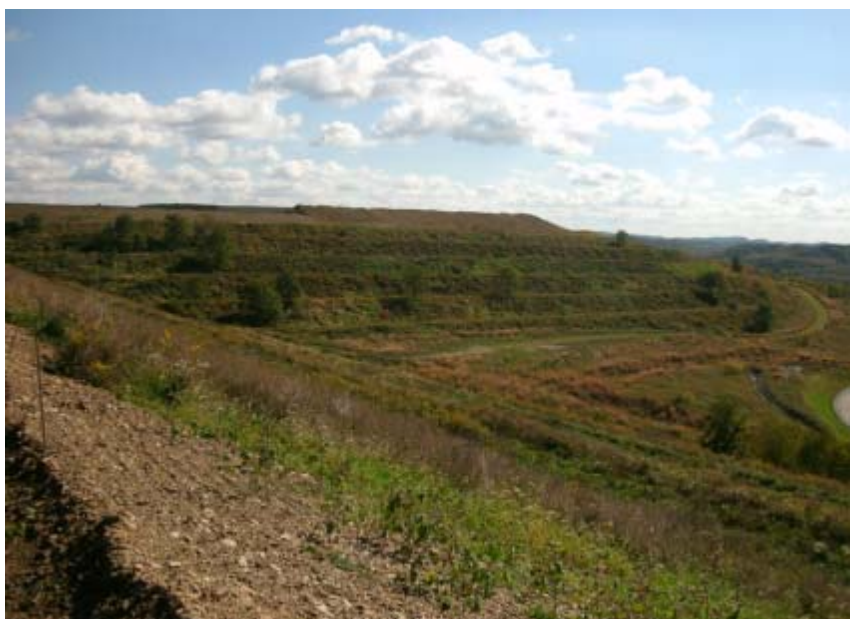
<p>Photograph No. 8</p> <p>Date: October 15, 2015</p> <p>Direction: Southeast</p>

A photograph of a large, grassy hillside under a blue sky with scattered white clouds. The terrain appears to be a landfill expansion area with visible slopes and benches. A dirt road or path runs along the base of the hill.
<p>Description: Interim slopes and benches for East Valley; active lifts at top.</p>

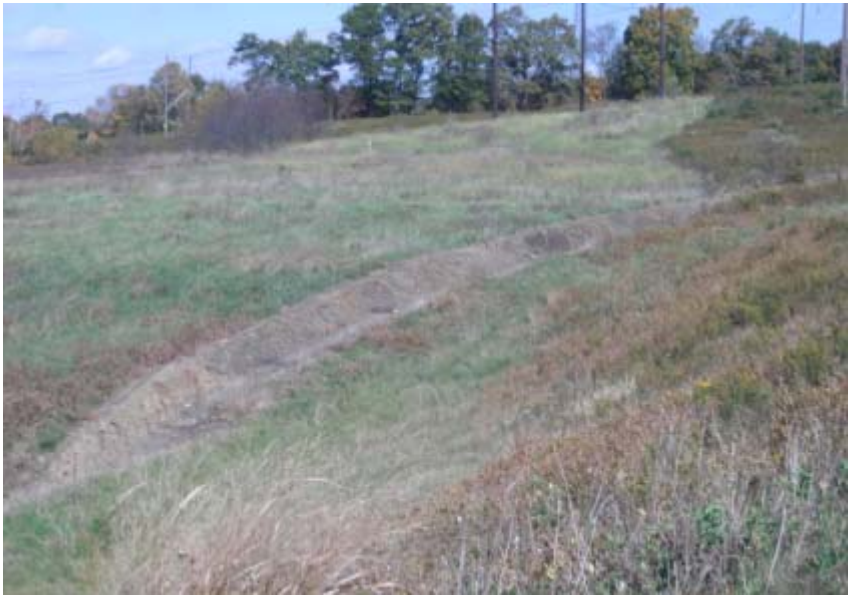
<p>Photograph No. 12</p> <p>Date: October 15, 2015</p> <p>Direction: Northwest</p>

<p>Description: View of slope and toe of slope transitioning between waste fill and existing topography along western perimeter of West Valley completed area slopes.</p>

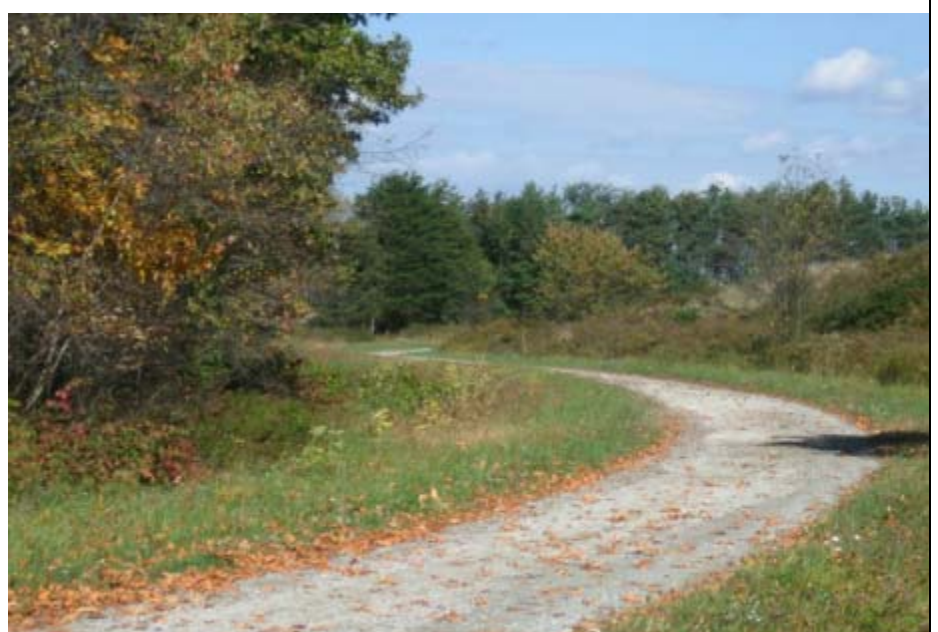
<p>Photograph No. 14</p> <p>Date: October 15, 2015</p> <p>Direction: North</p>

<p>Description: Continued traverse along western perimeter access road; no evidence of sloughing along completed area toe of slope.</p>

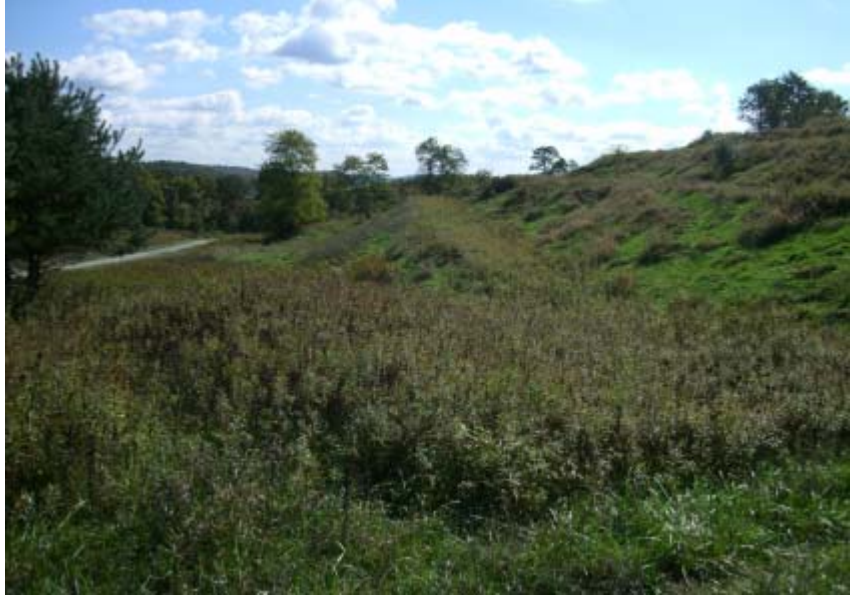
<p>Photograph No. 15</p> <p>Date: October 15, 2015</p> <p>Direction: North</p>

A photograph showing a grassy hillside with a dirt path winding through it. The sky is blue with white clouds. The vegetation is green and brown, suggesting a mix of grass and shrubs.
<p>Description: Western perimeter of West Valley; no evidence of sloughing along toe of slope and transitioning to benches along completed area slopes.</p>

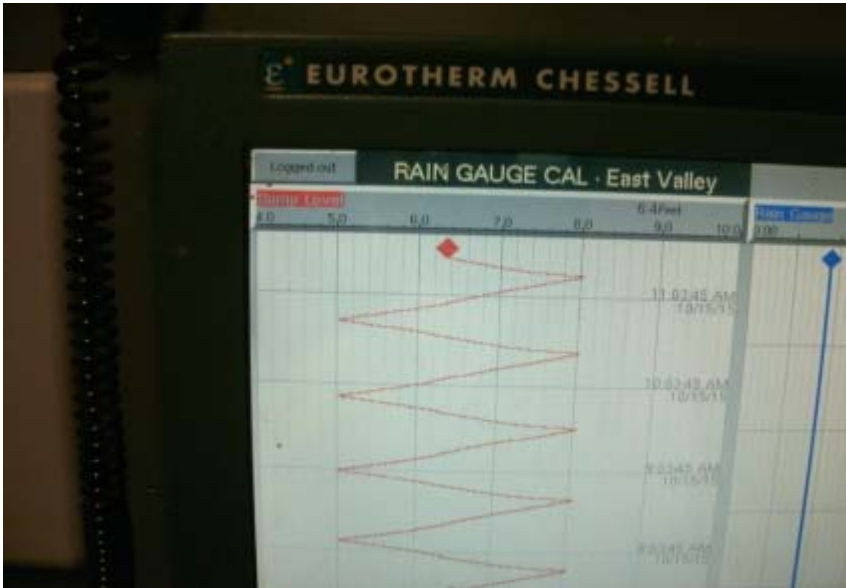
<p>Photograph No. 22</p> <p>Date: October 15, 2015</p> <p>Direction: N/A</p>

<p>Description: Chart recorder for sump level at East Valley Pumping Station.</p>
