Inspection Report

To: Nate Rozic (Keystone Generating Station)
From: Richard Southorn, P.E., P.G.
Re: Keystone Ash Disposal Site – Annual CCR Unit Inspection Report
Inspection Date: October 21, 2019
Report Date: January 16, 2020

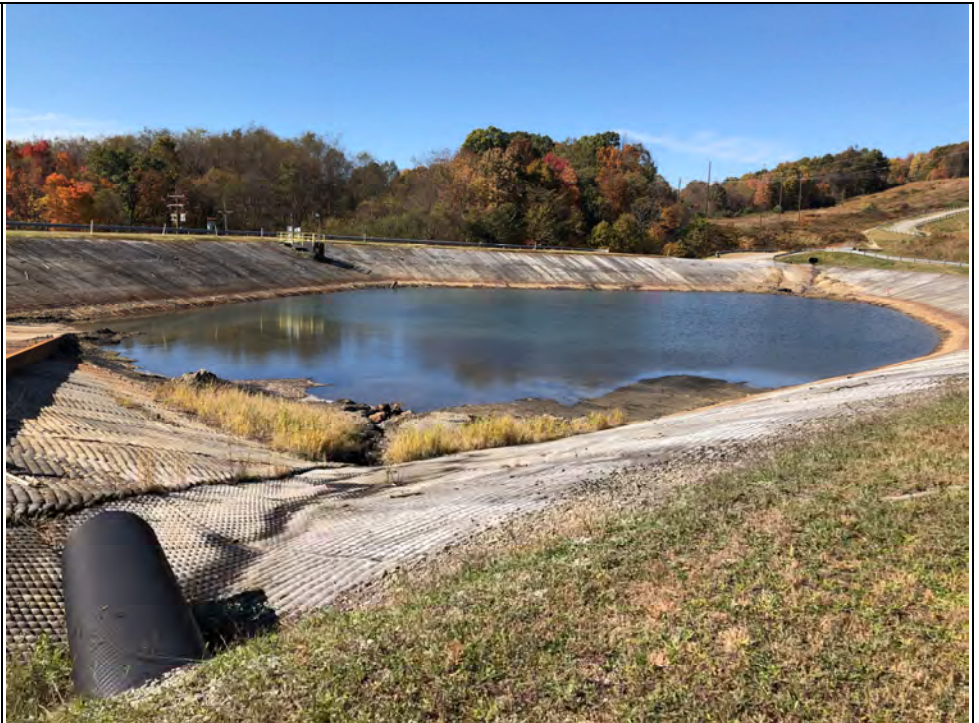
Image: 3535
Date: 10/21/2019
Time: 10:48 AM
Direction: West

West Valley Equalization Pond. Well maintained. Minor sediment buildup in pond.

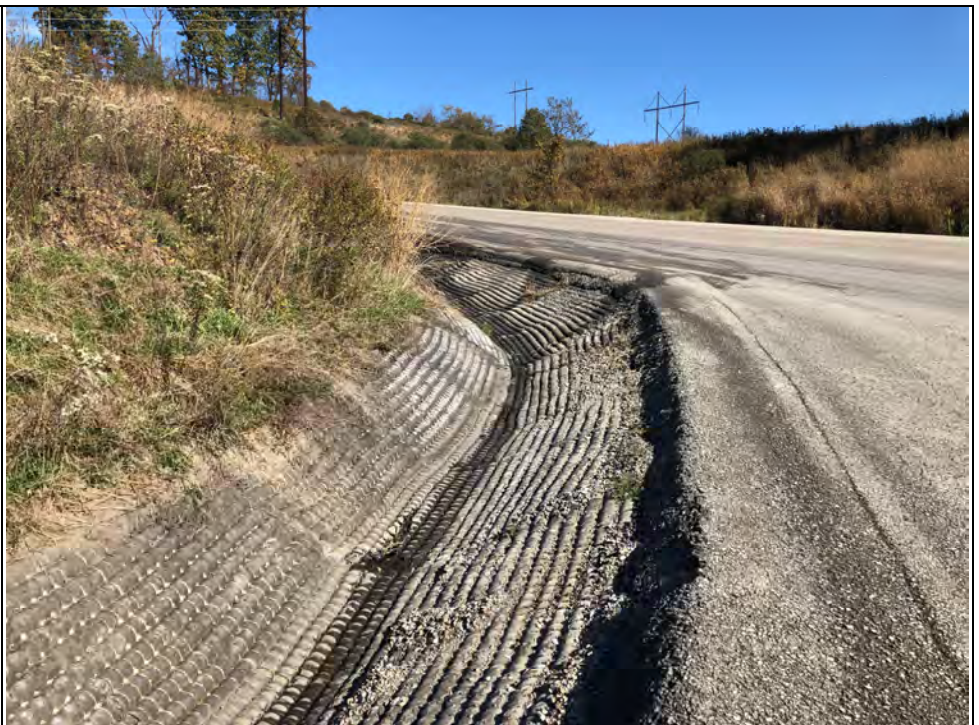
Image: 3537
Date: 10/21/2019
Time: 10:48 AM
Direction: Northeast

Contact water ditch lined with revetment matting. Free of obstructions.

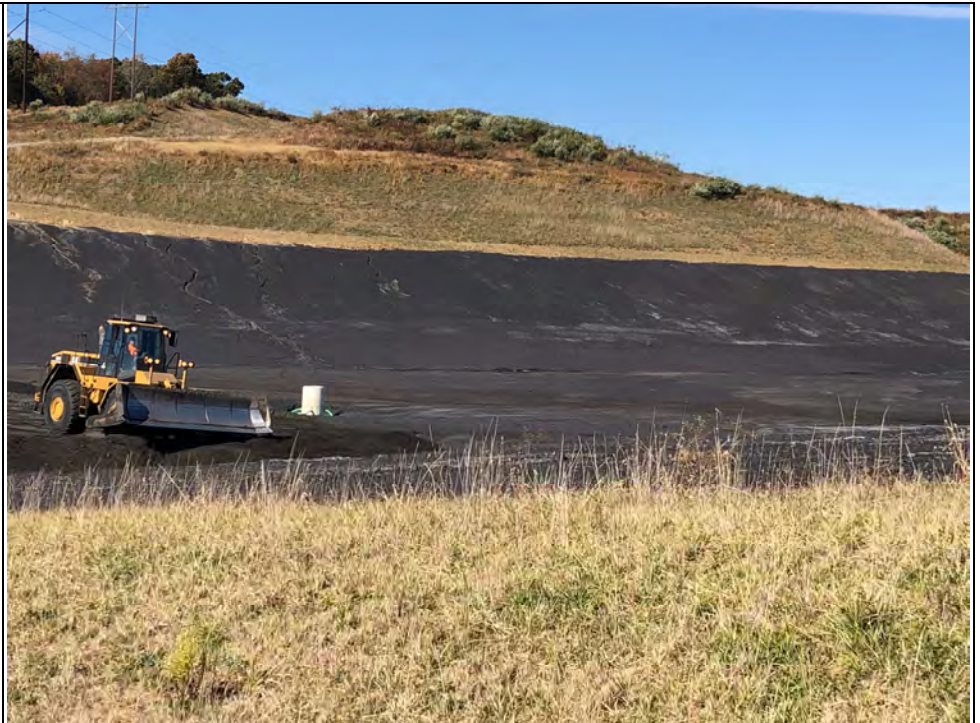
Image: 3543
Date: 10/21/2019
Time: 10:52 AM
Direction: Northwest

Bottom ash being spread over West Valley Expansion Area as protective cover over bottom liner system.

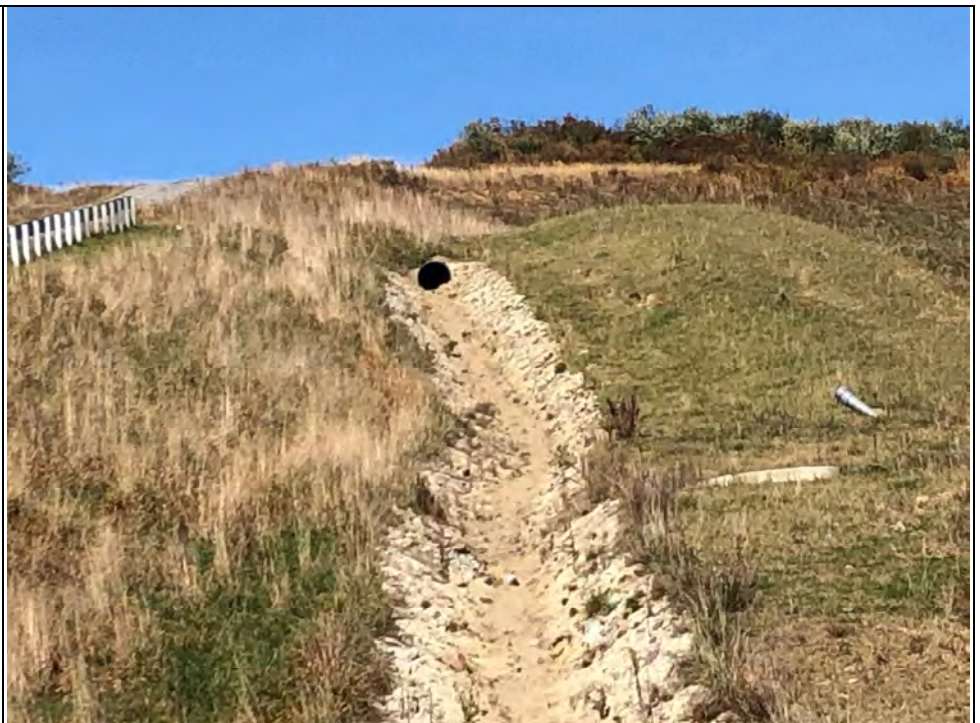
Image: 3545
Date: 10/21/2019
Time: 10:53 AM
Direction: Northwest

Stormwater run-on control ditch near limits of construction in West Valley Expansion Area.

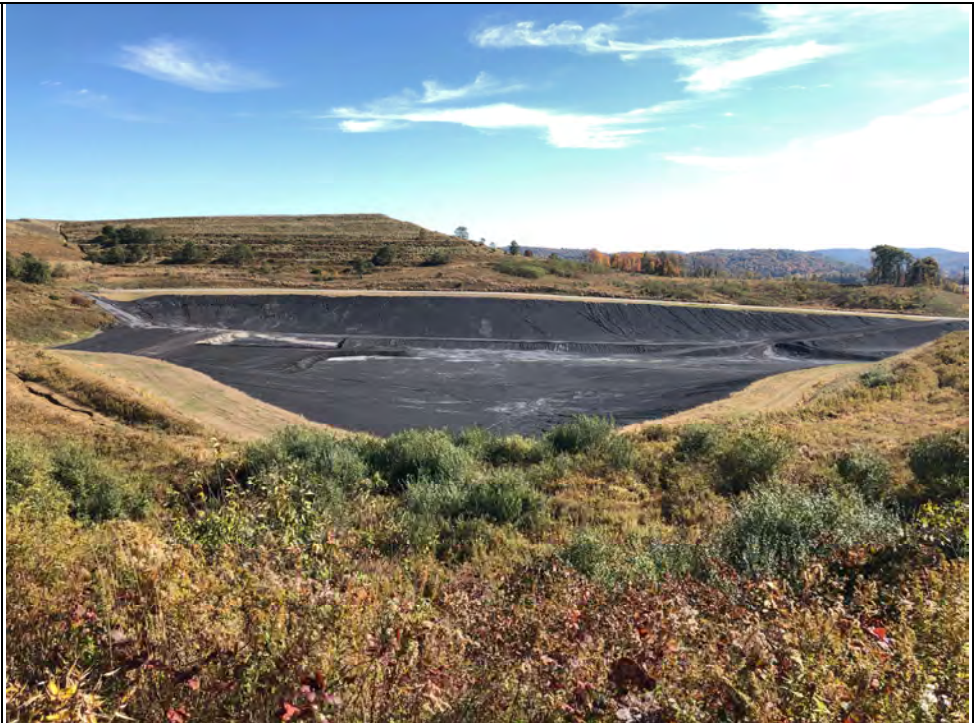
Image: 3547
Date: 10/21/2019
Time: 10:55 AM
Direction: East

Overview of West Valley Expansion Area. The bottom liner has been covered with a protective layer of bottom ash.

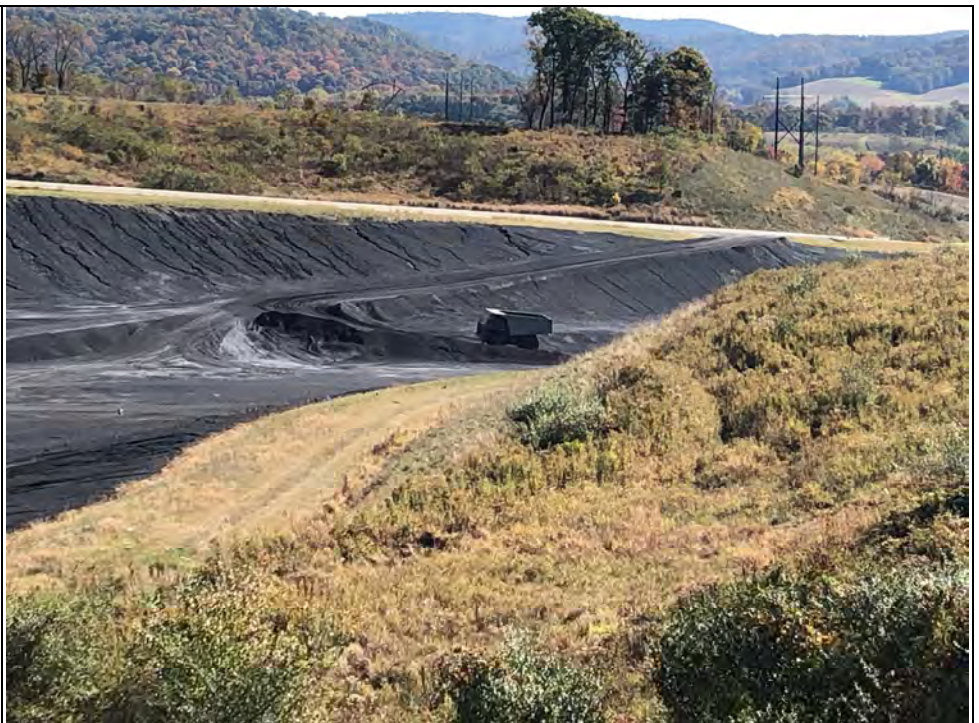
Image: 3549
Date: 10/21/2019
Time: 10:55 AM
Direction: East

West Valley Expansion Area.

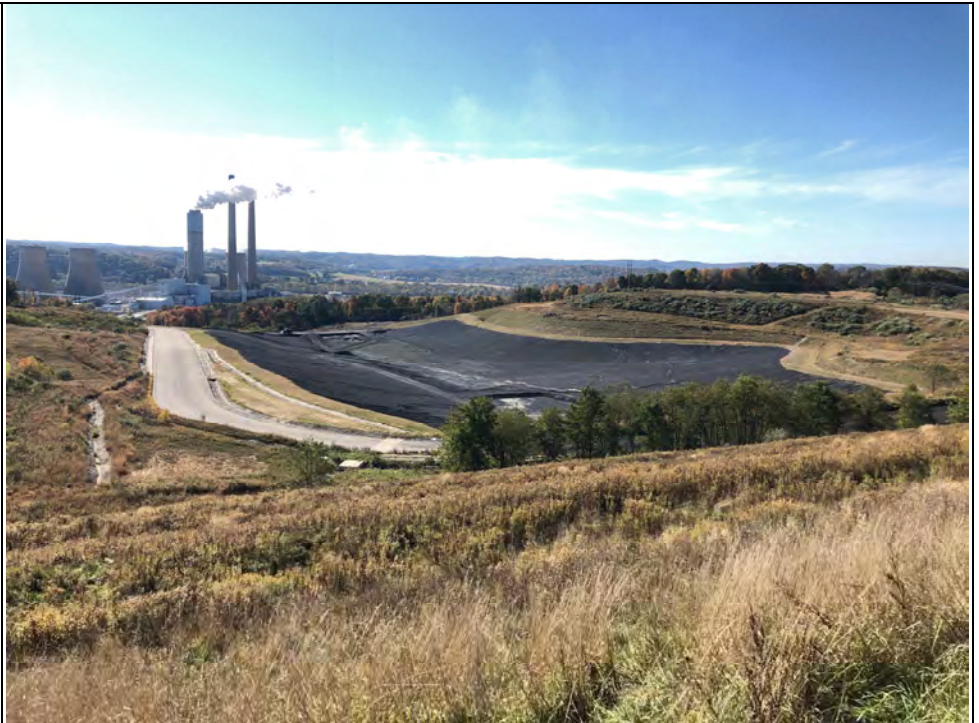
Image: 3559
 Date: 10/21/2019
 Time: 10:59 AM
 Direction: Southwest

Southern view between East Valley and West Valley Expansion Area from active area.

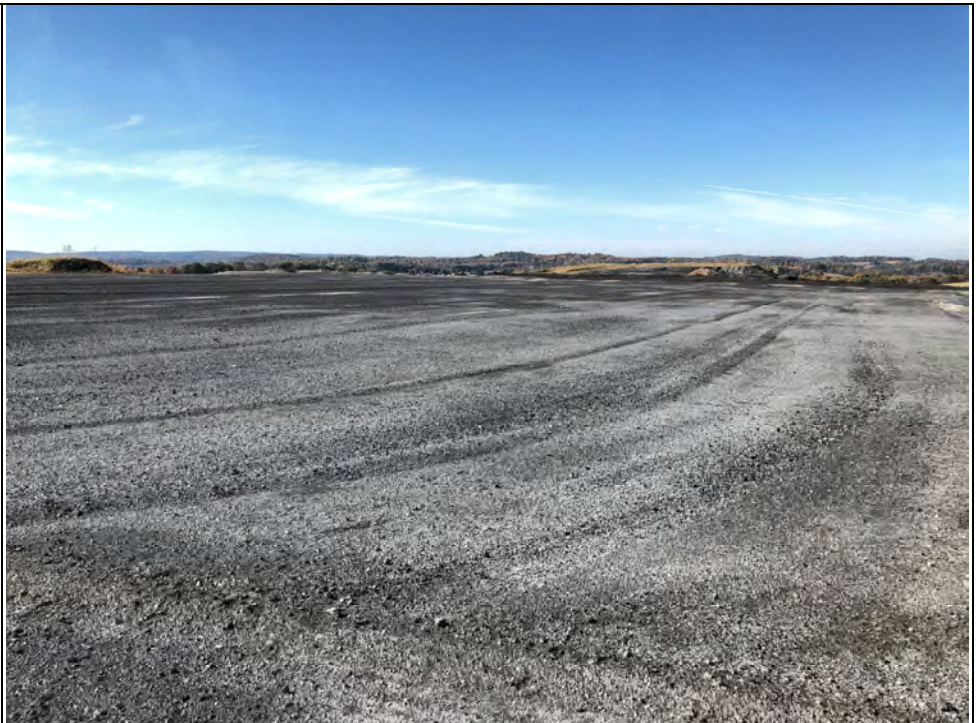
Image: 3561
 Date: 10/21/2019
 Time: 11:02 AM
 Direction: Southwest

West Valley active area. Compacted and graded to prevent ponding water.

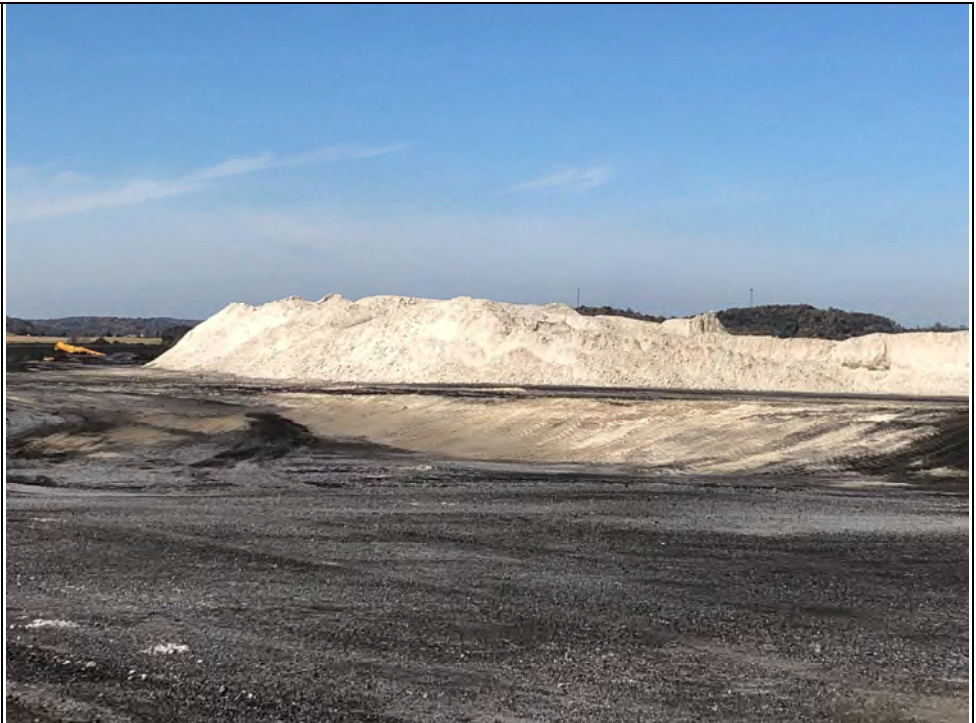
Image: 3563
Date: 10/21/2019
Time: 11:02 AM
Direction: Northwest

Gypsum pile in background of West Valley active area. The active area in the foreground is well compacted and graded to prevent ponding water.

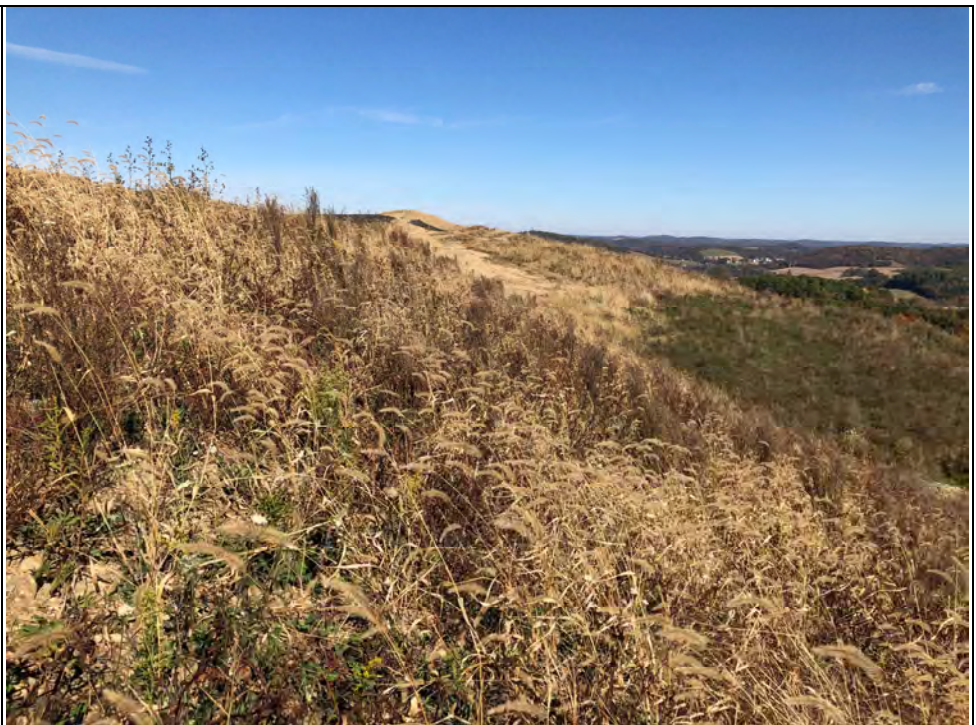
Image: 3567
Date: 10/21/2019
Time: 11:03 AM
Direction: North

Final cover installed on East Valley sideslope. The vegetation is dense, healthy, and uniformly distributed. The final cover slopes show no evidence of erosion, animal burrows, or failure (e.g. sloughing or sliding).

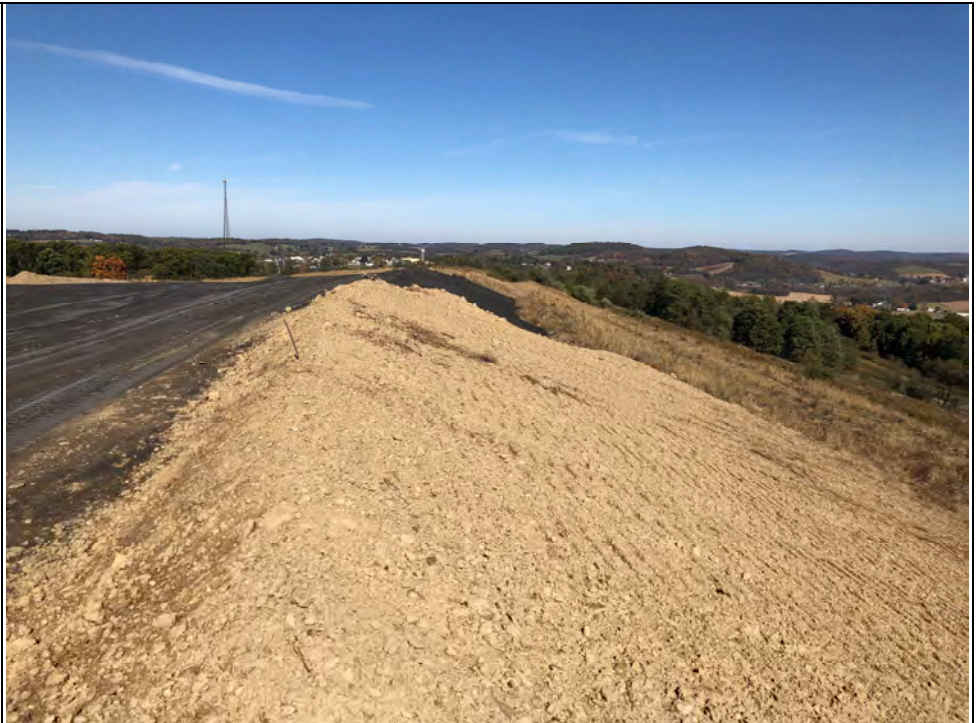
Image: 3569
Date: 10/21/2019
Time: 11:05 AM
Direction: North

Recently installed final cover soils that will be vegetated and stabilized. Survey staking is used to ensure construction follows the permitted design.

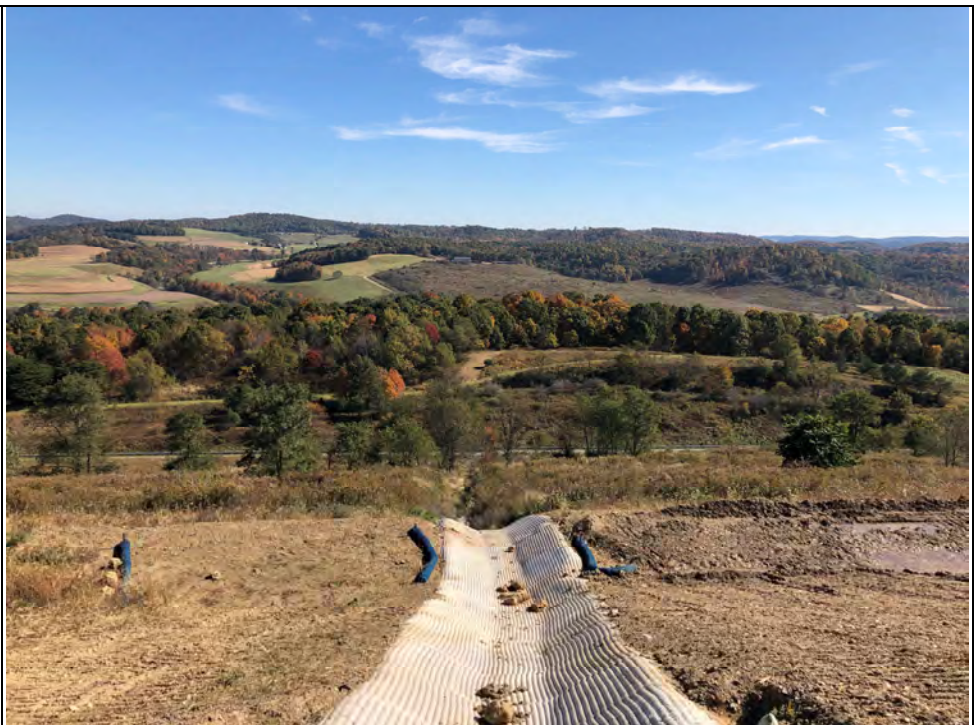
Image: 3571
Date: 10/21/2019
Time: 11:05 AM
Direction: East

A non-contact stormwater channel that is lined with revetment mat. The channel is generally free of obstructions (minor dirt clods only) and appears in good condition.

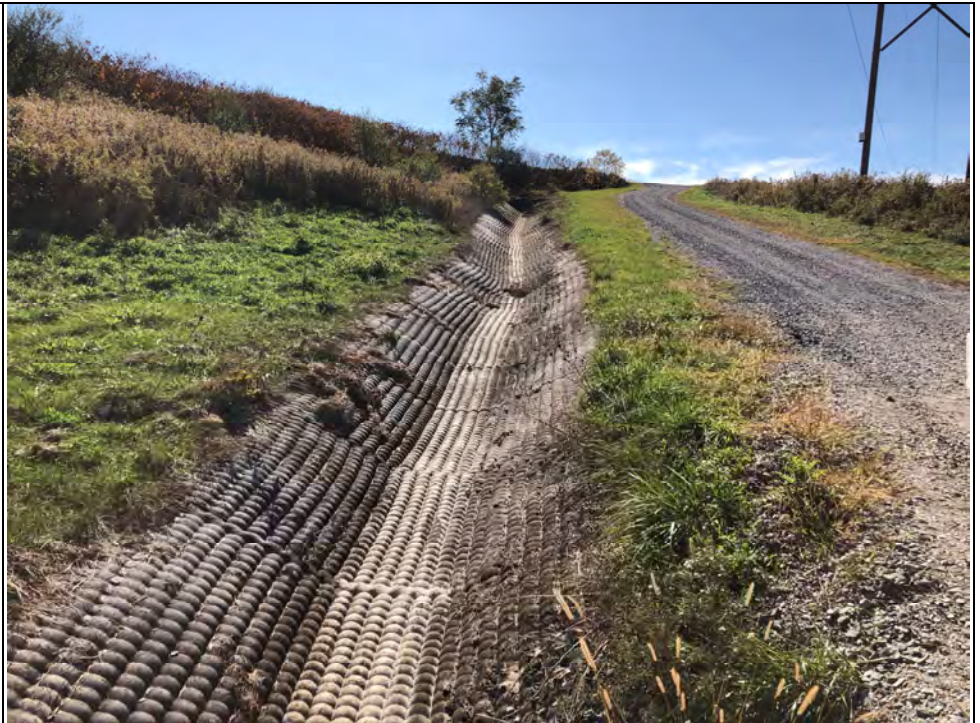
Image: 3579
Date: 10/21/2019
Time: 11:10 AM
Direction: South

A West Valley non-contact stormwater channel that is lined with revetment mat. The channel is free of obstructions and appears in good condition.

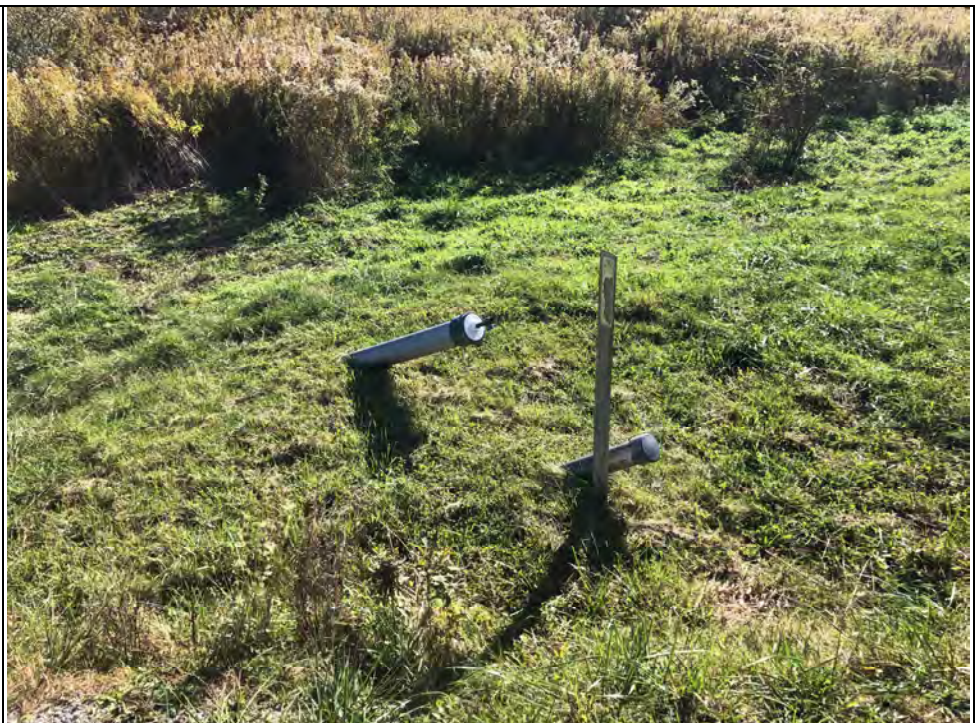
Image: 3581
Date: 10/21/2019
Time: 11:10 AM
Direction: Southeast

A leachate cleanout present within the West Valley final cover.

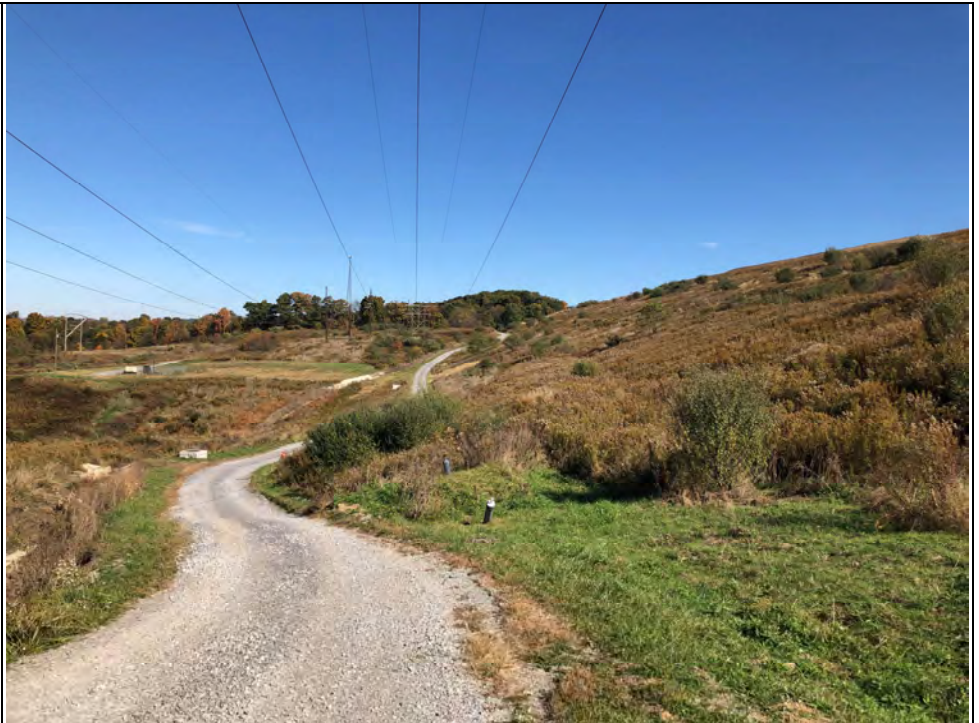
Image: 3583
Date: 10/21/2019
Time: 11:10 AM
Direction: Northeast

Perimeter road and final cover on sideslopes of West Valley. The vegetation is dense, healthy, and uniformly distributed. The final cover slopes show no evidence of erosion, animal burrows, or failure (e.g. sloughing or sliding).

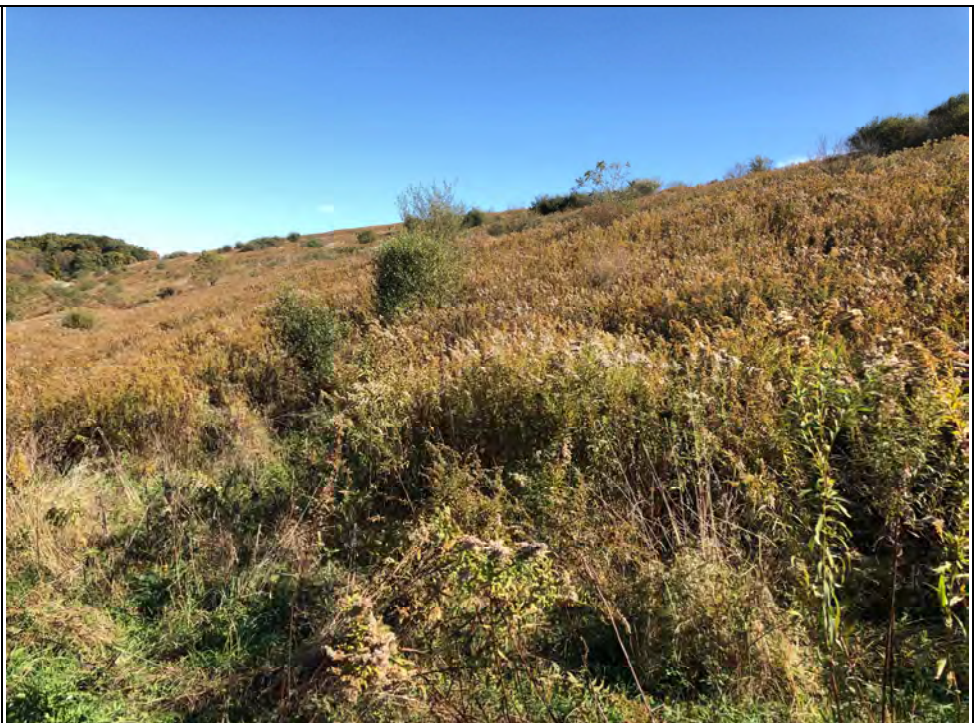
Image: 3585
Date: 10/21/2019
Time: 11:10 AM
Direction: Northeast

Final cover on sideslopes of West Valley. The vegetation is dense, healthy, and uniformly distributed. The final cover slopes show no evidence of erosion, animal burrows, or failure (e.g. sloughing or sliding).

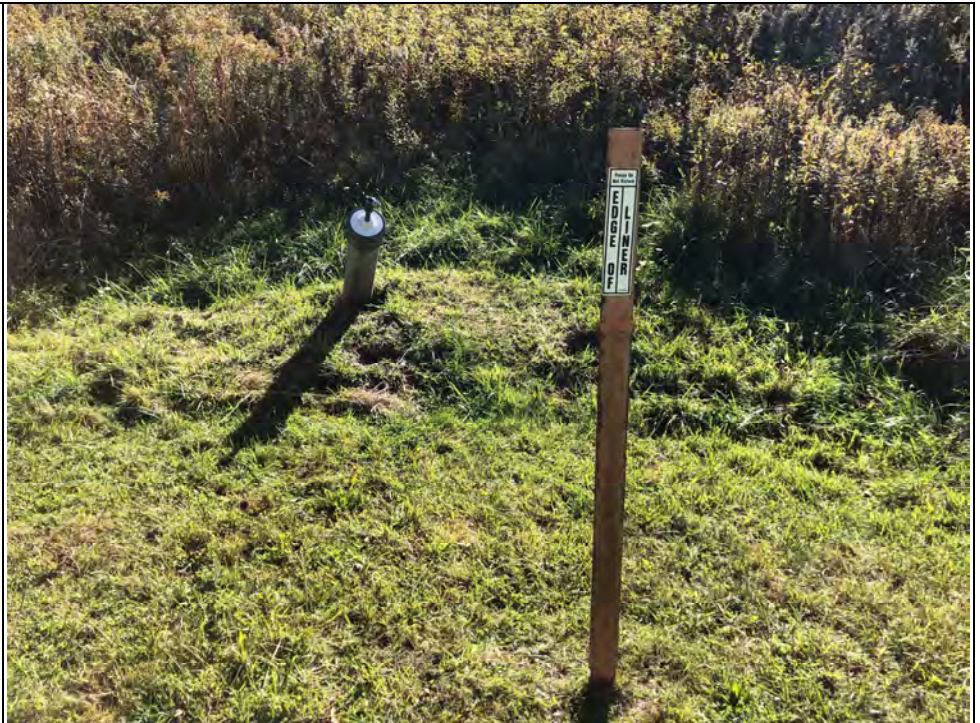
Image: 3591
Date: 10/21/2019
Time: 11:13 AM
Direction: Southeast

West Valley Edge-of-Liner marker in foreground and leachate cleanout access in background.

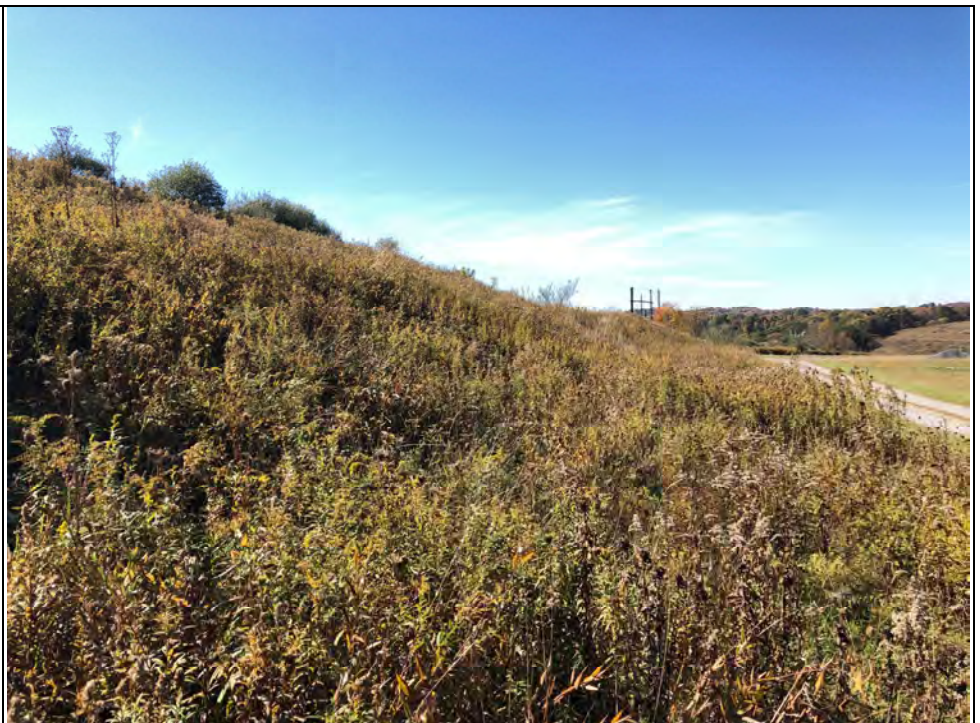
Image: 3593
Date: 10/21/2019
Time: 11:14 AM
Direction: Southwest

Final cover on sideslopes of West Valley. The vegetation is dense, healthy, and uniformly distributed. The final cover slopes show no evidence of erosion, animal burrows, or failure (e.g. sloughing or sliding).

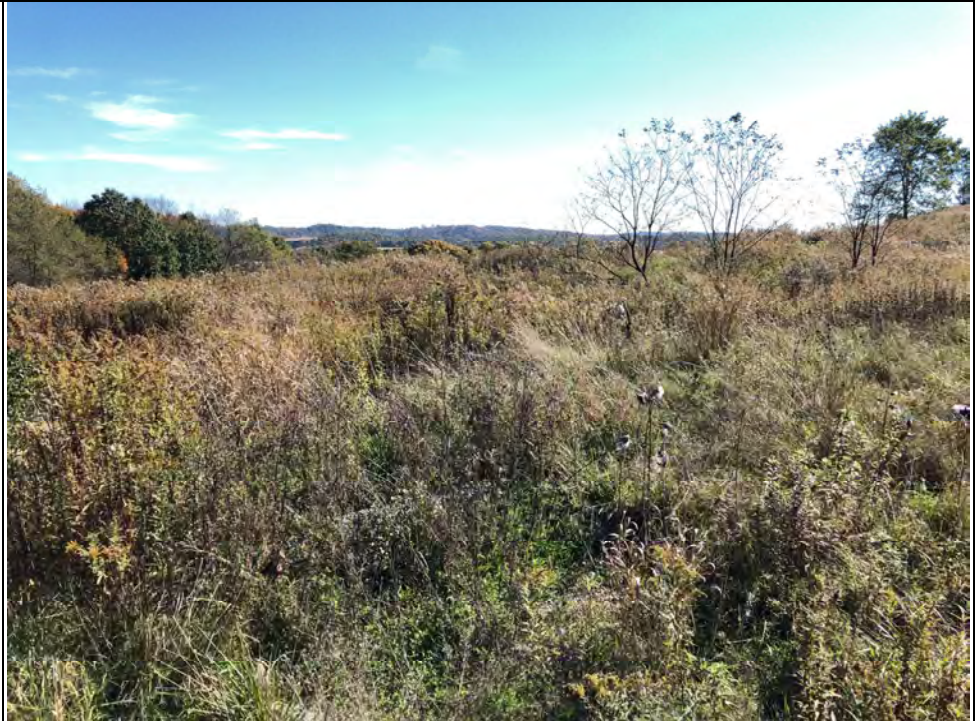
Image: 3599
Date: 10/21/2019
Time: 11:16 AM
Direction: Southeast

Final cover on topslopes of East Valley. The vegetation is dense, healthy, and uniformly distributed. The final cover slopes show no evidence of erosion, animal burrows, or failure (e.g. sloughing or sliding).

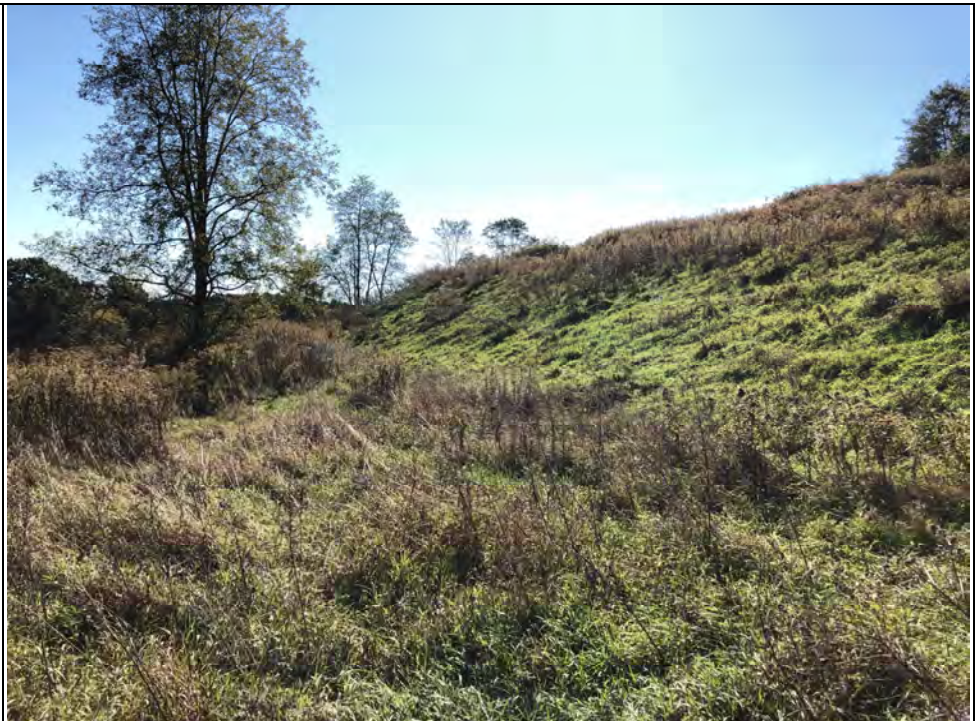
Image: 3601
Date: 10/21/2019
Time: 11:17 AM
Direction: South

Final cover on sideslopes of East Valley. The vegetation is dense, healthy, and uniformly distributed. The final cover slopes show no evidence of erosion, animal burrows, or failure (e.g. sloughing or sliding).

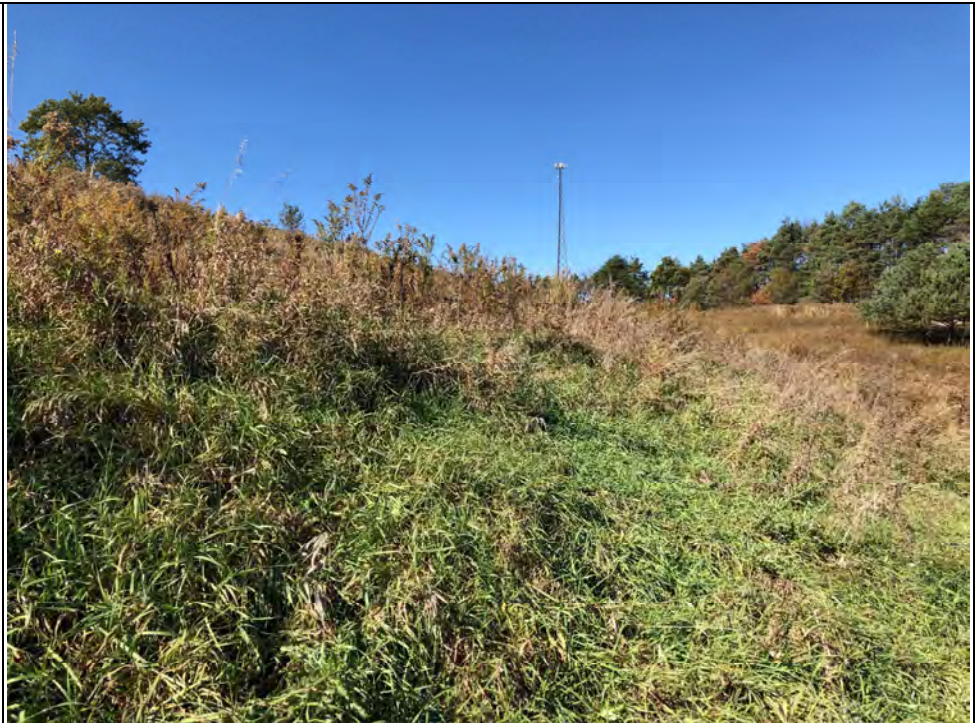
Image: 3603
Date: 10/21/2019
Time: 11:18 AM
Direction: Northwest

Final cover on sideslopes of East Valley. The vegetation is dense, healthy, and uniformly distributed. The final cover slopes show no evidence of erosion, animal burrows, or failure (e.g. sloughing or sliding).

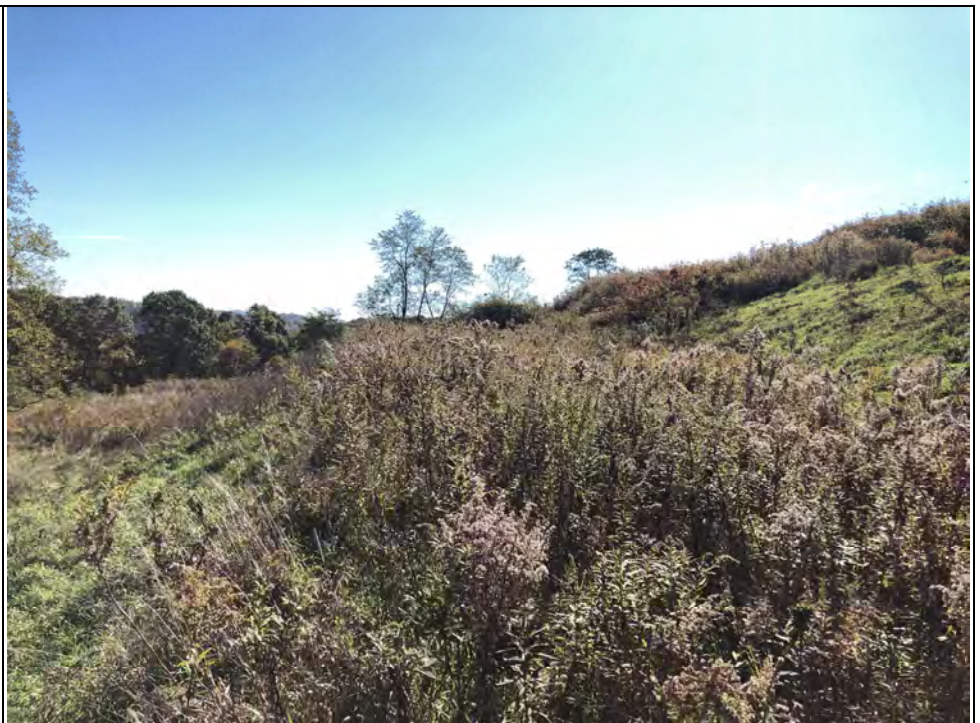
Image: 3605
Date: 10/21/2019
Time: 11:18 AM
Direction: Southeast

Final cover and terrace berm on sideslopes of East Valley. The vegetation is dense, healthy, and uniformly distributed. The final cover slopes show no evidence of erosion, animal burrows, or failure (e.g. sloughing or sliding).

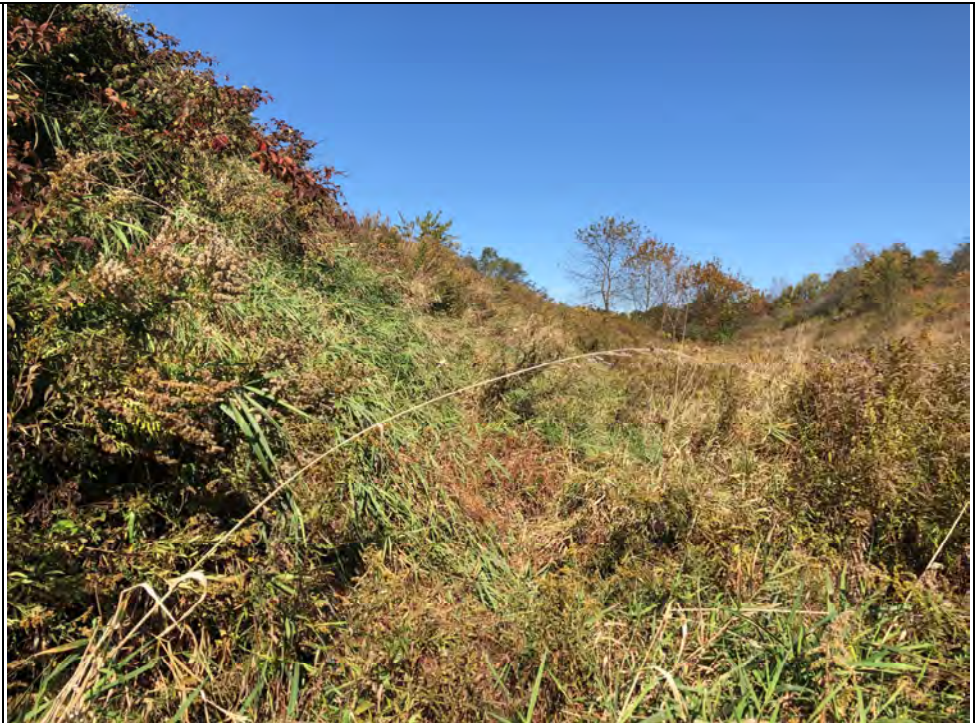
Image: 3612
Date: 10/21/2019
Time: 11:22 AM
Direction: North

Final cover terrace on sideslopes of East Valley. The vegetation is dense, healthy, and uniformly distributed. The final cover slopes show no evidence of erosion, animal burrows, or failure (e.g. sloughing or sliding).

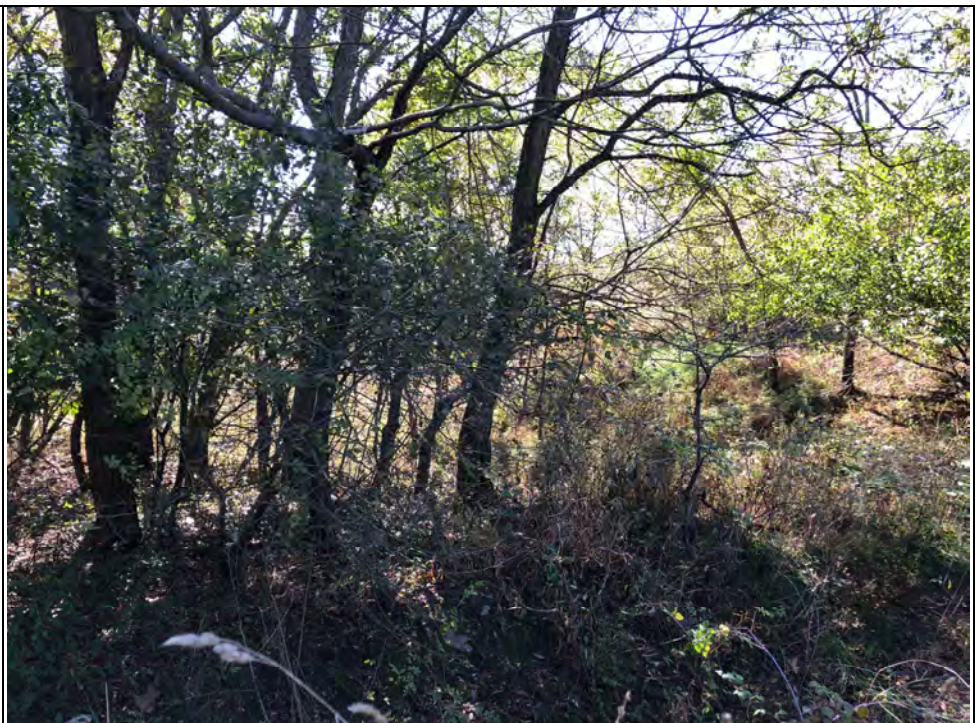
Image: 3614
Date: 10/21/2019
Time: 11:23 AM
Direction: South

Woody vegetation on sideslopes of East Valley final cover. The final cover slopes show no evidence of erosion, animal burrows, or failure (e.g. sloughing or sliding).

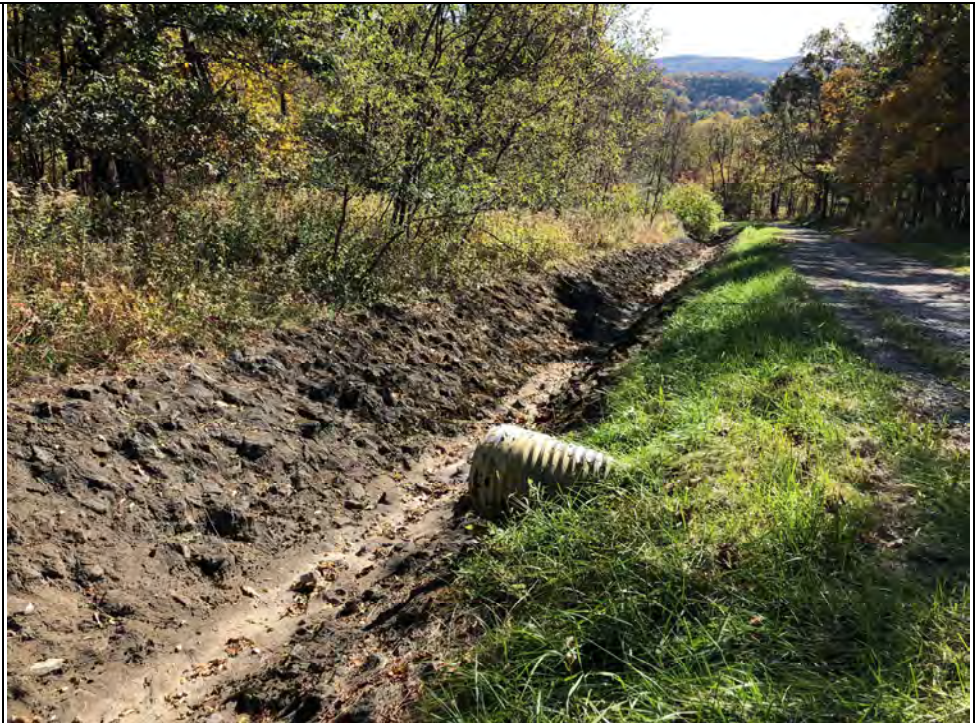
Image: 3616
Date: 10/21/2019
Time: 11:23 AM
Direction: Southeast

Non-contact stormwater channel looking downslope at East Valley. Armored and functioning as intended.

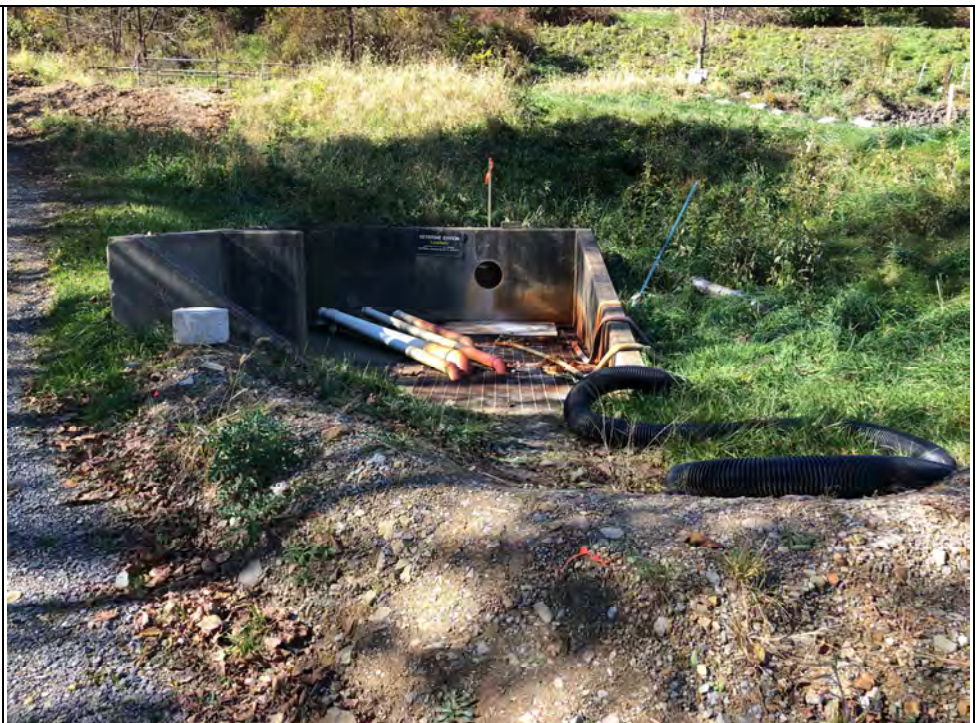
Image: 3620
Date: 10/21/2019
Time: 11:26 AM
Direction: West

East Valley leachate collection structure (routes to Pump Station and then to IWT facility).

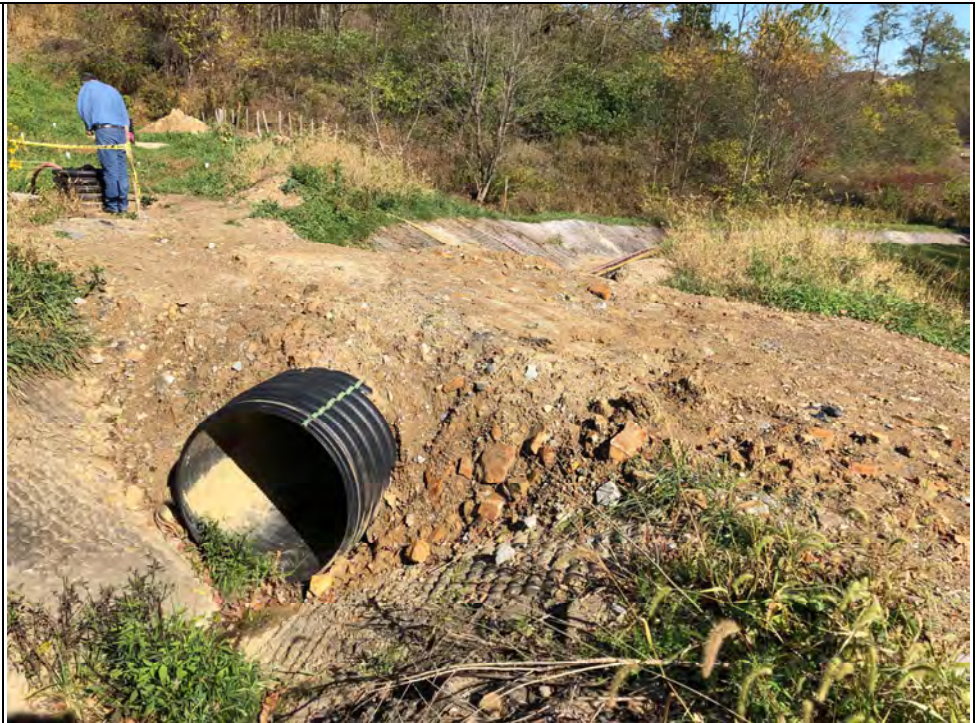
Image: 3622
Date: 10/21/2019
Time: 11:27 AM
Direction: North

Description: Temporary contact water conveyance pipe to allow access to East Valley sideslope area where contact water (leachate) was observed seeping out of landfill sideslope.

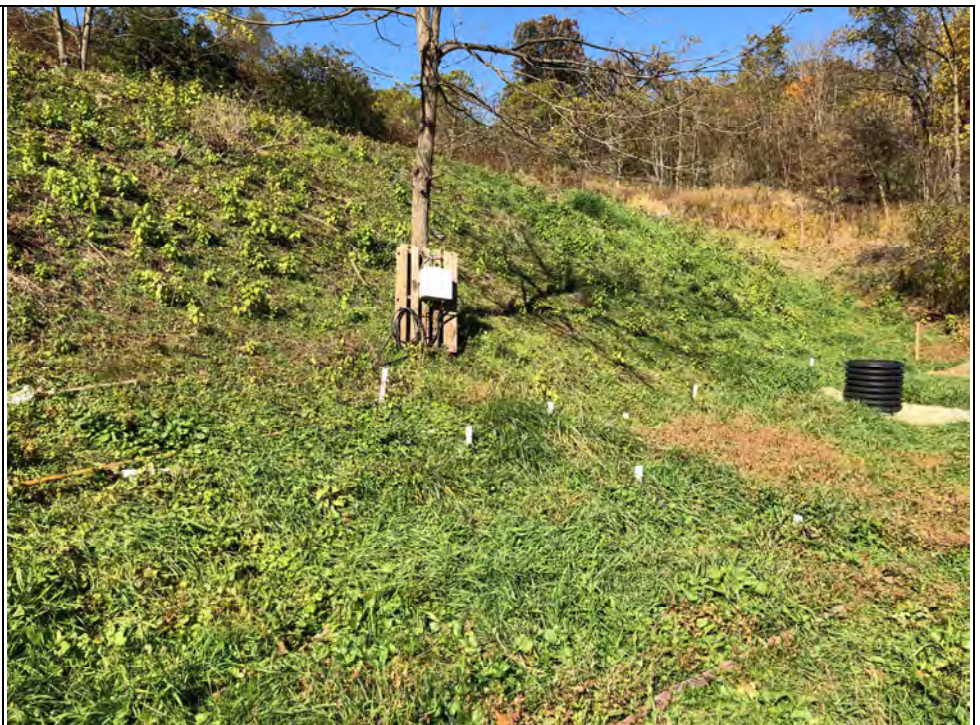
Image: 3624
Date: 10/21/2019
Time: 11:28 AM
Direction: Northwest

A review of the site operating record acknowledged that a leachate seep had been identified at East Valley on March 21, 2019 on the first bench near the eastern toe. The bench surface was soft and wet indicating that water had built up in the toe of the landfill at that location. The existing standpipe showed the water level about four feet above the bench ground surface. The central and northern leachate pipes were cleaned by water jetting; however, this did not resolve the situation. There was concern and evidence that the East Valley leachate collection system (installed in 1991) was not draining properly.

The seep area was visited during the 2019 investigation. The ground surface was found to be firm with no standing water present. Numerous piezometers and the dewatering well were observed. The dewatering well was actively drawing down leachate levels at the time of inspection. It is the opinion of APTIM's certifying engineer that the field remedies are appropriate and appear to be improving the observed conditions.

Description: Contact water had been observed seeping out of East Valley slope during routine CCR inspections. An extraction well was installed through sideslope to just above base liner in black corrugated pipe. Contact water has been actively pumped down and directed to leachate. White pipes are piezometers to gauge depth of contact water. An interceptor trench will be installed.

1. Continue to monitor and maintain the East Valley toe seep collection outfall pipe, piezometers and manhole as part of routine landfill inspections. As required, additional stability evaluations may need to be performed in the event that leachate levels rise above the modeled conditions.
2. Continue operation and maintenance in the active areas as currently performed.
3. Ensure adequate access to the closed portions of the landfill to maintain the ability to perform weekly visual site structural inspections.

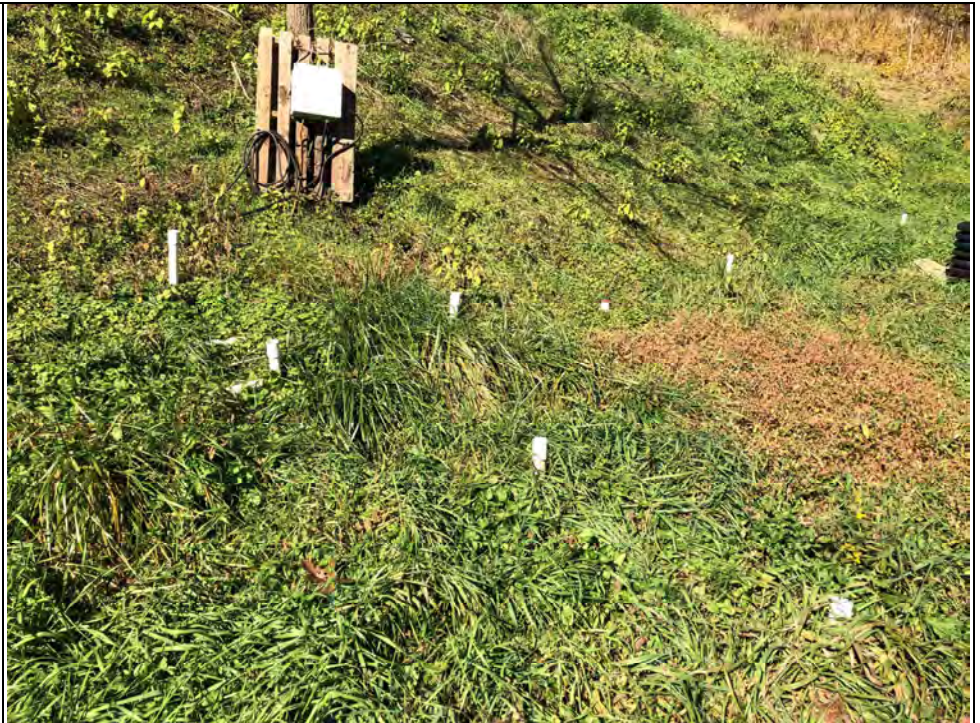
Image: 3626
Date: 10/21/2019
Time: 11:28 AM
Direction: Northwest

Piezometers are used to ensure that contact water level remains at acceptable levels and are used to gauge the success of the temporary pumping until the contact water interceptor trench is installed at East Valley.
