Inspection Report

To: Nate Rozic (Keystone Generating Station)
From: Richard Southorn, P.E., P.G.
Re: Keystone Ash Disposal Site – Annual CCR Unit Inspection Report
Inspection Date: October 21, 2019
Report Date: January 16, 2020

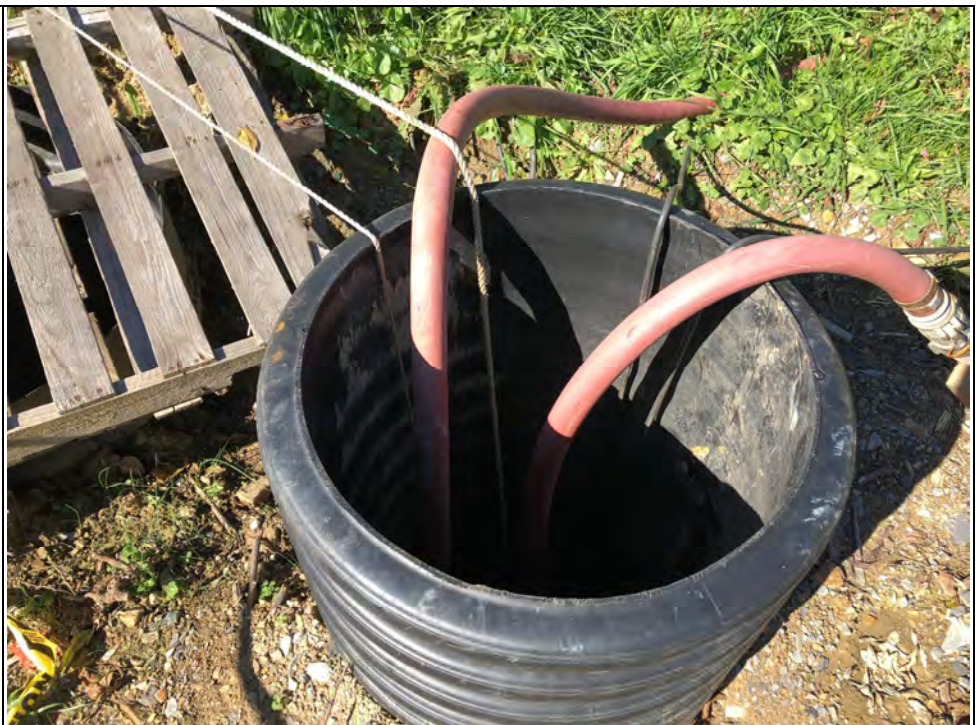
Image: 3628
Date: 10/21/2019
Time: 11:29 AM
Direction: Northwest

Temporary leachate extraction well at East Valley. Leachate is pumped from within the landfill and discharged to the contact water system.

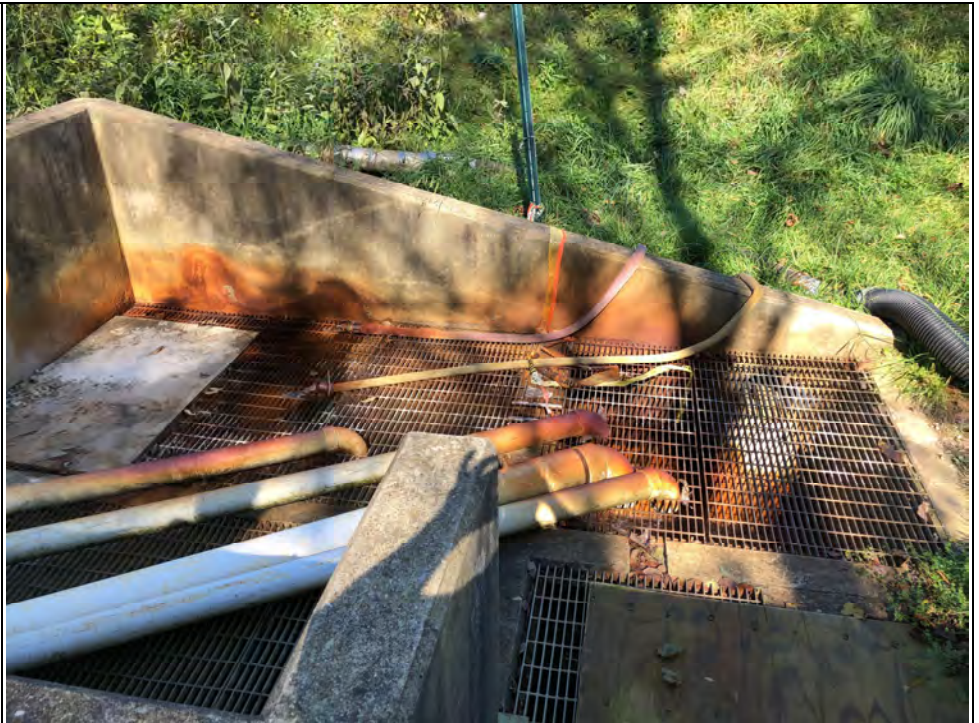
Image: 3632
Date: 10/21/2019
Time: 11:31 AM
Direction: North

Discharge location for contact water from temporary leachate extraction well at East Valley. This structure routes to the Pump Station and then to the IWT facility.
