## **Inspection Report**

**To:** John Shimshock (Conemaugh Generating Station)  
**From:** Richard Southorn, P.E., P.G.  
**Re:** Ash/Refuse Disposal Site – Annual CCR Unit Inspection Report  
**Inspection Date:** October 21, 2019  
**Report Date:** January 16, 2020

Project: Conemaugh 2019 Annual Inspection

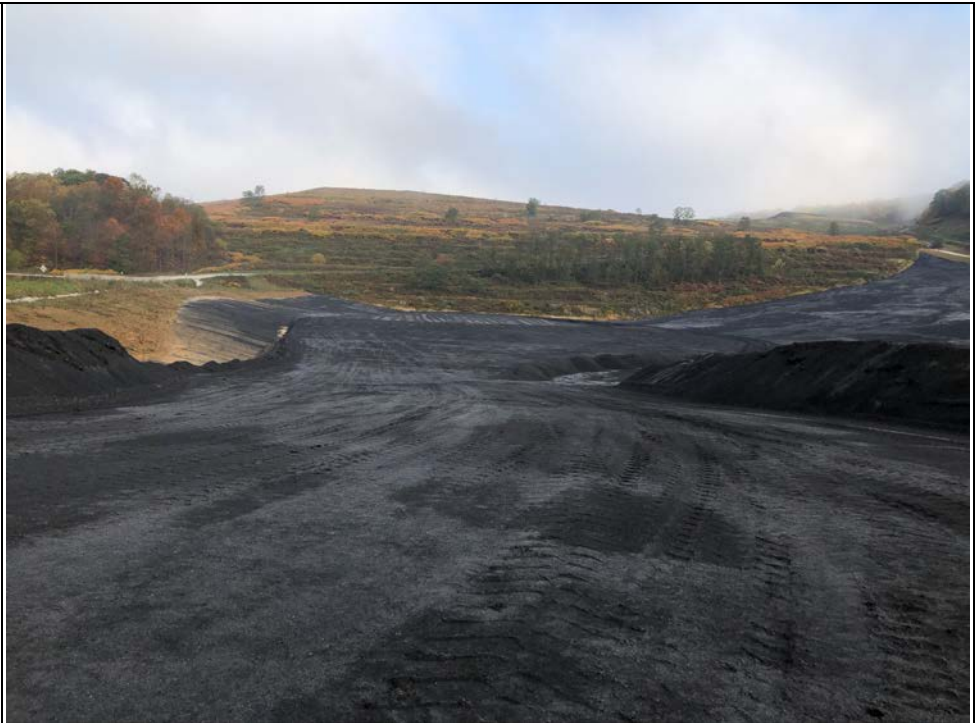
Image: 3427  
Date: 10/21/2019  
Time: 7:57 AM  
Direction: North

Stage IIIA construction area, placing bottom ash material over the drainage layer.

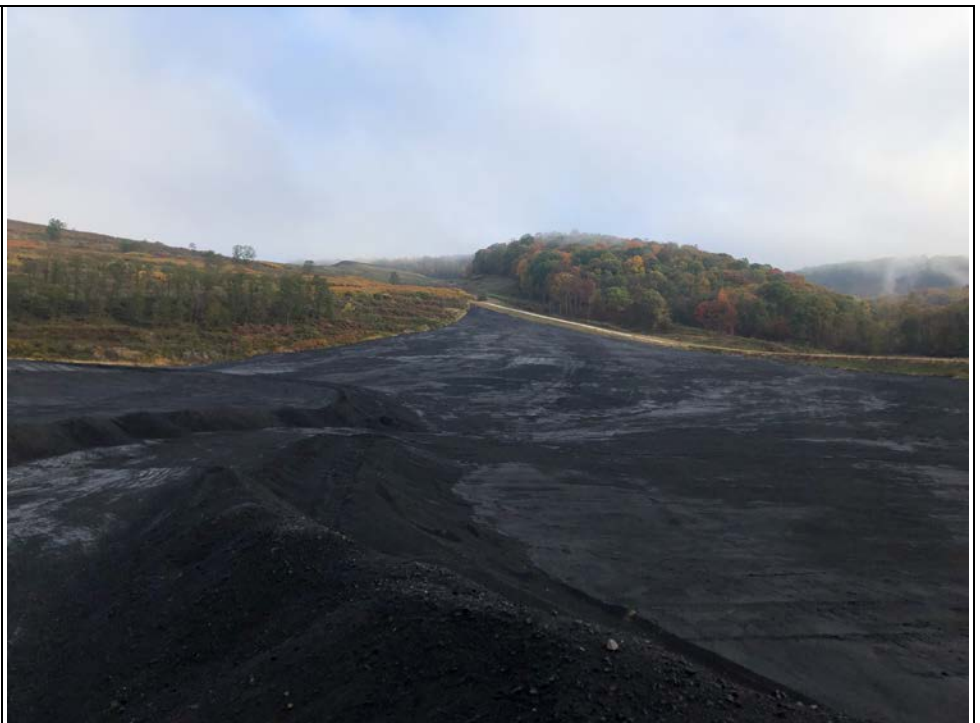
Image: 3429  
Date: 10/21/2019  
Time: 7:58 AM  
Direction: North

Stage IIIA construction area, placing bottom ash material over the drainage layer.

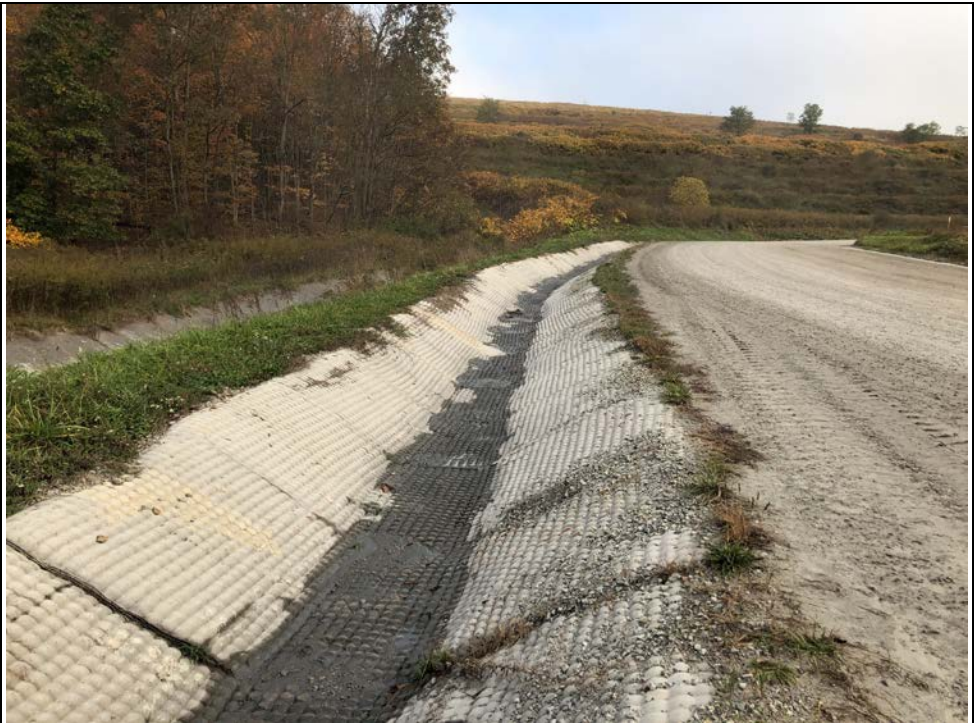
Image: 3431  
Date: 10/21/2019  
Time: 8:01 AM  
Direction: North

Contact water channel that follows main haul road.  
Clear of debris.

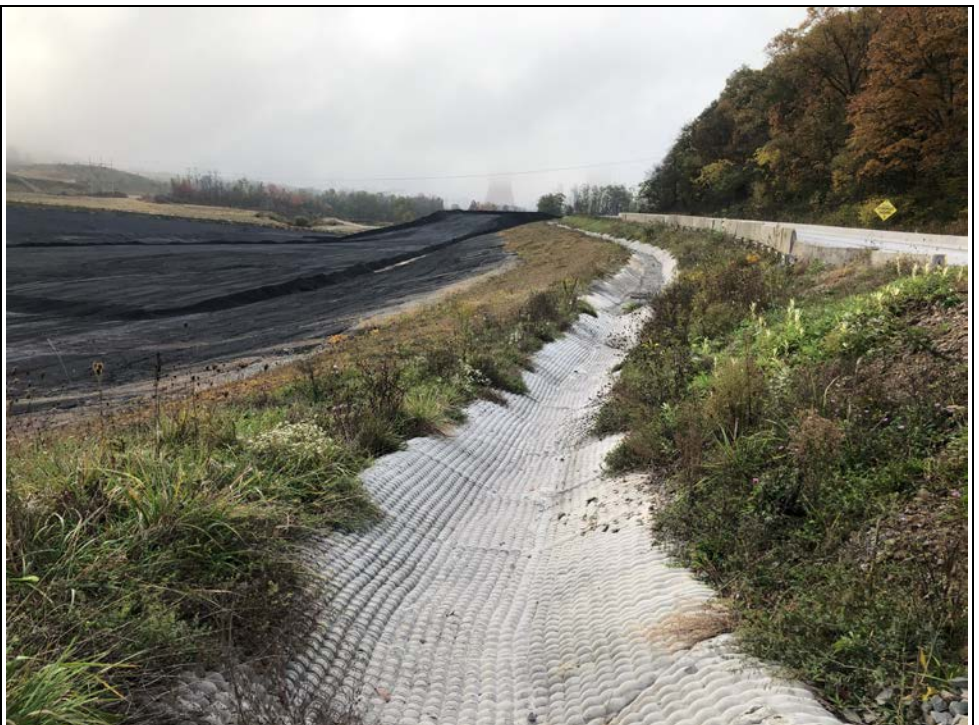
Image: 3433  
Date: 10/21/2019  
Time: 8:01 AM  
Direction: Southeast

Contact water channel that follows main haul road.  
Clear of debris.

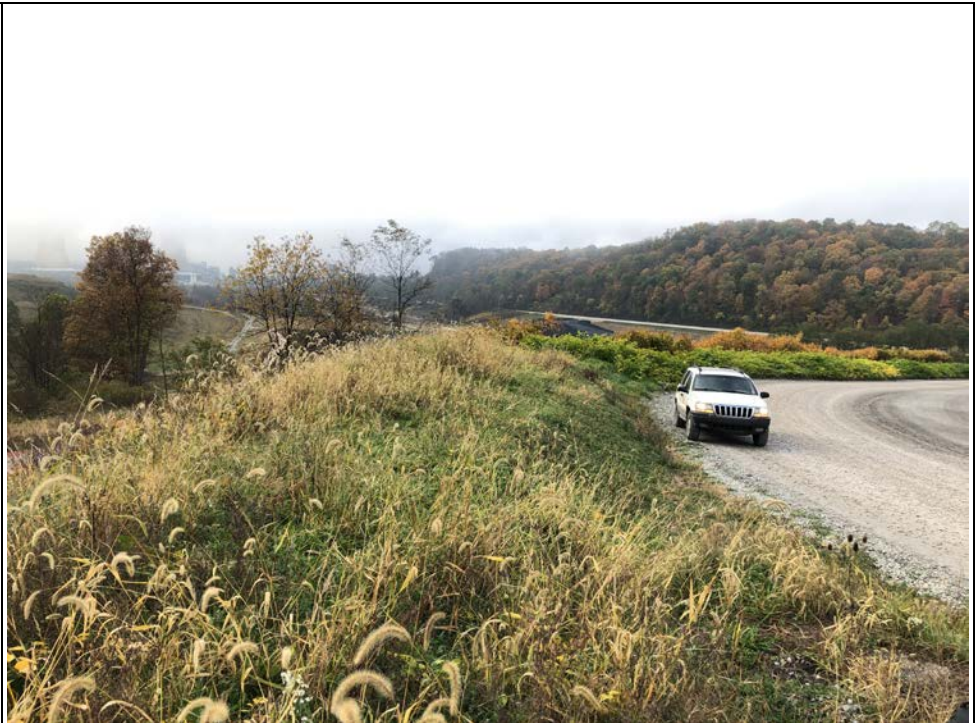
Image: 3443  
Date: 10/21/2019  
Time: 8:06 AM  
Direction: South

Stormwater controls that were impacted during the 2018 surficial release event were appropriately restored in 2018, but vegetation had not yet been established. At the time of the 2019 inspection, vegetation was observed to be healthy and well established (see Images 3437 and 3443 in the attached Photograph Log), and no CCR deposits were observed (Image 3531).

Diversion berm that was raised and improved along main haul road in 2018 to prevent run-off water from leaving the landfill during rainstorms. Vegetation has become well established.

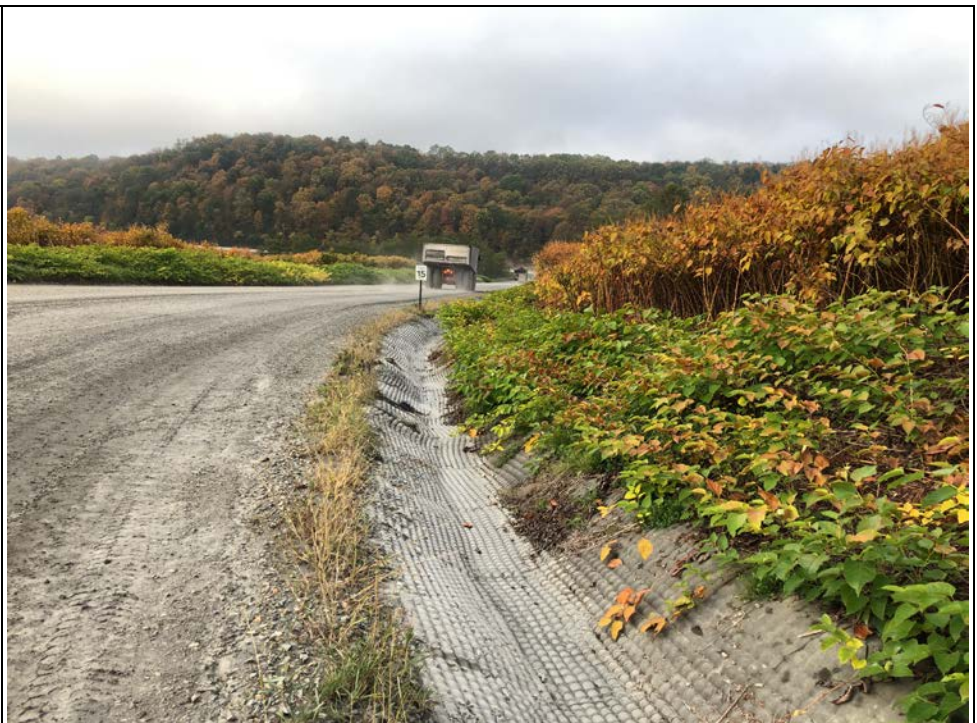
Image: 3445  
Date: 10/21/2019  
Time: 8:07 AM  
Direction: Southwest

Main haul road. Road is well maintained. Road was regraded in 2019 to better direct water to contact water channel on inside toe (on right in picture).

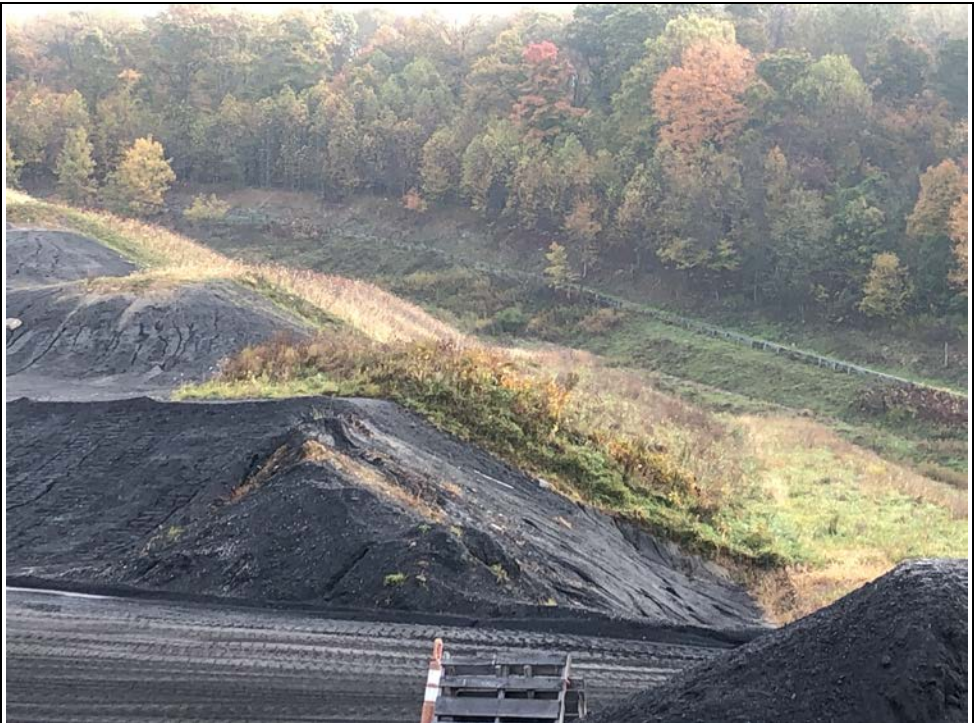
Image: 3447  
Date: 10/21/2019  
Time: 8:08 AM  
Direction: Northeast

CCR material placed near the top of Stage II CCR design grades. The CCR has been placed in benches (terraces) for stability.

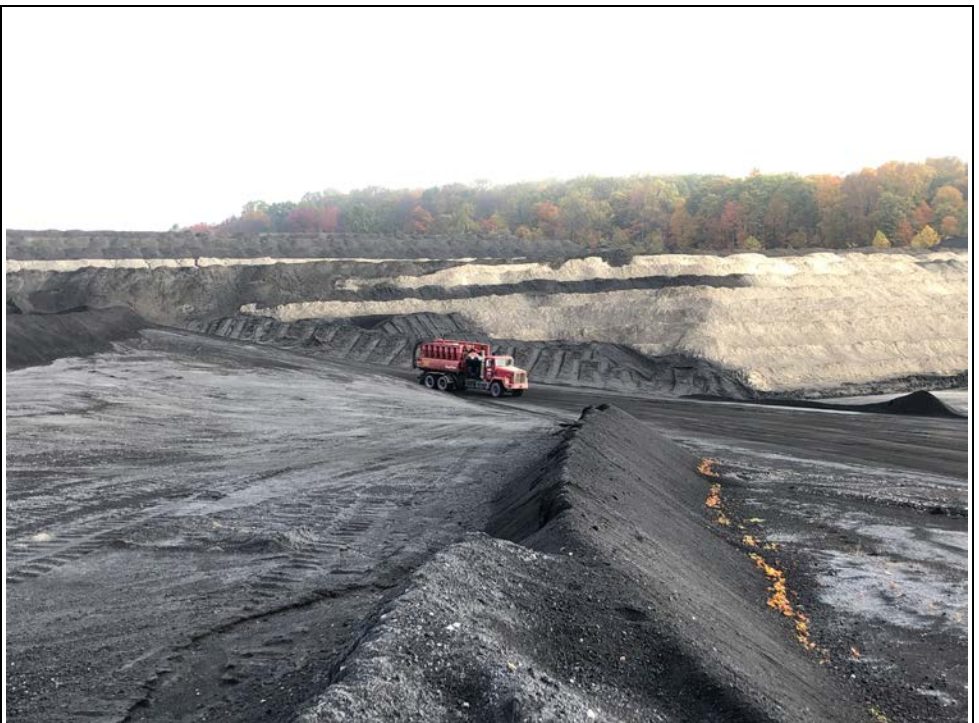
Image: 3449  
Date: 10/21/2019  
Time: 8:09 AM  
Direction: Northeast

Berms made of CCR material have been installed to slow and direct stormwater on the active face.

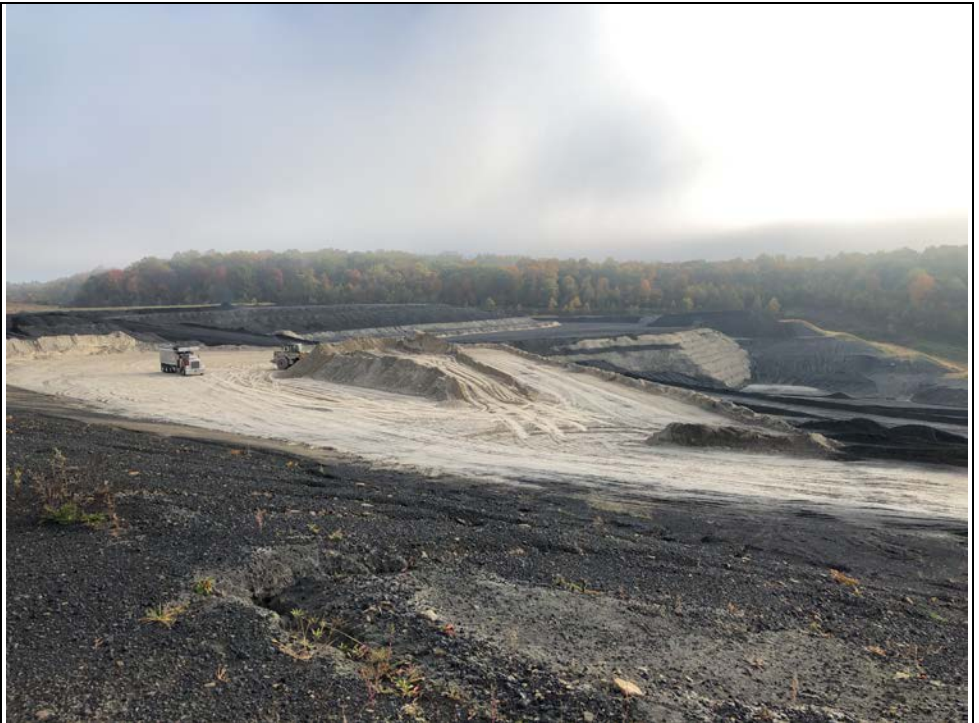
Image: 3457  
 Date: 10/21/2019  
 Time: 8:14 AM  
 Direction: Northeast

Gypsum pile in Stage II active area.

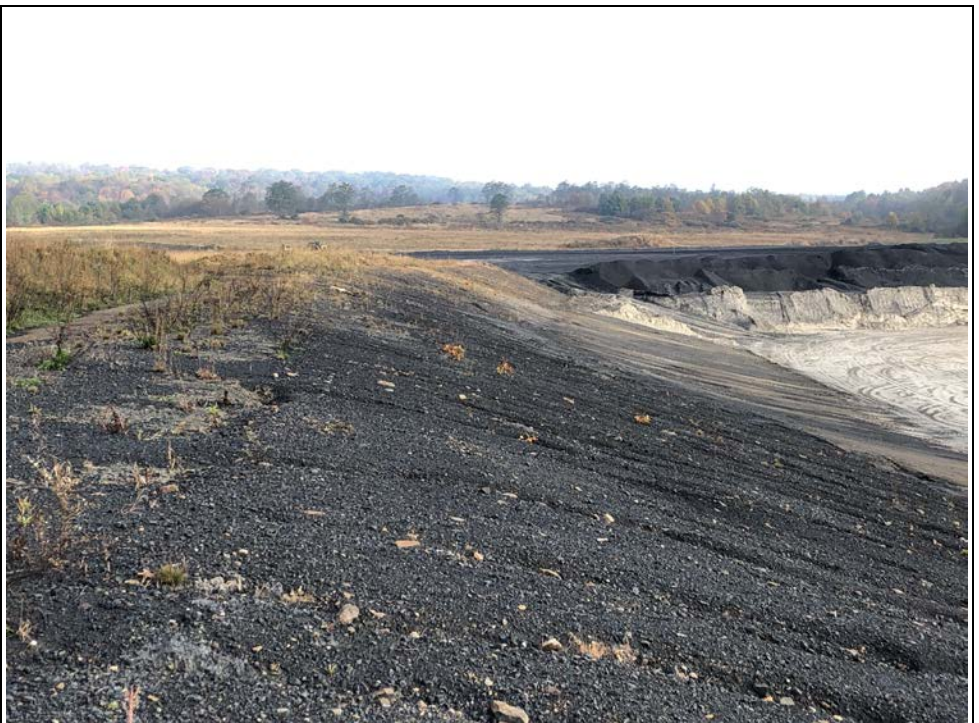
Image: 3459  
 Date: 10/21/2019  
 Time: 8:15 AM  
 Direction: North

CCR material placed near to top of permitted CCR grades. Approximate limits of active area.

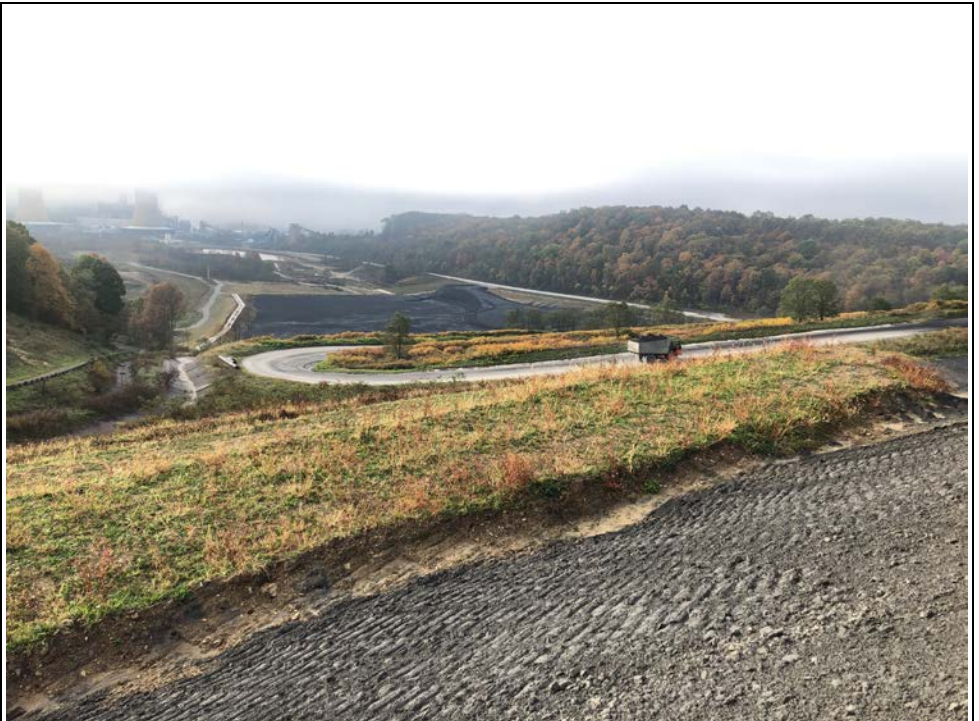
Image: 3467  
 Date: 10/21/2019  
 Time: 8:21 AM  
 Direction: South

Standing at limits of Stage II active area with intermediate cover in the center of the picture and the Stage IIIA construction area in background.

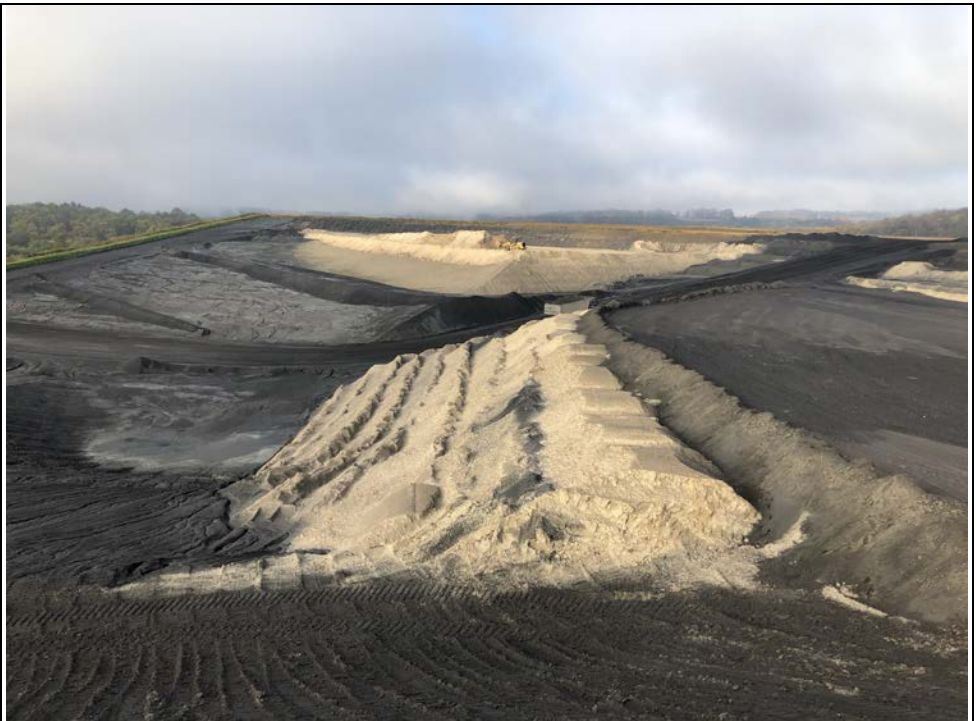
Image: 3469  
 Date: 10/21/2019  
 Time: 8:22 AM  
 Direction: West

Overview of Stage II active area.

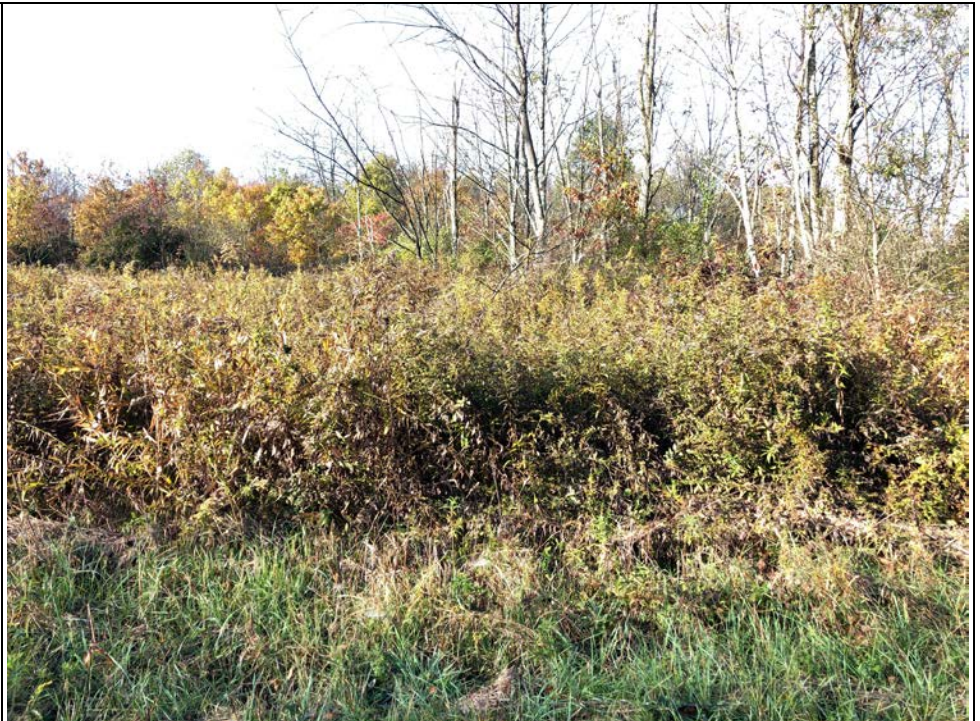
Image: 3497  
 Date: 10/21/2019  
 Time: 8:39 AM  
 Direction: West

Stage I Final Cover  
 showing healthy vegetation  
 that has no bare spots.  
 No evidence of erosion or  
 signs of instability.

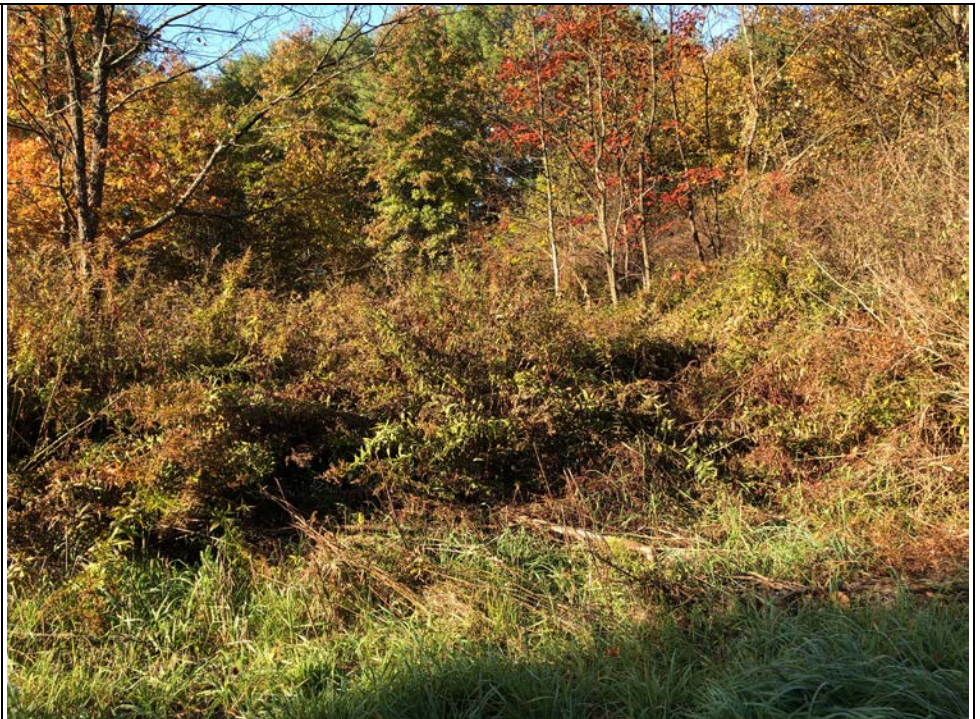
Image: 3499  
 Date: 10/21/2019  
 Time: 8:40 AM  
 Direction: West

Stage I Final Cover  
 showing healthy vegetation  
 that has no bare spots.  
 No evidence of erosion or  
 signs of instability.

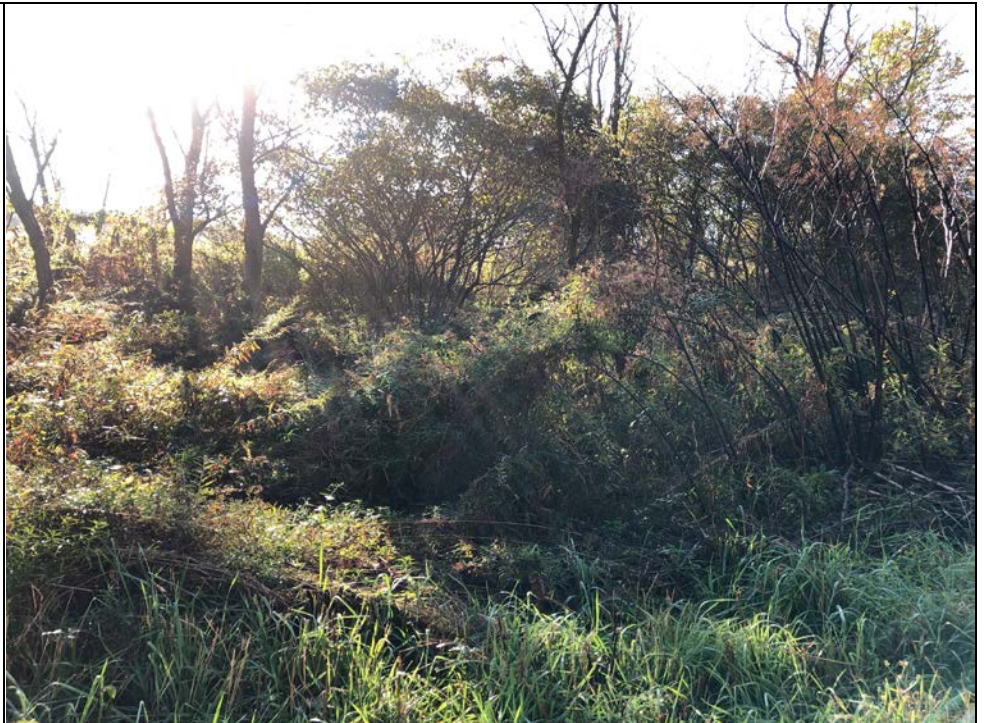
Image: 3501  
Date: 10/21/2019  
Time: 8:42 AM  
Direction: South

Stage I Final Cover  
showing healthy vegetation  
that has no bare spots.  
No evidence of erosion or  
signs of instability.

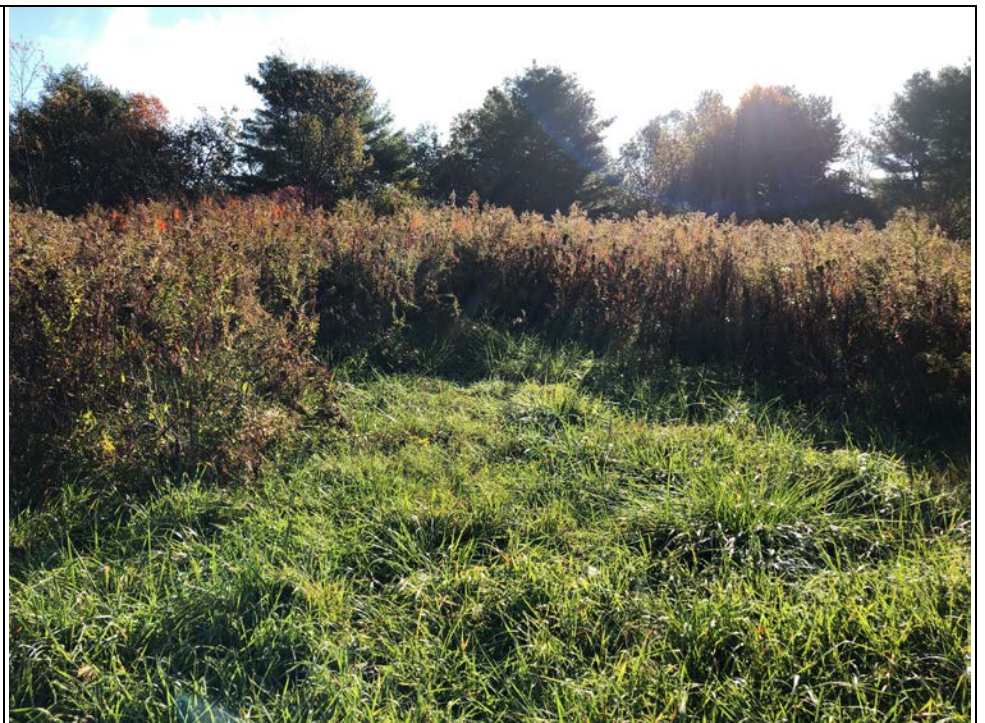
Image: 3503  
Date: 10/21/2019  
Time: 8:43 AM  
Direction: Southeast

Stage I Final Cover  
showing healthy vegetation  
that has no bare spots.  
No evidence of erosion or  
signs of instability.

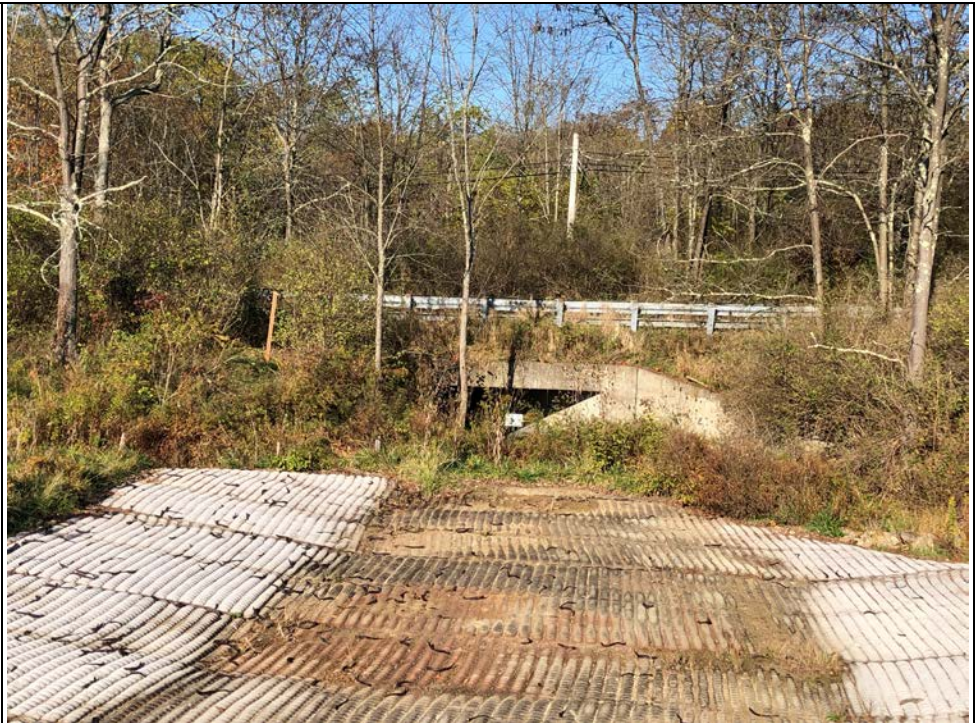
Image: 3509  
Date: 10/21/2019  
Time: 8:46 AM  
Direction: Northwest

Revetment mat installed on final cover area of Stage I to improve drainage and eliminate water that was found to pond in this area. Water is not ponding.

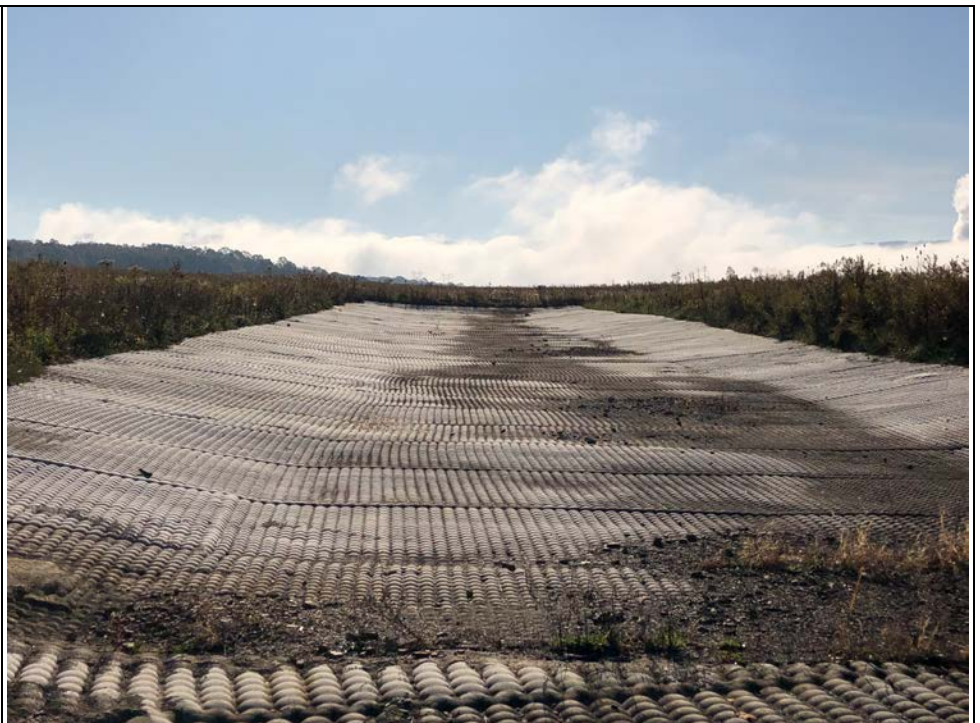
Image: 3511  
Date: 10/21/2019  
Time: 8:47 AM  
Direction: Southeast

Revetment mat installed on final cover area of Stage I to improve drainage and eliminate water that was found to pond in this area. Water is not ponding.

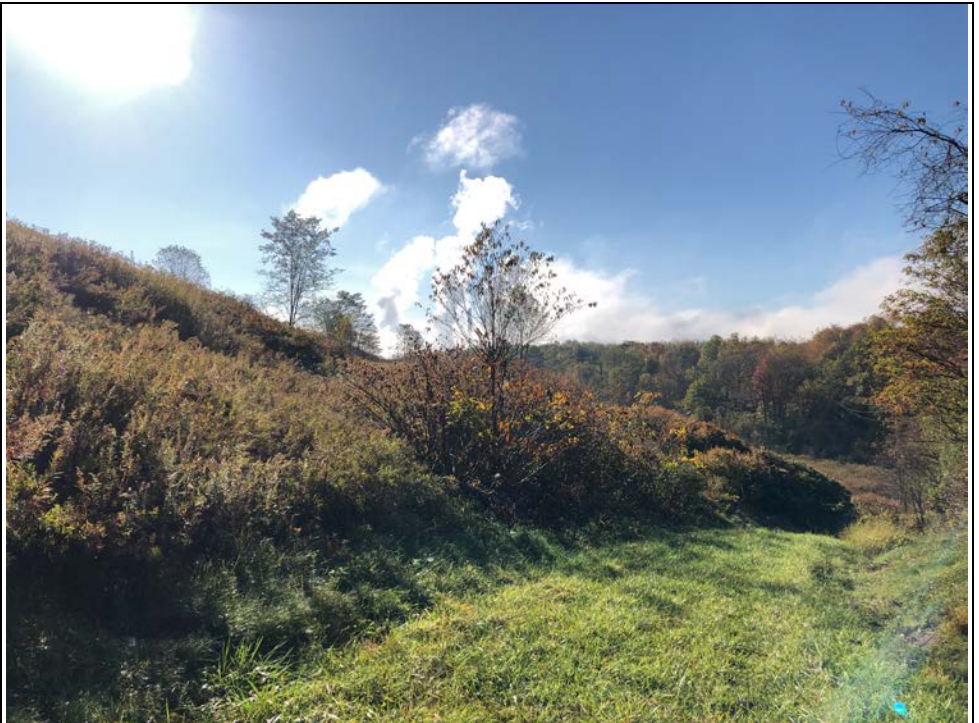
Image: 3517  
Date: 10/21/2019  
Time: 8:50 AM  
Direction: West

Final Cover vegetation on Stage II. Slopes show no signs of instability.

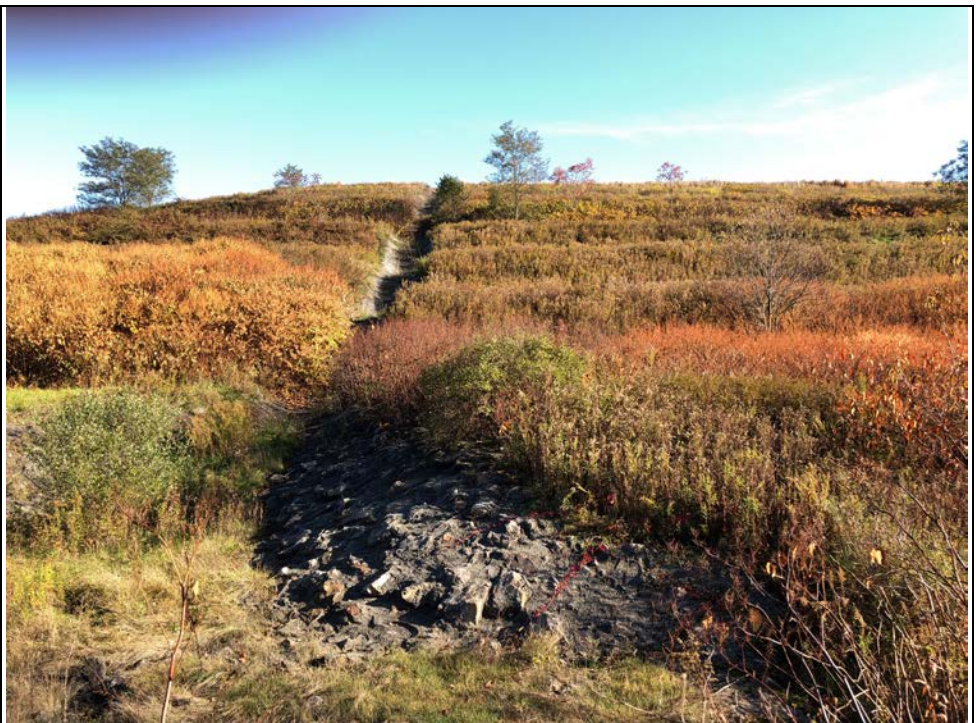
Image: 3519  
Date: 10/21/2019  
Time: 8:52 AM  
Direction: Northeast

Stage II area downchute with revetment lining. Clear of obstructions. No structural damage observed.

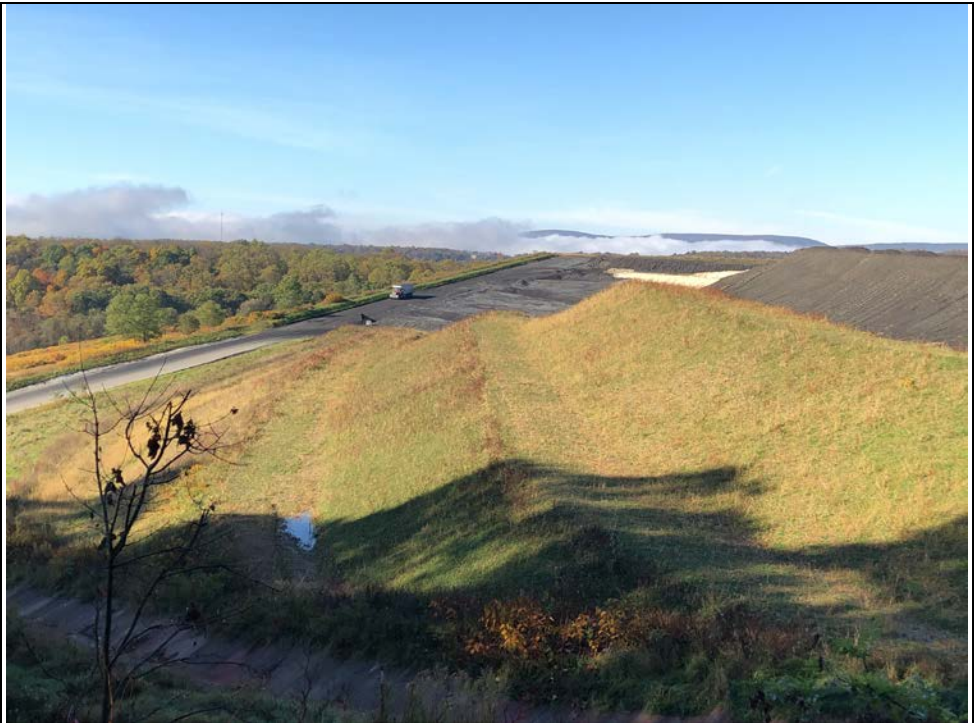
Image: 3521  
Date: 10/21/2019  
Time: 9:06 AM  
Direction: West

Intermediate cover on  
sideslopes of Stage II.  
Well maintained.

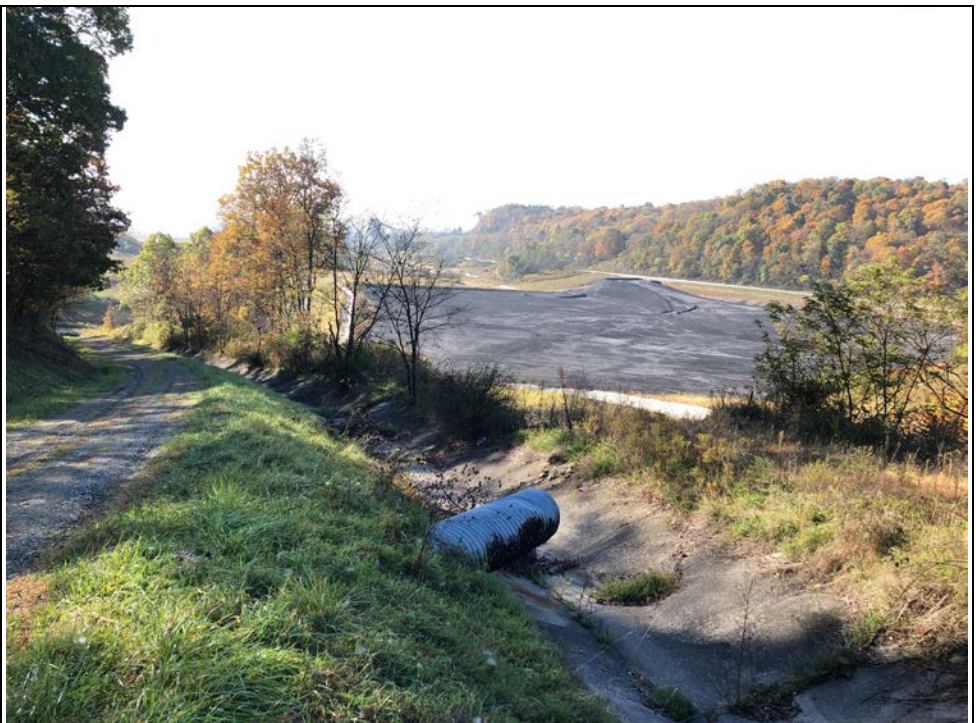
Image: 3525  
Date: 10/21/2019  
Time: 9:07 AM  
Direction: South

Stage II stormwater run-on  
diversion channel (non-  
contact water). Clear, free  
of obstructions. Stage  
IIIA construction area in  
background.

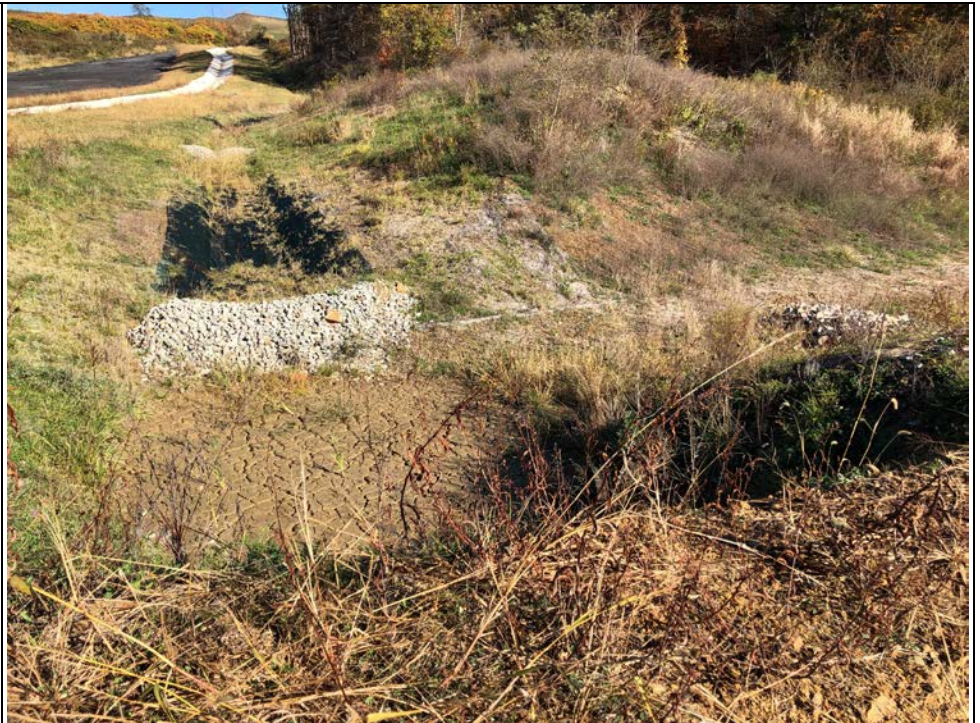
Image: 3527  
Date: 10/21/2019  
Time: 9:09 AM  
Direction: North

Non-contact water ditch and rock check dam. Well maintained.

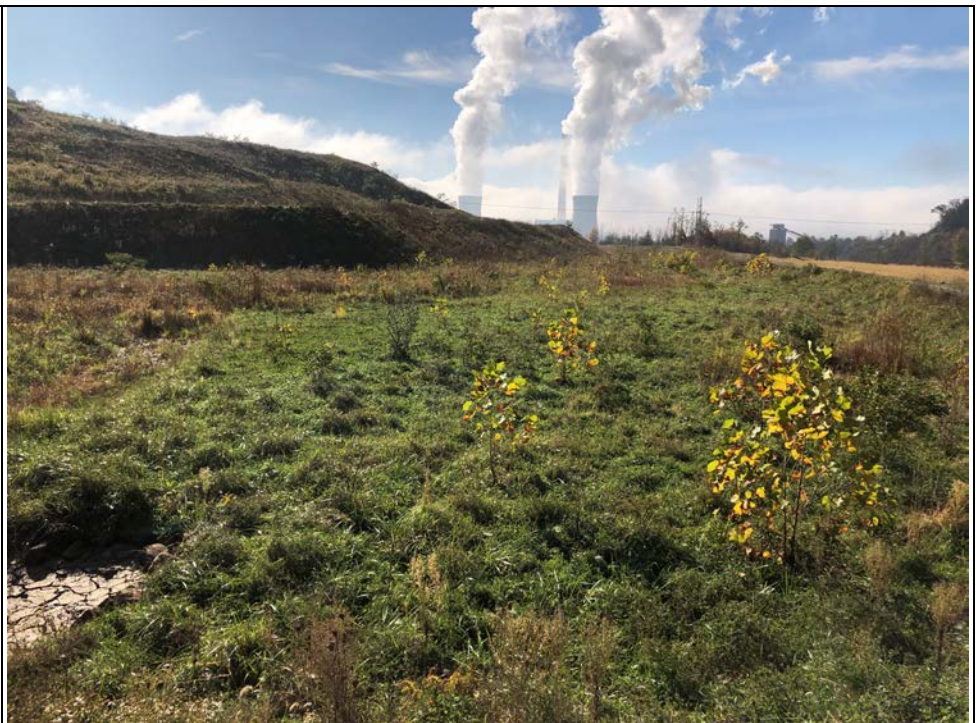
Image: 3531  
Date: 10/21/2019  
Time: 9:09 AM  
Direction: South

2018 CCR Surficial Release area. No CCR material is observed. Vegetation is healthy and well established.
