Inspection Report

To: John Shimshock (Conemaugh Generating Station)
From: Richard Southorn, P.E., P.G.
Re: Ash/Refuse Disposal Site – Annual CCR Unit Inspection Report
Inspection Date: November 11, 2020
Report Date: January 15, 2021

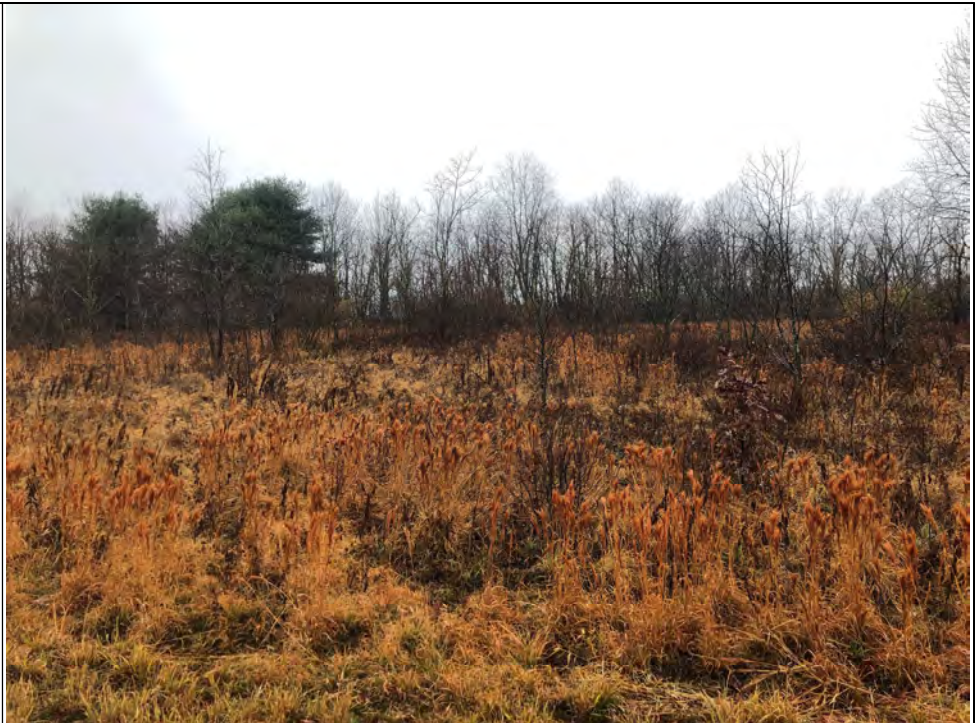
Image: 7827
Date: 11/11/2020
Time: 10:52 AM
Direction: West

Stage I Final Cover showing healthy vegetation that has no bare spots. No evidence of erosion or signs of instability.

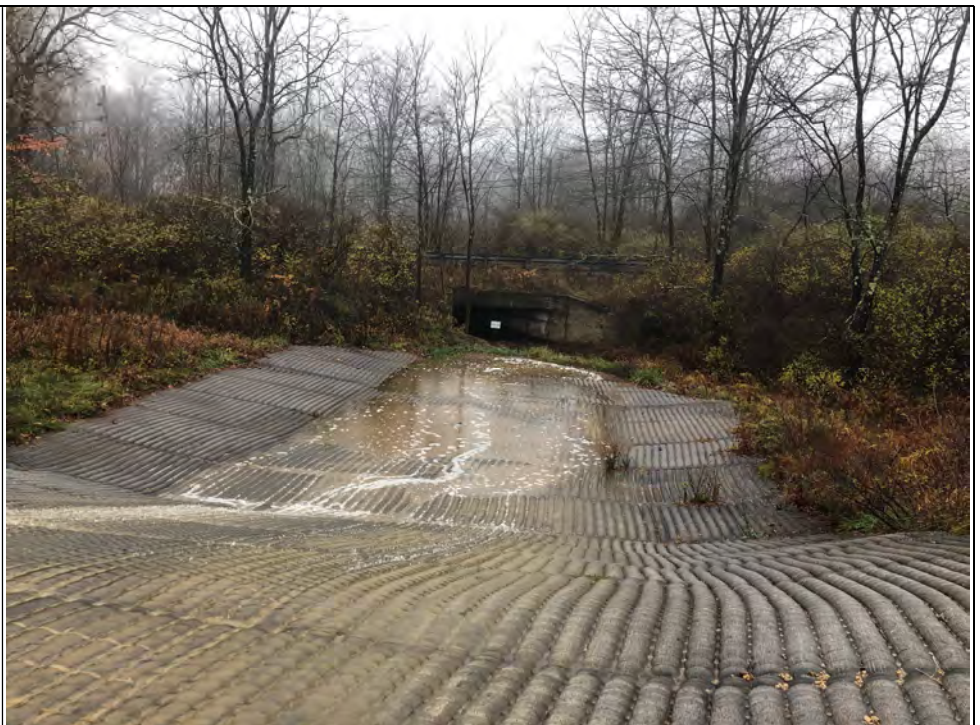
Image: 7829
Date: 11/11/2020
Time: 10:59 AM
Direction: West-Northwest

Revetment mat installed on final cover area of Stage I to improve localized drainage.

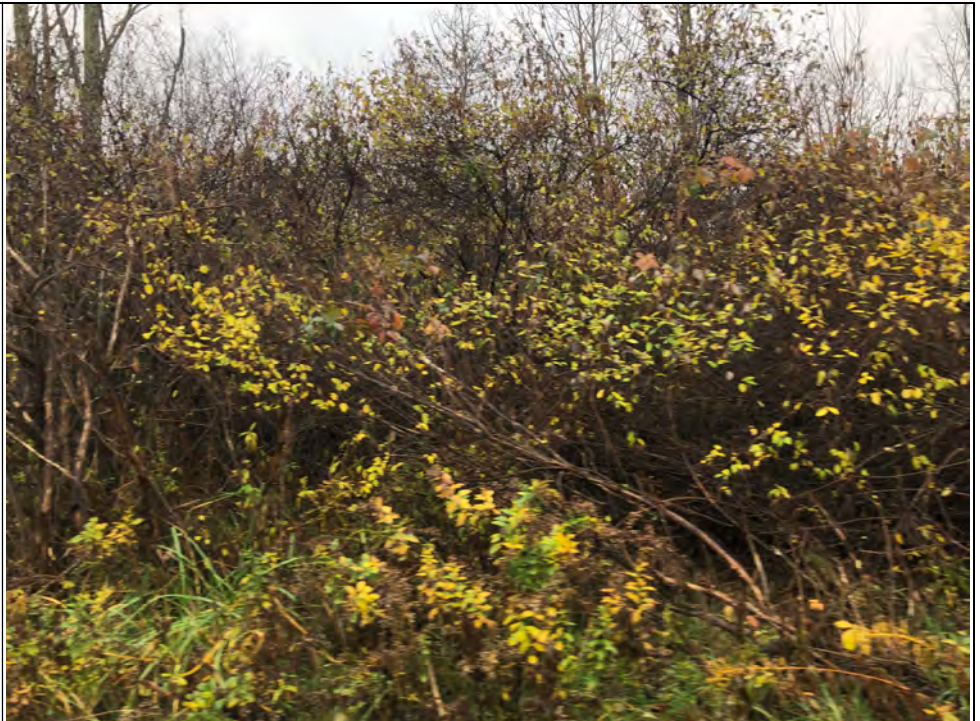
Image: 7841
 Date: 11/11/2020
 Time: 11:02 AM
 Direction: Northeast

Stage I Final Cover
 showing healthy vegetation
 that has no bare spots.
 No evidence of erosion or
 signs of instability.

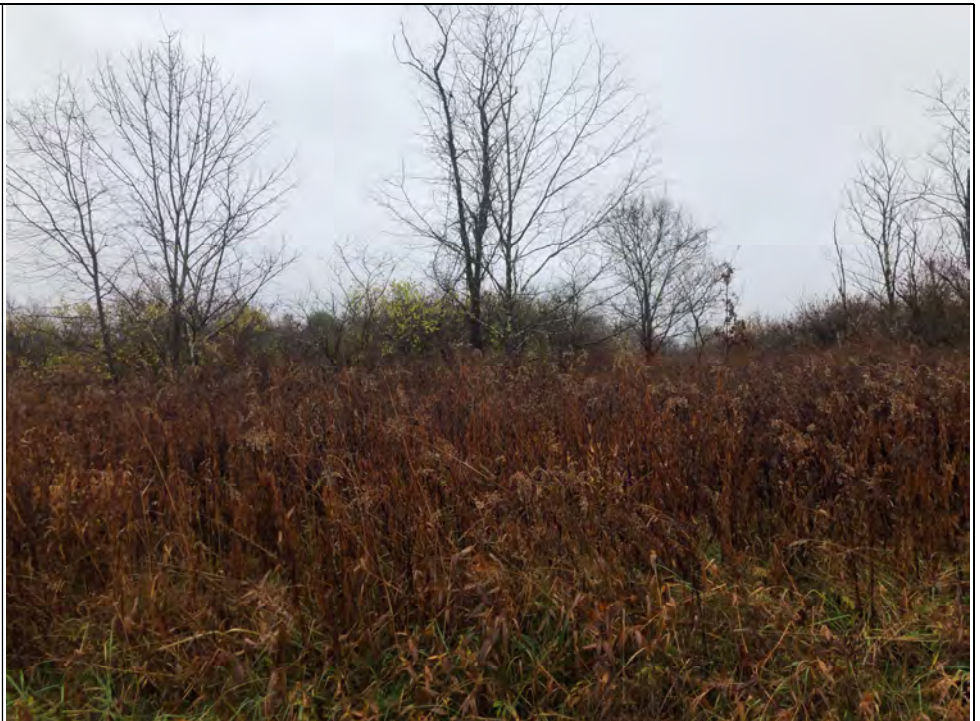
Image: 7843
 Date: 11/11/2020
 Time: 11:02 AM
 Direction: Northeast

Stage I Final Cover
 showing healthy vegetation
 that has no bare spots.
 No evidence of erosion or
 signs of instability.

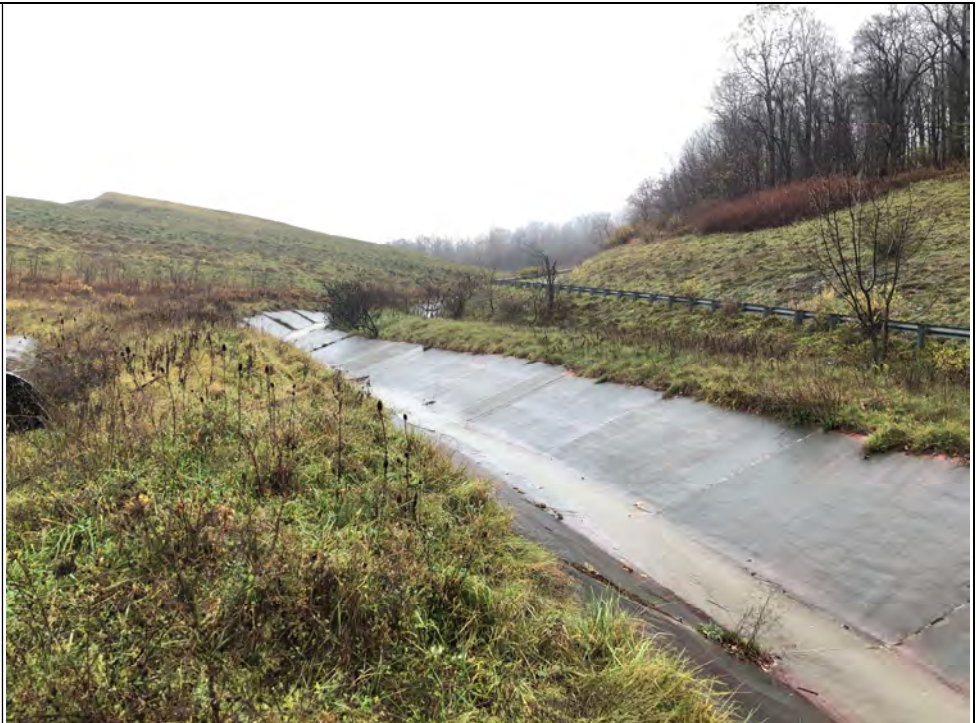
Image: 7863
 Date: 11/11/2020
 Time: 11:19 AM
 Direction: Northeast

Contact stormwater channel. Free of debris. Good condition.

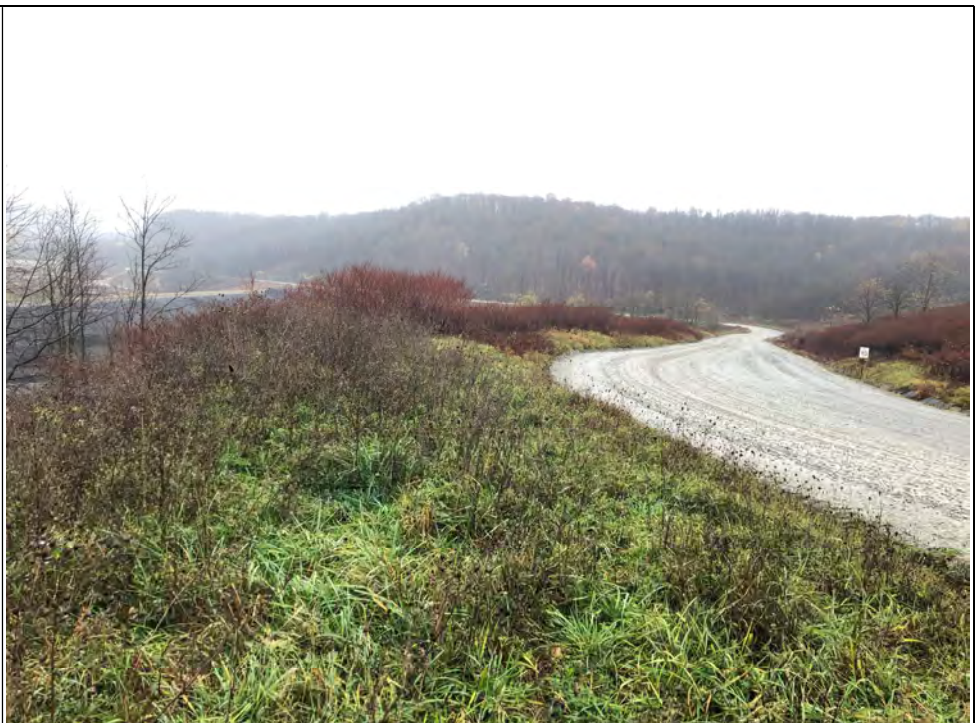
Image: 7865
 Date: 11/11/2020
 Time: 11:19 AM
 Direction: Southwest

Diversion berm that was raised and improved along main haul road in 2018 to prevent run-off water from leaving the landfill during rainstorms. Vegetation has become well established.

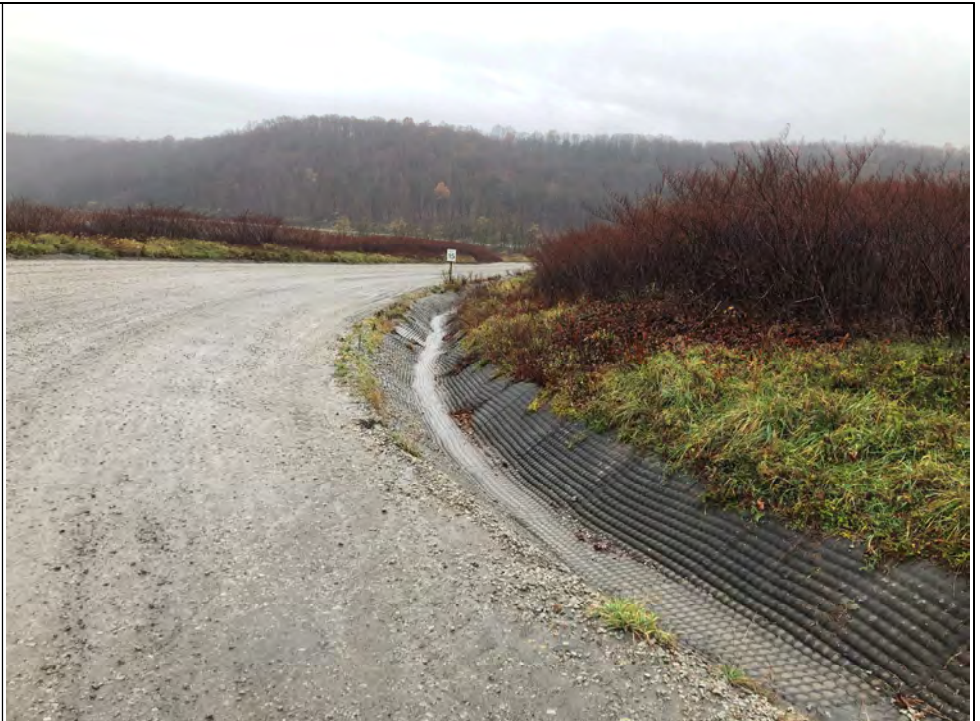
Image: 7867
 Date: 11/11/2020
 Time: 11:19 AM
 Direction: Southwest

Main haul road. Road is well maintained. Inside toe of road was regraded in 2019 to better direct flow to contact stormwater channel.

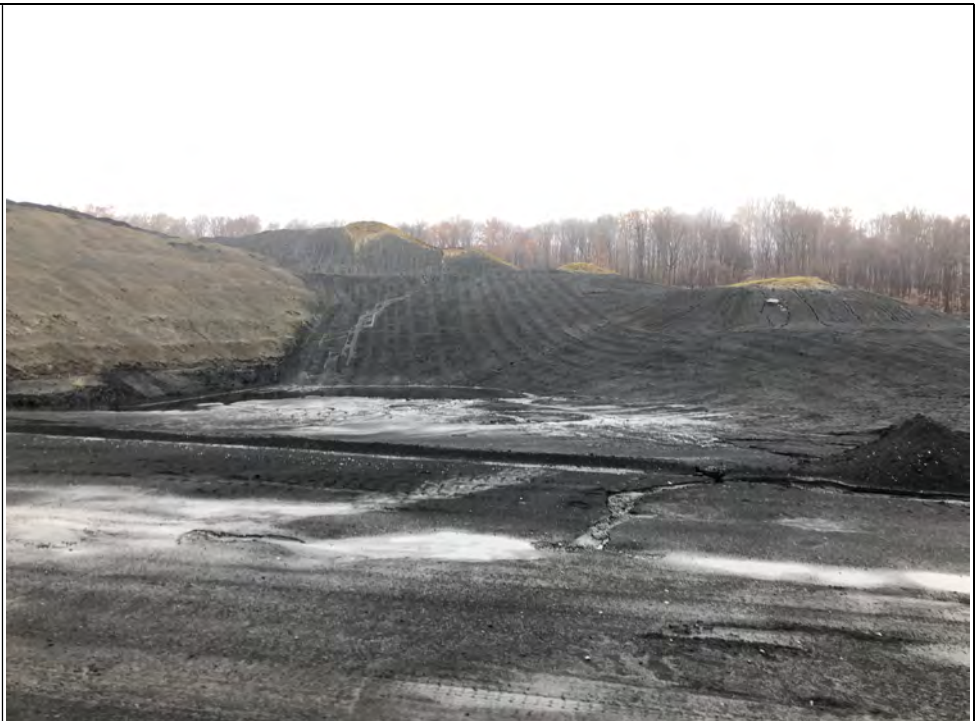
Image: 7869
 Date: 11/11/2020
 Time: 11:20 AM
 Direction: East

Location on Stage II active face that is maintained as a low point to temporarily collect contact stormwater during significant precipitation events.

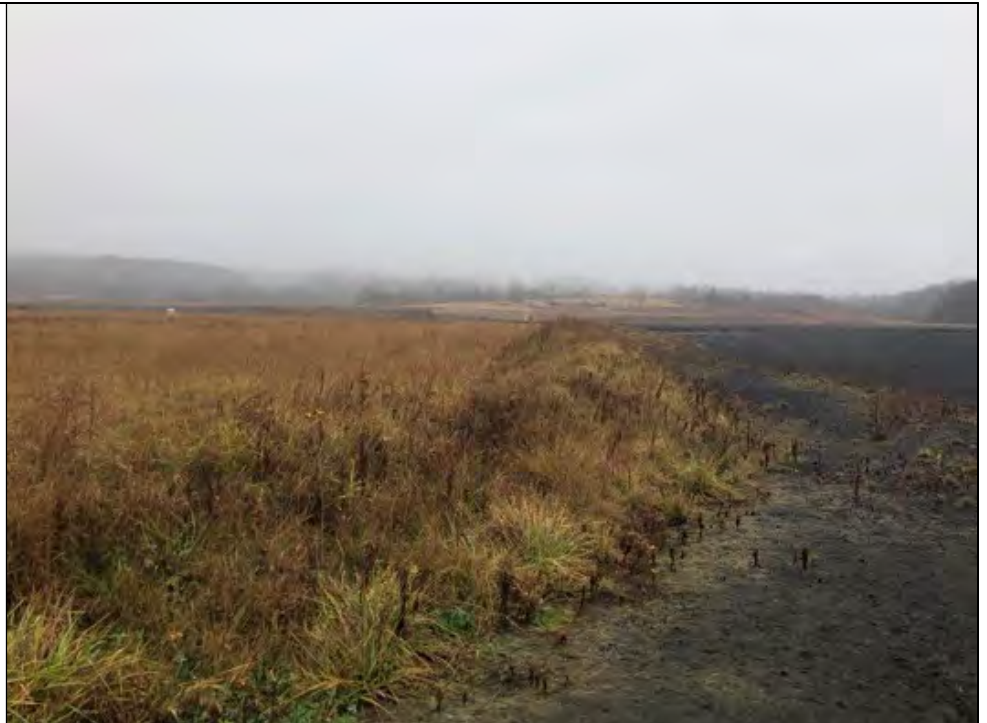
Image: 7886
Date: 11/11/2020
Time: 11:28 AM
Direction: North

Boundary of Stage II intermediate cover (left) and active areas (right).
