Inspection Report

To: Nate Rozic (Keystone Generating Station)
From: Richard Southorn, P.E., P.G.
Re: Keystone Ash Disposal Site – Annual CCR Unit Inspection Report
Inspection Date: November 11, 2020
Report Date: January 15, 2021

Project: Keystone Landfill 2020 Annual Inspection

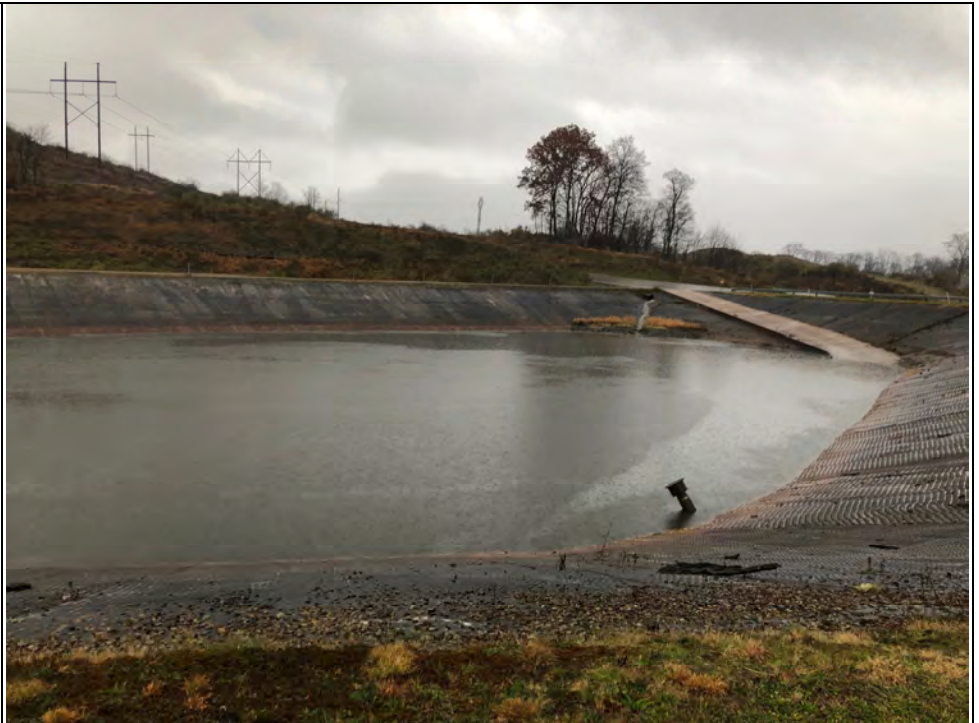
Image: 7732
 Date: 11/11/2020
 Time: 8:02 AM
 Direction: Northeast

West Valley Equalization Pond. Well maintained. Minor sediment buildup in pond.

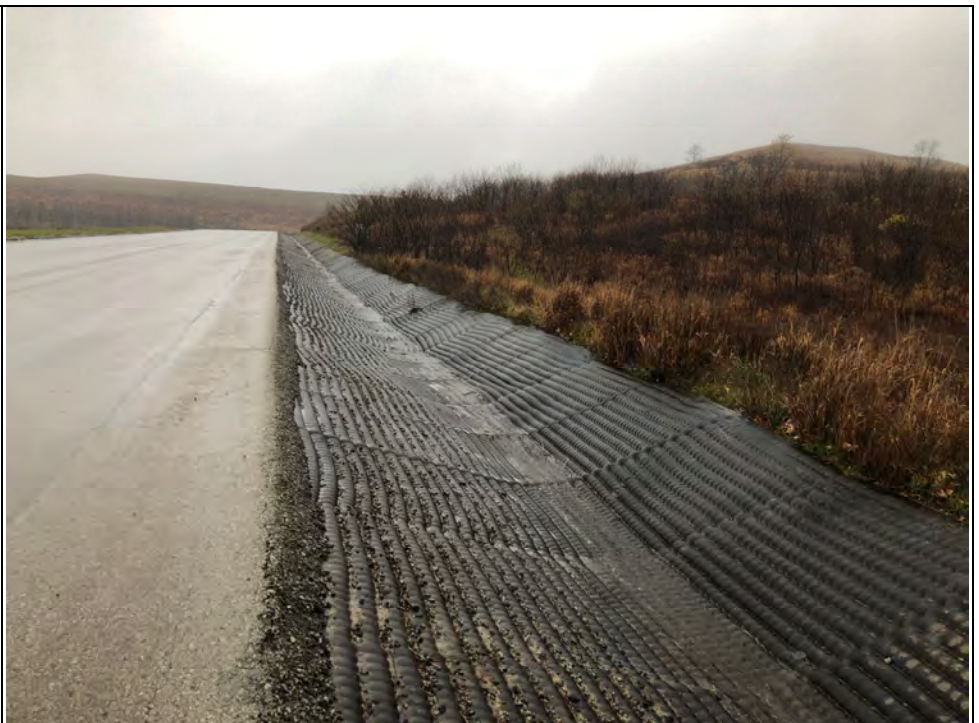
Image: 7736
 Date: 11/11/2020
 Time: 8:07 AM
 Direction: North

Non-contact stormwater ditch lined with revetment matting. Free of obstructions.

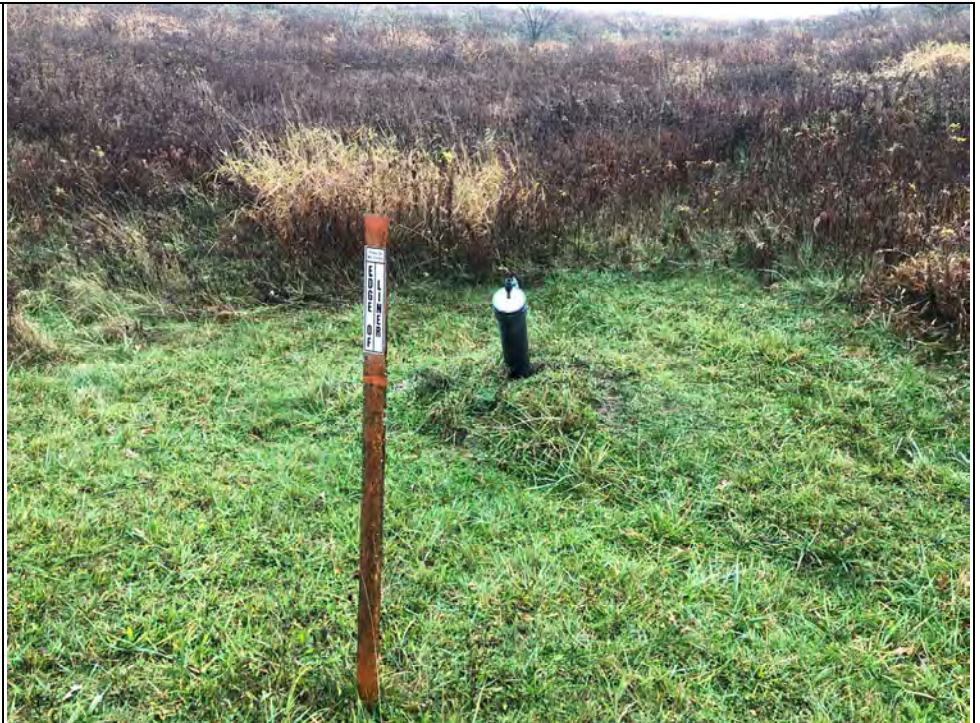
Image: 7782
Date: 11/11/2020
Time: 8:36 AM
Direction: Southeast

West Valley Edge-of-Liner marker in foreground and leachate cleanout access in background.

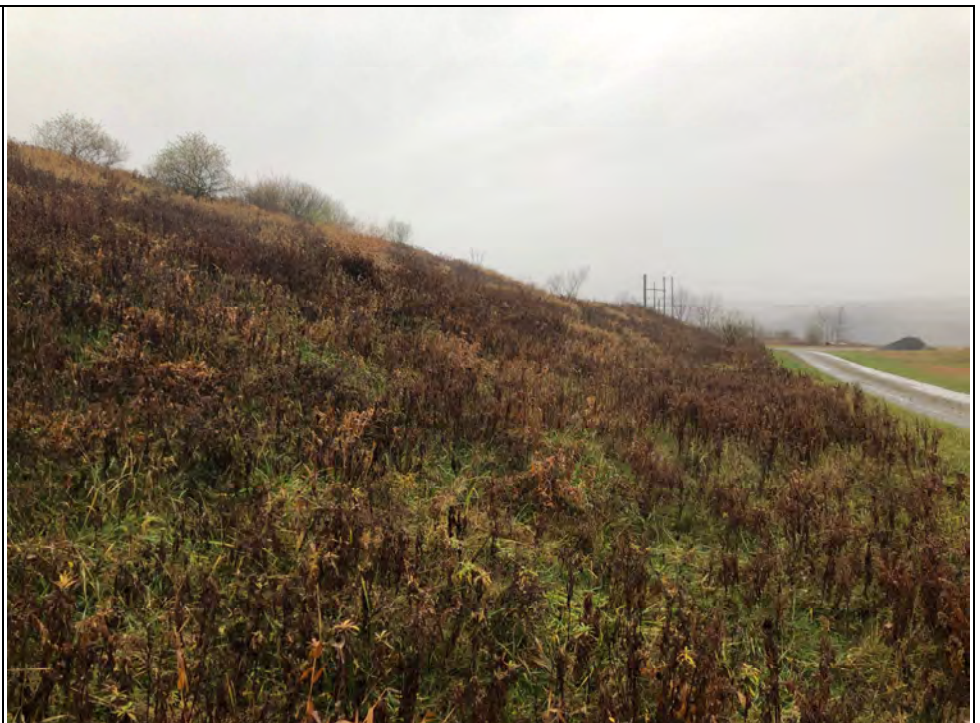
Image: 7784
Date: 11/11/2020
Time: 8:36 AM
Direction: Southwest

Final cover on sideslopes of West Valley. The vegetation is dense, healthy, and uniformly distributed. The final cover slopes show no evidence of erosion, animal burrows, or failure (e.g. sloughing or sliding).

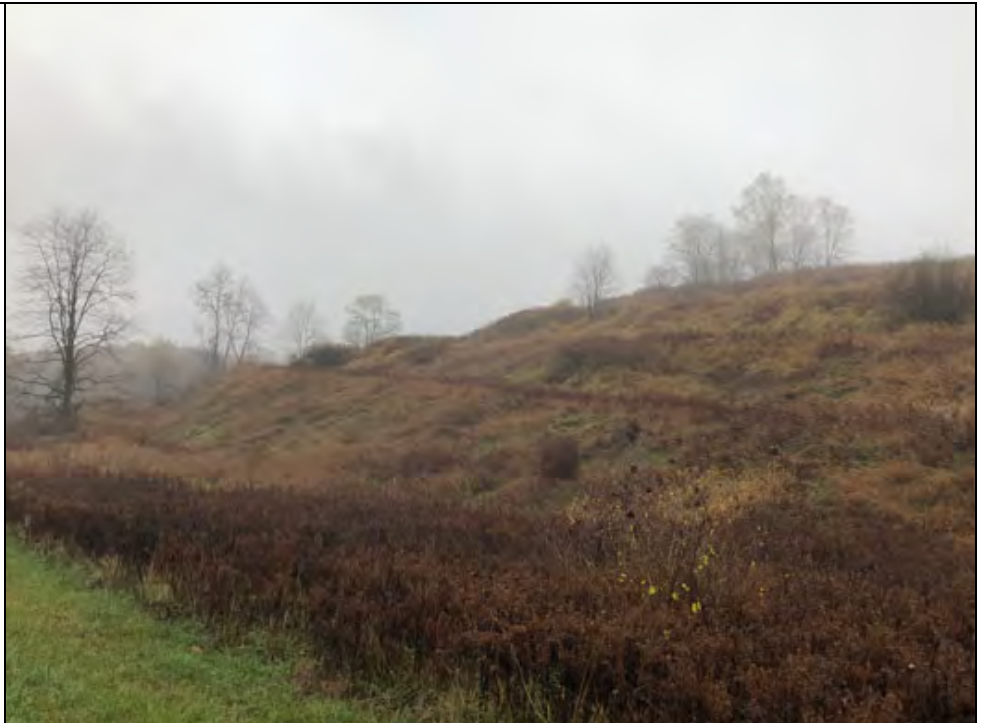
Image: 7796
Date: 11/11/2020
Time: 8:42 AM
Direction: South-Southeast

Final cover on sideslopes of East Valley. The vegetation is dense, healthy, and uniformly distributed. The final cover slopes show no evidence of erosion, animal burrows, or failure (e.g. sloughing or sliding).

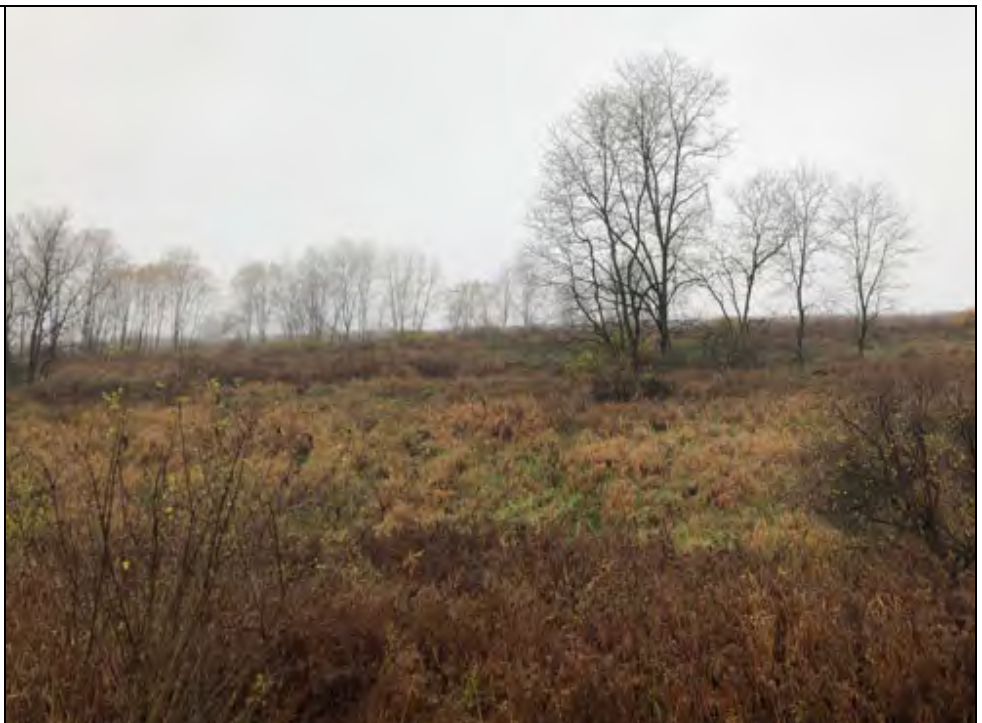
Image: 7798
Date: 11/11/2020
Time: 8:43 AM
Direction: Southwest

Final cover on sideslopes of East Valley. The vegetation is dense, healthy, and uniformly distributed. The final cover slopes show no evidence of erosion, animal burrows, or failure (e.g. sloughing or sliding).

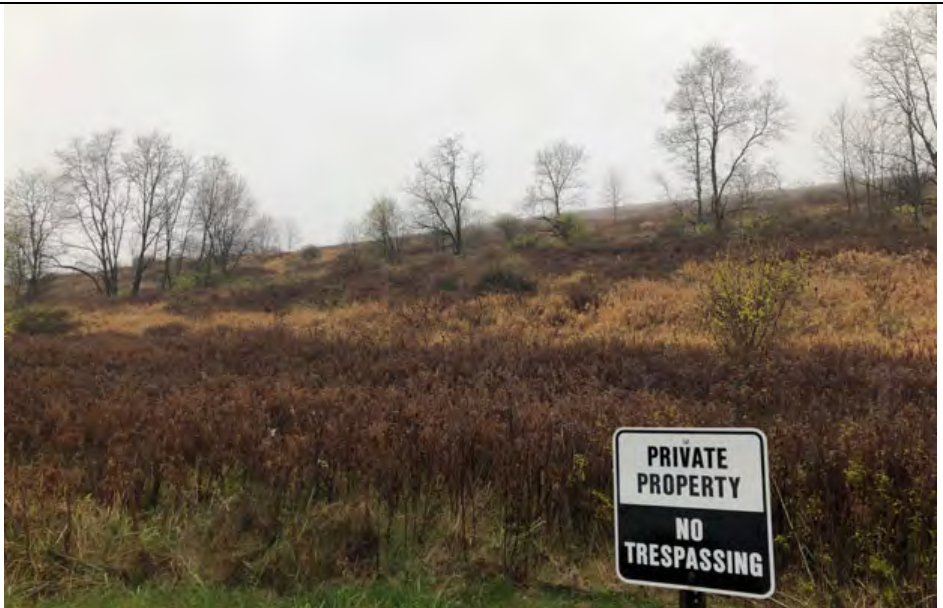
<p>Image: 7799 Date: 11/11/2020 Time: 8:44 AM Direction: Southwest</p> <p>Description:</p> <p>Final cover on sideslopes of East Valley. The vegetation is dense, healthy, and uniformly distributed. The final cover slopes show no evidence of erosion, animal burrows, or failure (e.g. sloughing or sliding).</p>

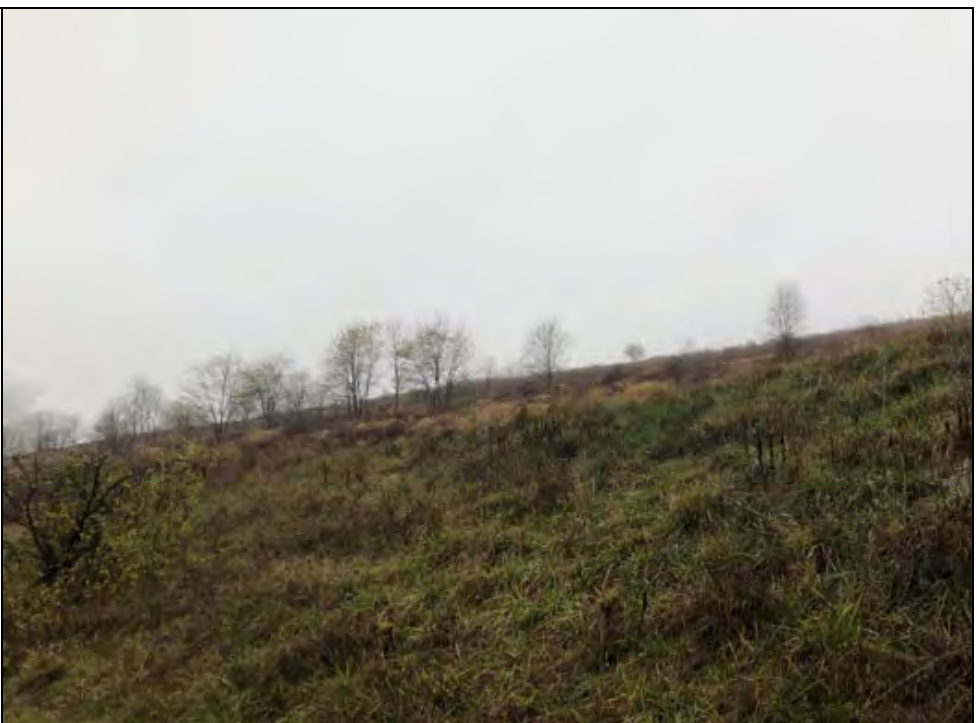
<p>Image: 7800 Date: 11/11/2020 Time: 8:45 AM Direction: Southwest</p> <p>Description:</p> <p>Final cover on sideslopes of East Valley. The vegetation is dense, healthy, and uniformly distributed. The final cover slopes show no evidence of erosion, animal burrows, or failure (e.g. sloughing or sliding).</p>
