Annual CCR Unit Inspection Report For Reporting Year 2021

Keystone-Conemaugh Projects, LLC
Conemaugh Ash/Refuse Disposal Site
Conemaugh Generating Station
New Florence, Pennsylvania

GAI Project Number: C151611.04, Task 003
January 2022

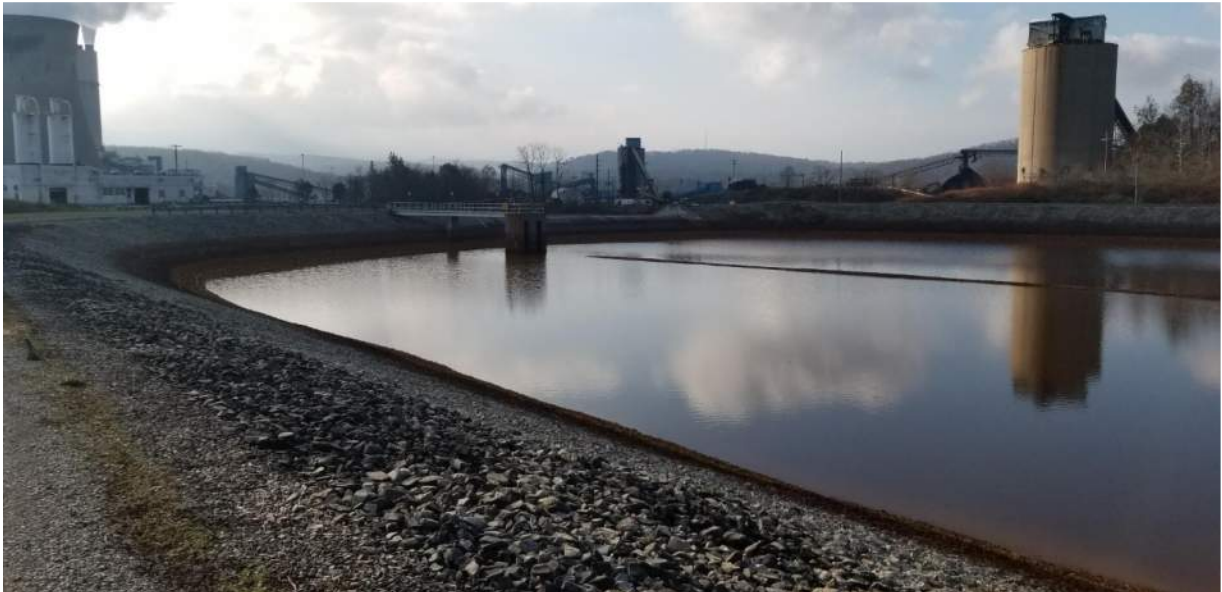
Photograph 1. Equalization Pond, immediately north of disposal site treatment plant; view southeast

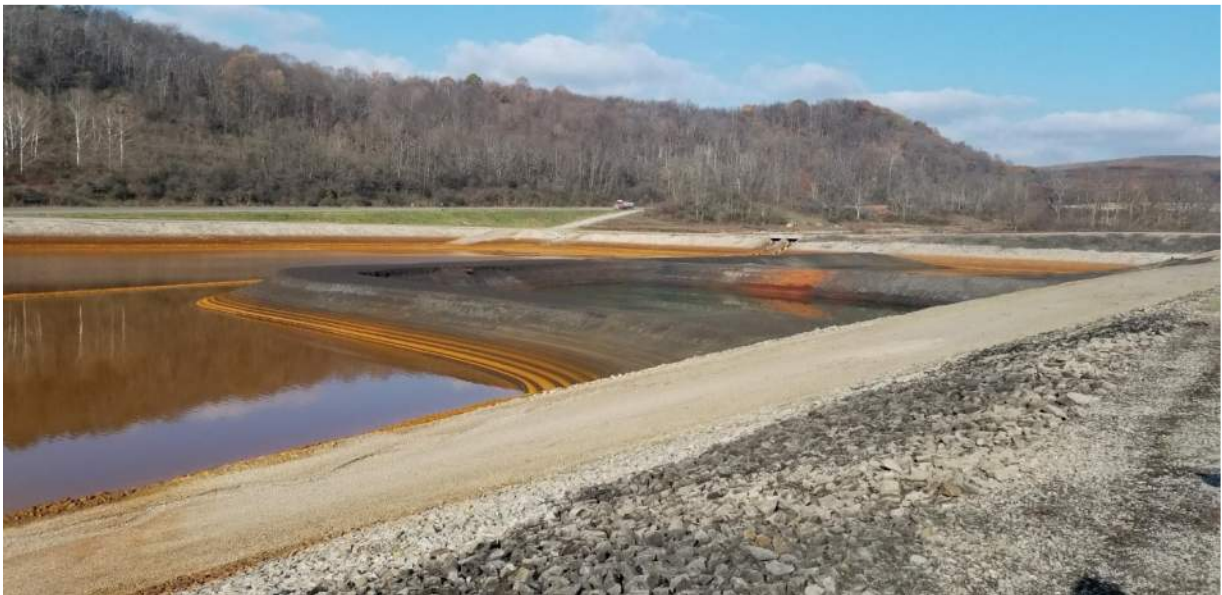
Photograph 2. Disposal Site Surge Pond; view northwest

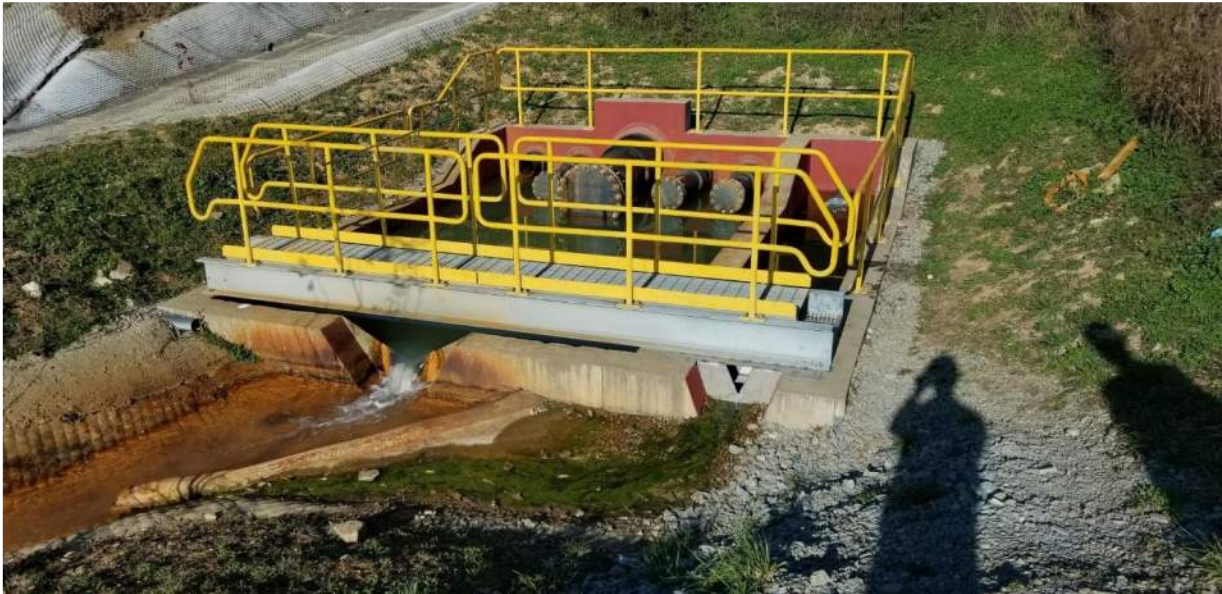
Photograph 3. Stage IIIA Stilling Basin, Leachate collection piping and v-notch weir (left), Leak detection pipe and v-notch weir (right)

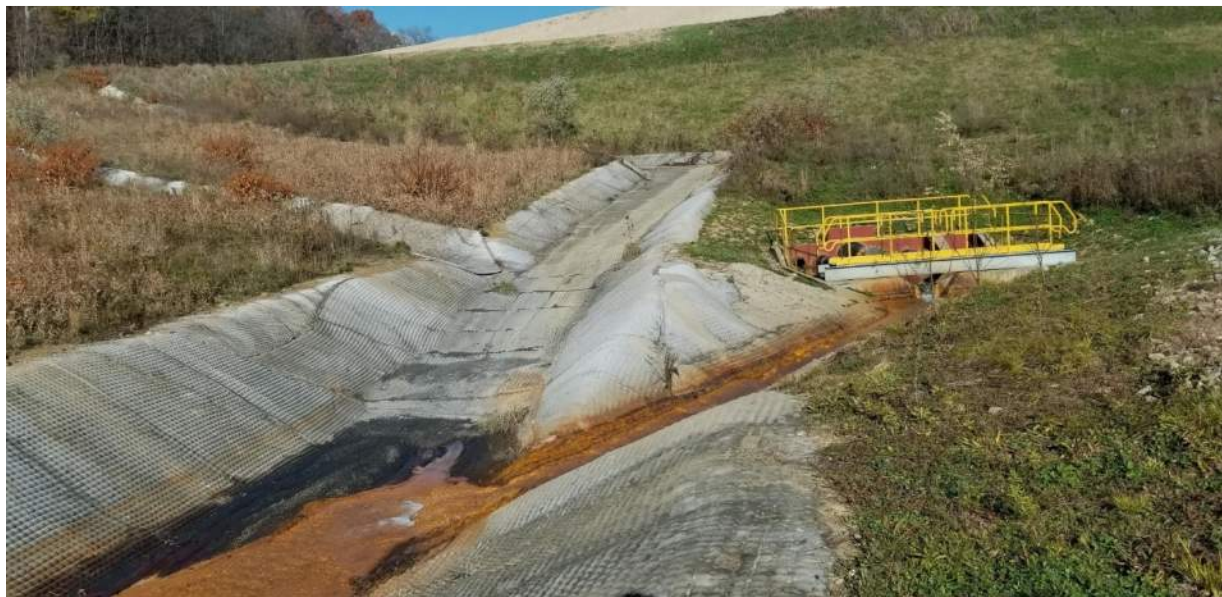
Photograph 4. Stage IIIA toe collection channels and leachate and leak detection flows from stilling basin (right); view north

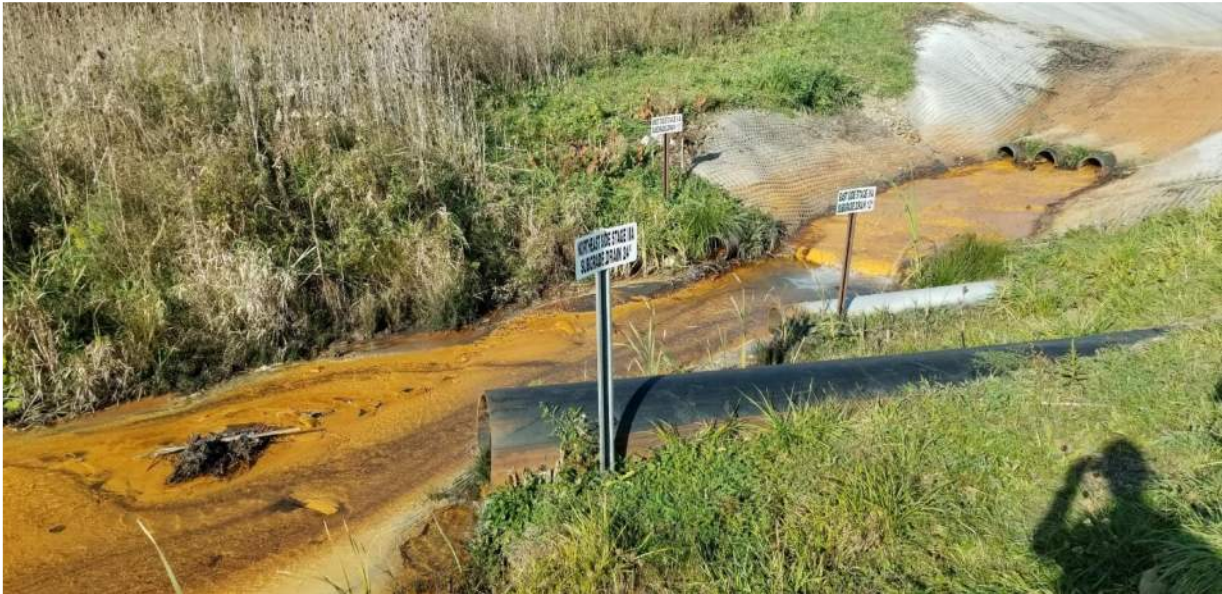
Photograph 5. Stage IIIA toe collection channel and flows from subgrade drain pipes (with signs) from Stages II/III; view westward

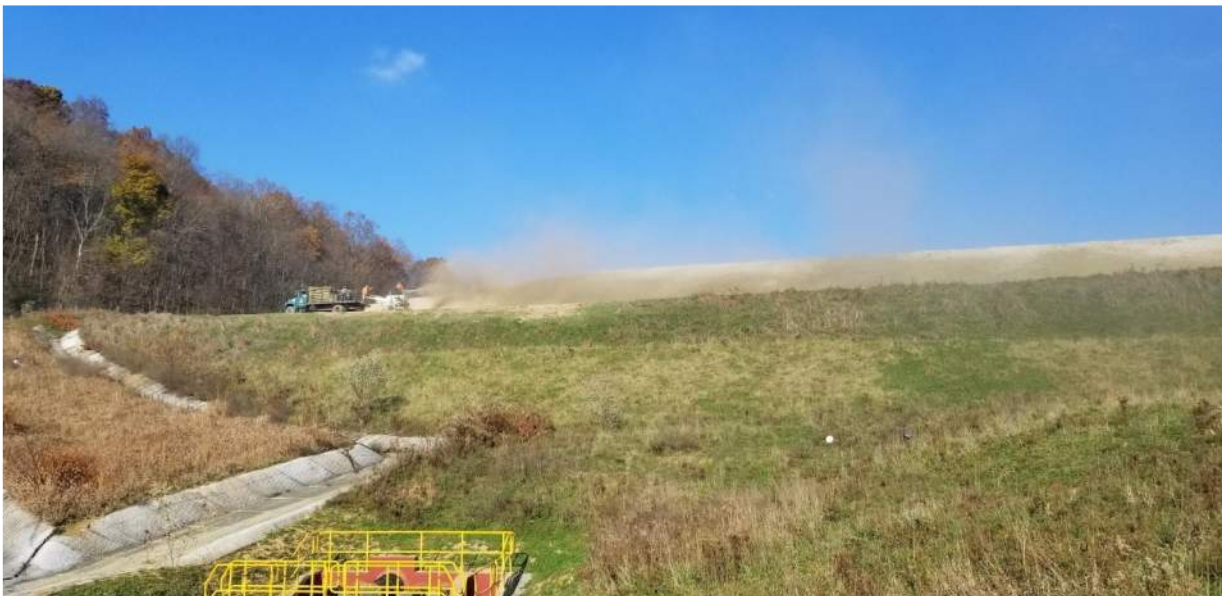
Photograph 6. Mulching taking place on a recently seeded Stage IIIA slope on the southern facing benches; view north

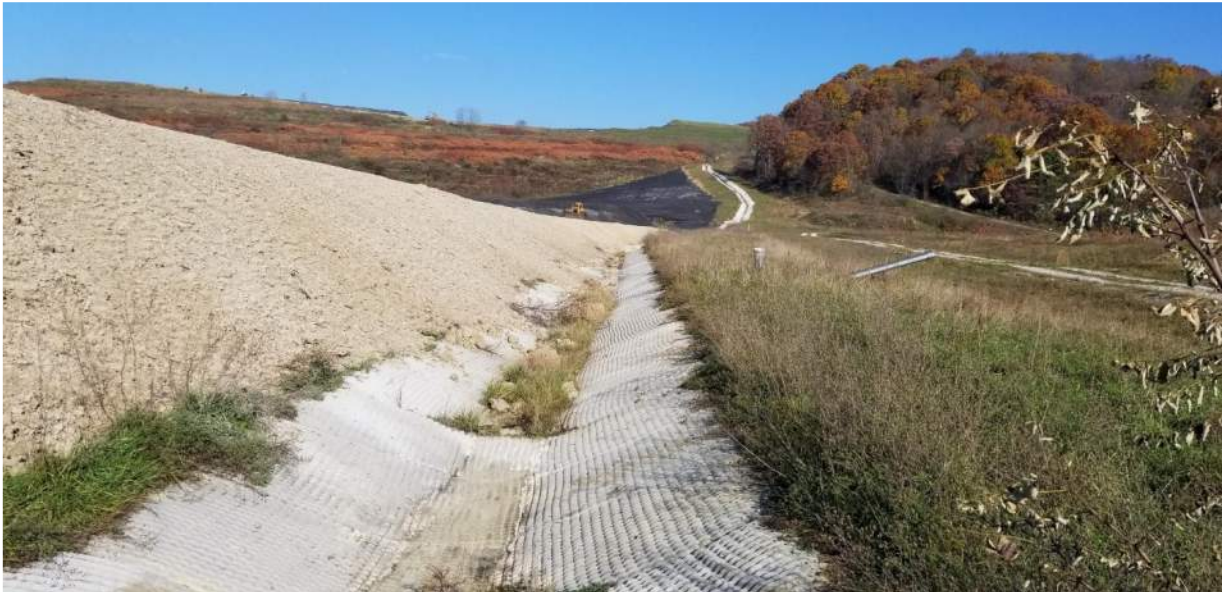
Photograph 7. Stage IIIA Collection Channel along first bench on east side of Stage IIIA; view northeast

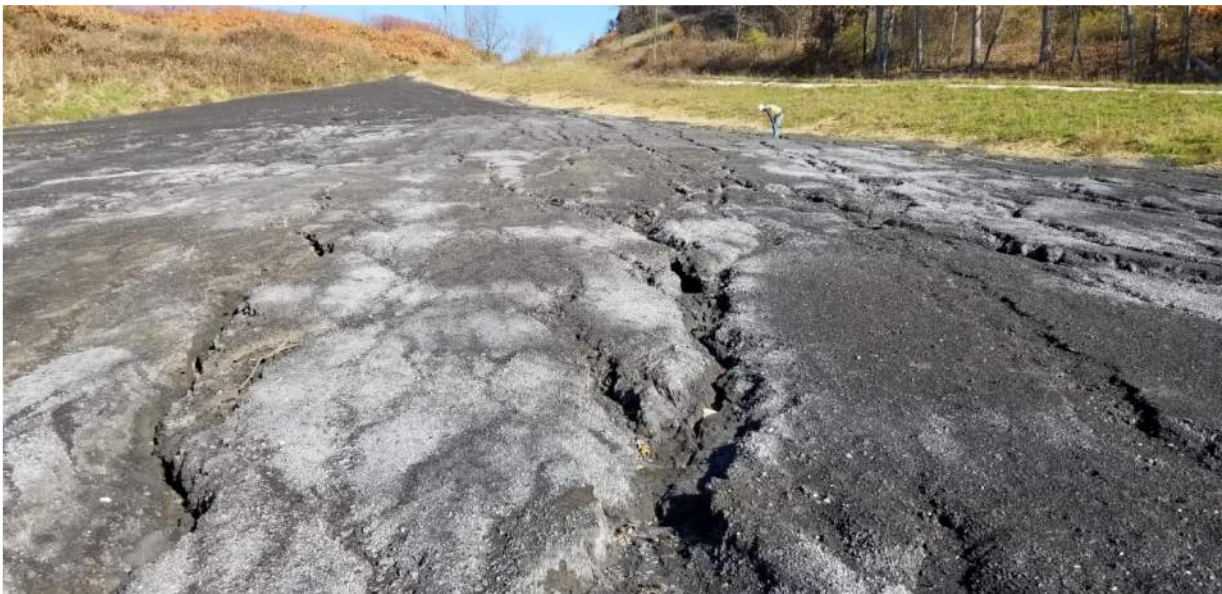
Photograph 8. Erosion rills to be repaired in the northeast corner of Stage IIIA

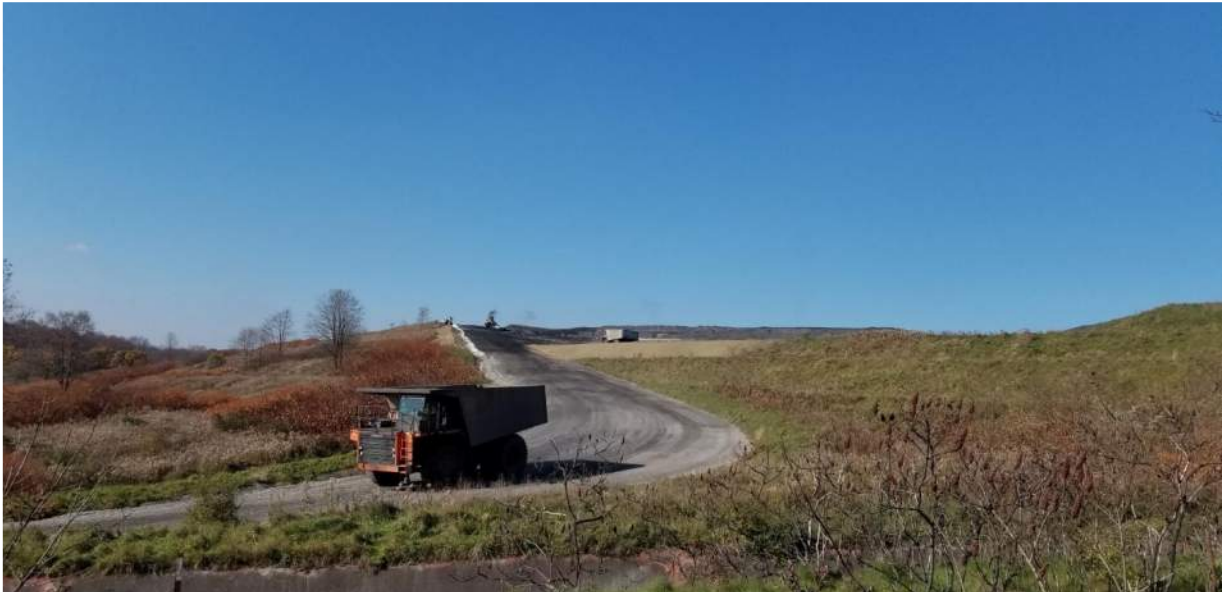
Photograph 9. Haul truck returning to the plant after disposal in southern Stage II; view west

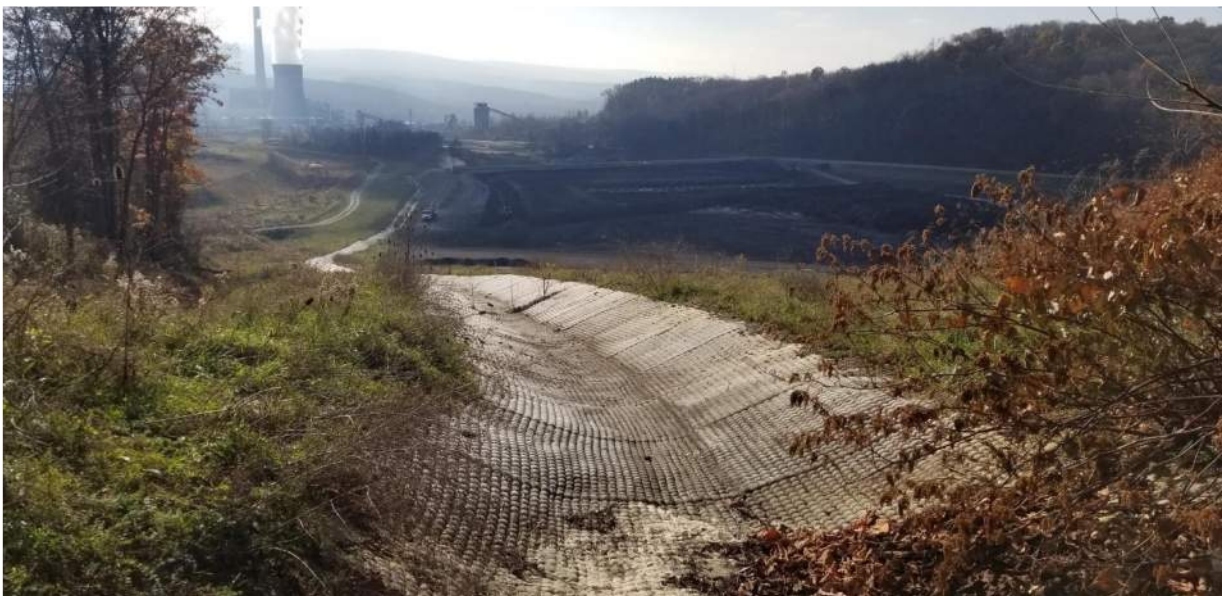
Photograph 10. East Side Collection Channel (foreground) and active Stage IIIA (background); view south

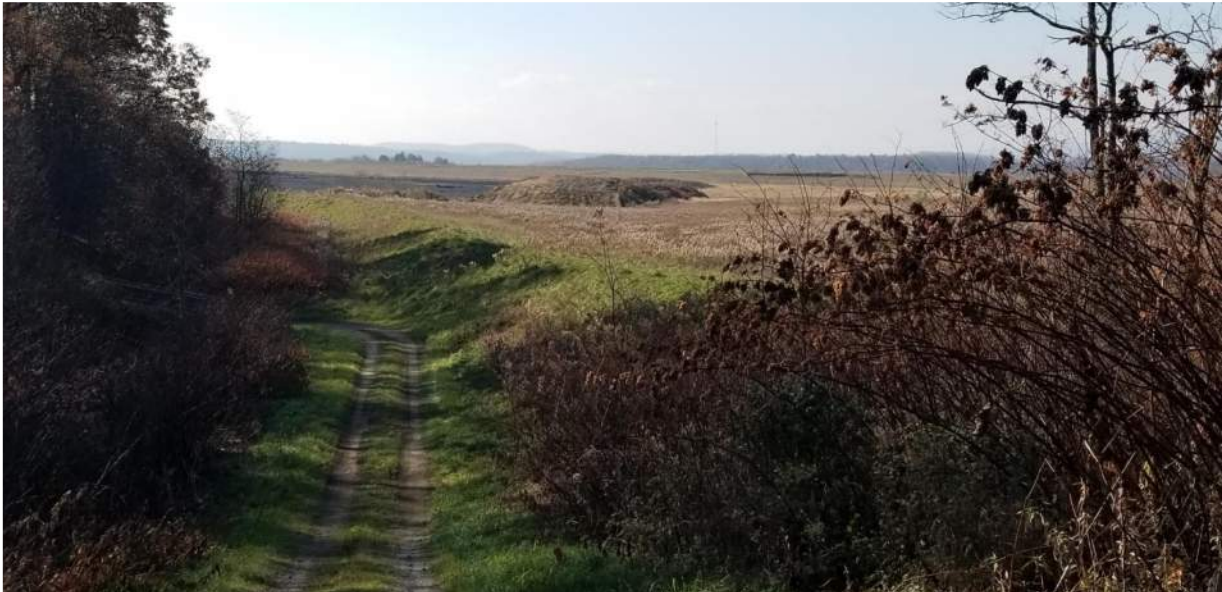
Photograph 11. The vegetated northeastern side of Stage II (foreground) and active Stage II in background; view southwest

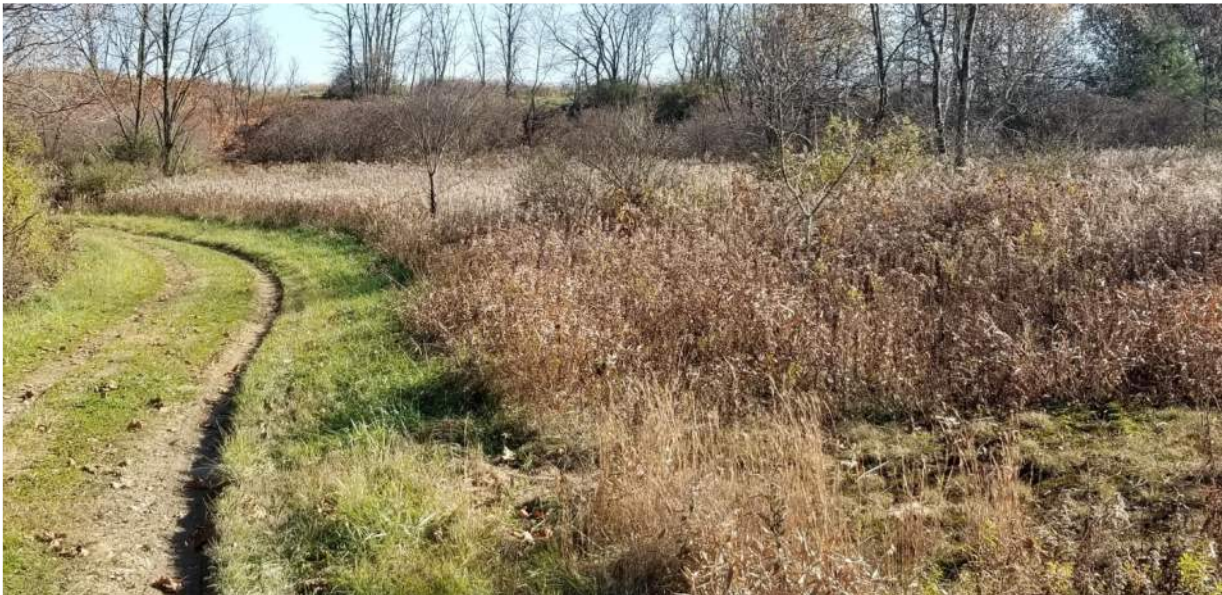
Photograph 12. Perimeter access road on the northern end of Stage I; view eastward

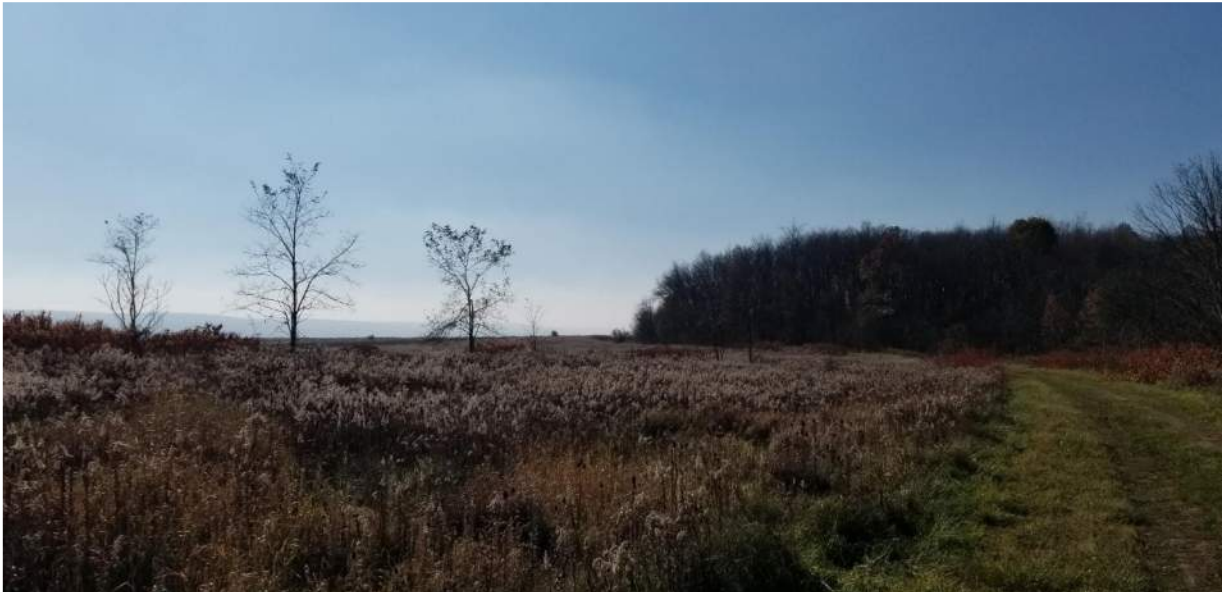
Photograph 13. Perimeter access road along the northern portion of Stage I; view southwest

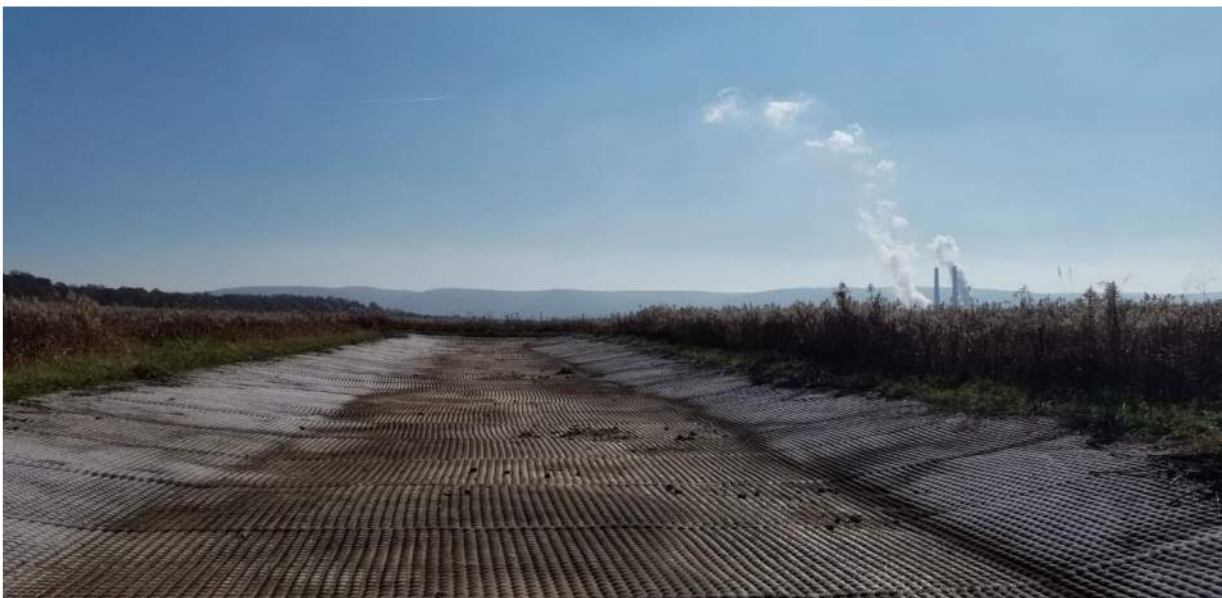
Photograph 14. Stage II northwest top surface drainage channel; view southeast

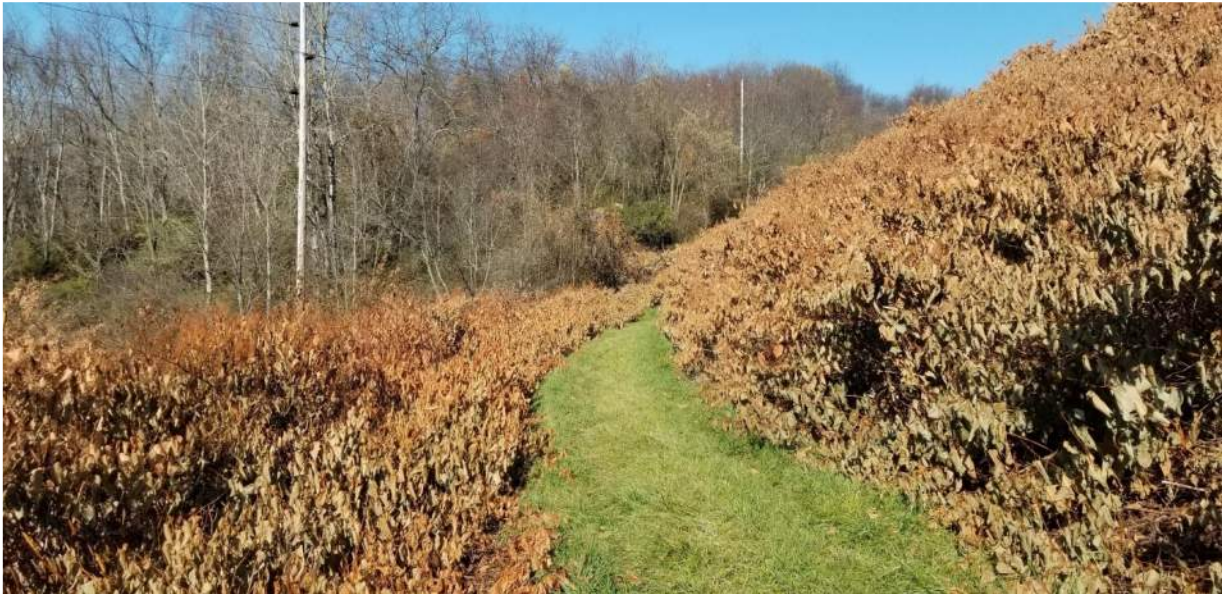
Photograph 15. Western benches of Stage II

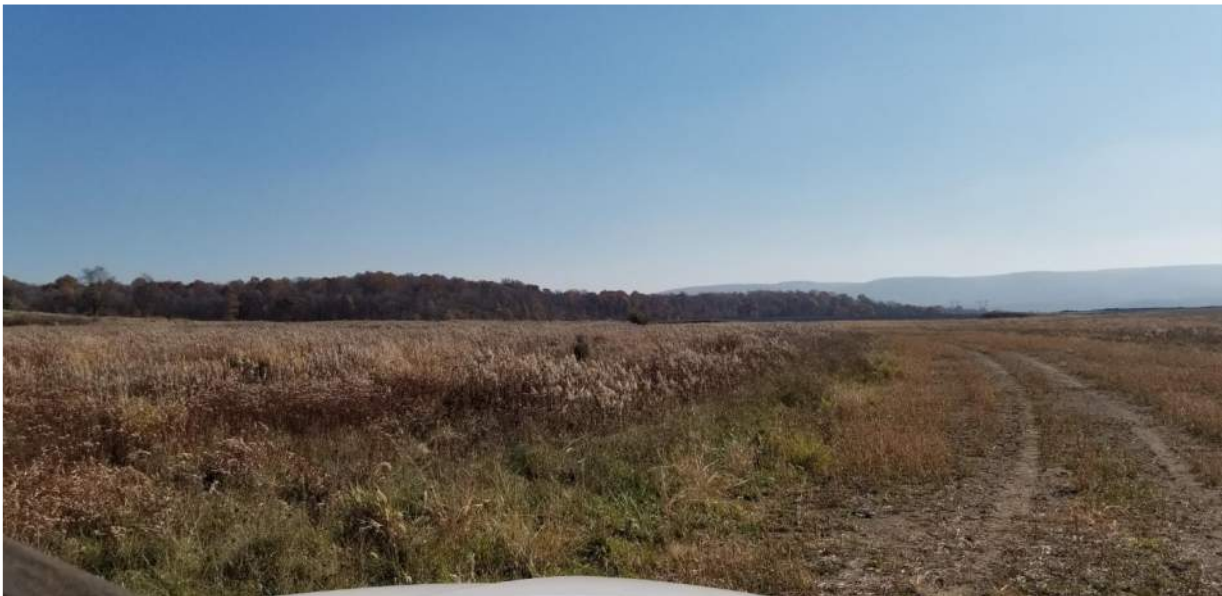
Photograph 16. Northwest portion of Stage II; view southeast
