Coal Combustion Residuals

Annual CCR Unit Inspection Report for Reporting Year 2022

Keystone-Conemaugh Projects, LLC
Conemaugh Ash/Refuse Disposal Site
Conemaugh Generating Station
New Florence, Pennsylvania

GAI Project Number: C151611.06, Task 003
January 2023

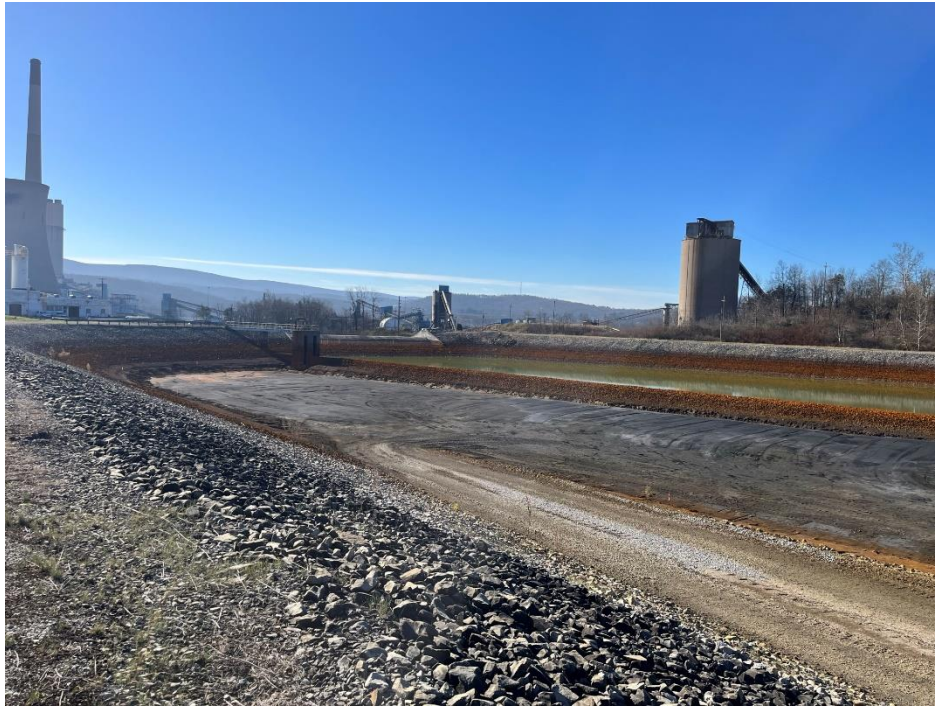
Photograph 1. Equalization Pond, immediately north of disposal site treatment plant; view southeast.

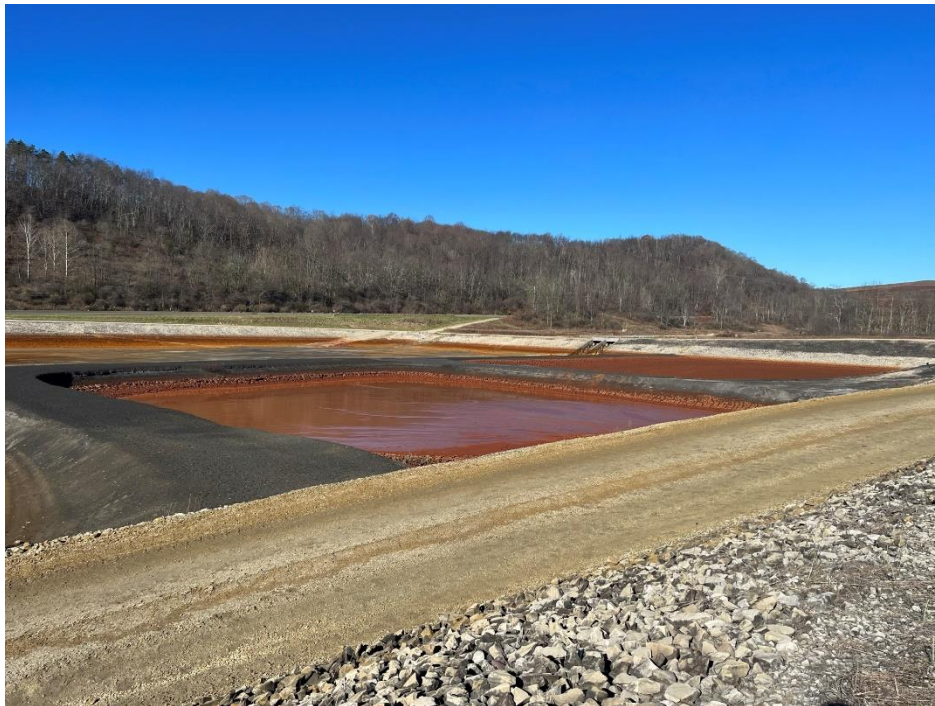
Photograph 2. Disposal Site Surge Pond; view northwest.

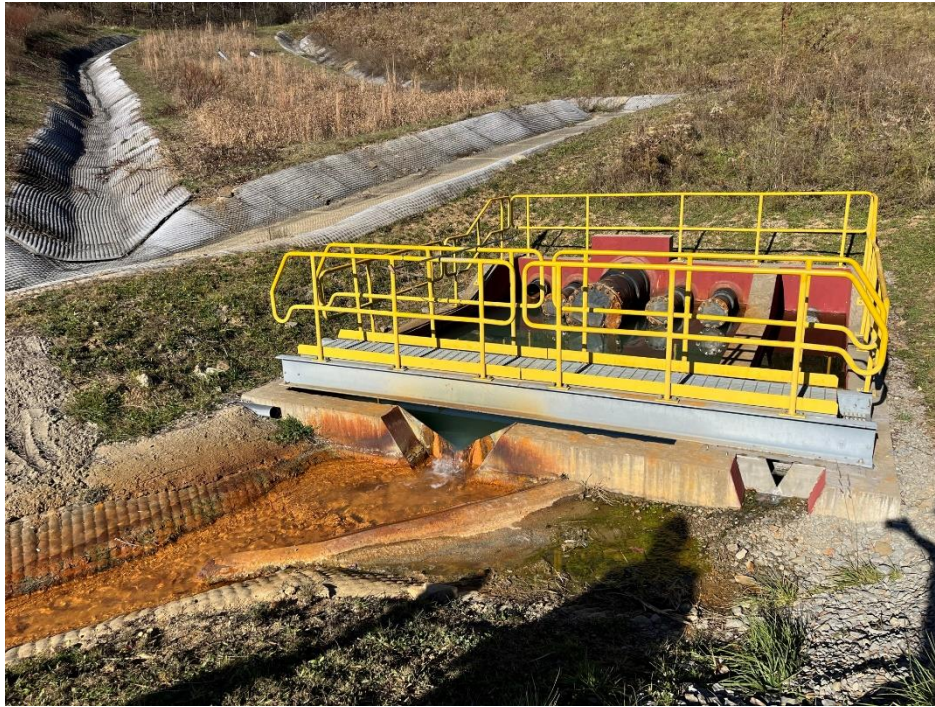
Photograph 3. Stage IIIA Stilling Basin, Leachate collection piping and v-notch weir (left), Leak detection pipe and v-notch weir (right).

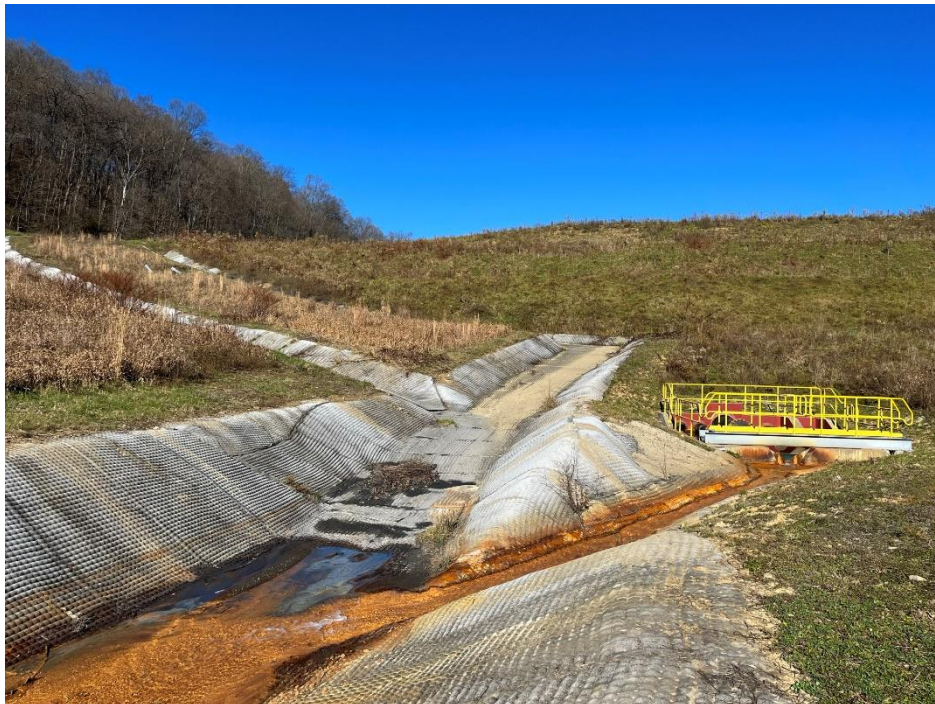
Photograph 4. Stage IIIA toe collection channels and leachate and leak detection flows from stilling basin (right); view north.

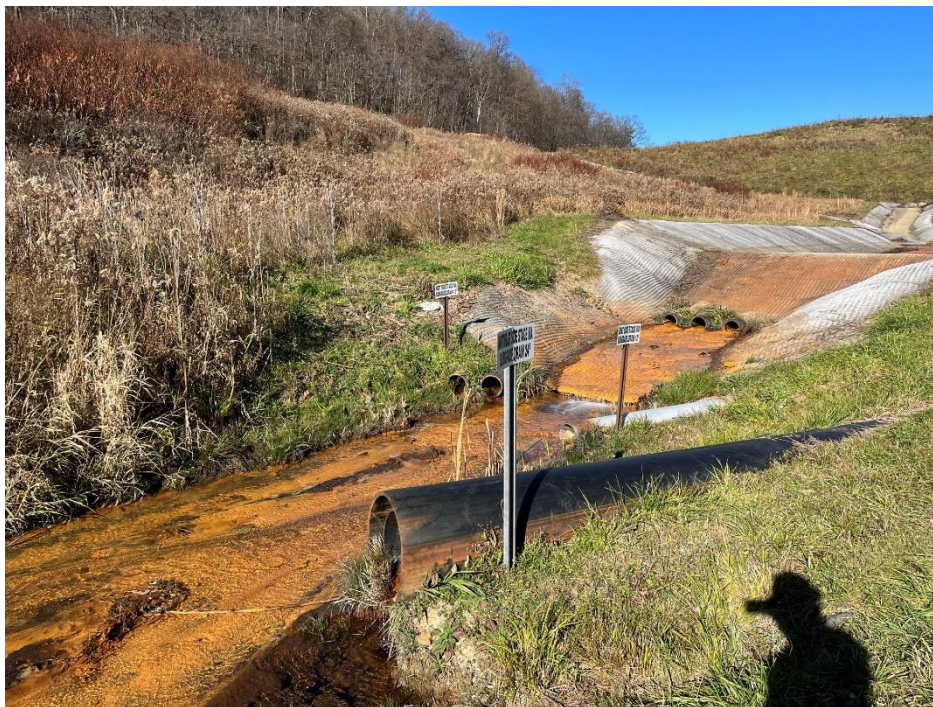
Photograph 5. Stage IIIA toe collection channel and flows from subgrade drainpipes (with signs) from Stages II/III; view westward.

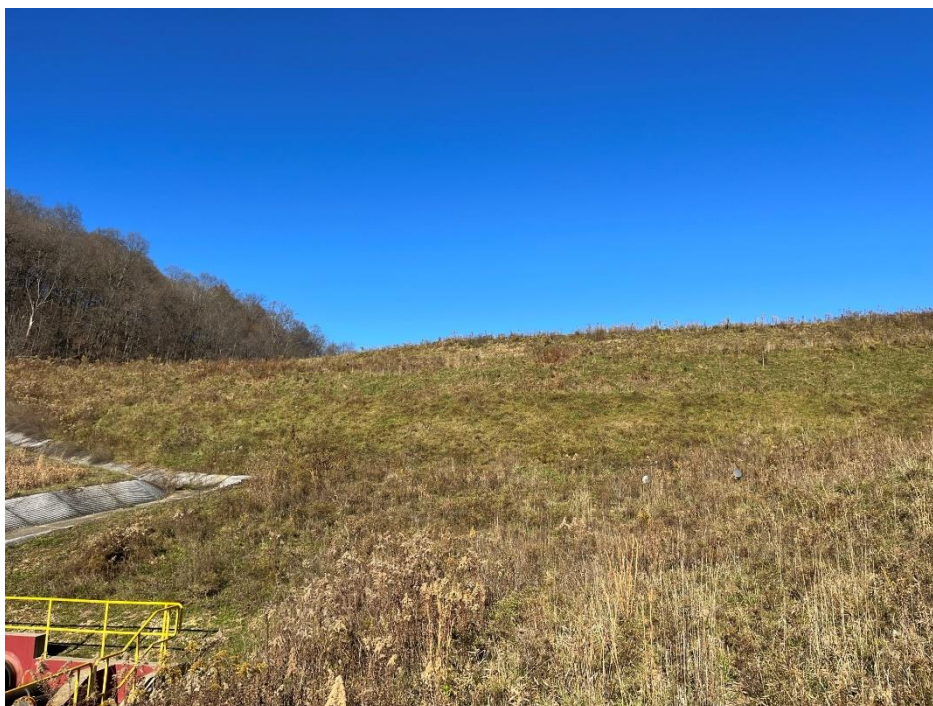
Photograph 6. Stage IIIA slope of southern facing benches; view north.

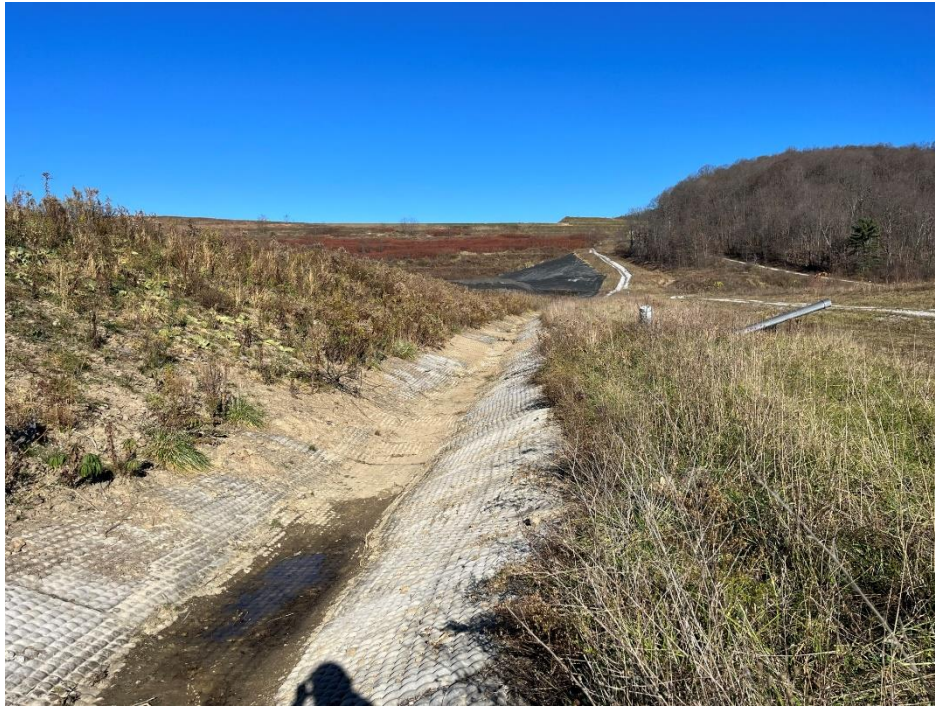
Photograph 7. Stage IIIA Collection Channel along first bench on east side of Stage IIIA; view northeast.

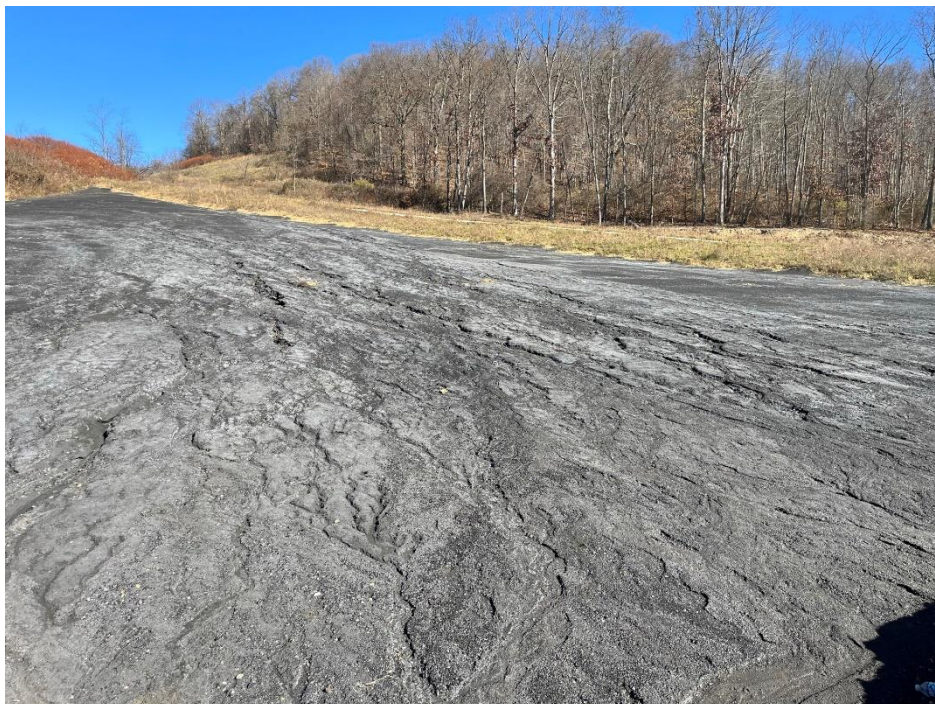
Photograph 8. Erosion rills to be monitored and repaired as necessary in the northeast corner of Stage IIIA.

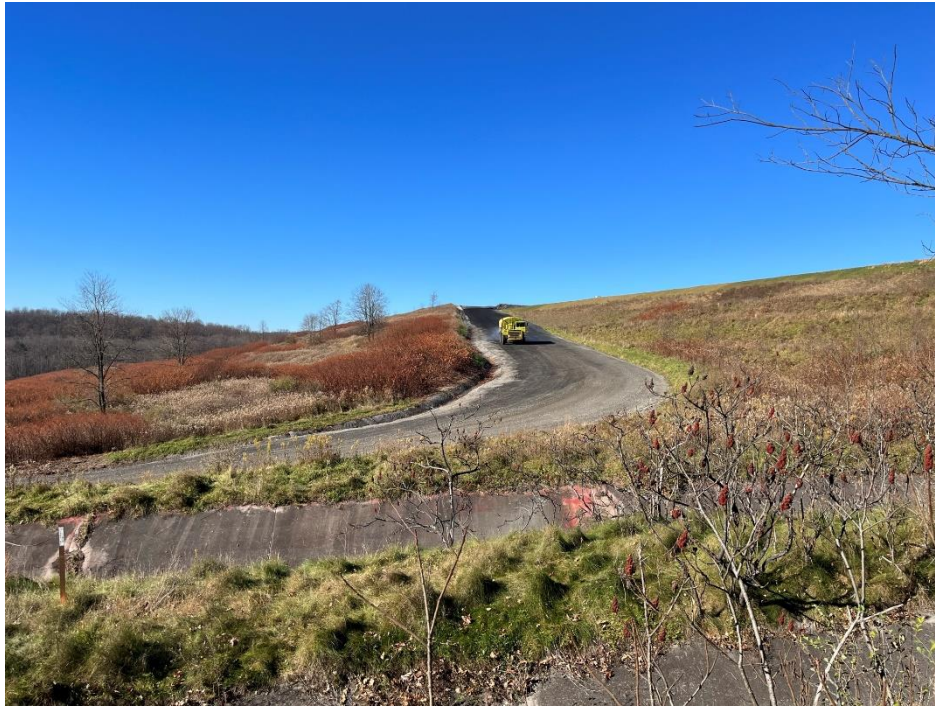
Photograph 9. Water truck, providing dust control on haul road to Stage II; view west.

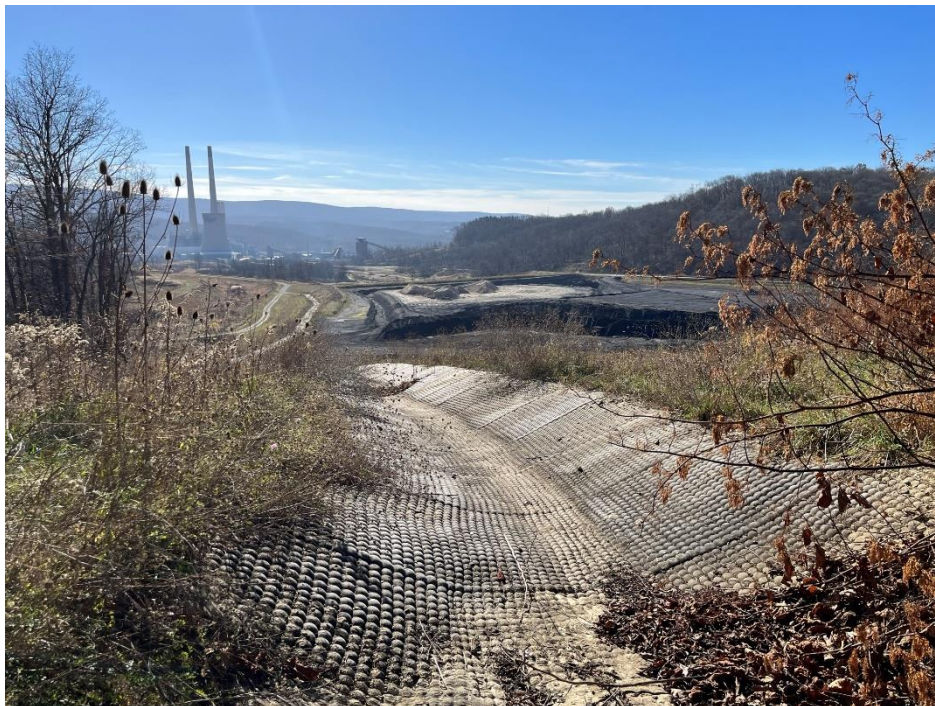
Photograph 10. East Side Collection Channel (foreground) and active Stage IIIA (background); view south.

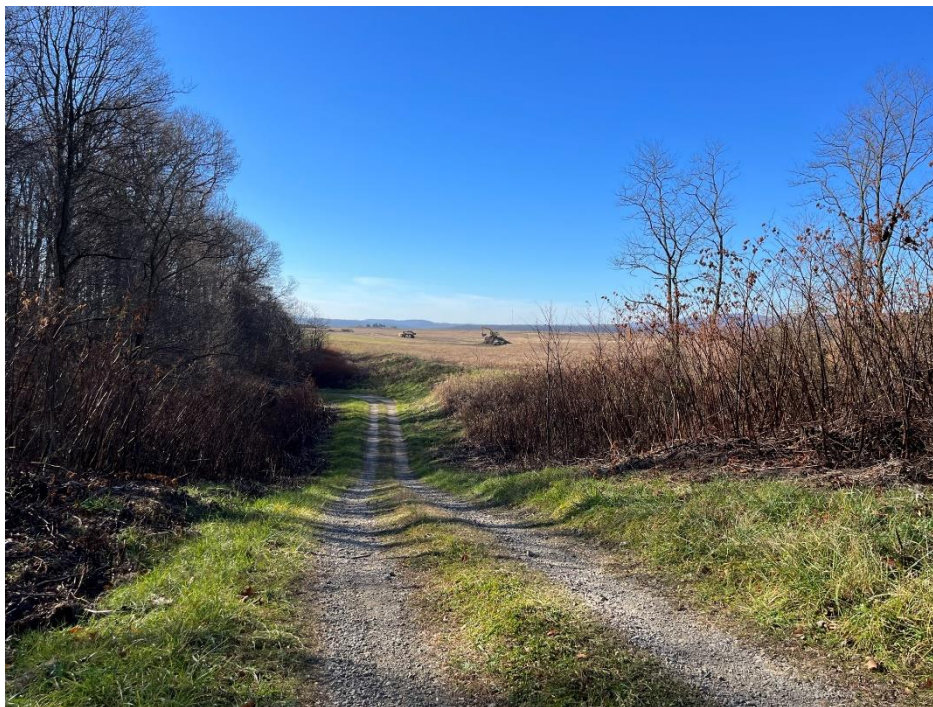
Photograph 11. The vegetated northeastern side of Stage II (foreground) and active Stage II in background; view southwest.

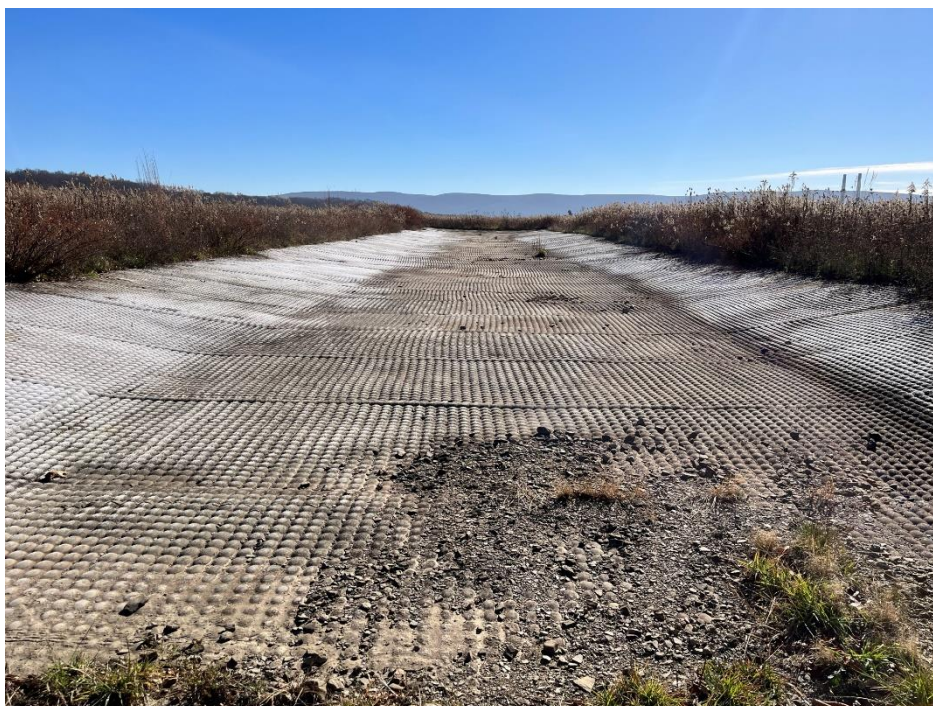
Photograph 12. Stage II northwest top surface drainage channel; view southeast.

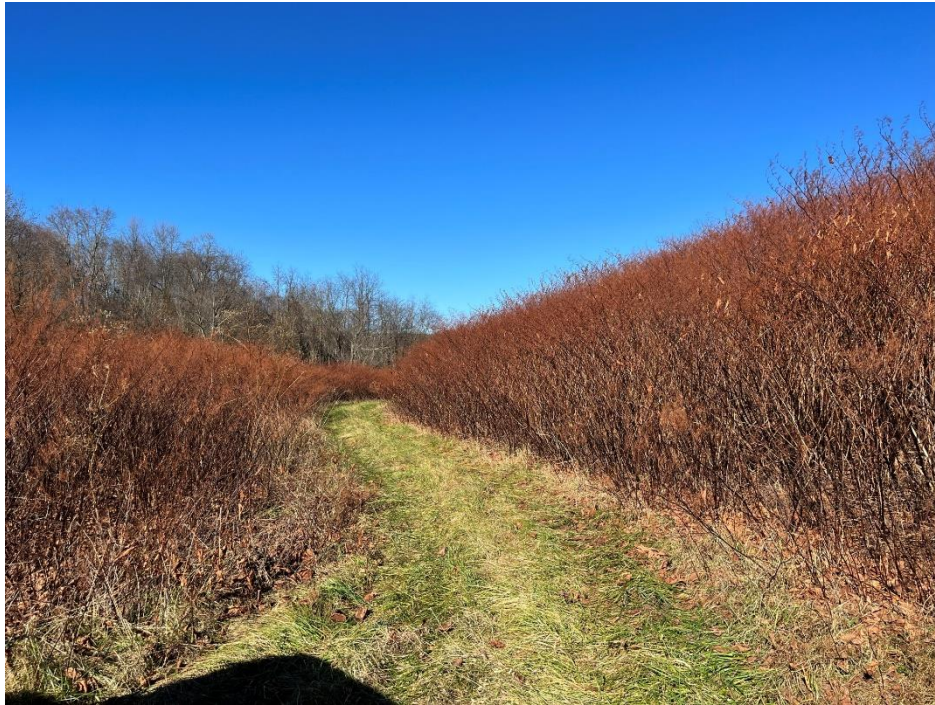
Photograph 13. Western benches of Stage II.

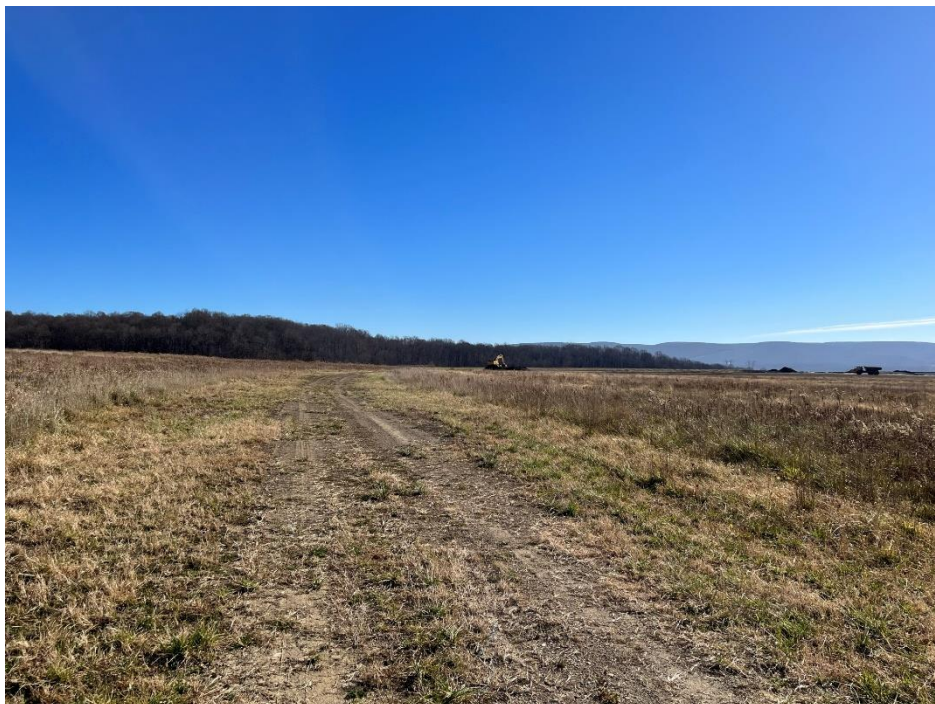
Photograph 14. Northwest portion of Stage II; view southeast.

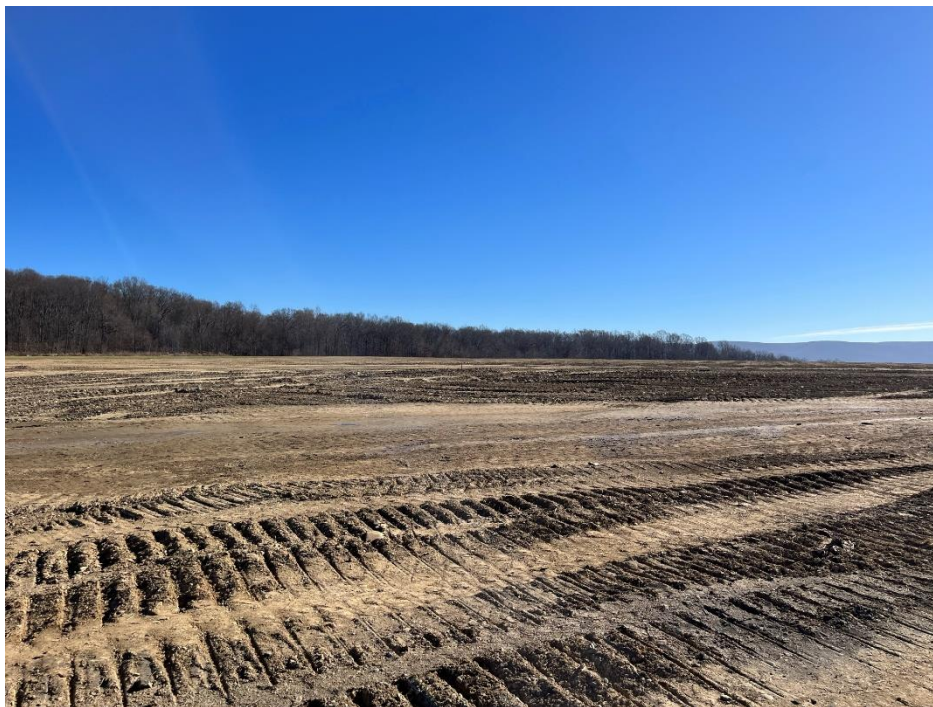
Photograph 15. The northern-most top area of Stage II, intermediate cover placement; view east.

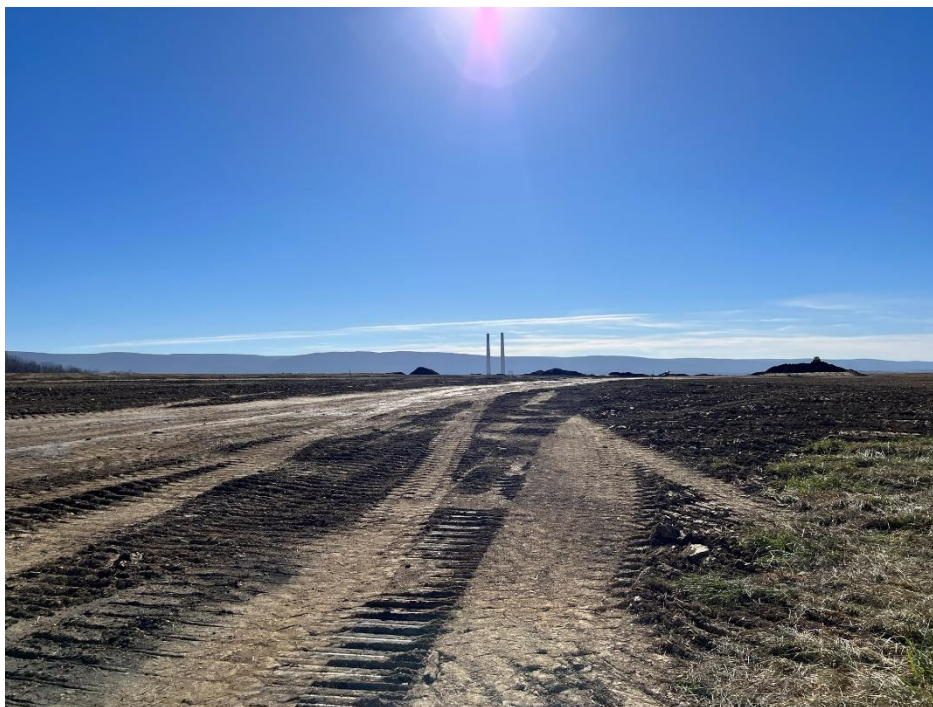
Photograph 16. Recent disposal of fly ash in the active southern portion of Stage II; view south.

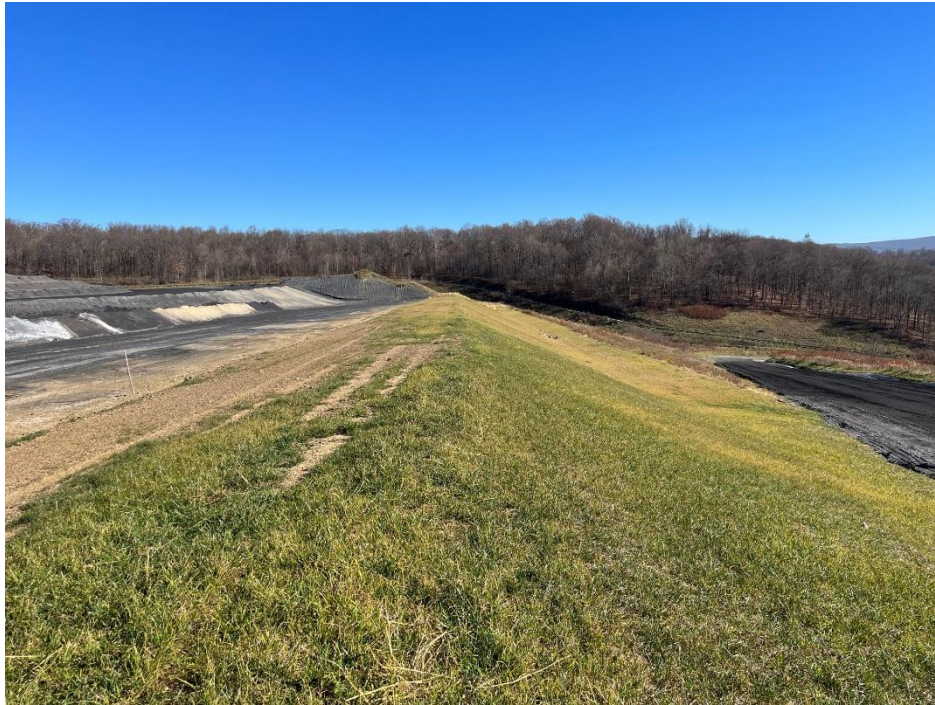
Photograph 17. Southern benches of Stage II, view east.

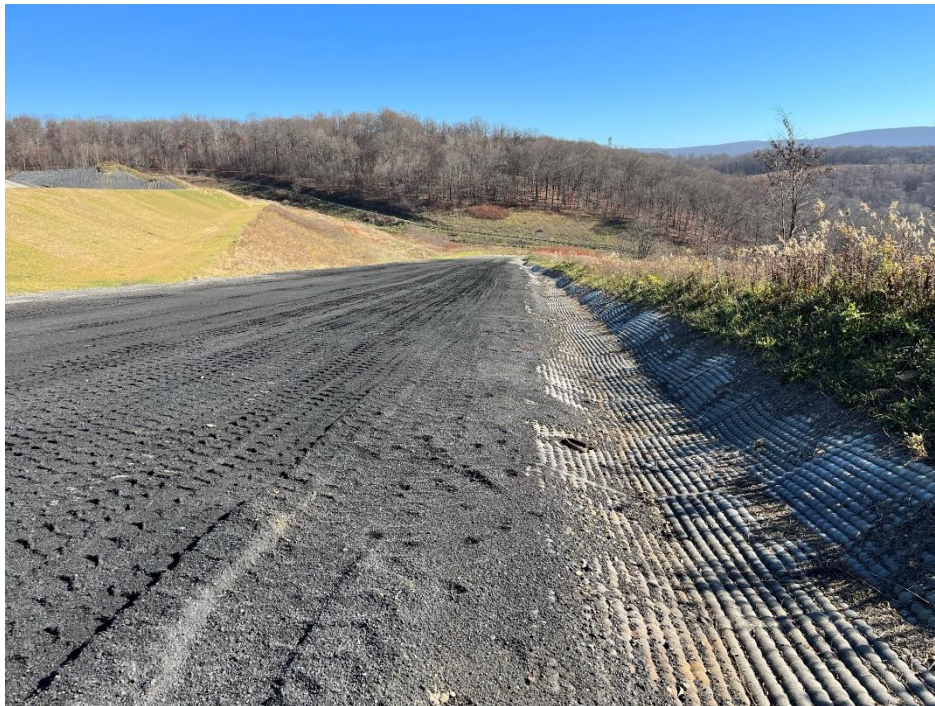
Photograph 18. Stage II active disposal area (left), haul road (center), and haul road drainage channel (right); view east.

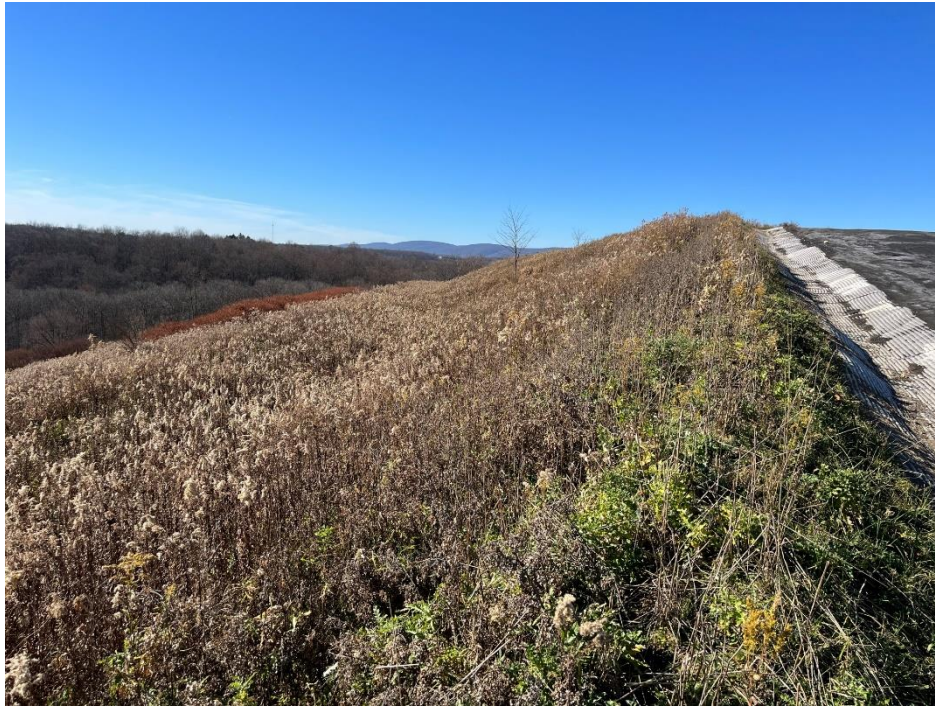
Photograph 19. Southern slope benches of Stage II; view west.

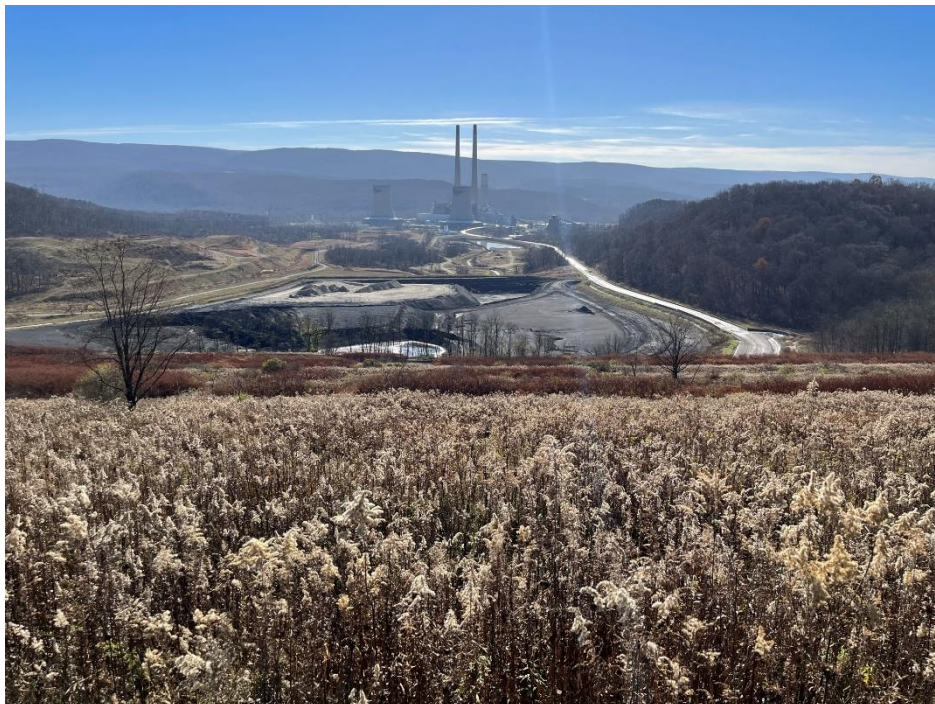
Photograph 20. Stage II southern benches (foreground) and active Stage IIIA (background); view south.

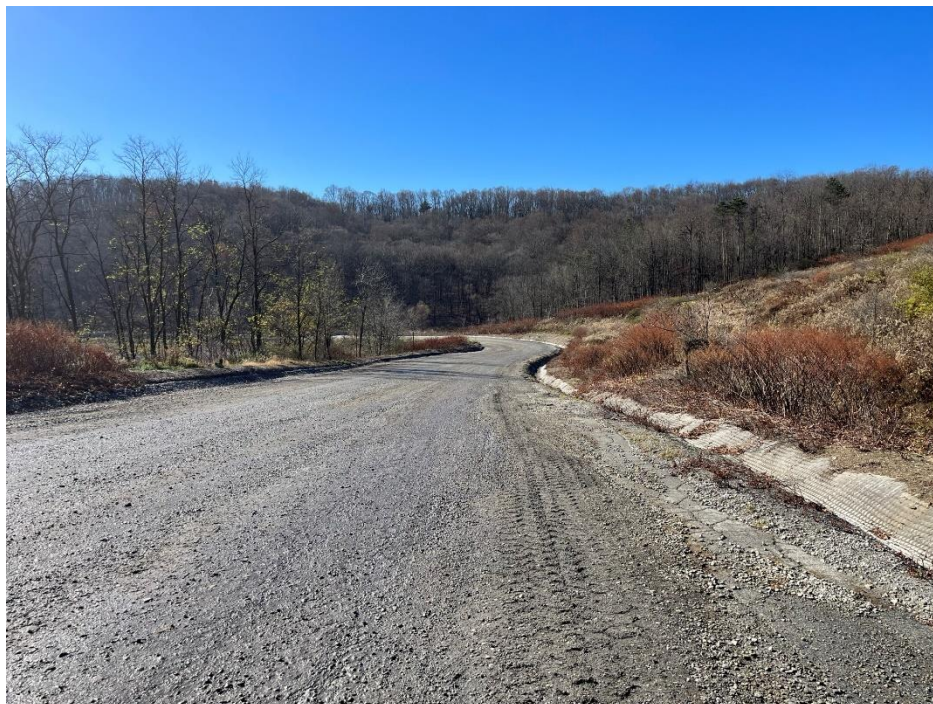
Photograph 21. Haul road with Stage II benches (right); view west.

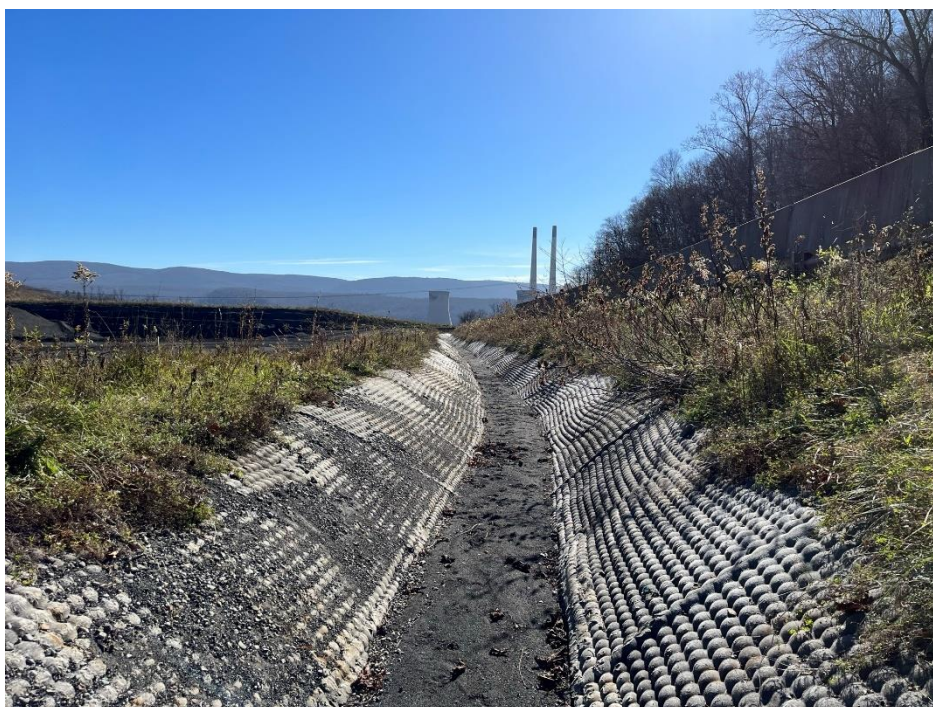
Photograph 22. Haul road collection channel, view south. In the photo, Stage IIIA is to the left (east) and the paved haul road is to the right (west).

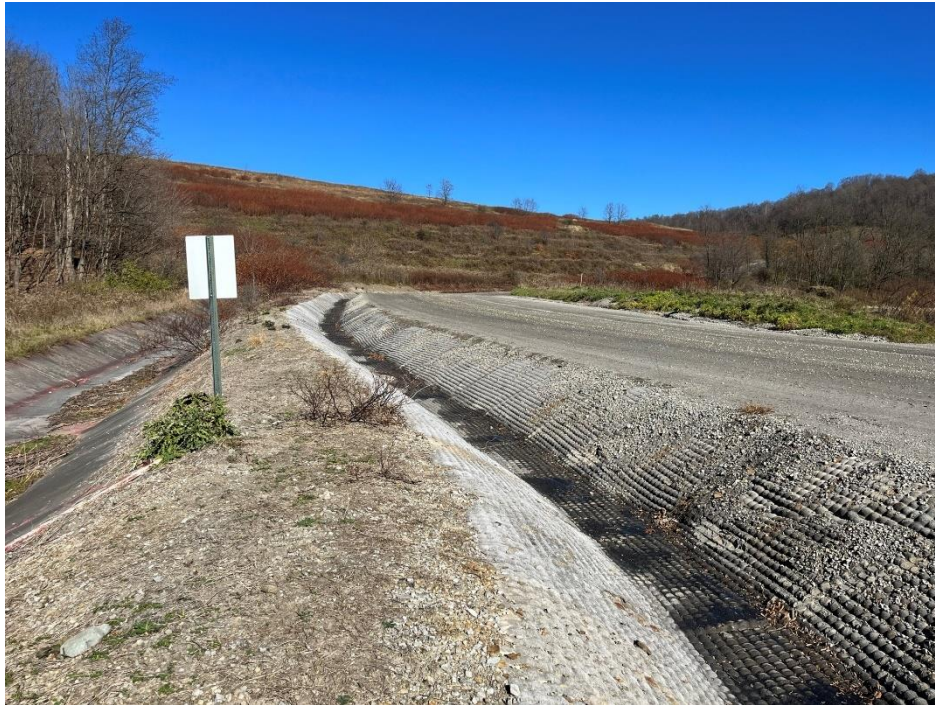
Photograph 23. Channels and revetment along the Stage II haul road; view northeast.

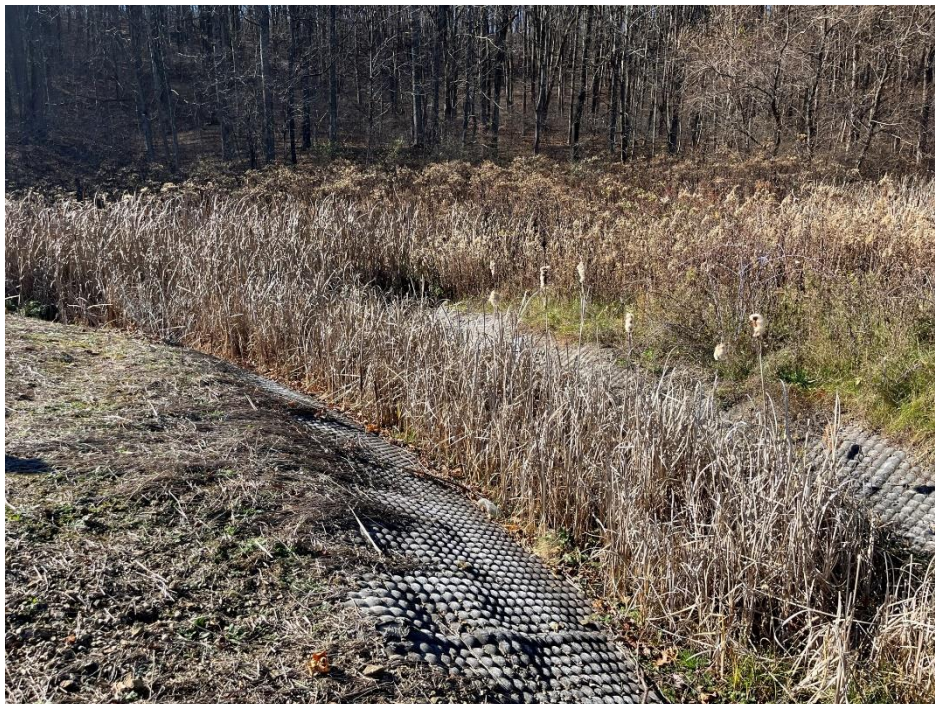
Stage II and IIIA disposal area stormwater channels, leachate collection, and intermediate cover areas (Stage II only) are functioning as intended. During the annual inspection, the West Diversion Channel adjacent to Stage IIIA, was found in need of maintenance, due to build-up of sediment within the channel in which vegetation had established. Following the inspection West Diversion Channel was cleaned out and maintained. With no evidence to the contrary, the bottom liner systems for the Stage II and IIIA disposal areas are believed to be in good operating condition and functioning as intended.

Photograph 24. West Diversion Channel, adjacent to Stage IIIA, along the Stage II haul road, to be cleaned of sediment build up; view south.

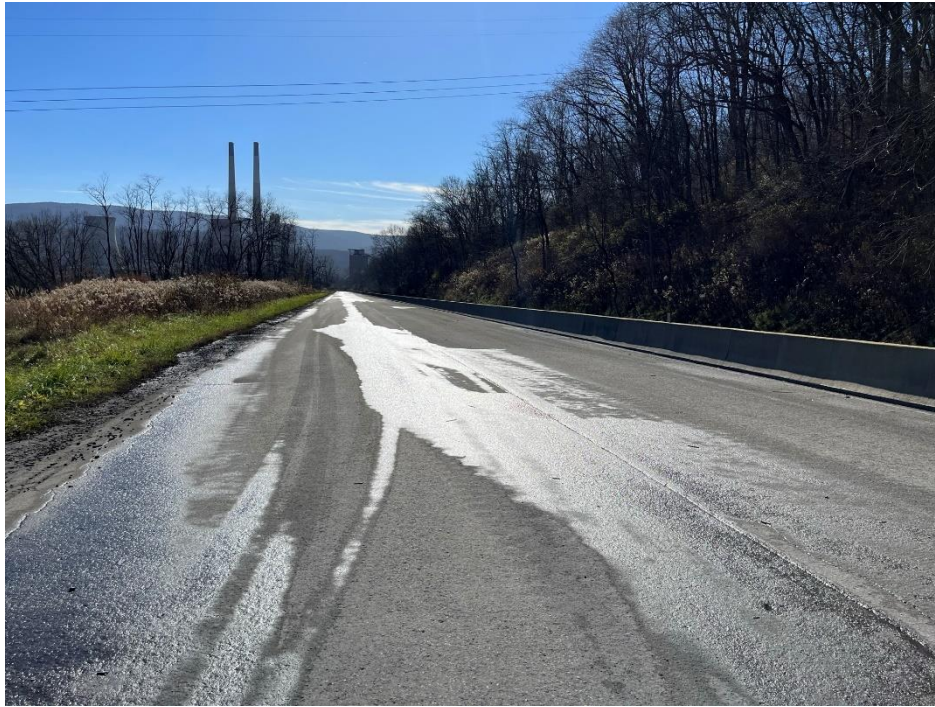
Photograph 25. Haul road south of Stage IIIA ; view south.

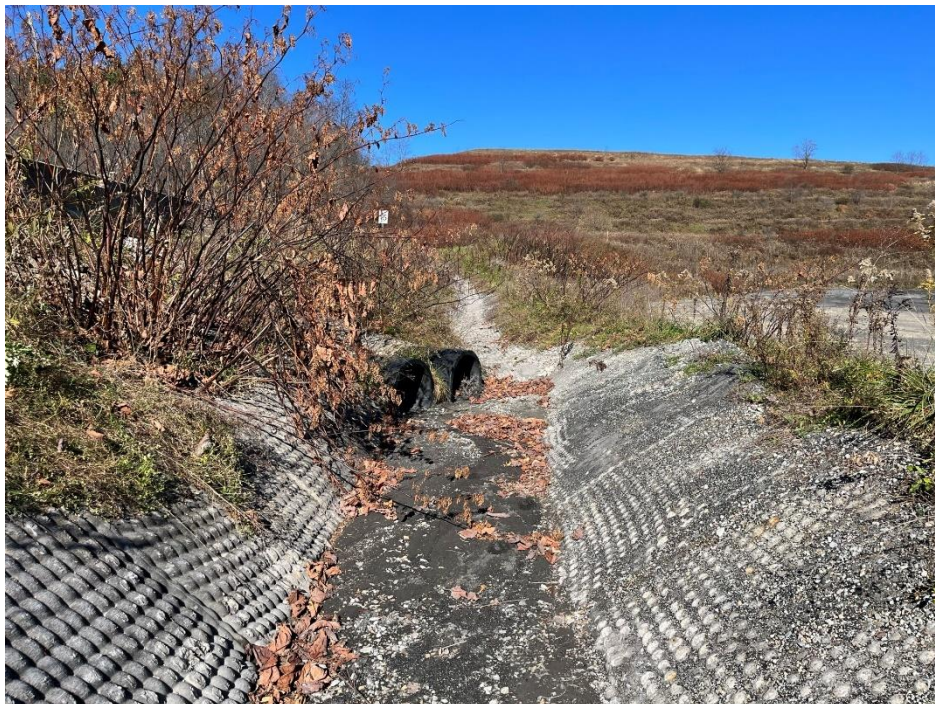
**Photograph 26. Haul road collection channel and culvert to be cleaned of sediment build up;
view north.**
