Coal Combustion Residuals Annual CCR Unit Inspection Report for Reporting Year 2022

Keystone-Conemaugh Projects, LLC
Keystone Station Ash Disposal Site
Keystone Generating Station
Shelocta, Pennsylvania

GAI Project Number: C151611.07, Task 003
January 2023

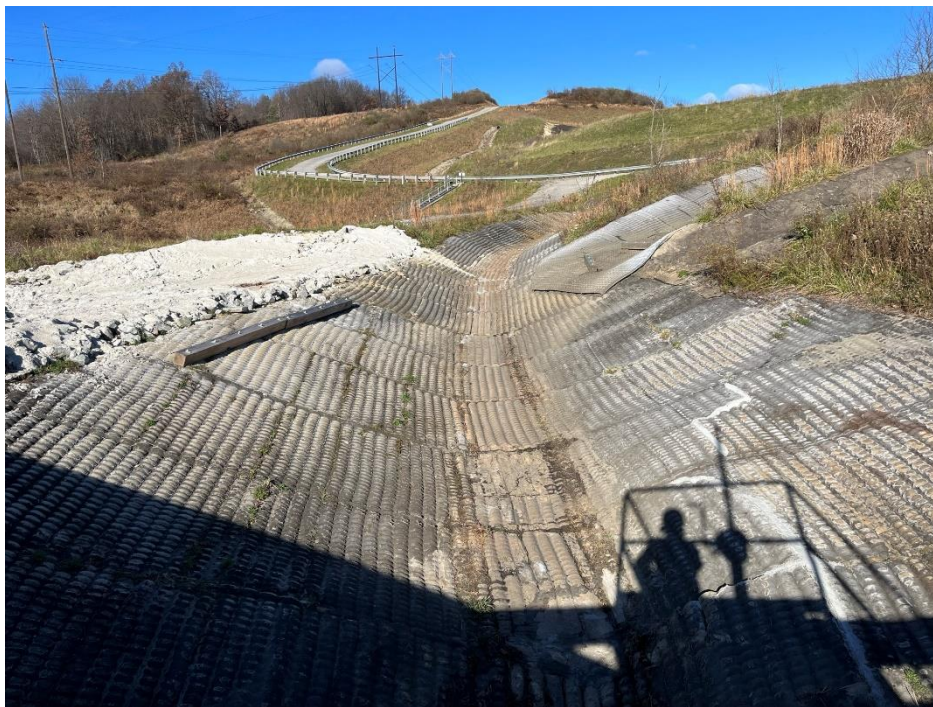
Photograph 1. Stage IV collection channel to West Valley Equalization Pond and Stage IV toe in background, view north.

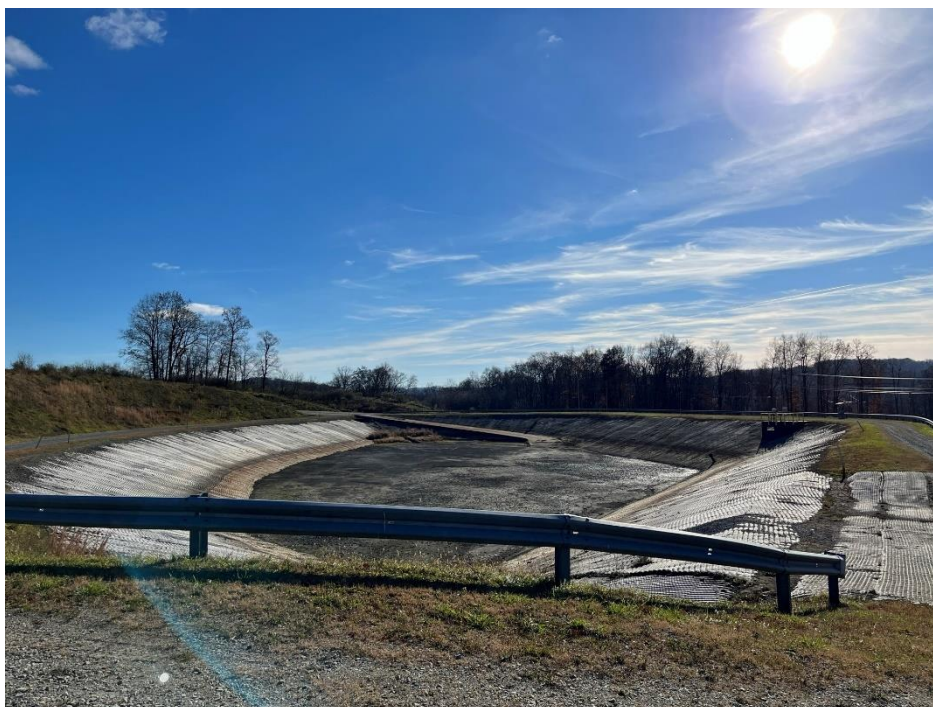
Photograph 2. West Valley Equalization Pond, view southwest.

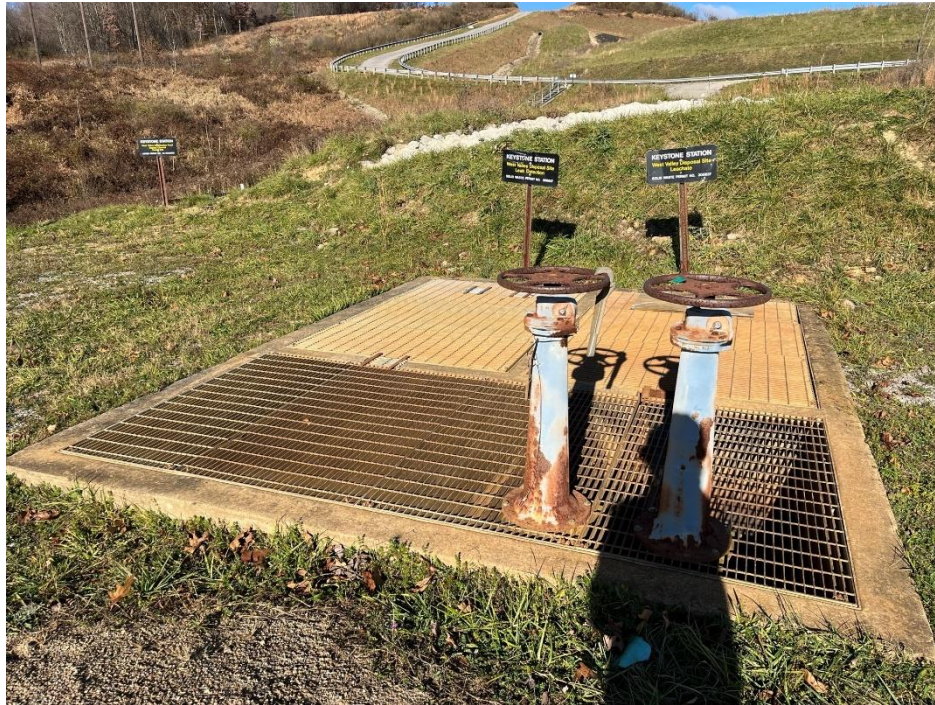
Photograph 3. West Valley Leak Detection and Leachate Collection Box.

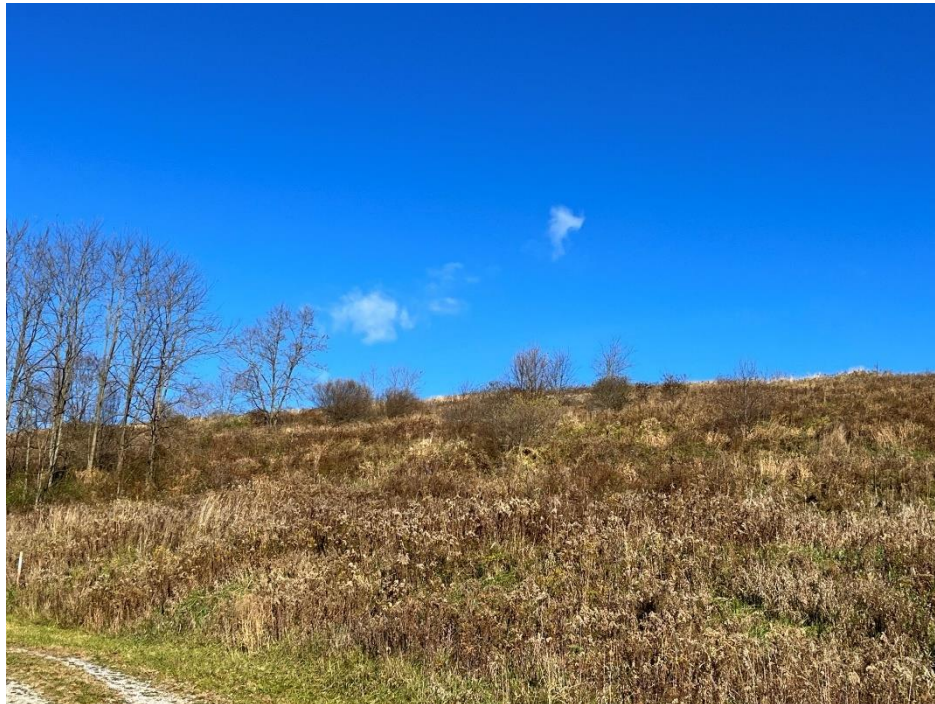
Photograph 4. Northwest view of the East Valley south facing benches.

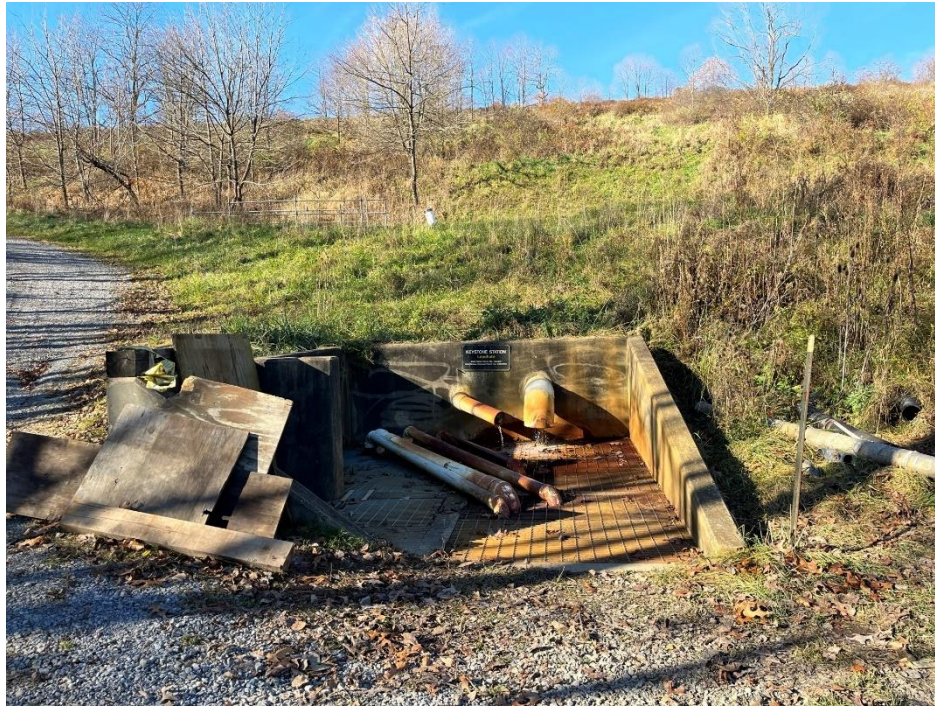
Photograph 5. East Valley Leachate Collection Box, view west.

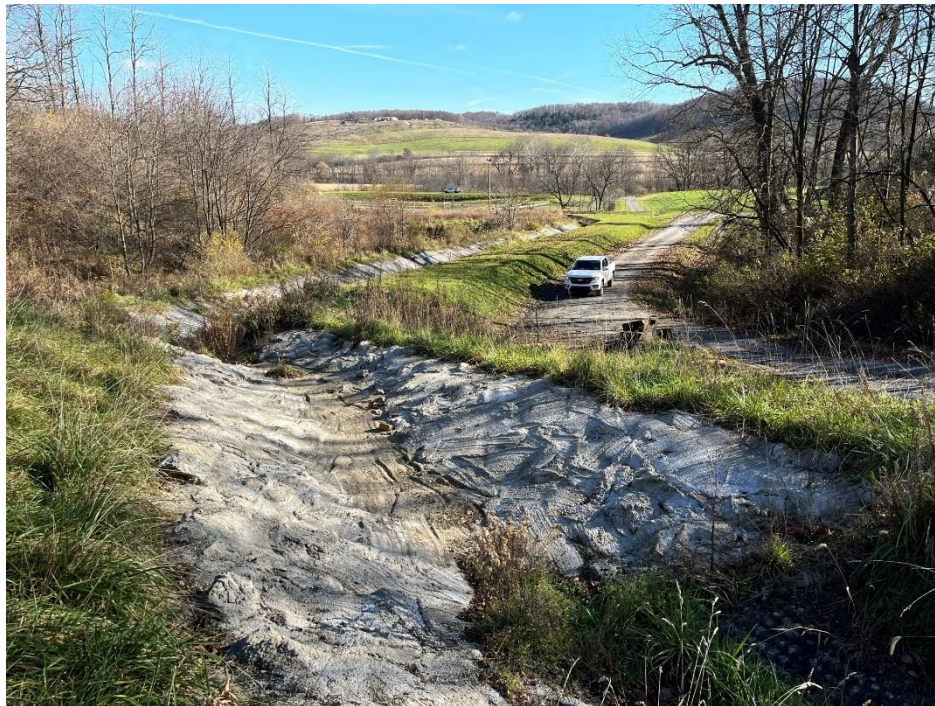
Photograph 6. East Valley Collection Channel at toe area, view east.

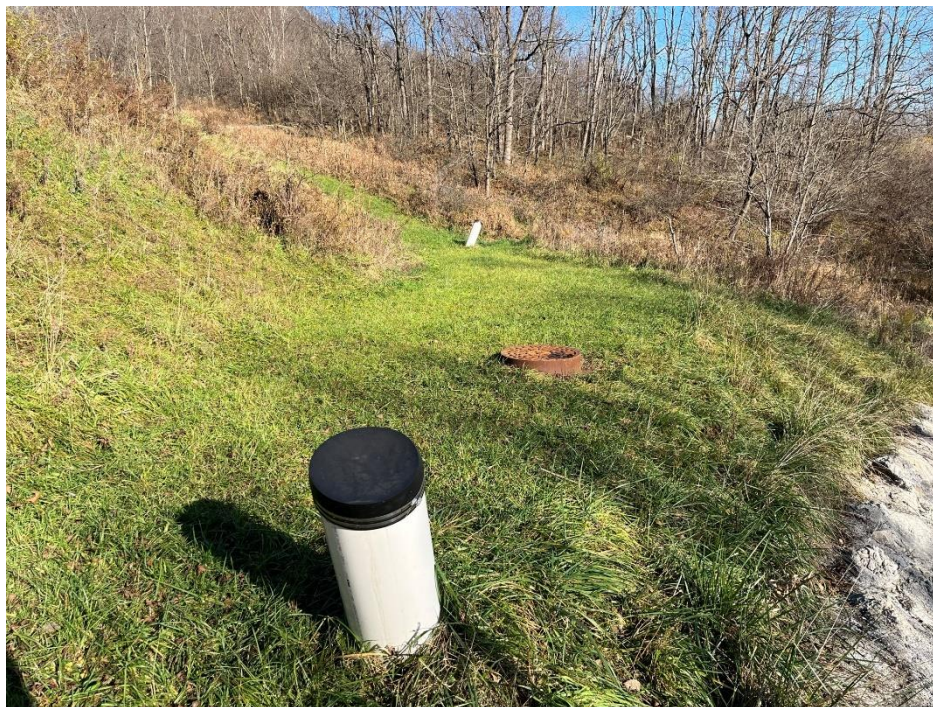
As noted above, a previous leachate seep was observed at the toe of East Valley in March 2019. The leachate seep has since been mitigated. No signs of geotechnical distress or environmental impact were observed at the former seep location at the time of the 2022 inspection. No visual signs of distress or malfunction were observed elsewhere at East Valley or West Valley during the inspection. Stormwater drainage features, slope appearance and stability, leachate conveyance mechanisms, and overall site conditions were assessed. Closed and intermediate cover areas of East Valley and West Valley exhibited well established vegetation.

Based on a review of inspection records and discussions with site personnel, GAI concludes that monitoring of the 2019 seep, including leachate elevations, was appropriately completed as recommended. The seep has been resolved with no further action required, other than ongoing monitoring.

Photograph 7. View of East Valley Toe Bench and Leachate Seep Collection Pipes and Cleanouts added in 2019, view north.

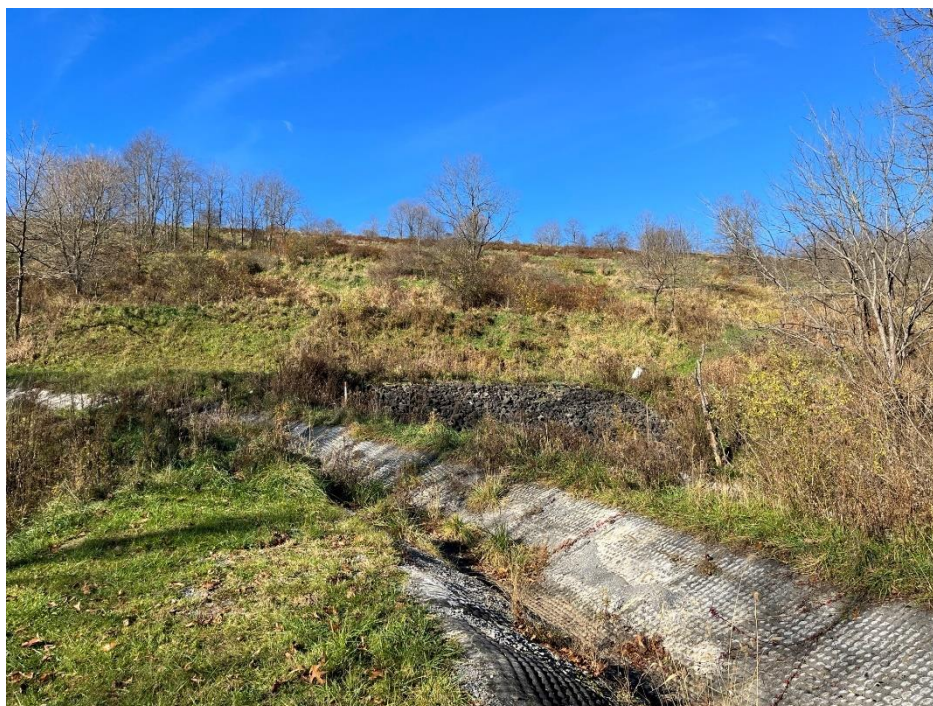
Photograph 8. East Valley Toe and east facing benches, view west.

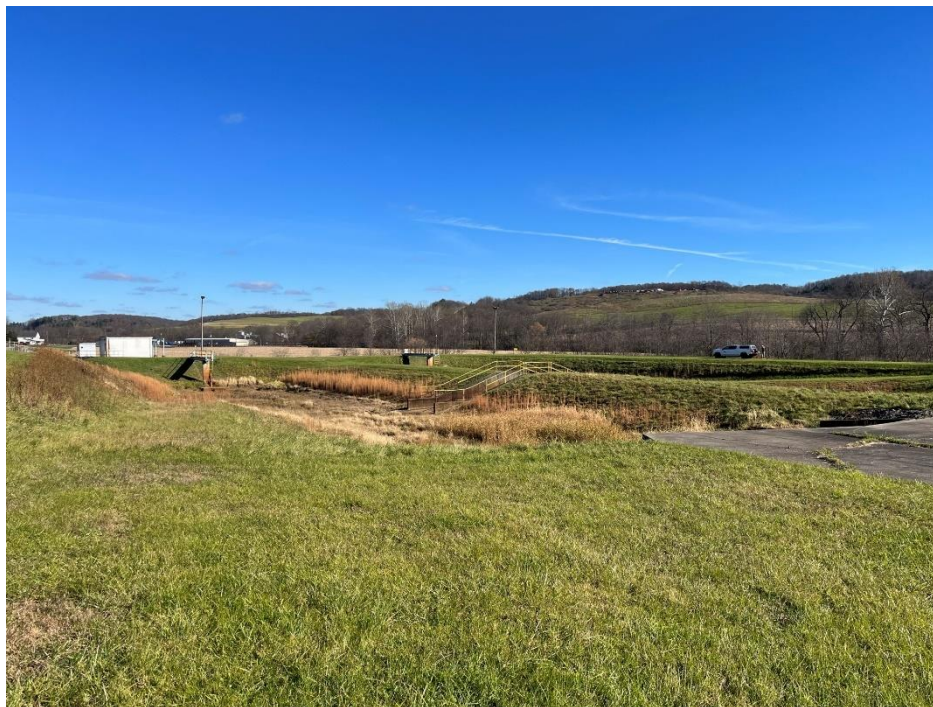
Photograph 9. View north of idled East Valley Equalization Ponds.

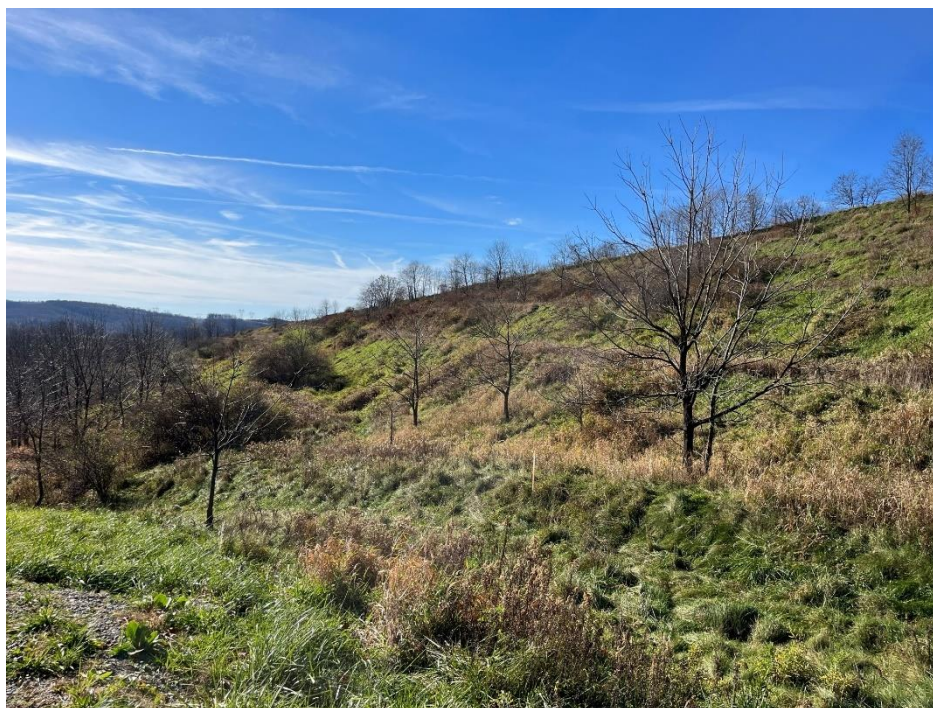
Photograph 10. East Valley east facing benches, view south.

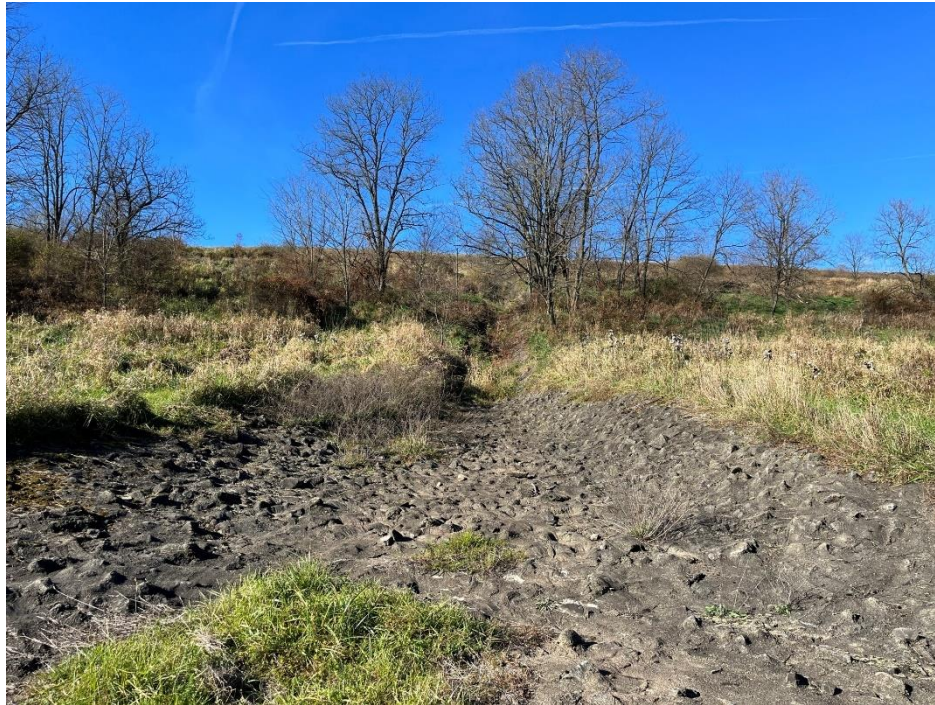
Photograph 11. East Valley collection channel, view west.

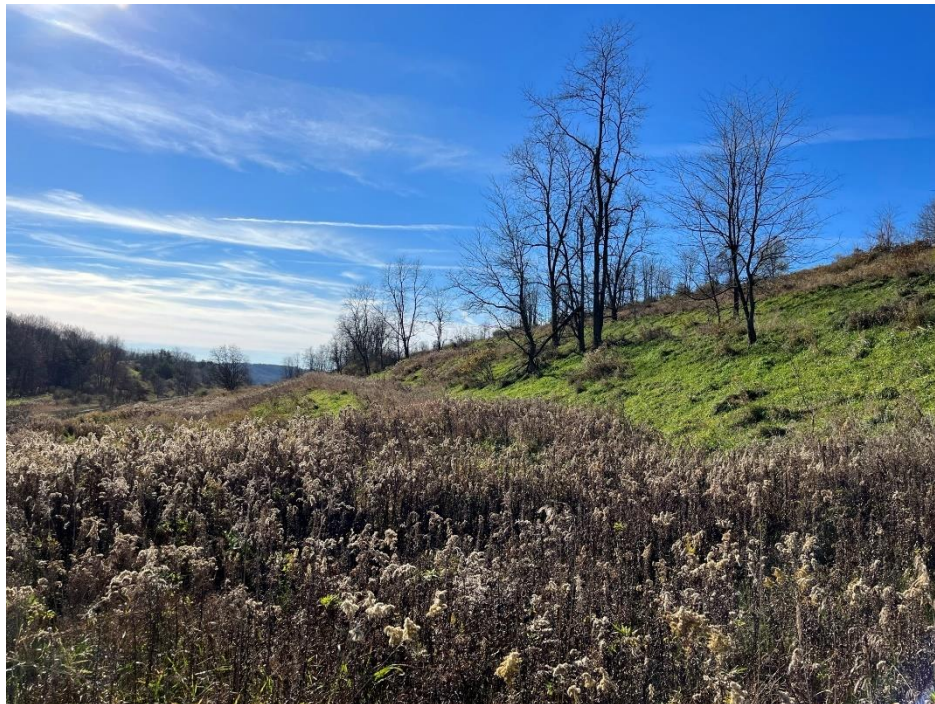
Photograph 12. East Valley east facing benches, view south.

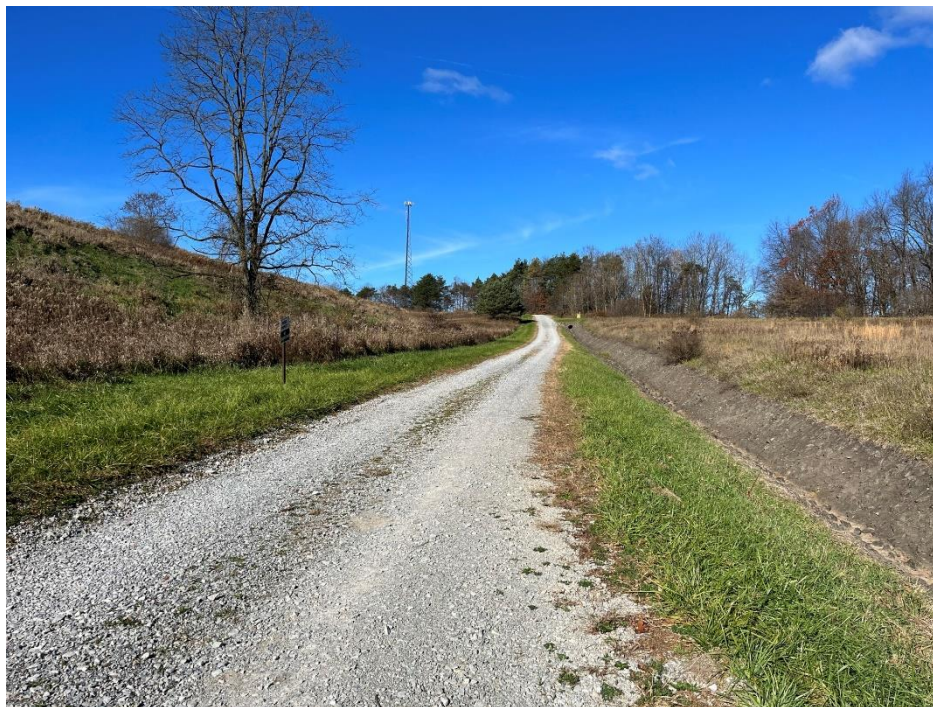
Photograph 13. East Valley east facing benches and Stage I/II collection channel, view north.

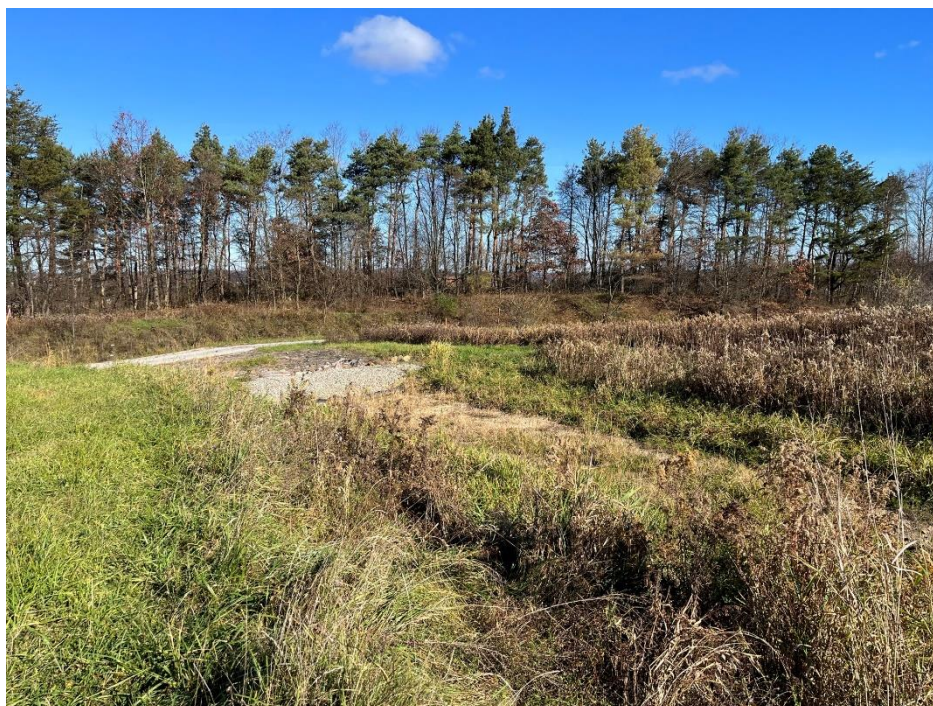
Photograph 14. Stage I/II revegetated top surface drainage swale, north end.

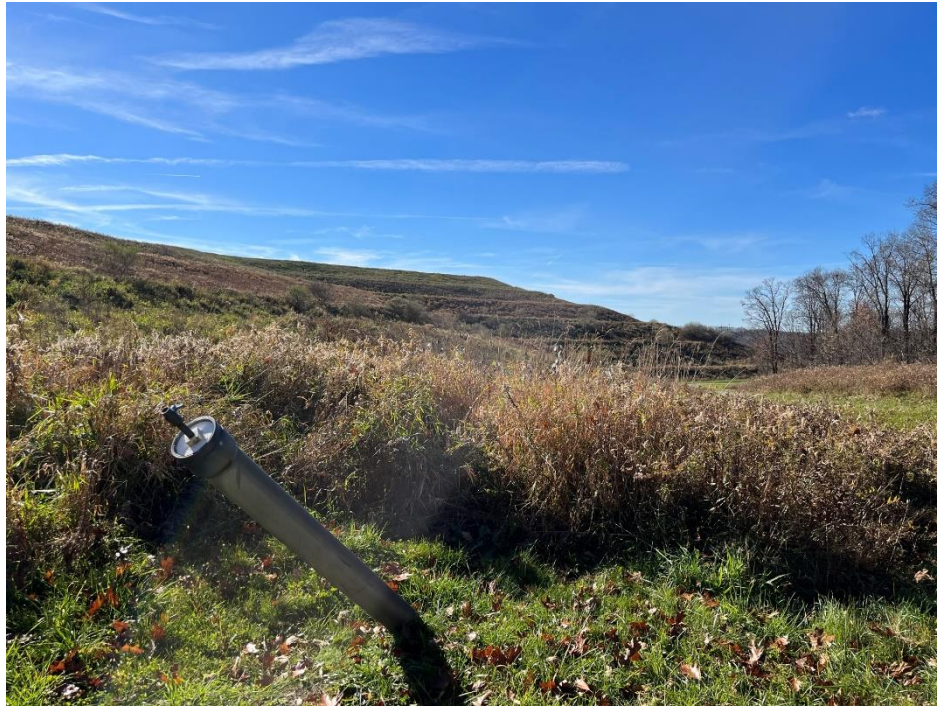
**Photograph 15. Foreground – Stage 1 west facing benches and leachate pipe cleanout.
Background – Stage III west facing benches.**

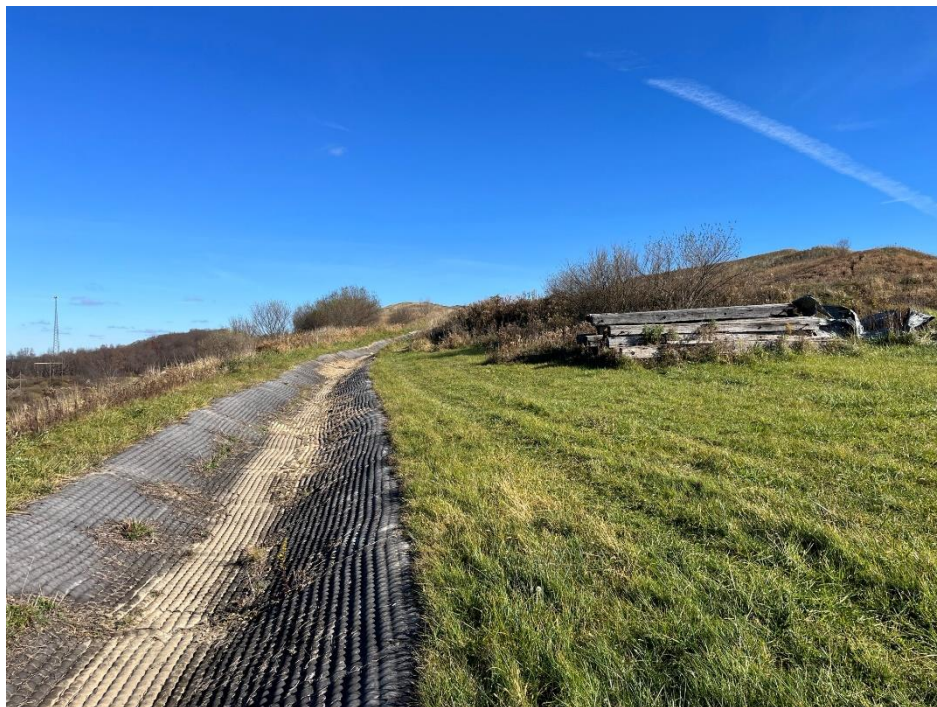
Photograph 16. West Valley Stage III Diversion Channel, view north.

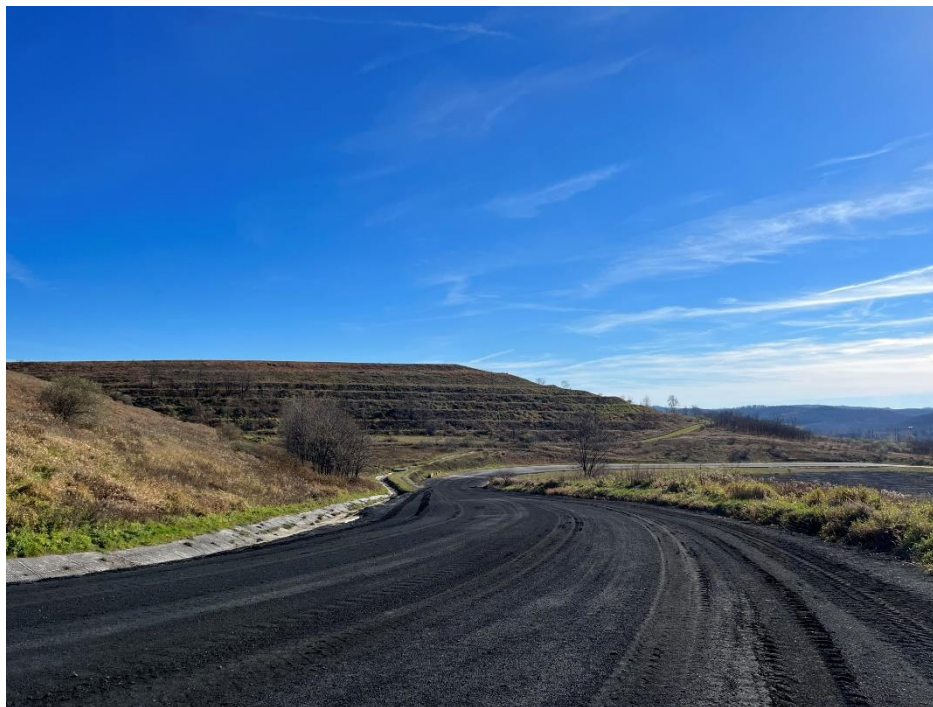
Photograph 17. Stage III Haul Road and view of the East Valley Benches, view southeast.

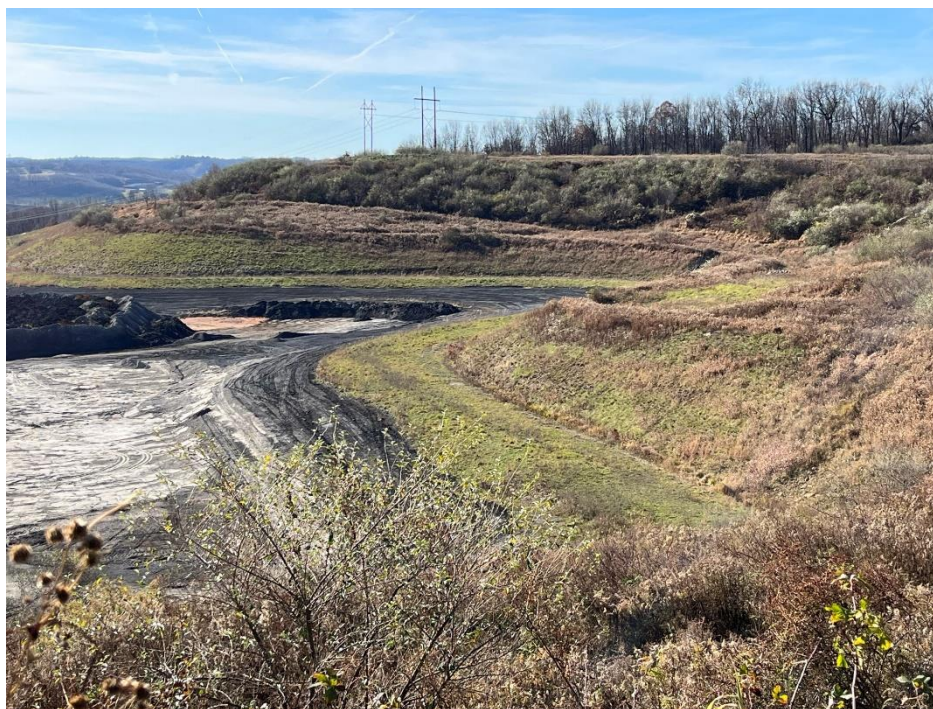
Photograph 18. West Valley Stage IV, view southwest.

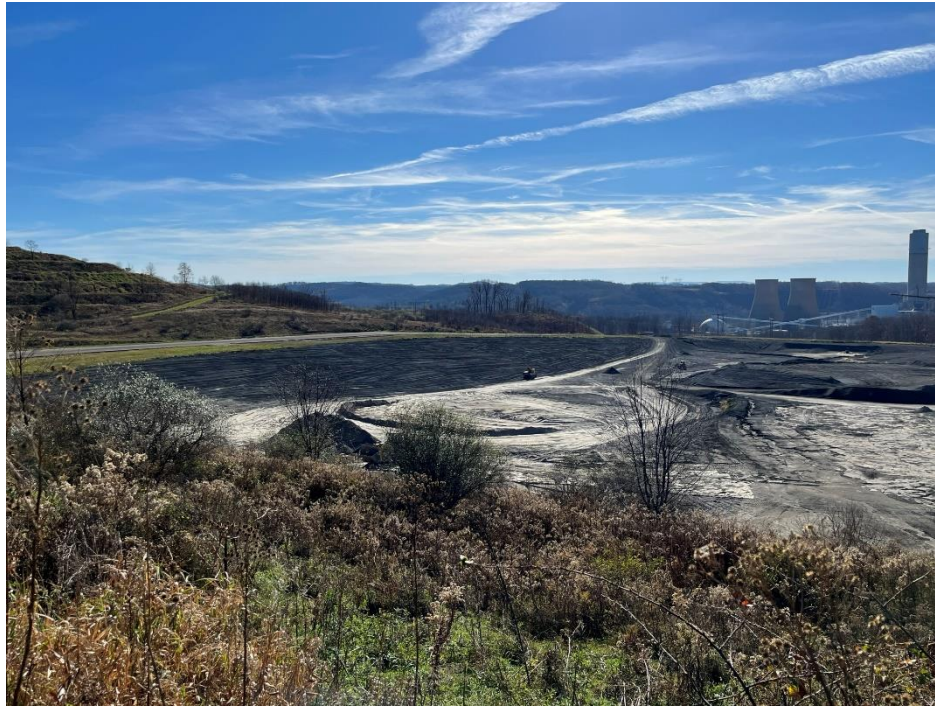
Photograph 19. West Valley Stage IV, view southeast.

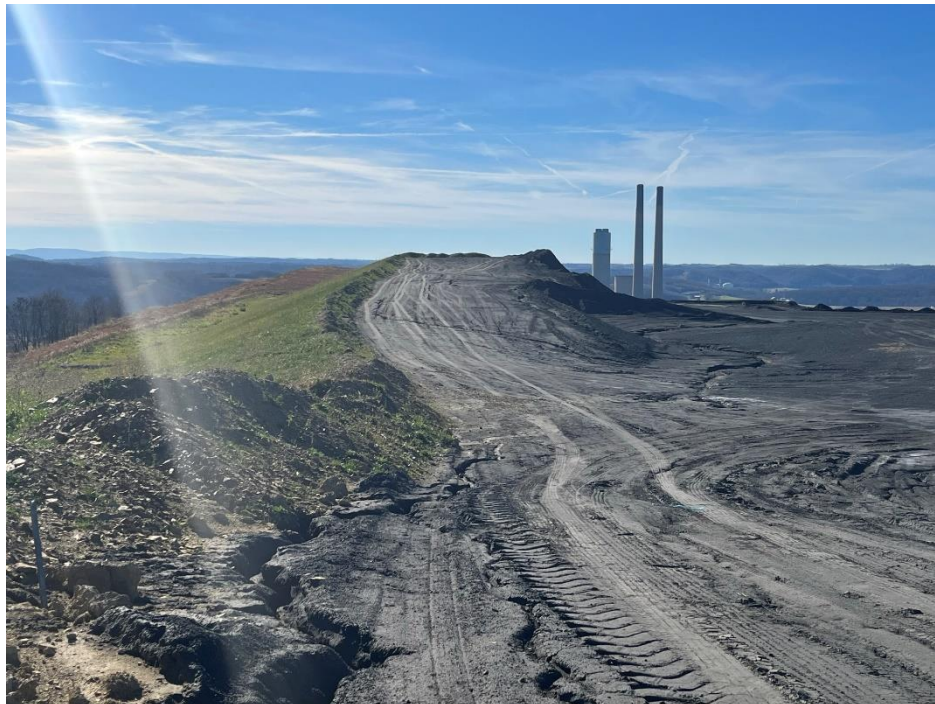
Photograph 20. Eastern side of active West Valley Stage III, view south.

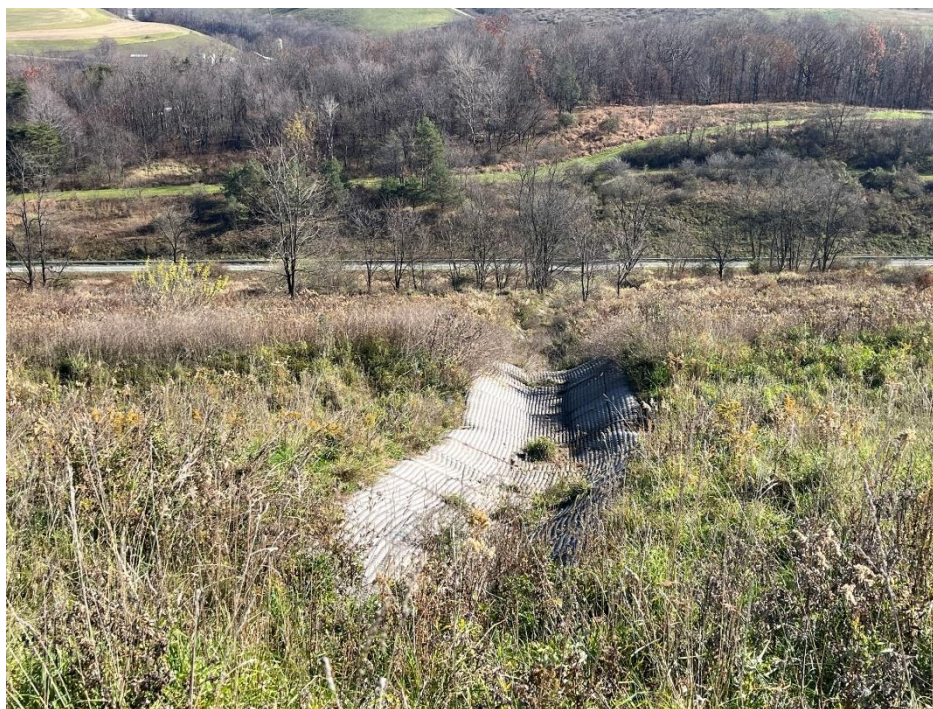
Photograph 21. East Valley Slope Drain, view east from Stage III top.

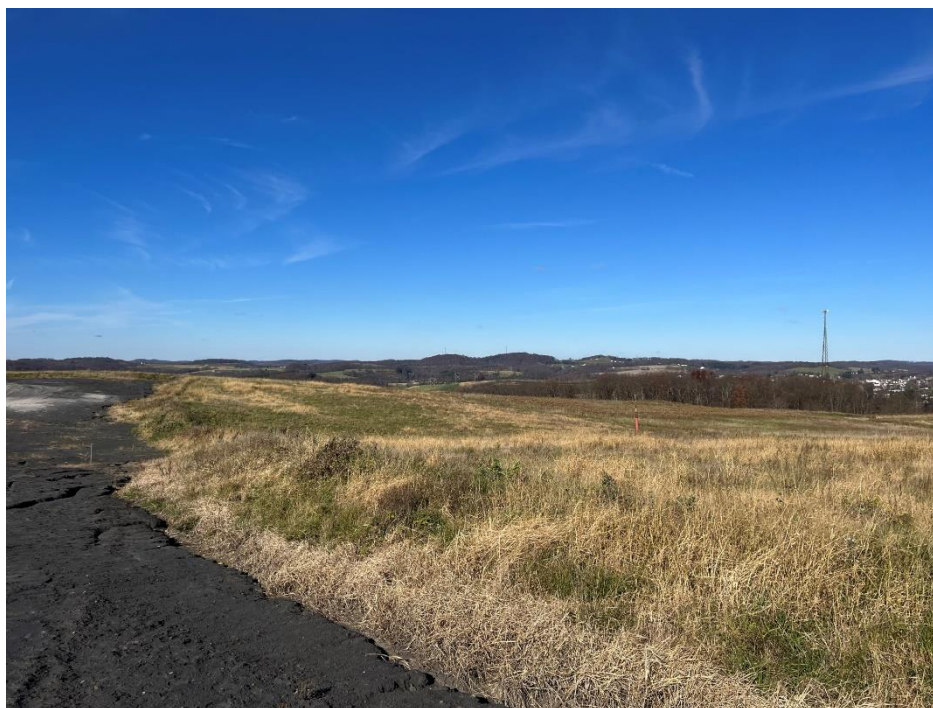
Photograph 22. North end of revegetated Stage III top.

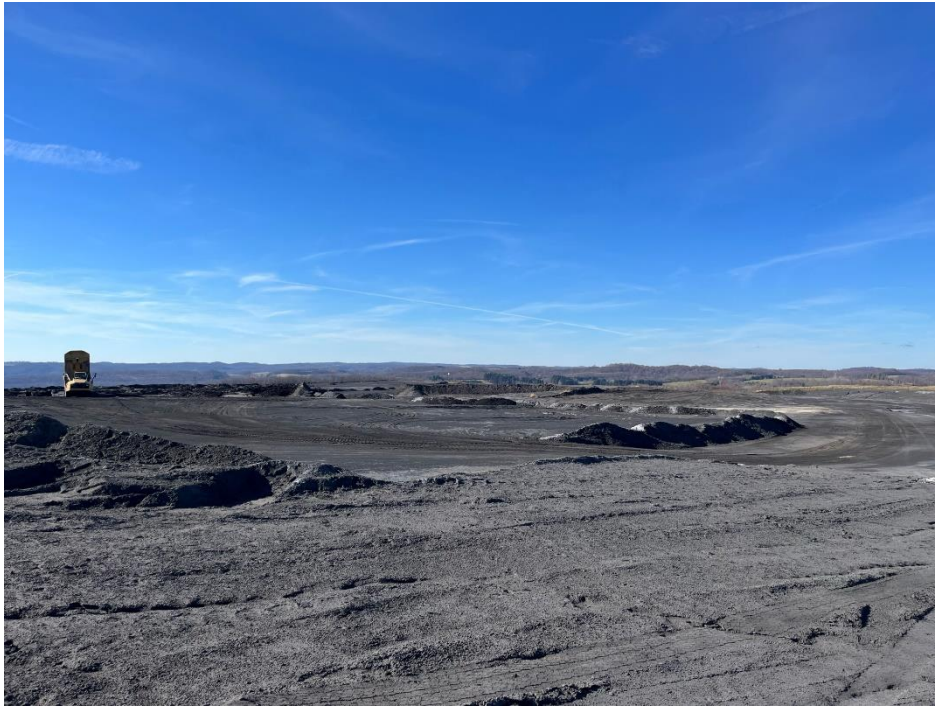
Photograph 23. Active top of West Valley Stage III.

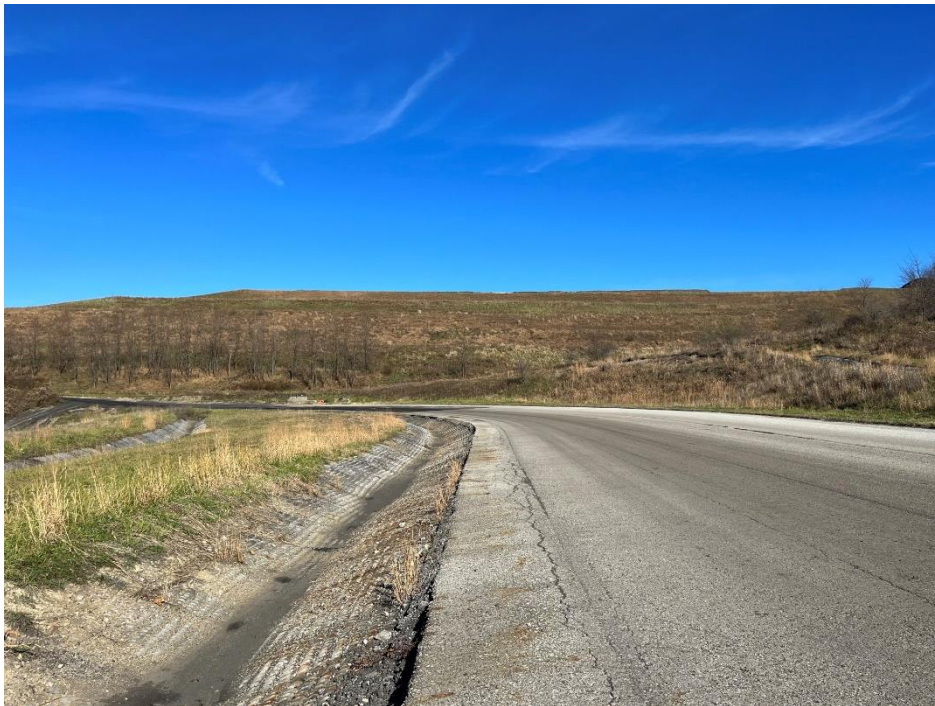
Photograph 24. West Valley Stage III haul road and benches.

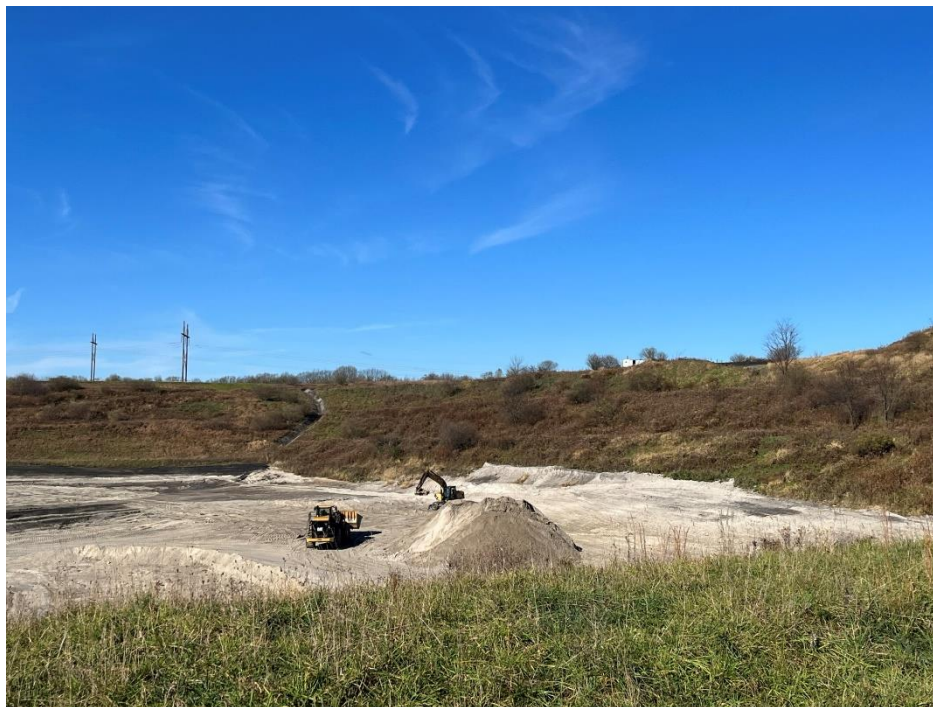
Photograph 25. Gypsum being loaded out of a stockpile in Stage IV for beneficial use.

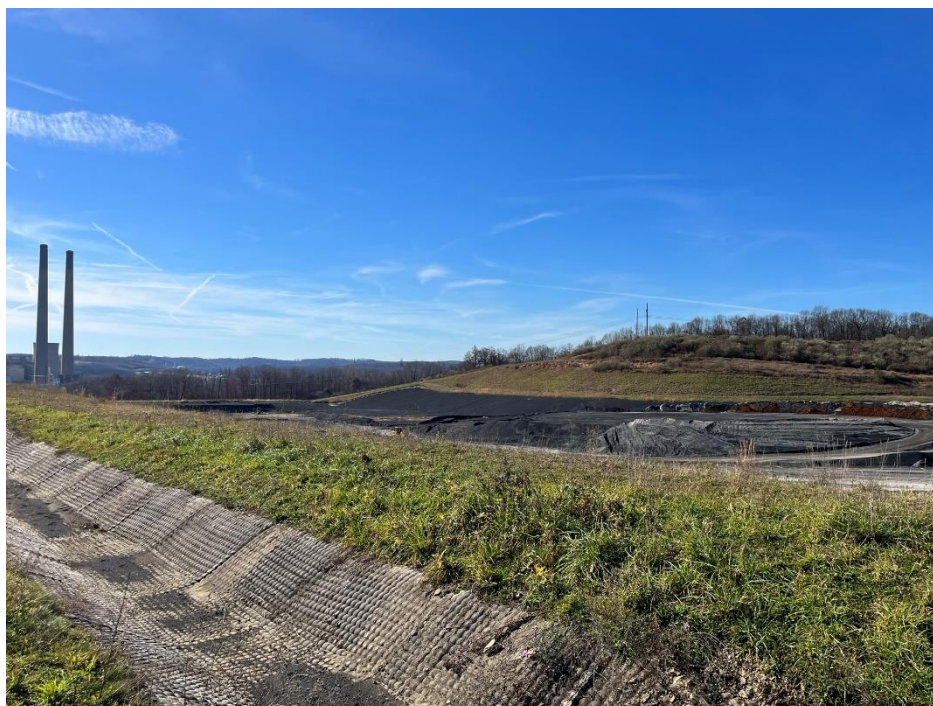
Photograph 26. West Valley Stage IV and haul road collection channel, view south.

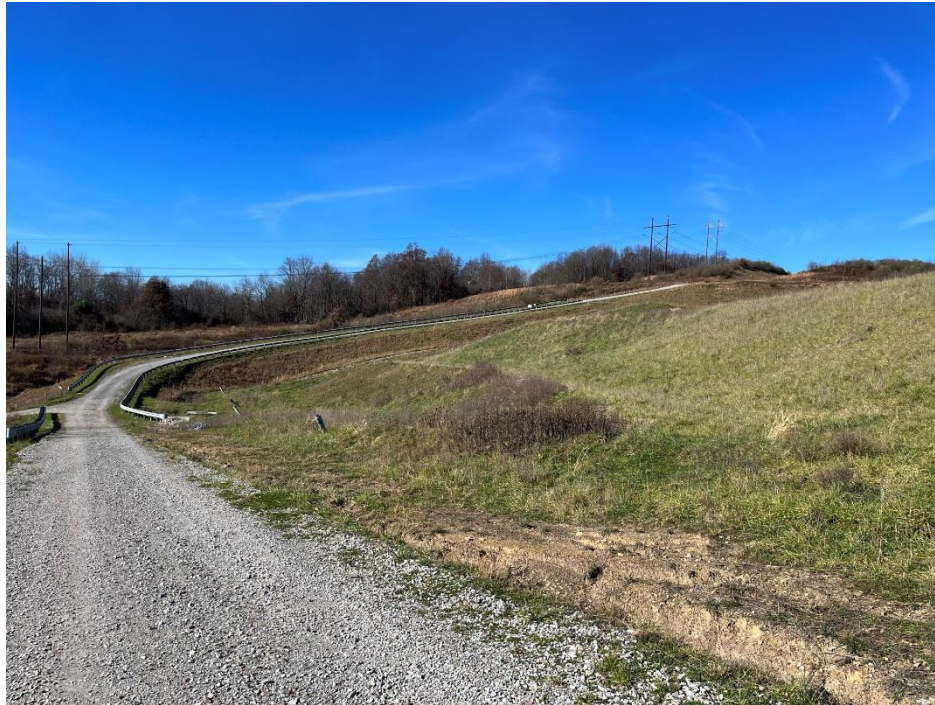
Photograph 27. View of the West Valley Stage IV toe access road, view west.
