Coal Combustion Residuals Annual CCR Unit Inspection Report for Reporting Year 2023

Keystone-Conemaugh Projects, LLC
Keystone Station Ash Disposal Site
Keystone Generating Station
Shelocta, Pennsylvania

GAI Project Number: C151611.09
January 2024

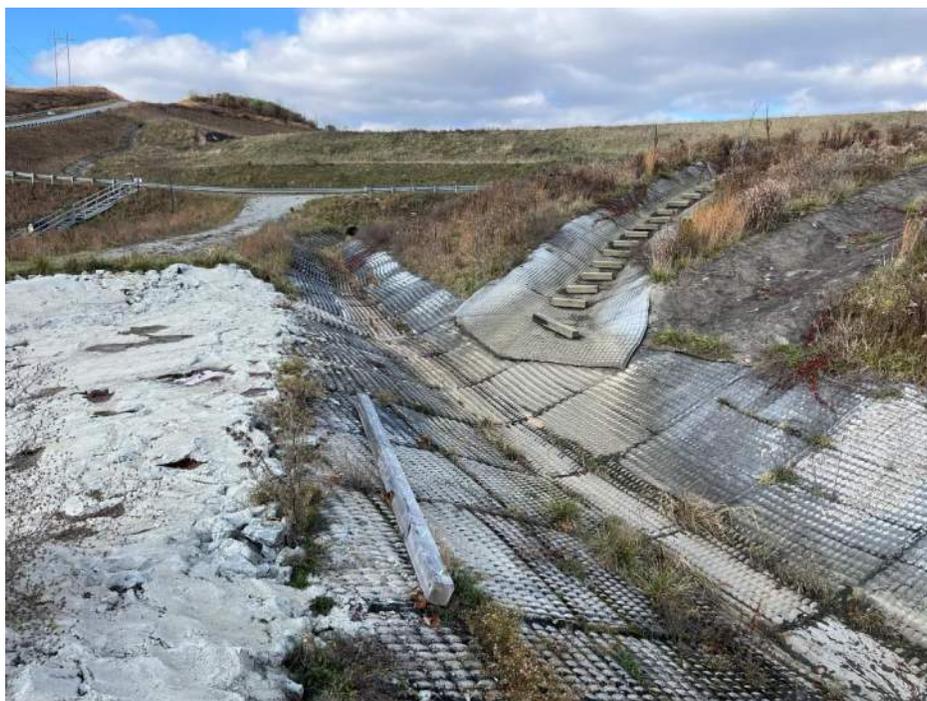
Photograph 1. Stage IV collection channel to West Valley Equalization Pond and Stage IV toe in background, view north.

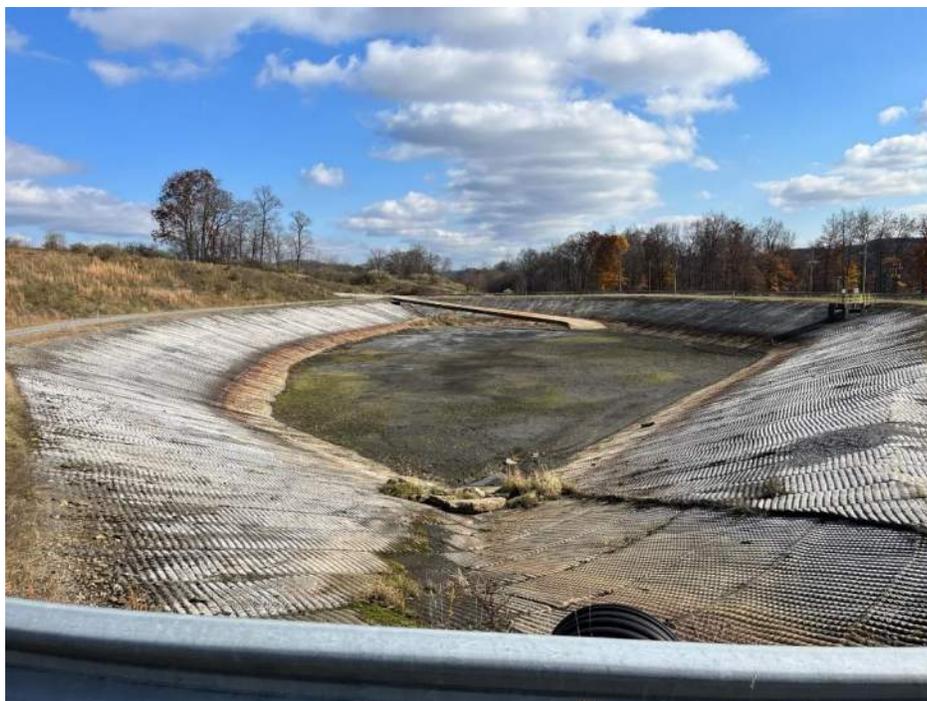
Photograph 2. West Valley Equalization Pond, view southwest.

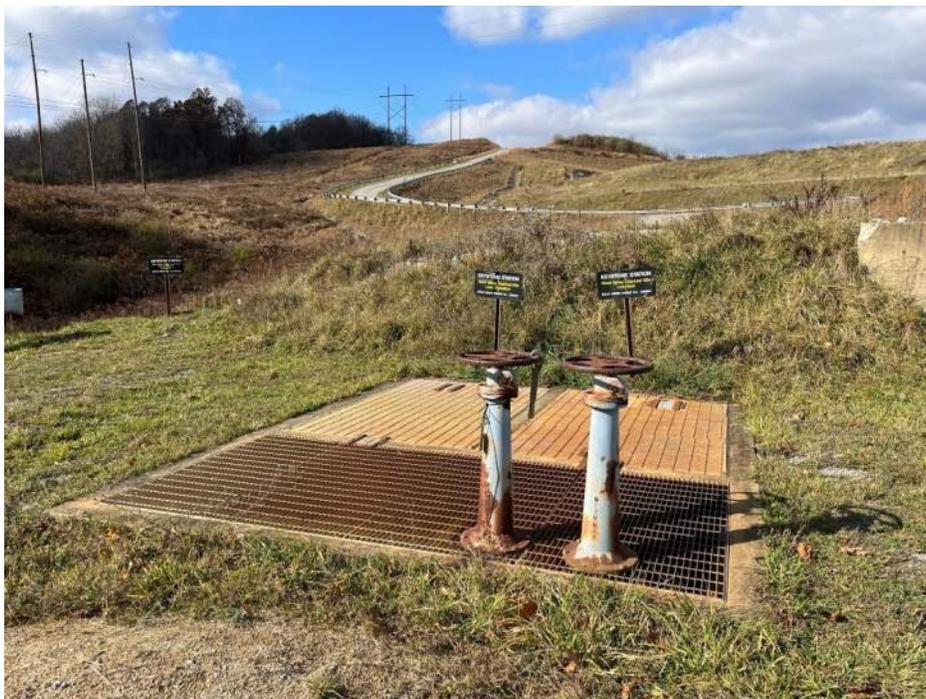
Photograph 3. West Valley Leachate Detection and Leachate Collection Box.

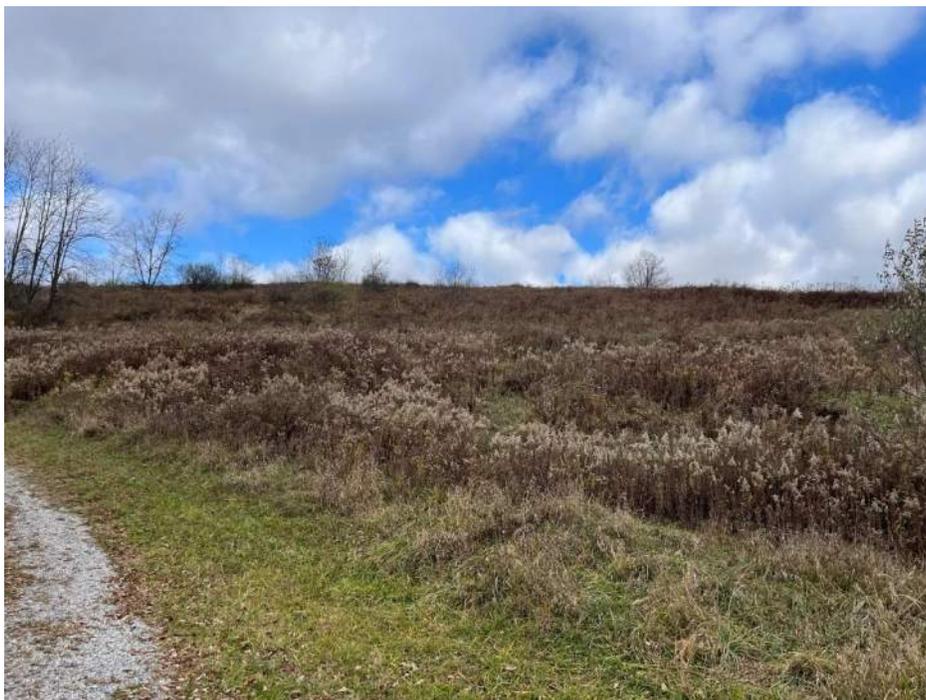
Photograph 4. Northwest view of the East Valley south facing benches.

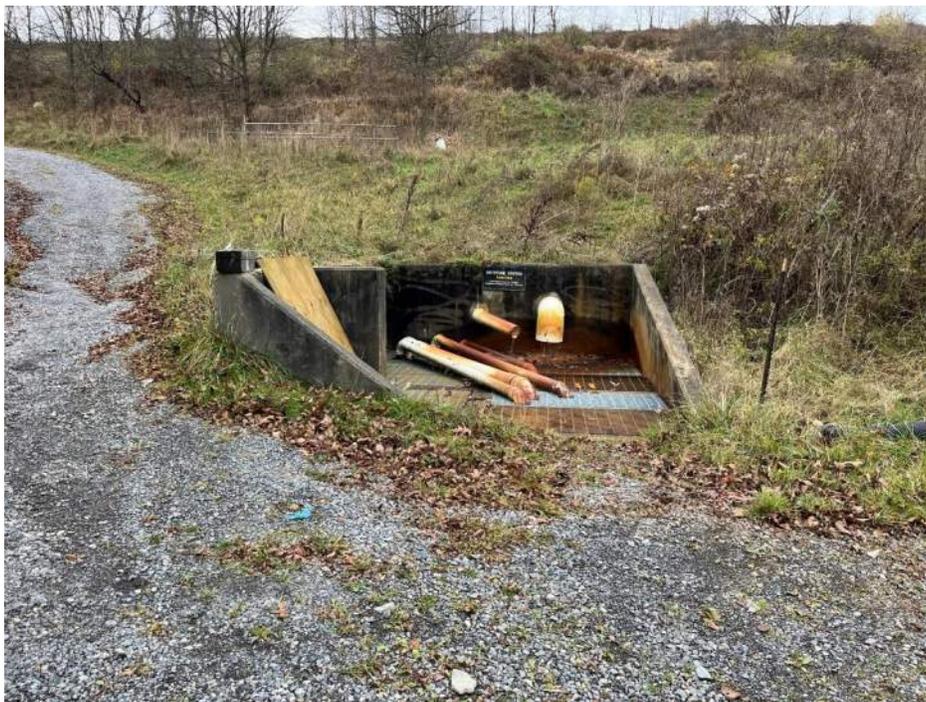
Photograph 5. East Valley Leachate Collection Box, view west.

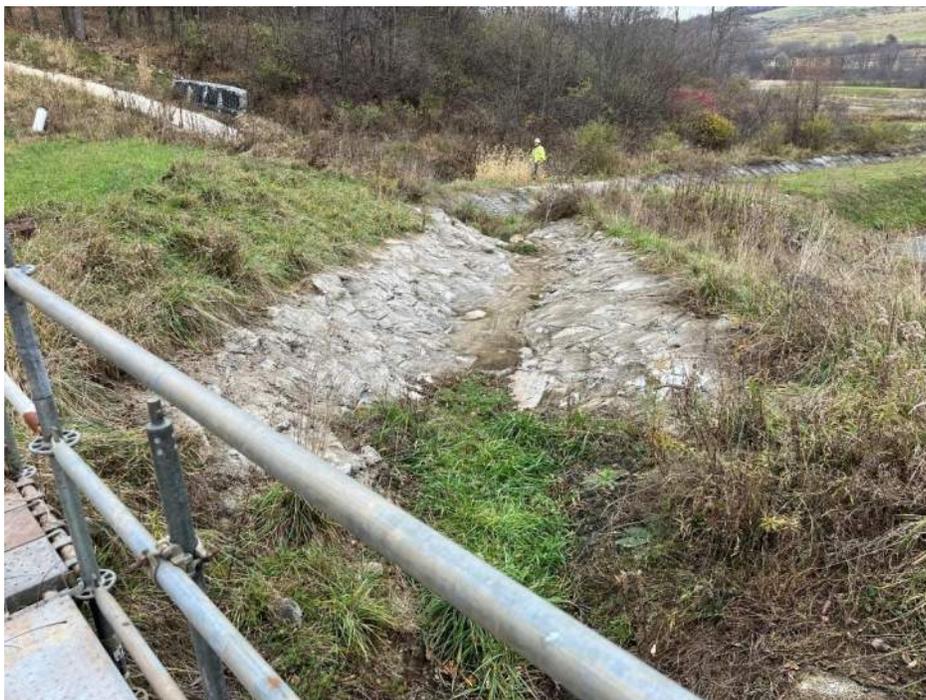
Photograph 6. East Valley Collection Channel at toe area, view east.

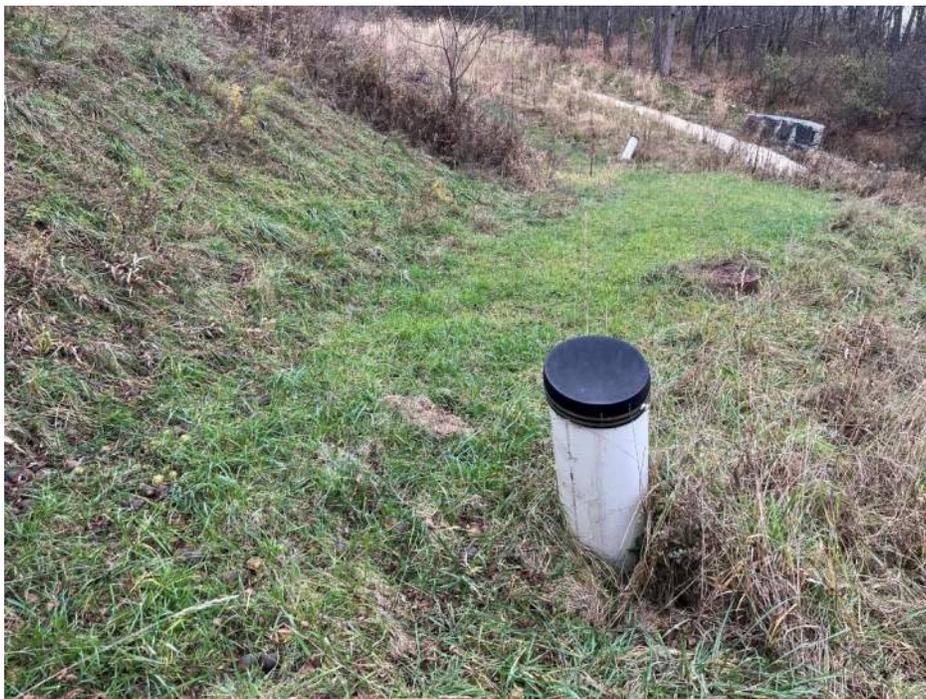
Photograph 7. View of East Valley Toe Bench and Leachate Seep Collection Pipes and Cleanouts added in 2019, view north.

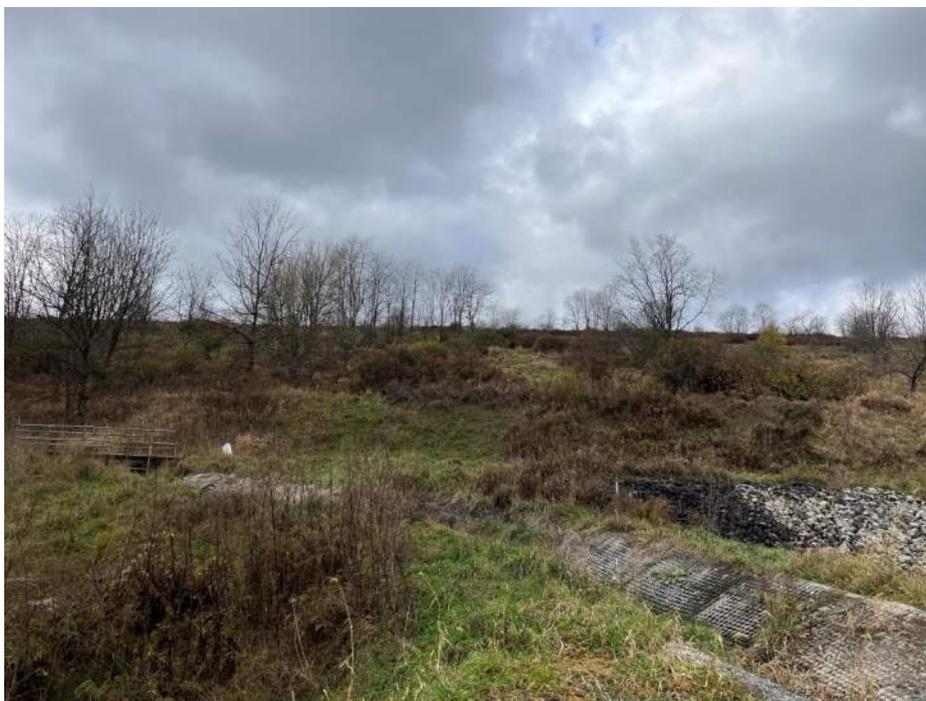
Photograph 8. East Valley Toe and east facing benches, view west.

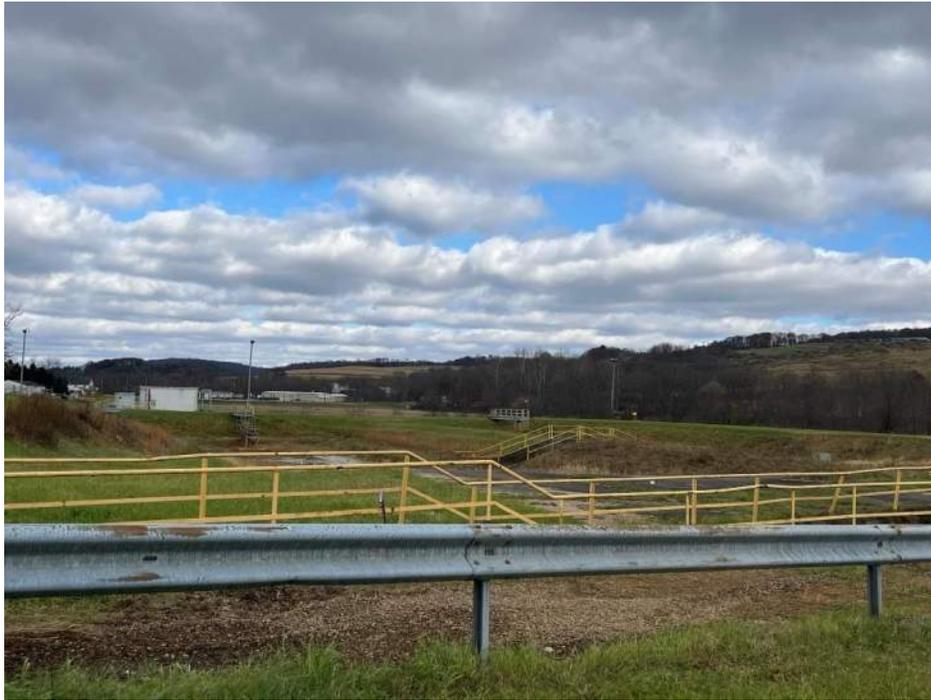
Photograph 9. View north of idled East Valley Equalization Ponds.

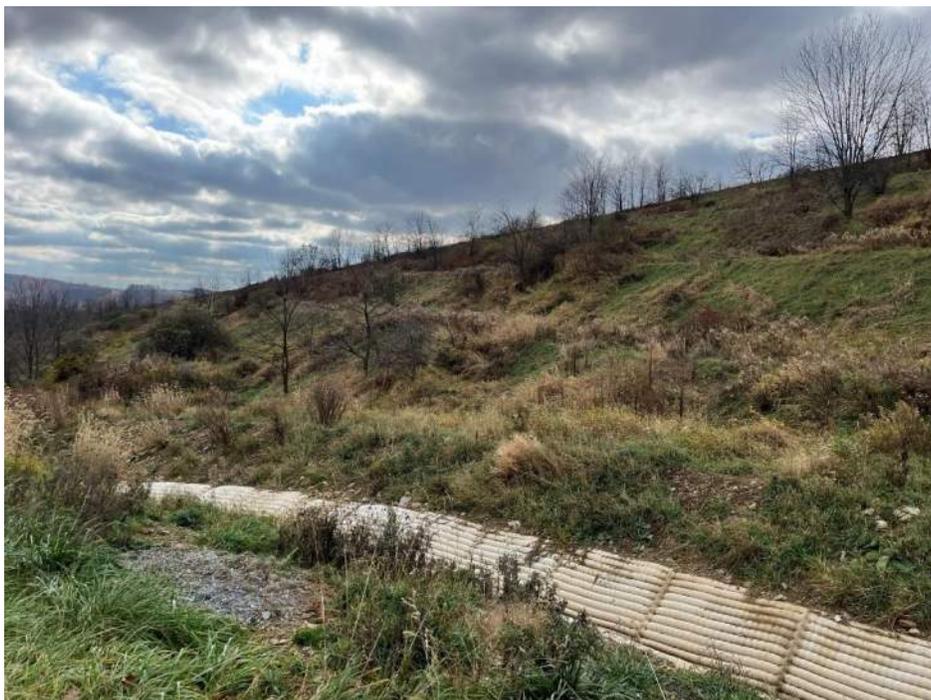
Photograph 10. East Valley east facing benches, view south.

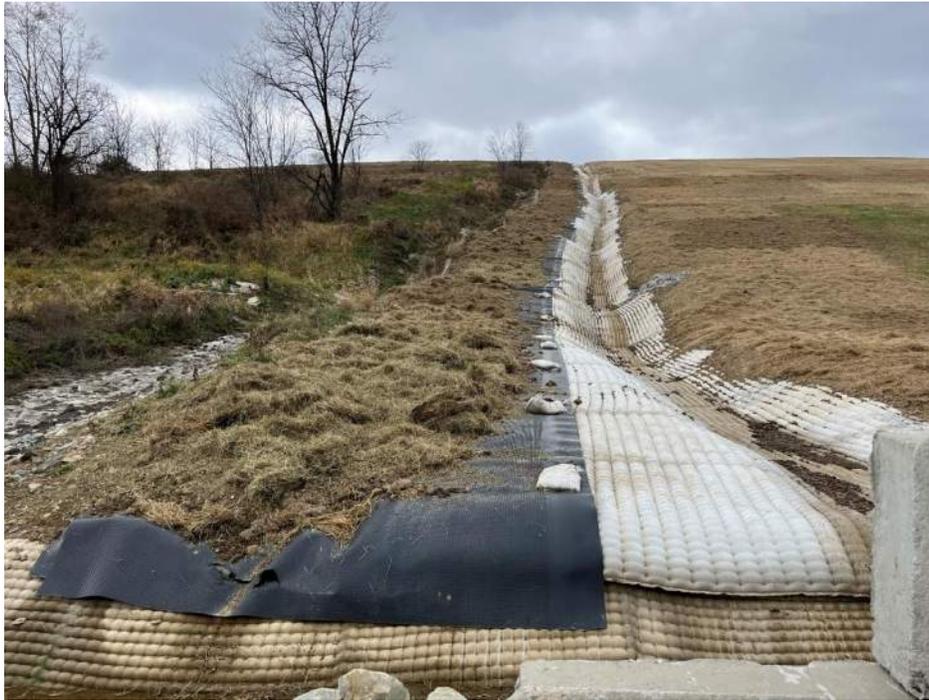
Photograph 11. Re-established channel and capping East Valley collection channels, view west.

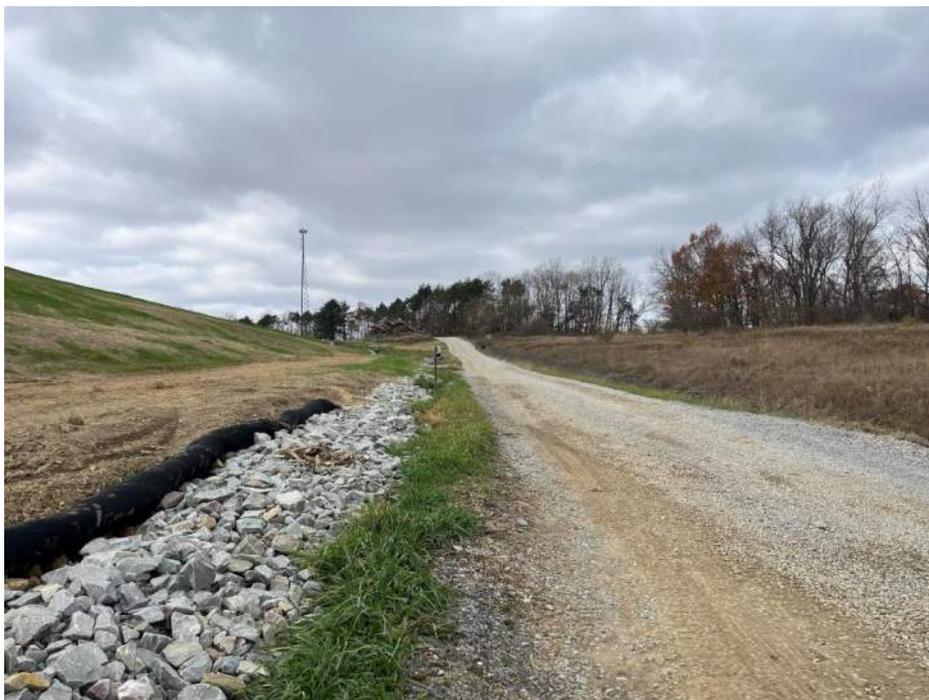
Photograph 12. Recently capped East Valley east facing benches and Stage I/II collection channel, view north.

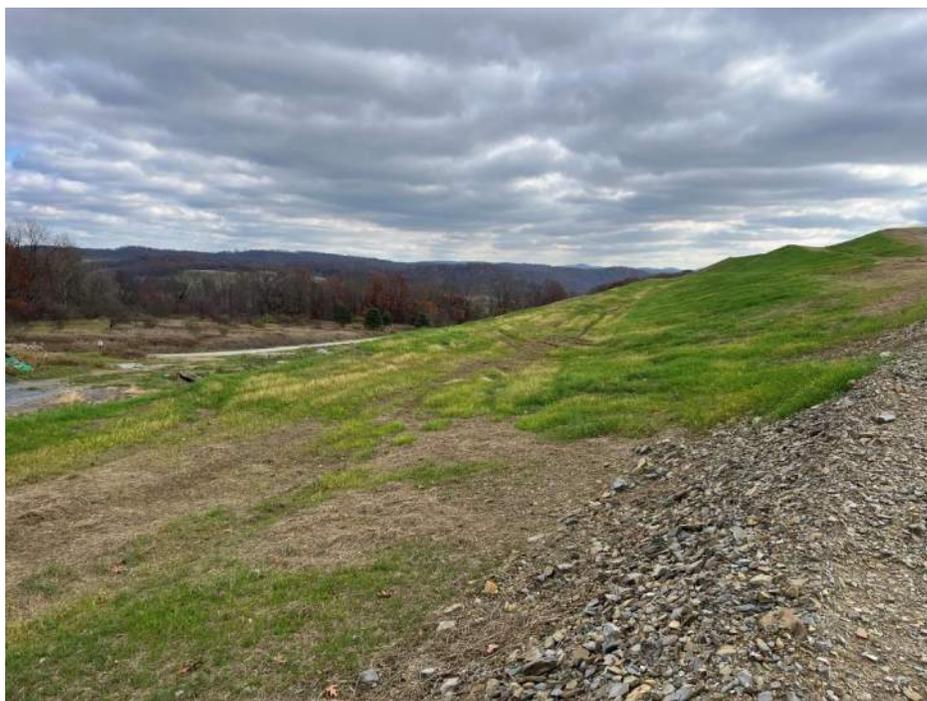
Photograph 13. Recently capped East Valley east facing benches, view south.

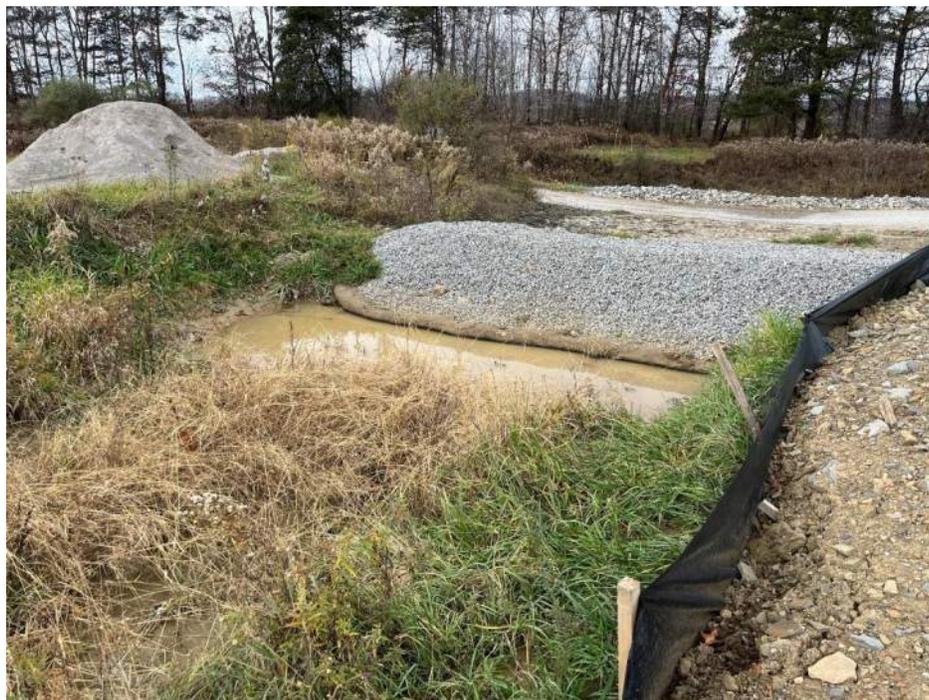
Photograph 14. Stage I/II revegetated top surface drainage swale, north end.

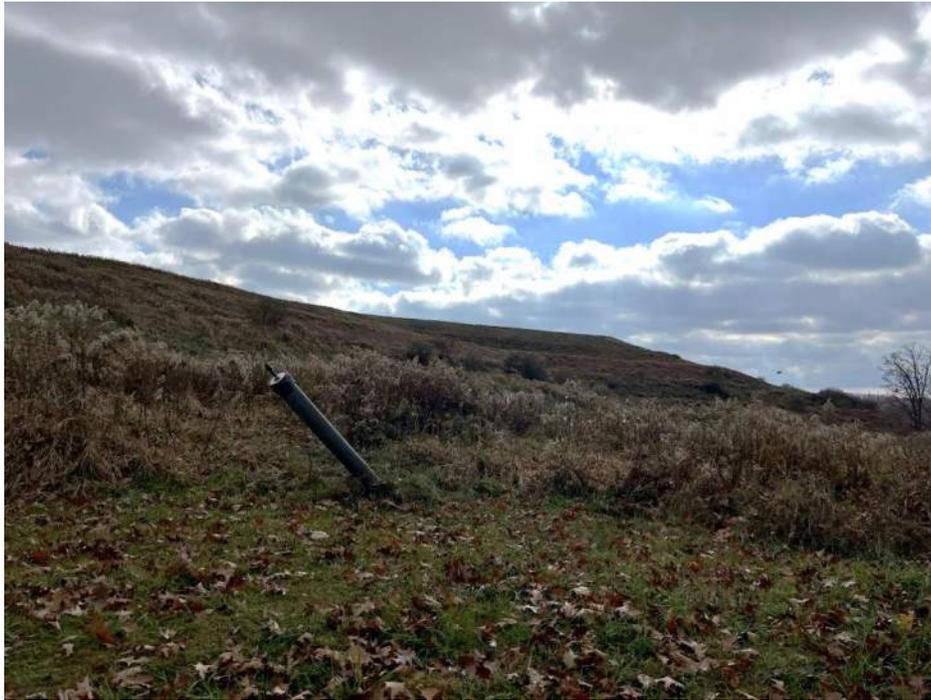
**Photograph 15. Foreground – Stage 1 west facing benches and leachate pipe cleanout.
Background – Stage III west facing benches.**

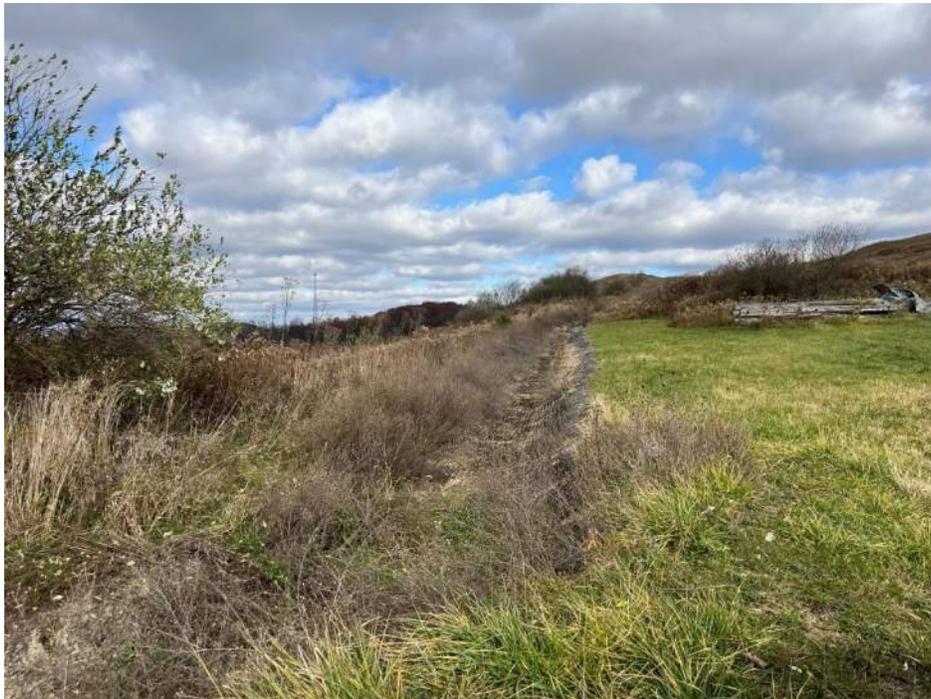
Photograph 16. West Valley Stage III Diversion Channel, view north.

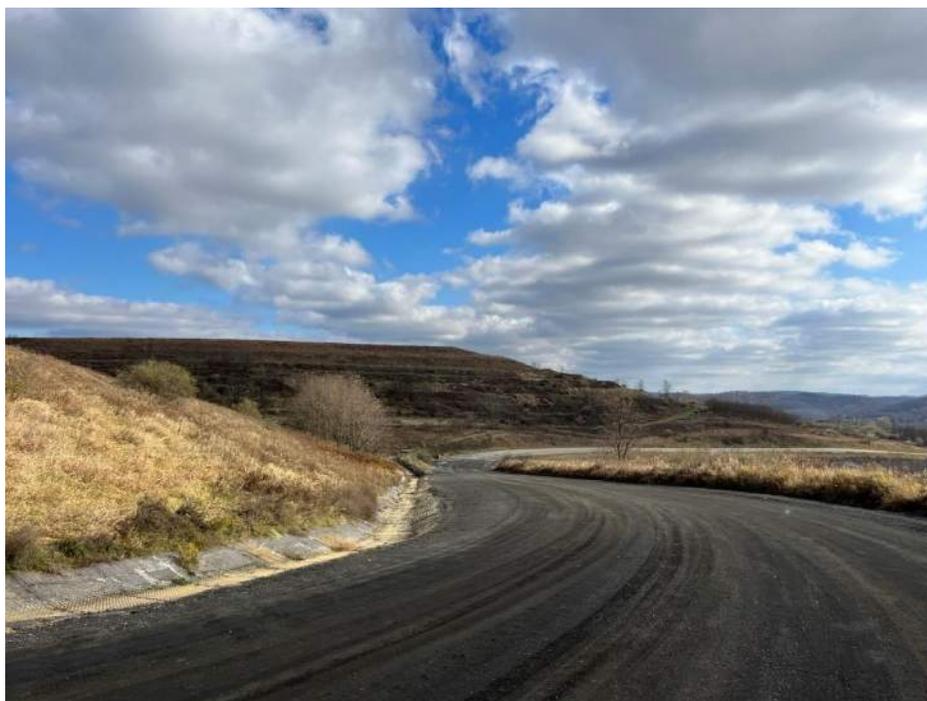
Photograph 17. Stage III Haul Road and view of the East Valley Benches, view southeast.

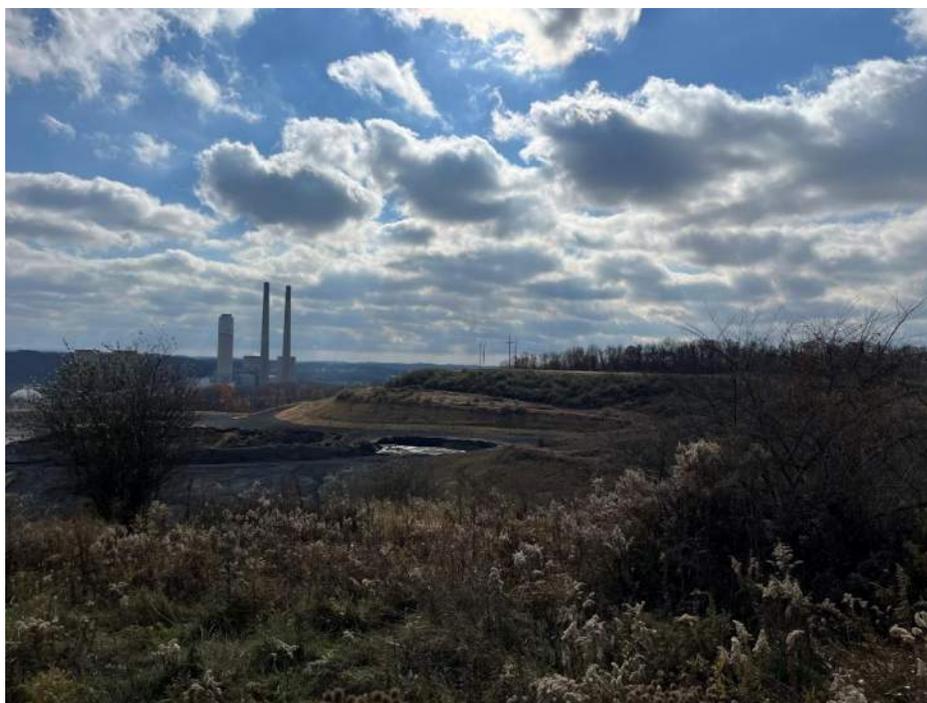
Photograph 18. West Valley Stage IV, view southwest.

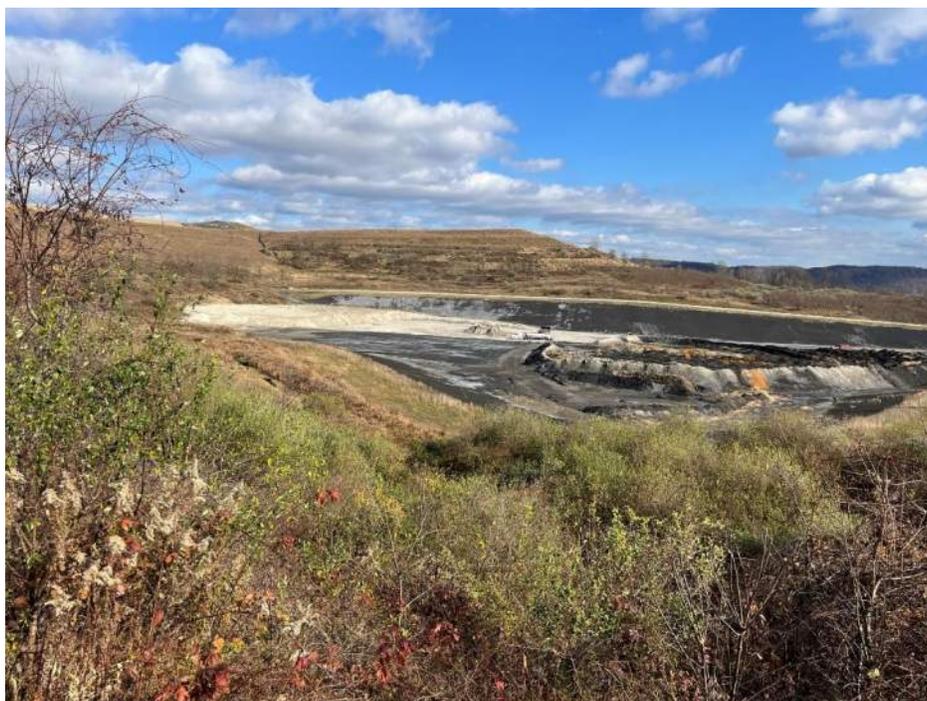
Photograph 19. West Valley Stage IV, view east.

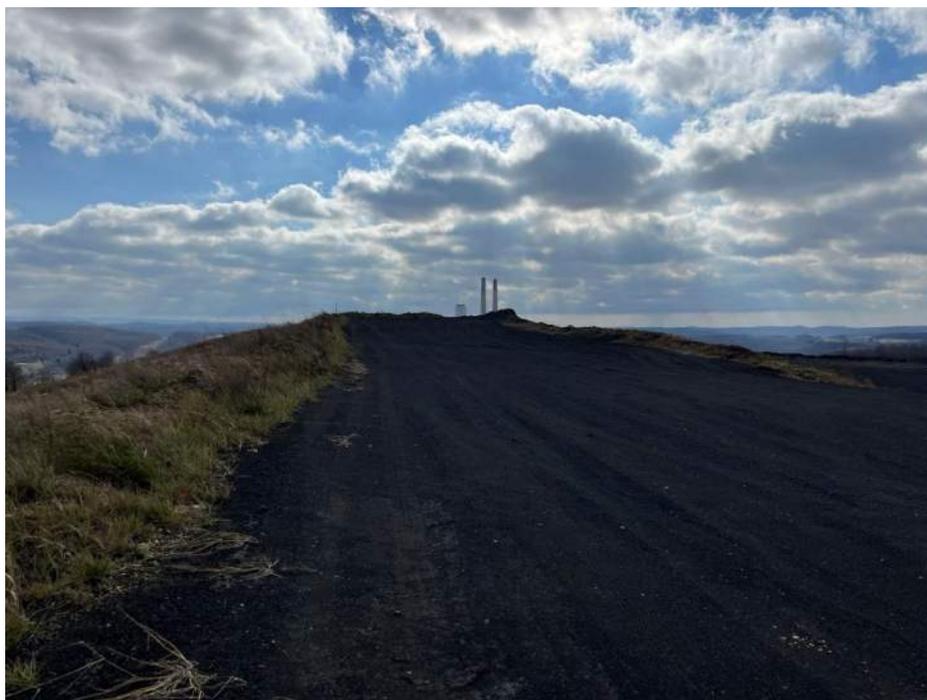
Photograph 20. Eastern side of active West Valley Stage III, view south.

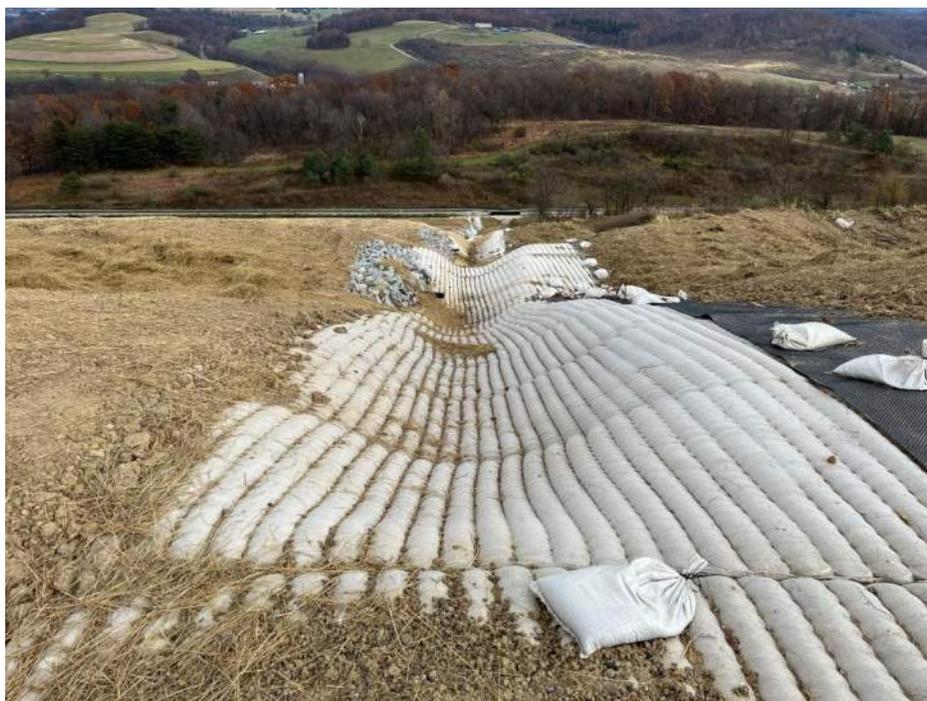
Photograph 21. East Valley Slope Drain, view east from Stage III top.

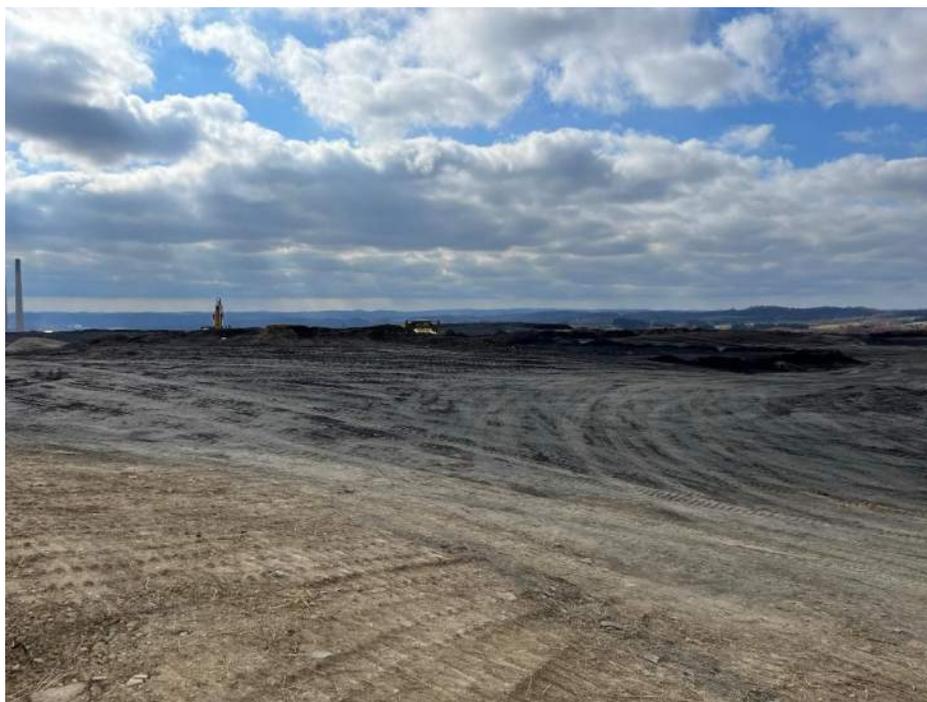
Photograph 22. Active top of West Valley Stage III.

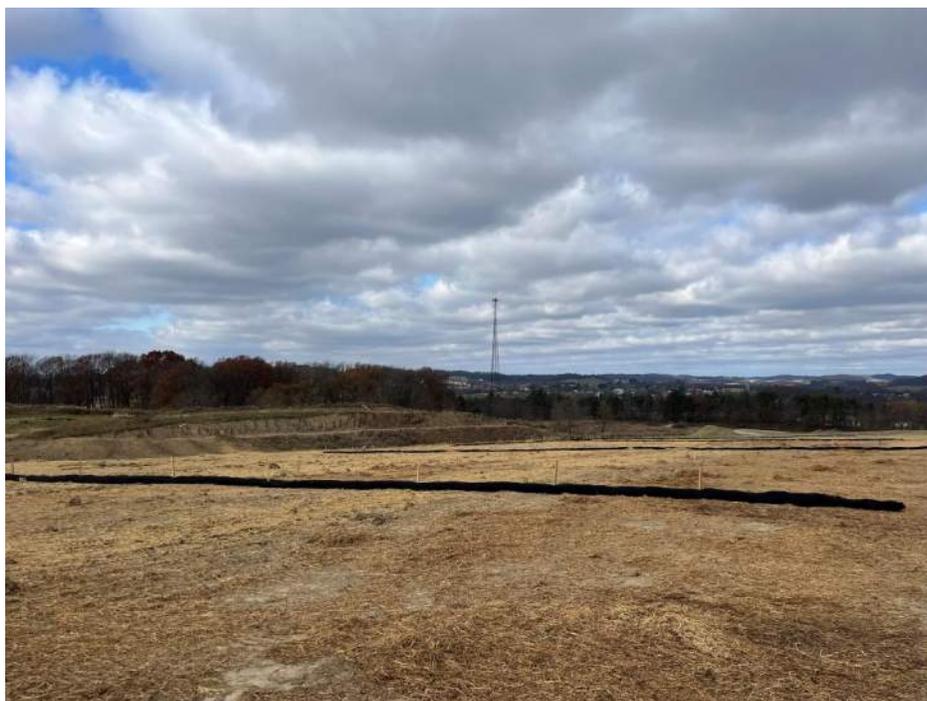
Photograph 23. North end of revegetated Stage III top.

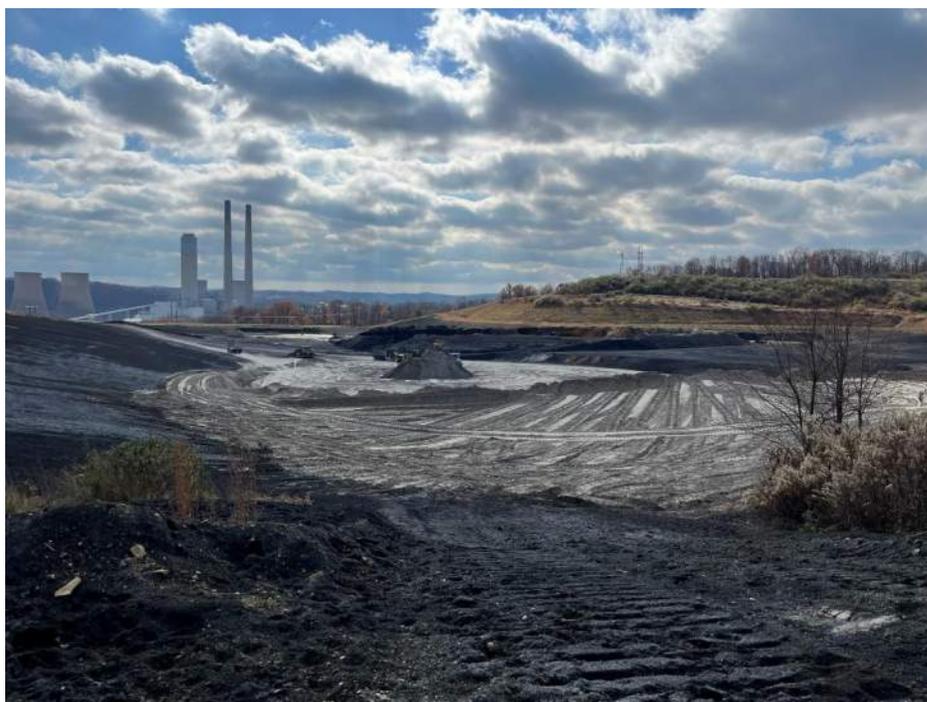
Photograph 24. Gypsum being loaded out of a stockpile in Stage IV for beneficial use.

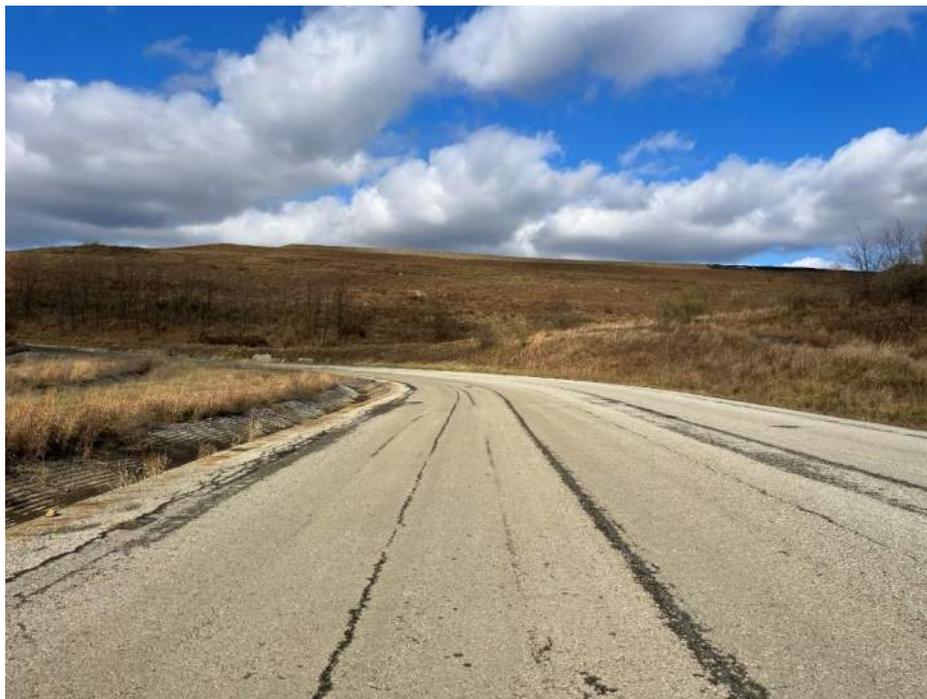
Photograph 25. West Valley Stage III haul road and benches.

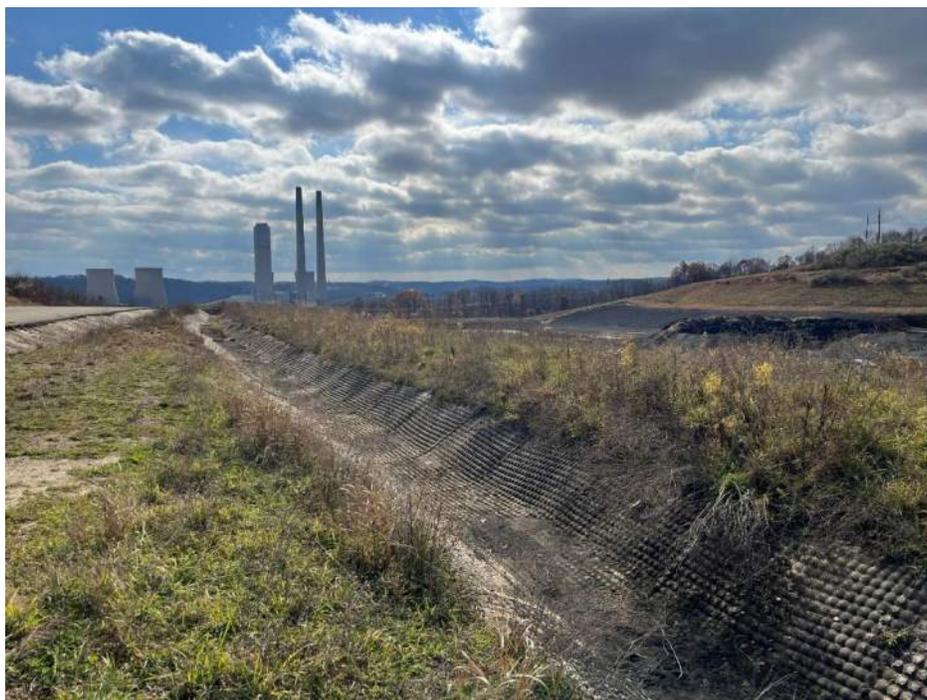
Photograph 26. West Valley Stage IV and haul road collection channel, view south.

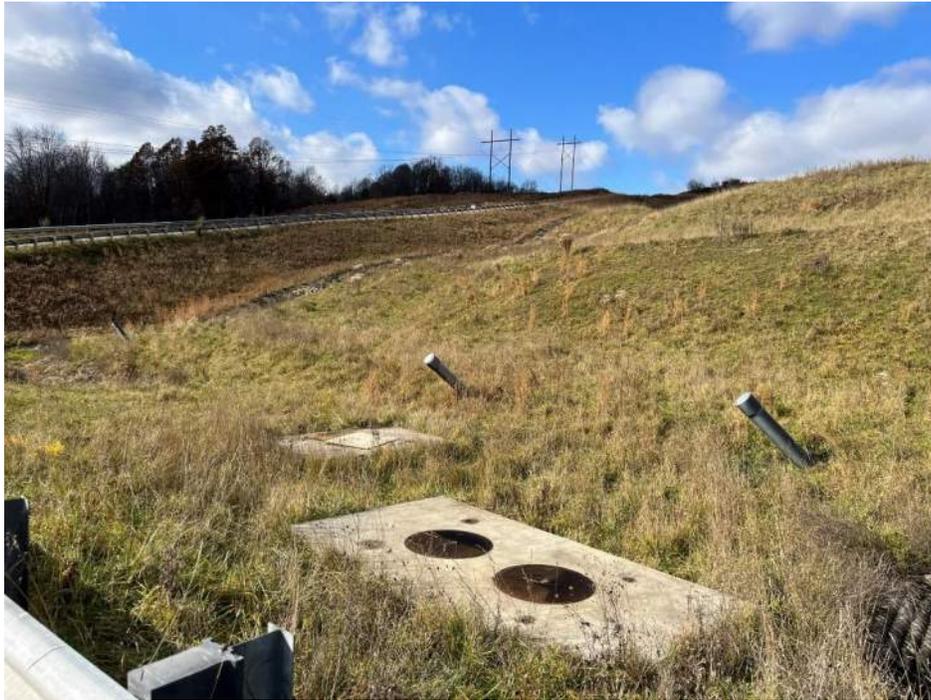
Photograph 27. View of the West Valley Stage IV toe access road, view west.
