# Coal Combustion Residuals Annual CCR Unit Inspection Report for Reporting Year 2025

Keystone-Conemaugh Projects, LLC  
Conemaugh Station Ash/Refuse Disposal Site  
Conemaugh Generating Station  
New Florence, Pennsylvania

GAI Project Number: C151611.10  
January 2026

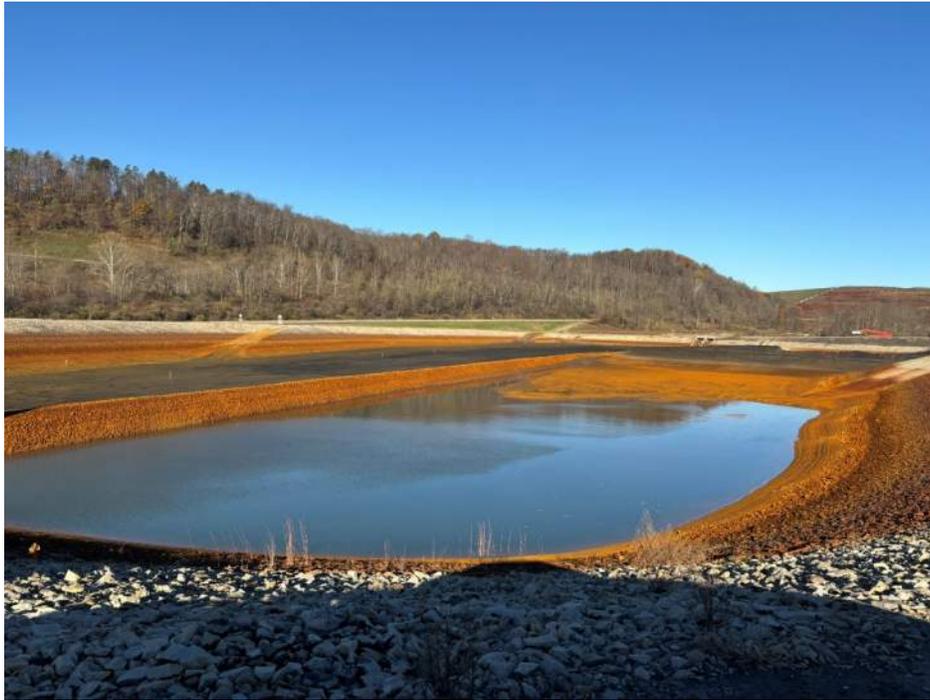
**Photograph 1. Surge Pond, immediately north of disposal site treatment plant; view northwest.**

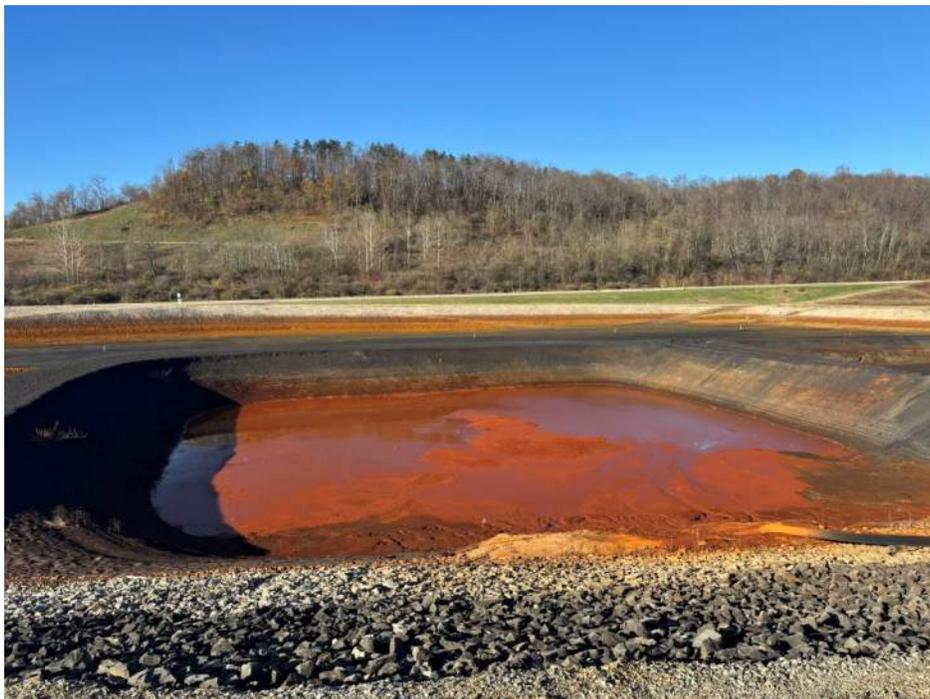
**Photograph 2. Disposal Site Surge Pond; view northwest.**

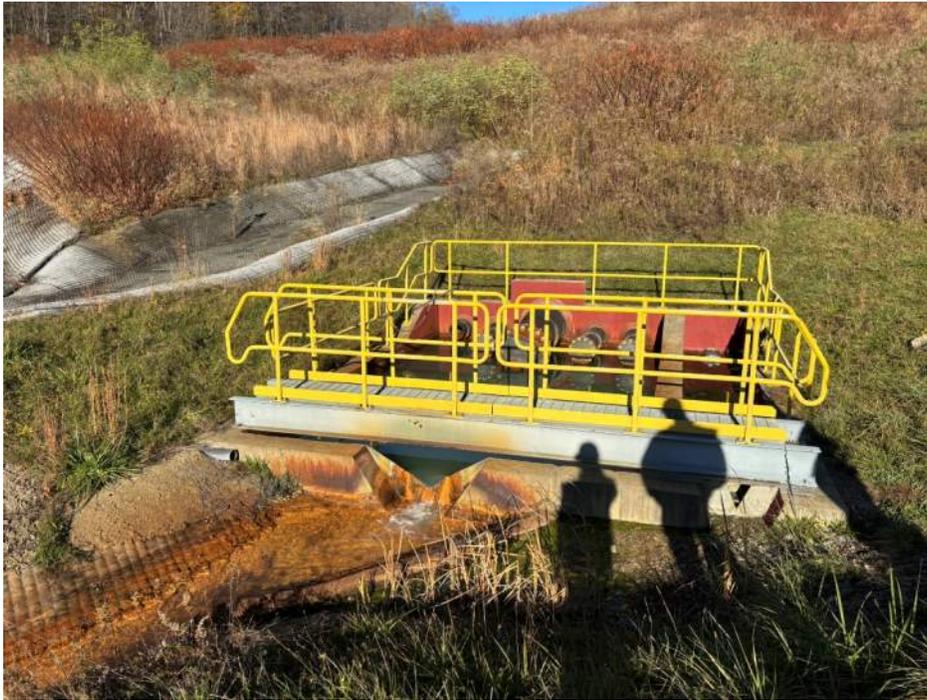
**Photograph 3. Stage IIIA Stilling Basin, Leachate collection piping and v-notch weir (left), Leachate detection pipe and v-notch weir (right).**

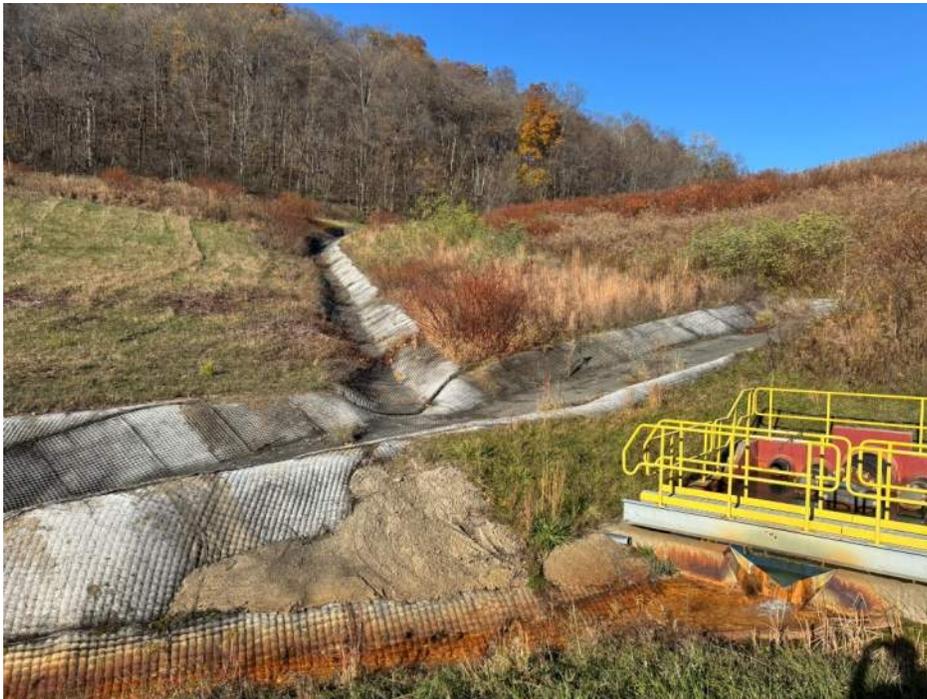
**Photograph 4. Stage IIIA toe collection channels and leachate and leak detection flows from stilling basin (right); view north.**

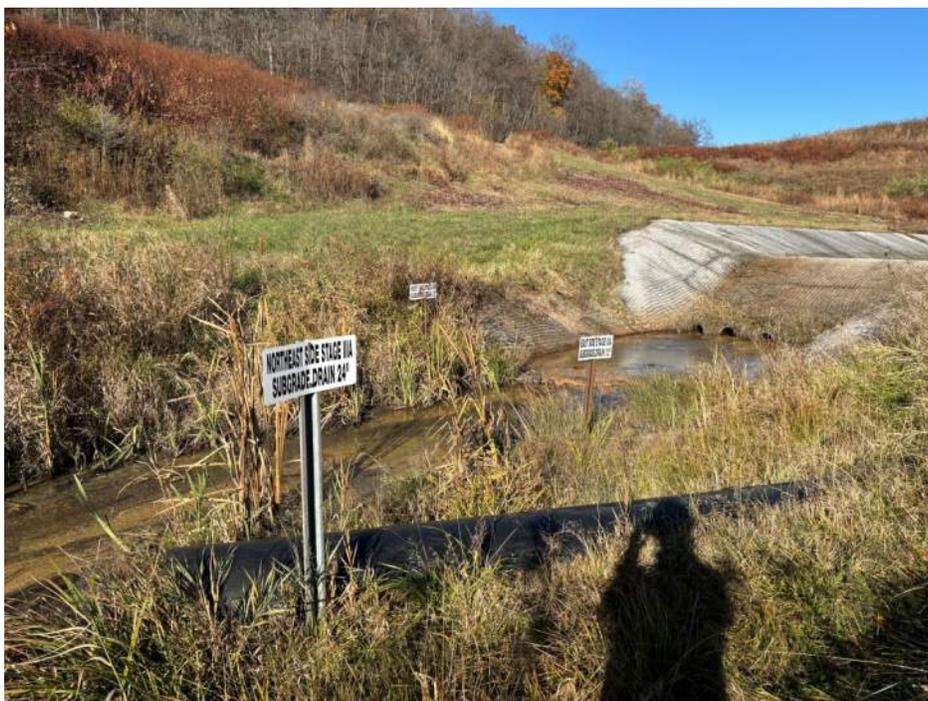
**Photograph 5. Stage IIIA toe collection channel and flows from subgrade drainpipes (with signs) from Stages II/III; view northwest.**

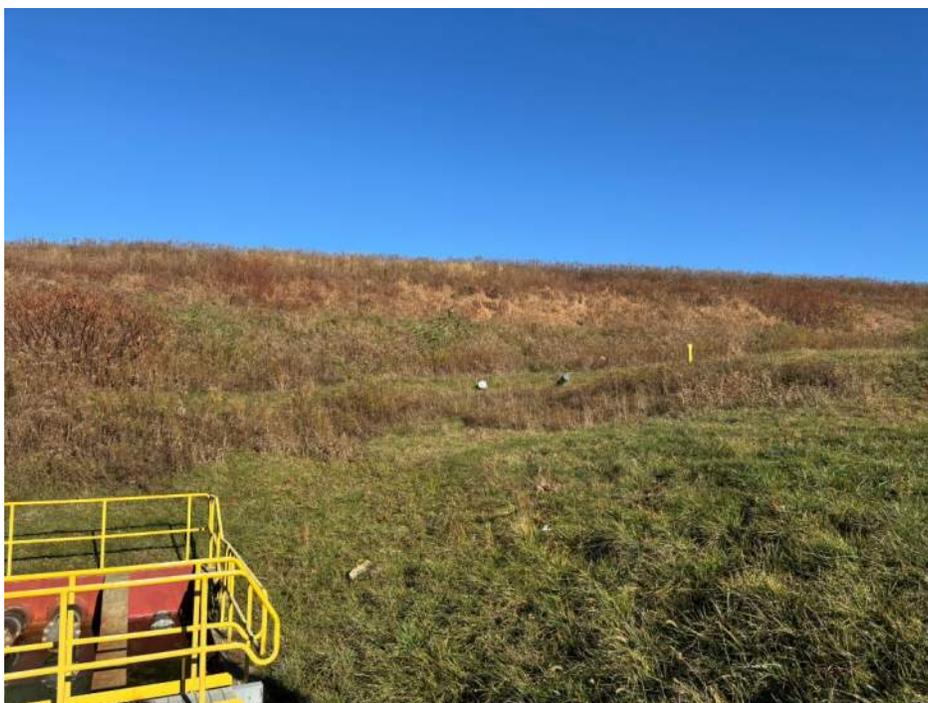
**Photograph 6. Stage IIIA slope of southern facing benches; view north.**

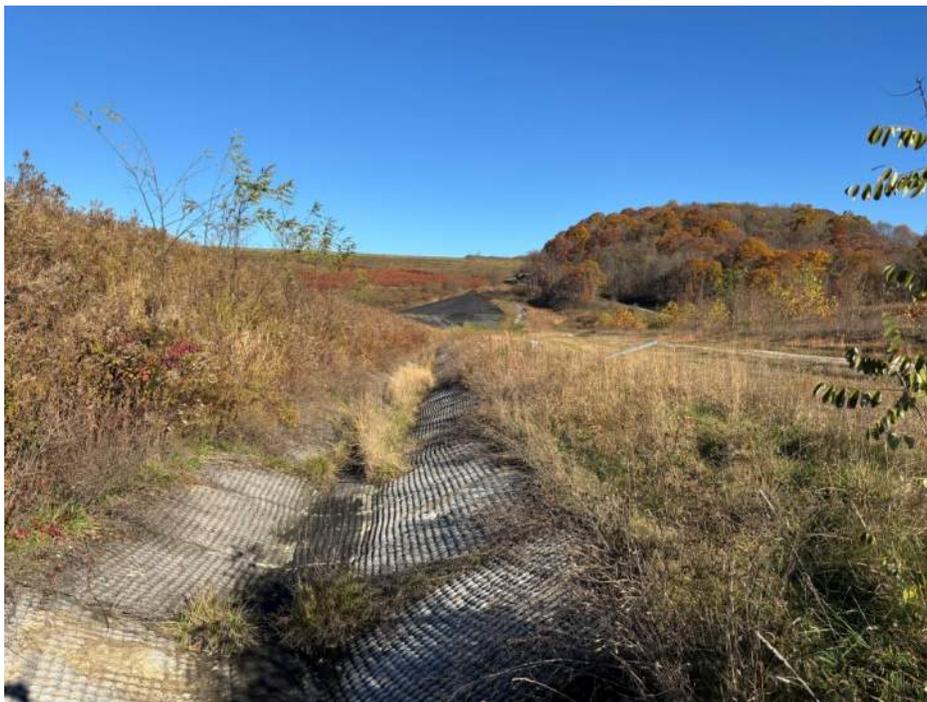
**Photograph 7. Stage IIIA Collection Channel along first bench on east side of Stage IIIA; view northeast.**

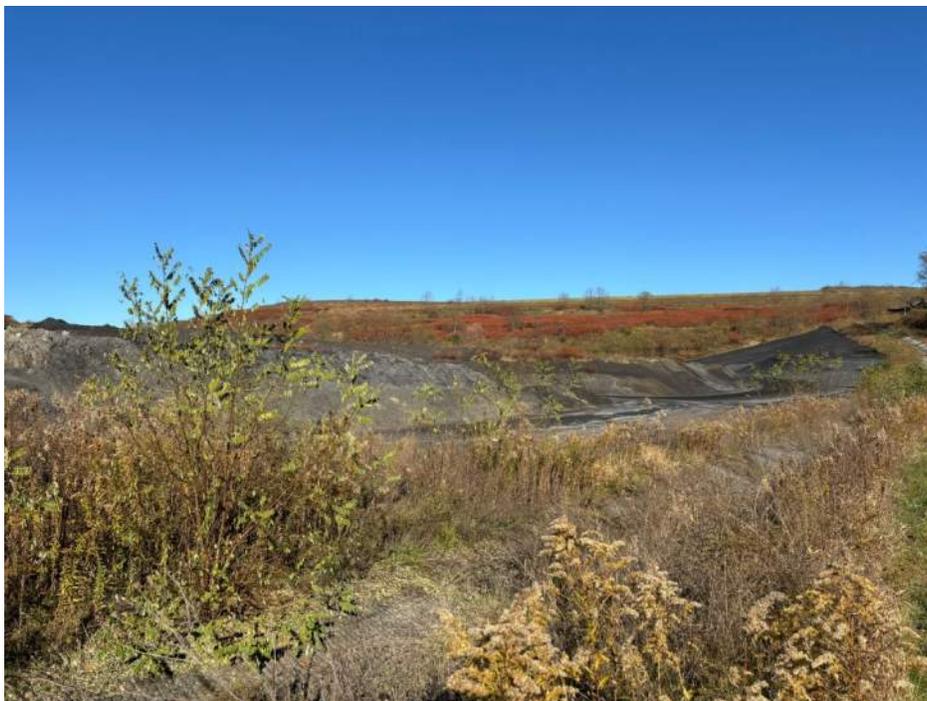
**Photograph 8. Stage IIIA Collection Channel; no erosion rills present in the northeast corner of Stage IIIA.**

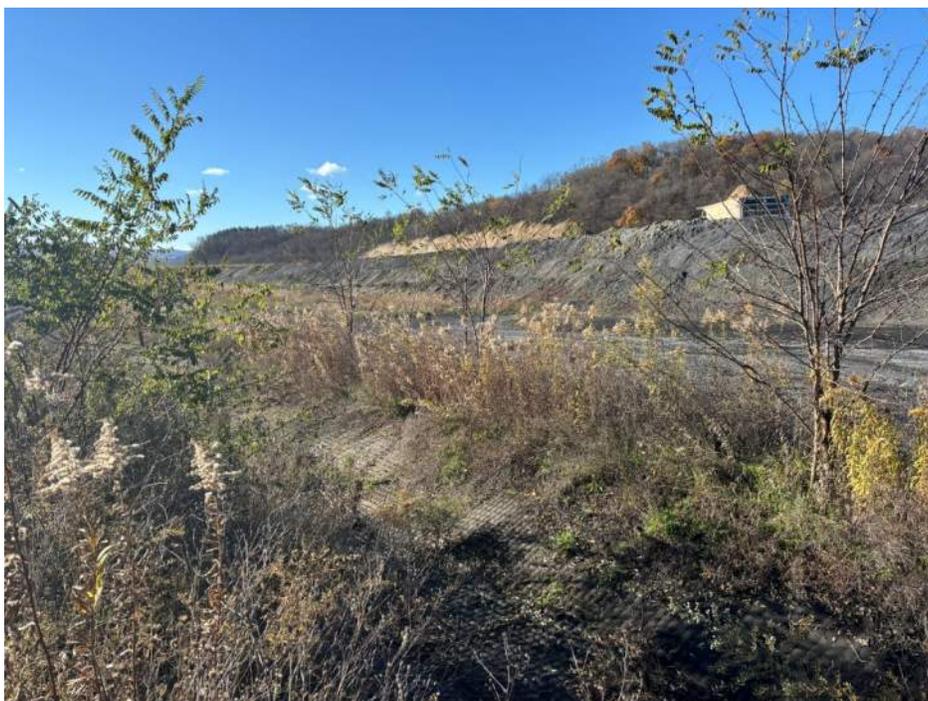
**Photograph 9. Saplings along Stage IIIA Collection Chanel to be removed; view west.**

1. Continue operation and maintenance in the active areas as currently performed.
2. Perform maintenance on the channels to clear sediment build up when necessary to maintain channel functionality.
3. Ensure adequate access to the closed portions of the landfill to maintain the ability to perform weekly visual site structural inspections.
4. Saplings identified along the inner edge of the Stage III collection channel should be removed as they may affect the anchor trench of the liner system in this area.
5. Downed tree across channel on the western side of the haul road should be removed to prevent obstruction of the channel.

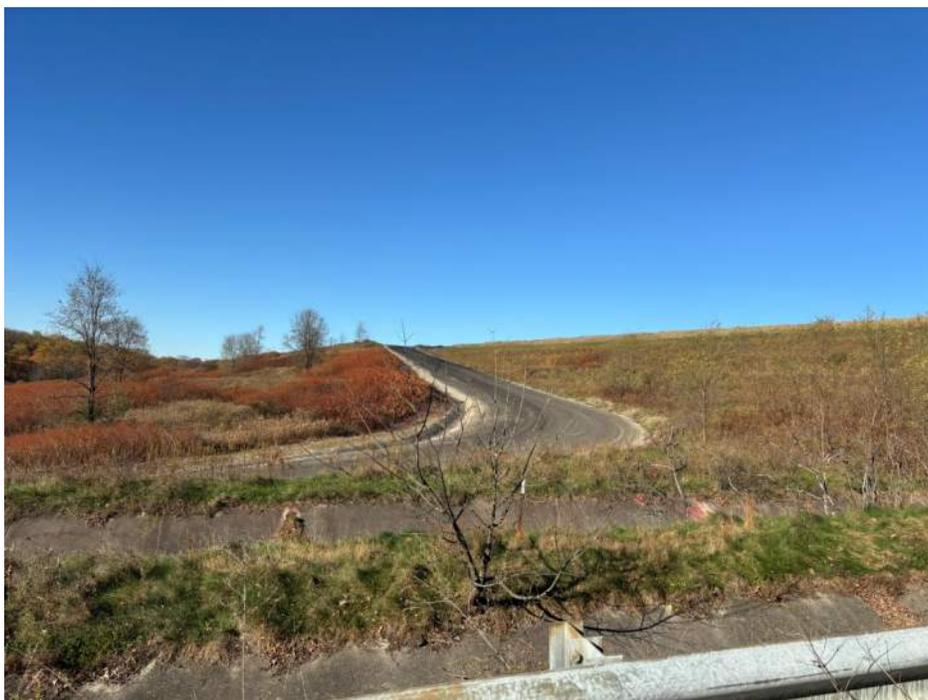
**Photograph 10. Haul road to Stage II; view west.**

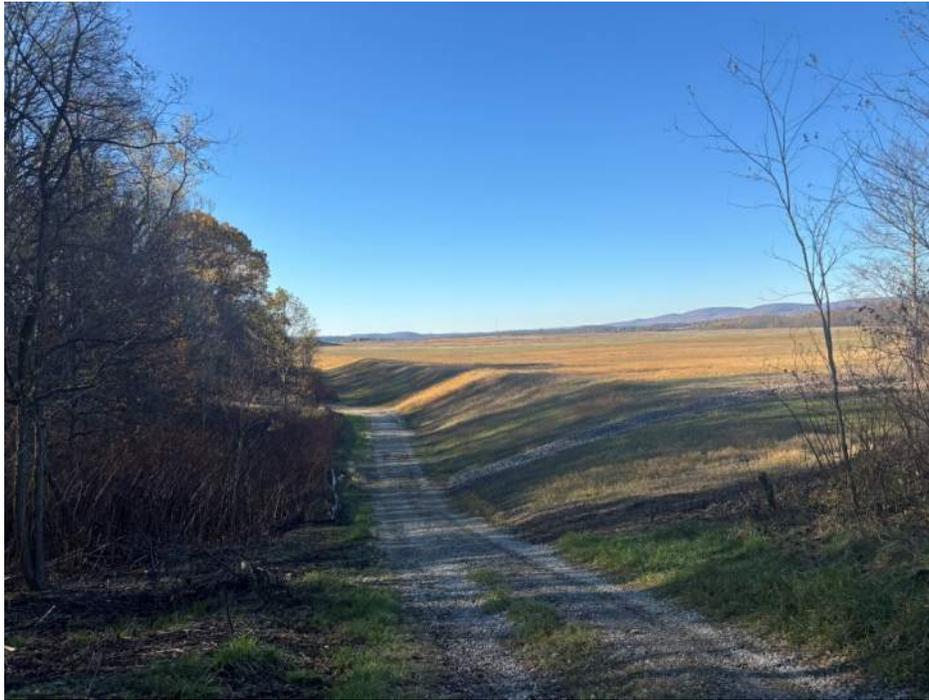
**Photograph 11. The recently capped and vegetated northeastern side of Stage II; view southwest.**

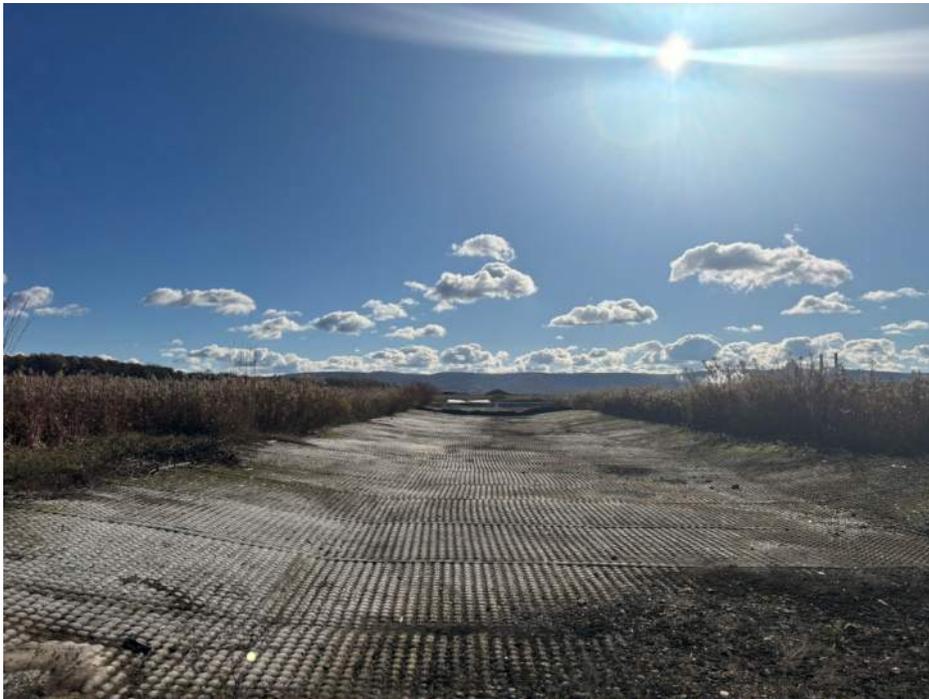
**Photograph 12. Stage II northwest top surface drainage channel; view southeast.**

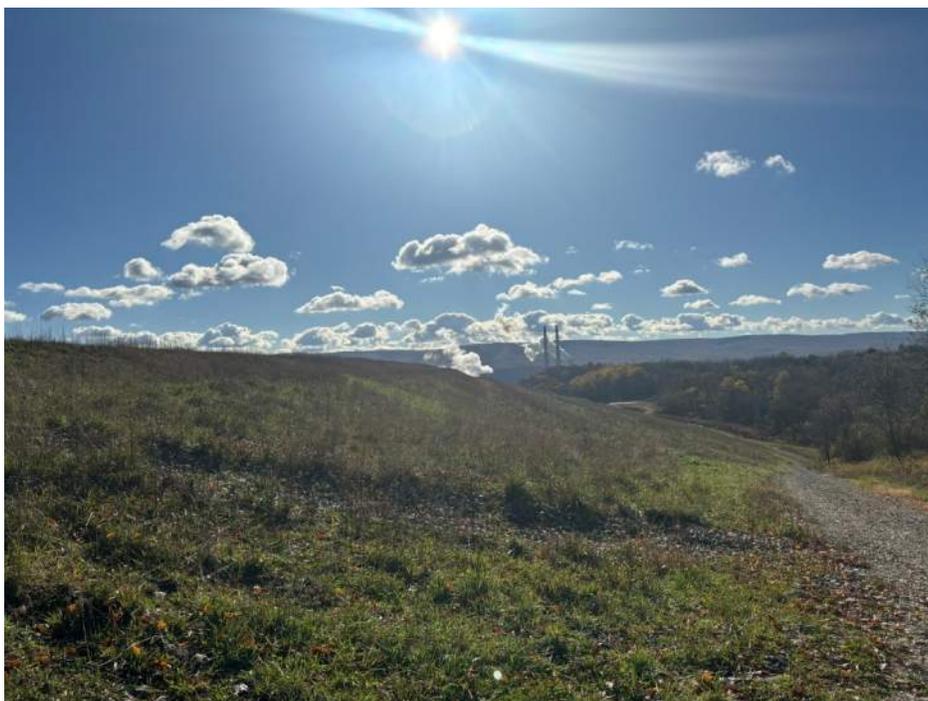
**Photograph 13. Capped Western benches of Stage II.**

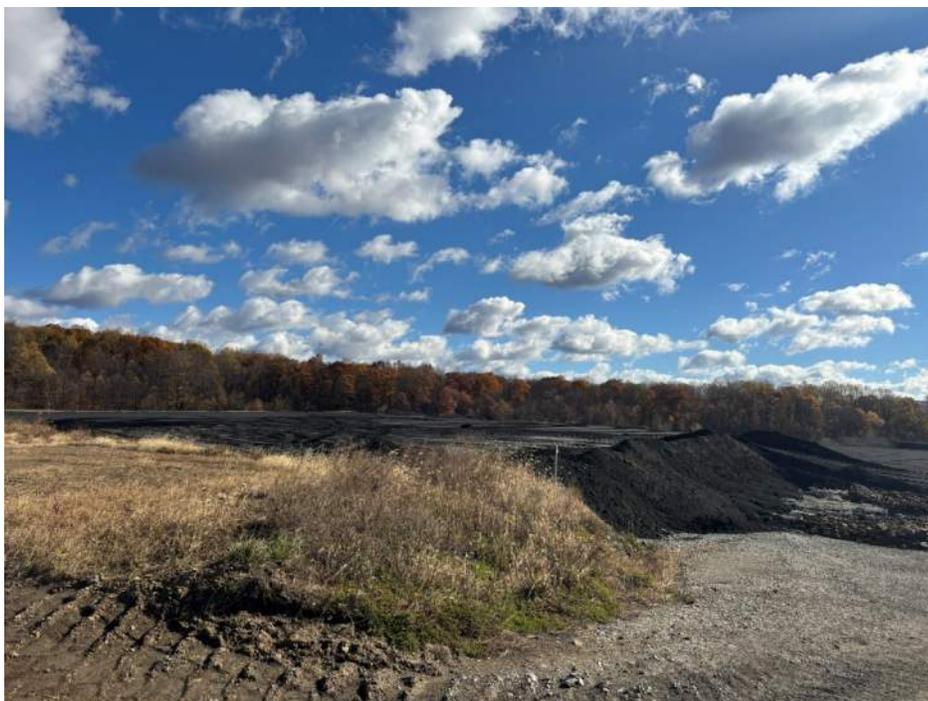
**Photograph 14. Northern portion of the active Stage II area; view east. Placement of recently disposed fly ash.**

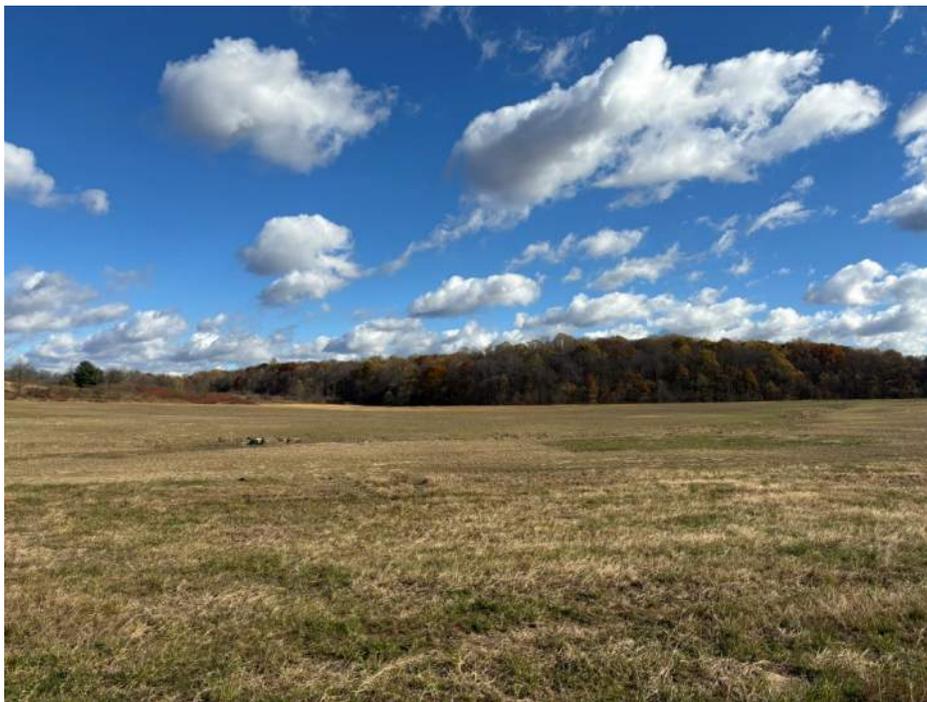
**Photograph 15. Recently capped top area of Stage II; view northeast.**

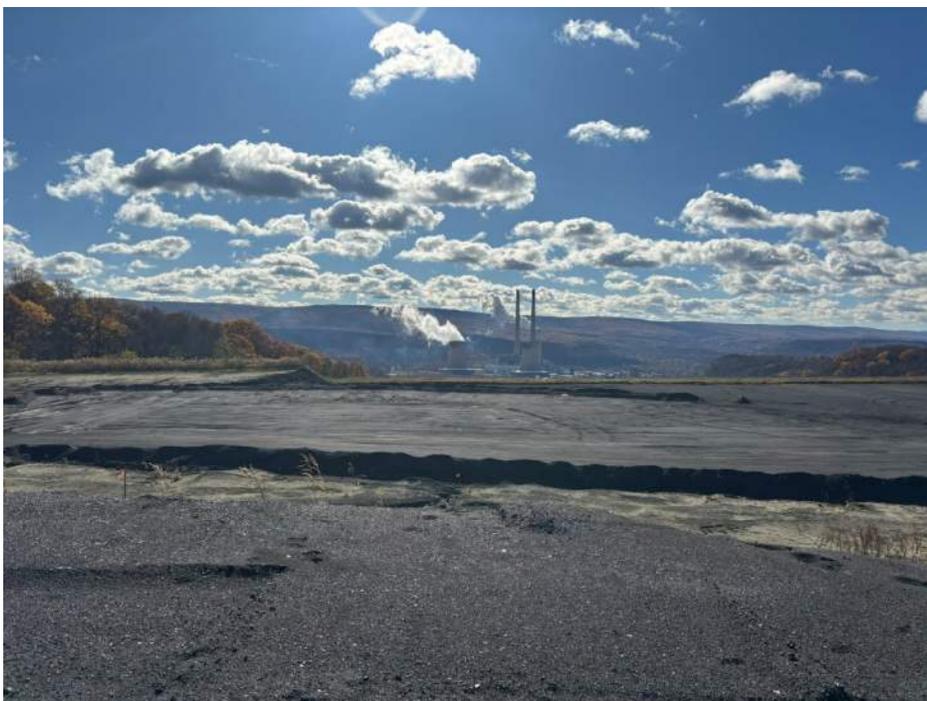
**Photograph 16. Southern portion of Stage II; view south.**

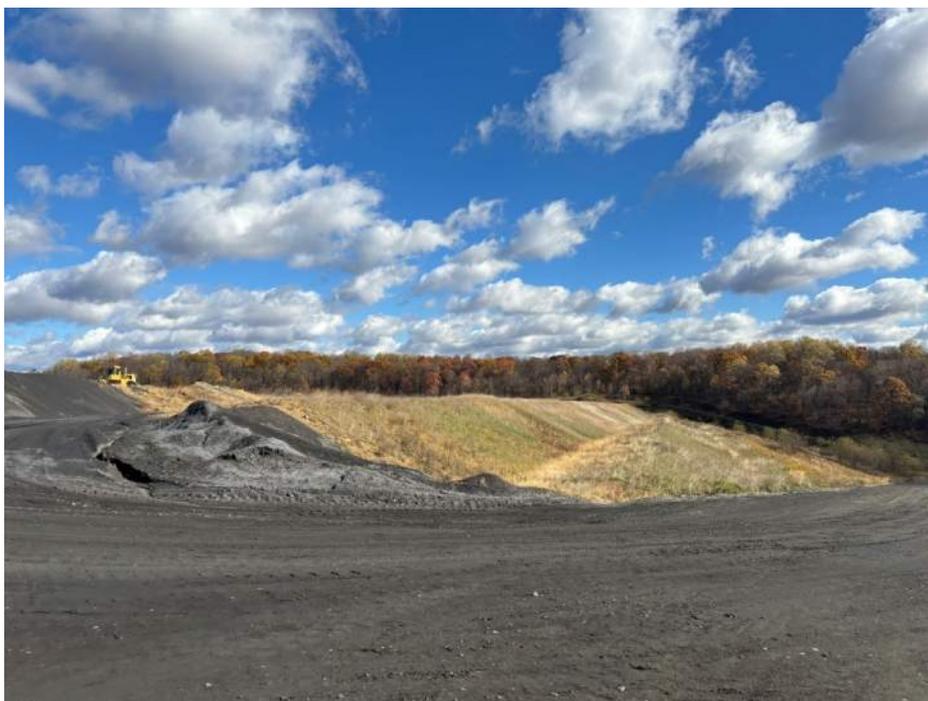
**Photograph 17. Southern benches of Stage II, view east.**

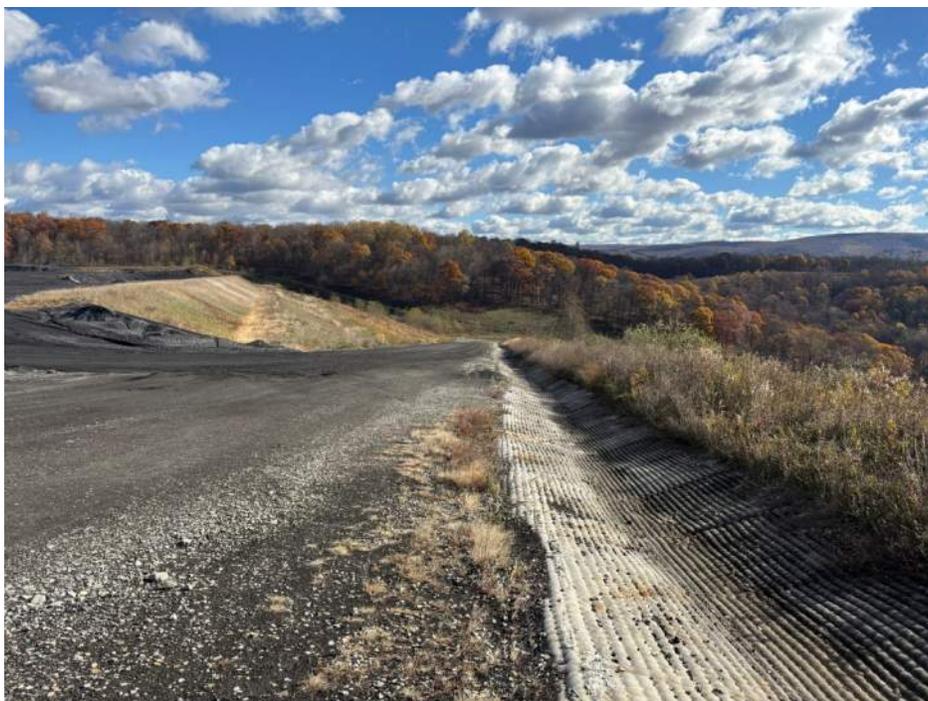
**Photograph 18. Stage II active disposal area (left), haul road (center), and haul road drainage channel (right); view east.**

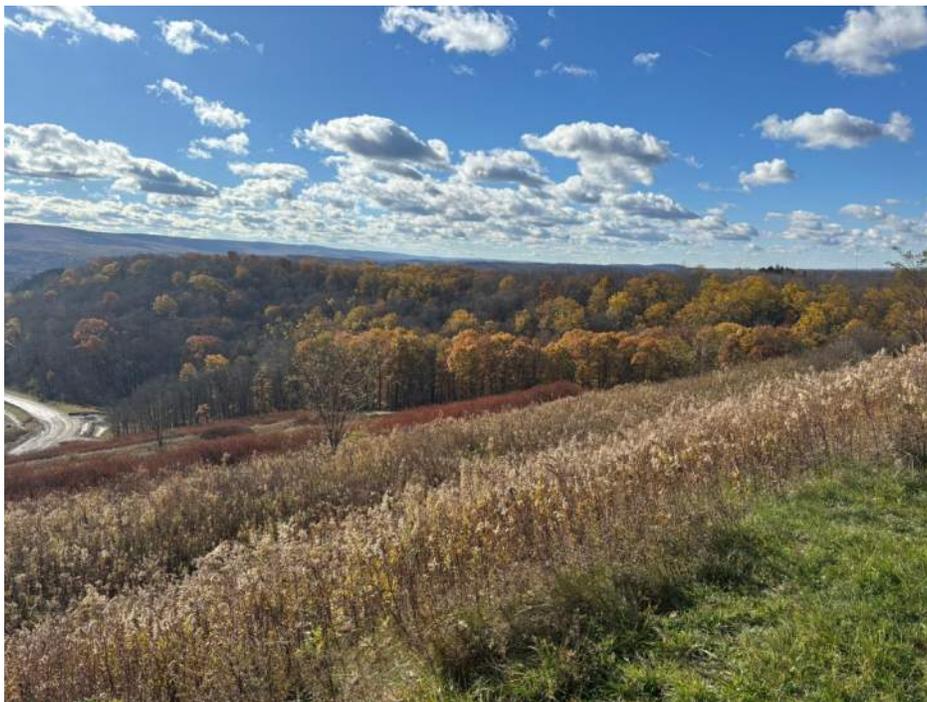
**Photograph 19. Southern slope benches of Stage II; view west.**

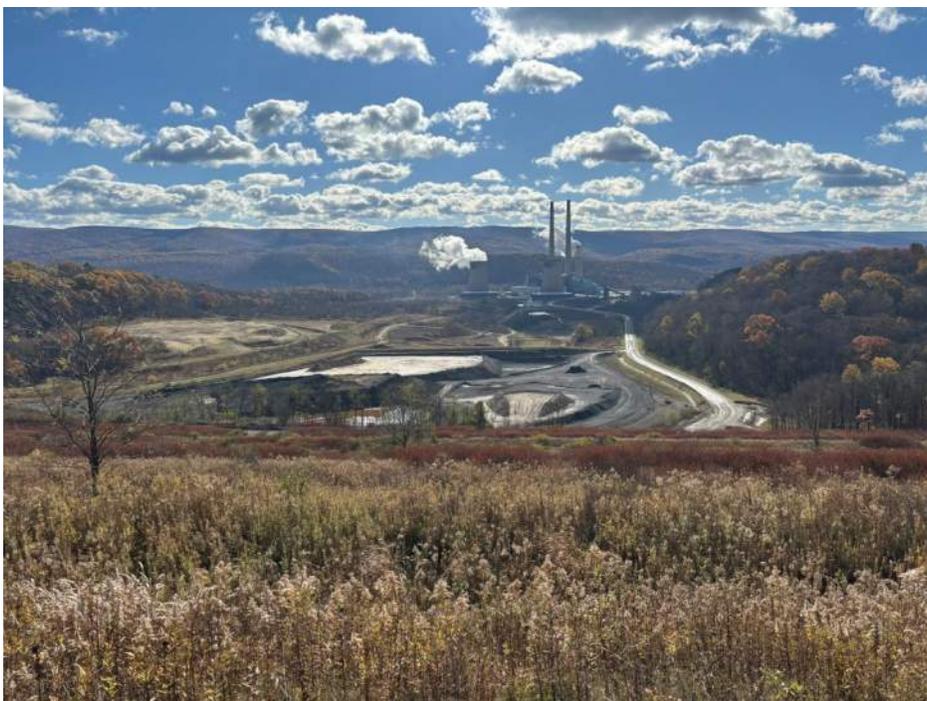
**Photograph 20. Stage II southern benches (foreground) and active Stage IIIA (background); view south.**

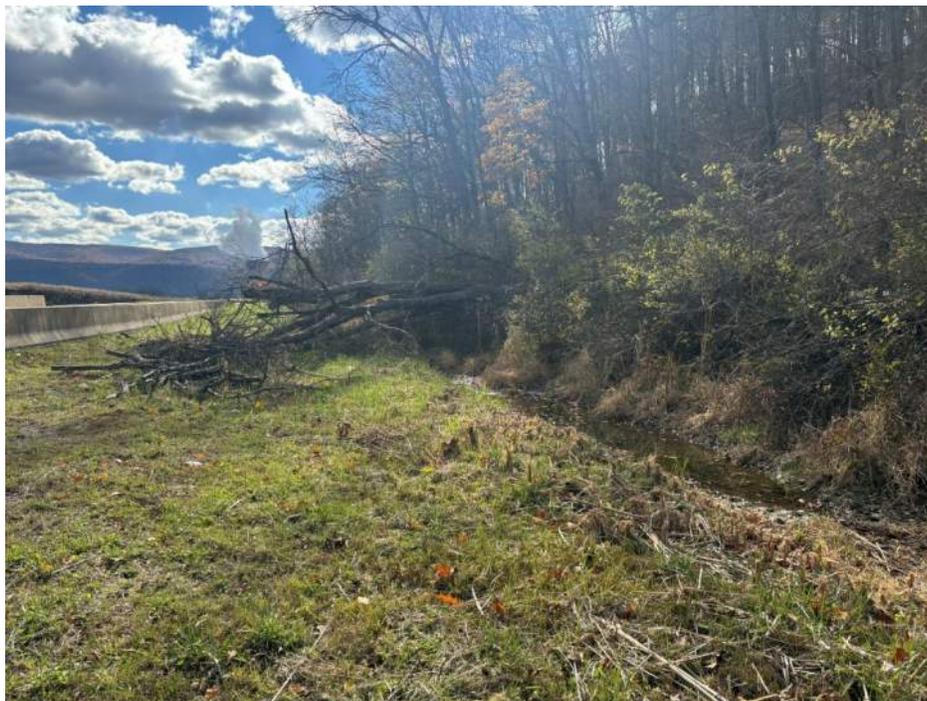
**Photograph 21. Downed tree in channel west of haul road; view south.**

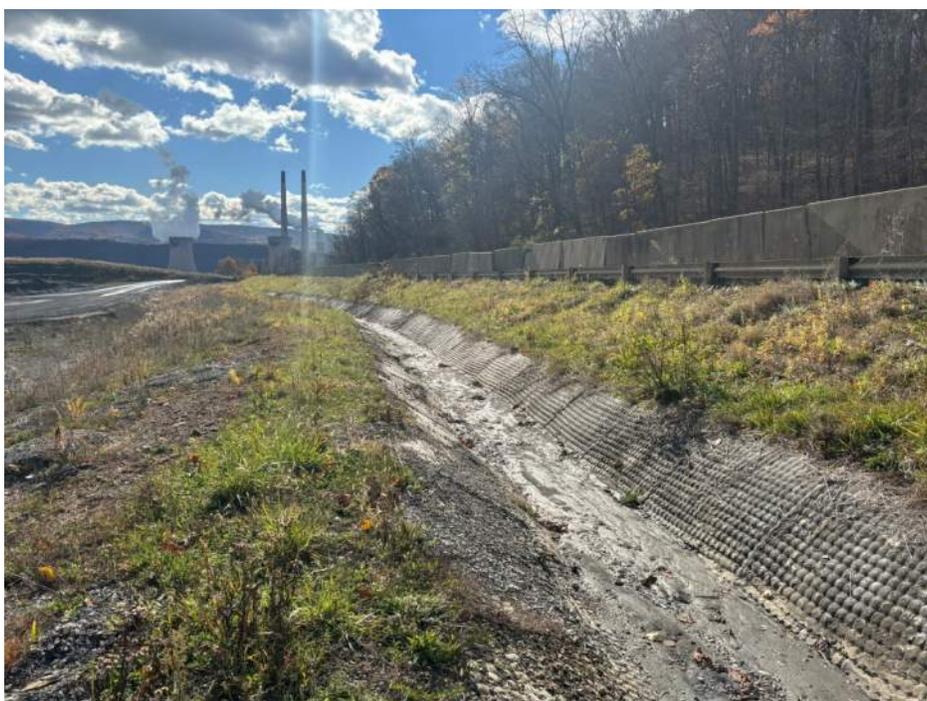
**Photograph 22. Haul road collection channel, view south. In the photo, Stage IIIA is to the left (east) and the paved haul road is to the right (west).**

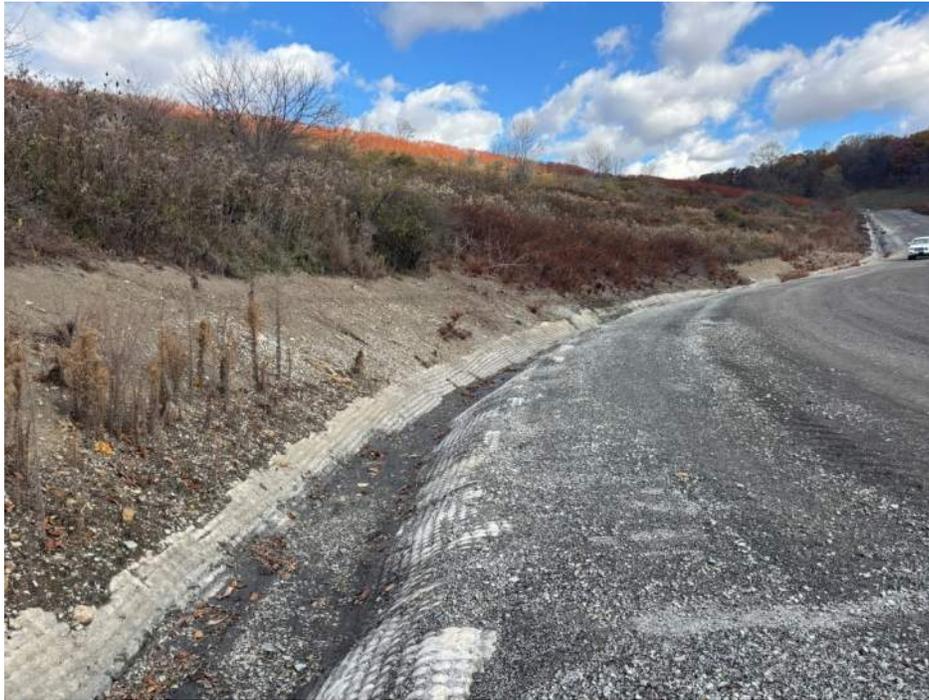
**Photograph 23. Channel along the Stage II haul road; view northeast.**

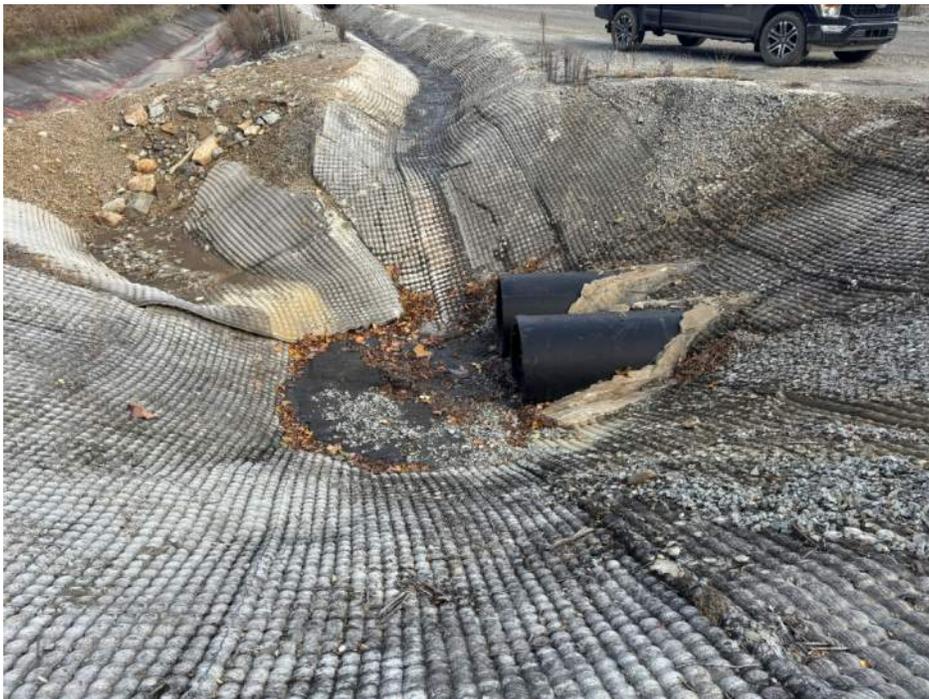
Stage II and IIIA disposal area stormwater channels, leachate collection, intermediate cover areas, and capped areas (Stage II only) are functioning as intended. The channels throughout the site appeared to be in functioning condition. Minor sediment build up was noted at the entrance to several culvert

locations but sediment build up was within normal operating standards and maintenance is not required at this time. With no evidence to the contrary, the bottom liner systems for the Stage II and IIIA disposal areas are believed to be in good operating condition and functioning as intended.

**Photograph 24. West Diversion Channel and Culvert 8 with minor sediment build up, adjacent to Stage IIIA, along the Stage II haul road; view north.**

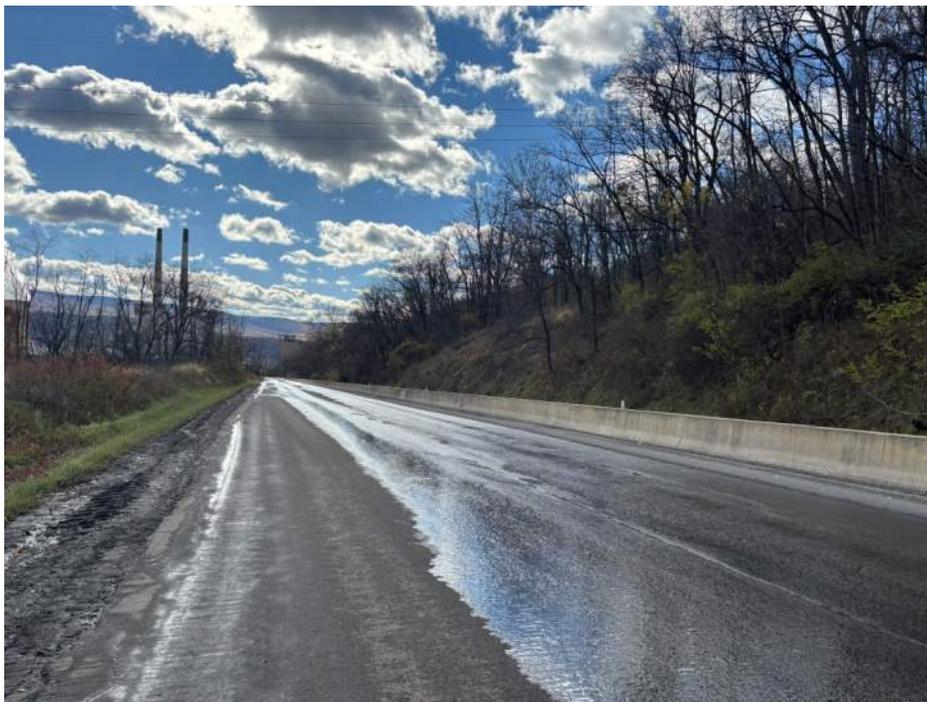
**Photograph 25. Haul road south of Stage IIIA; view south.**

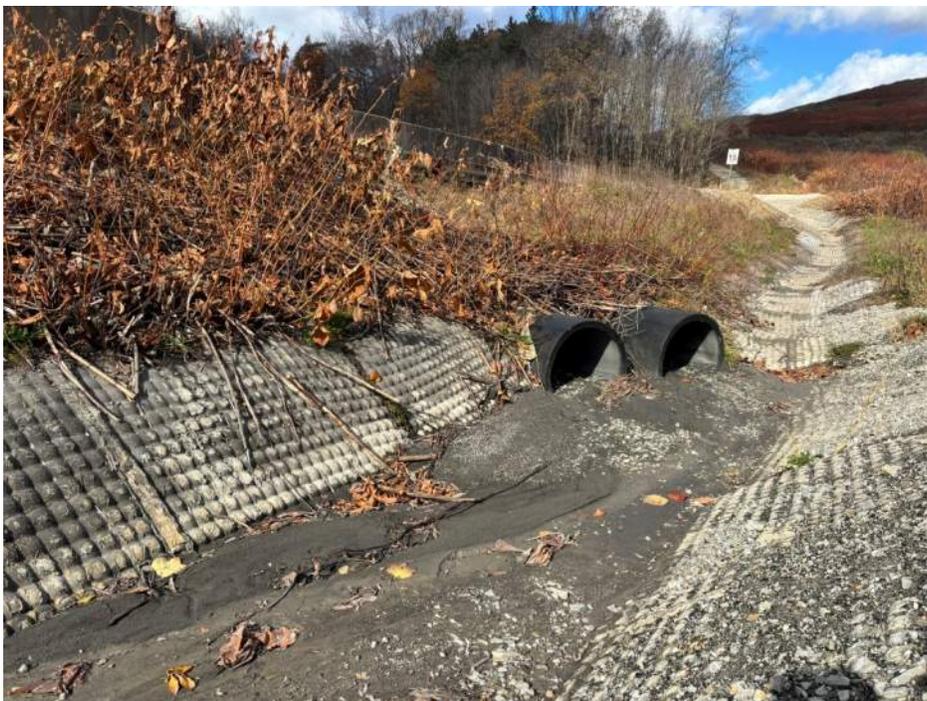
**Photograph 26. Haul road collection channel and culvert with sediment build up; view north.**
