Coal Combustion Residuals Annual CCR Unit Inspection Report for Reporting Year 2025

Keystone-Conemaugh Projects, LLC
Keystone Station Ash Disposal Site
Keystone Generating Station
Shelocta, Pennsylvania

GAI Project Number: C151611.11
January 2026

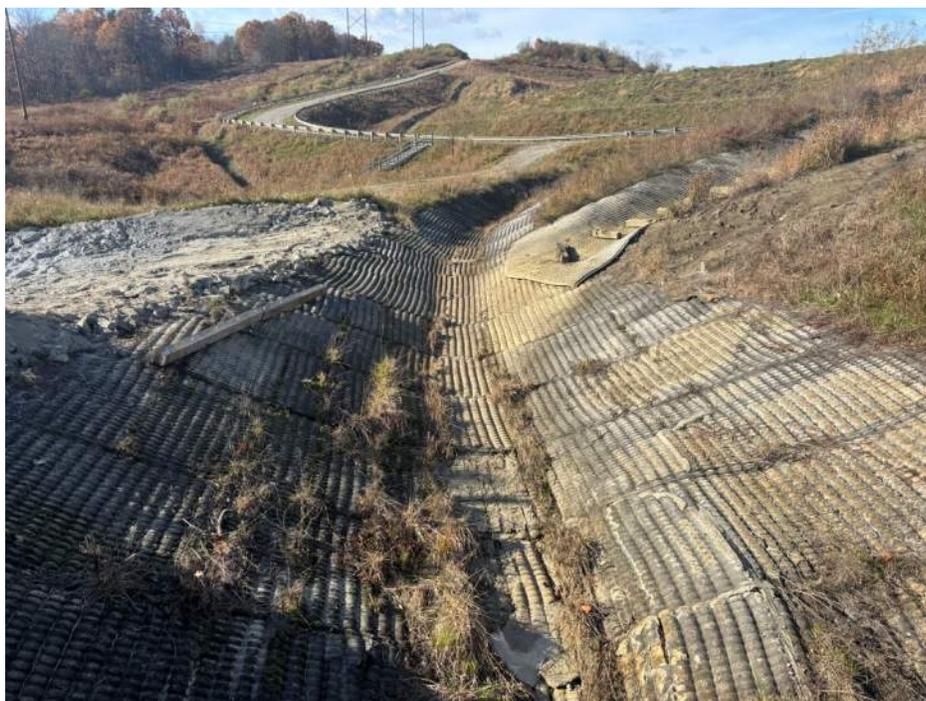
Photograph 1. Stage IV collection channel to West Valley Equalization Pond and Stage IV toe in background, view north.

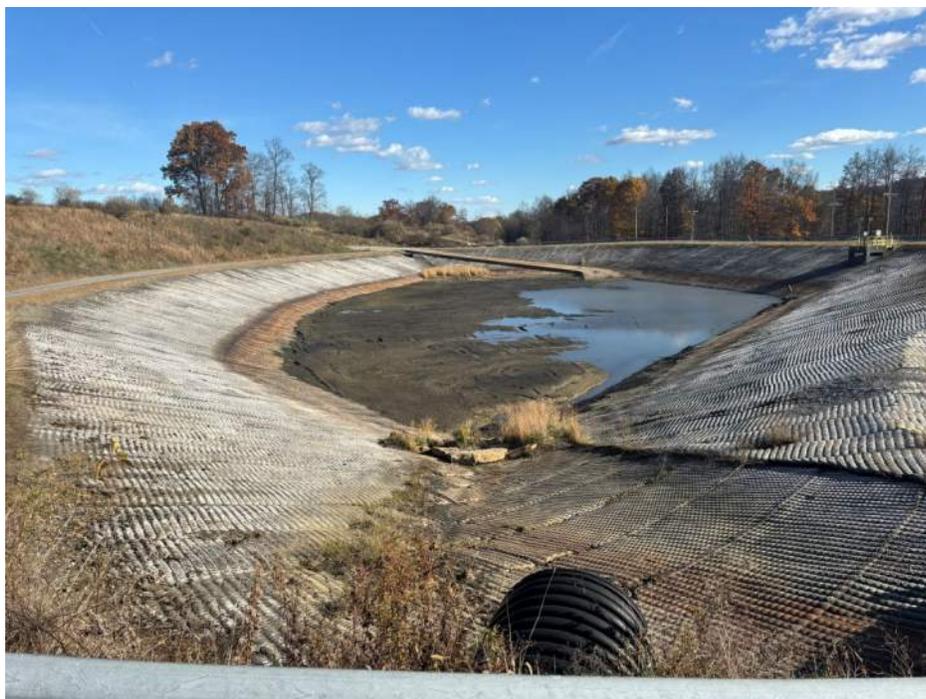
Photograph 2. West Valley Equalization Pond, view southwest.

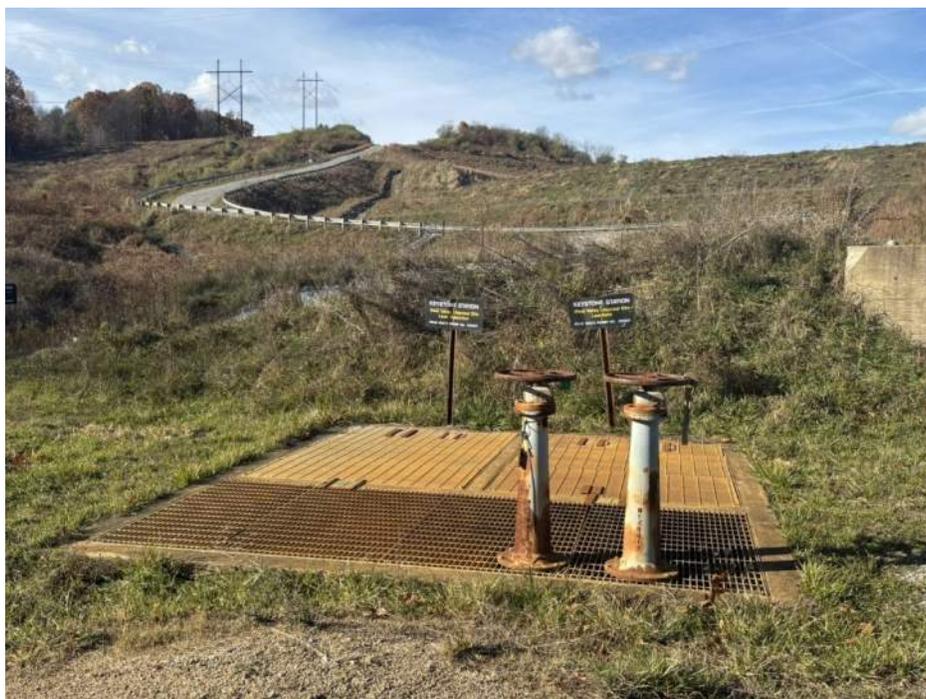
Photograph 3. West Valley Leachate Detection and Leachate Collection Box.

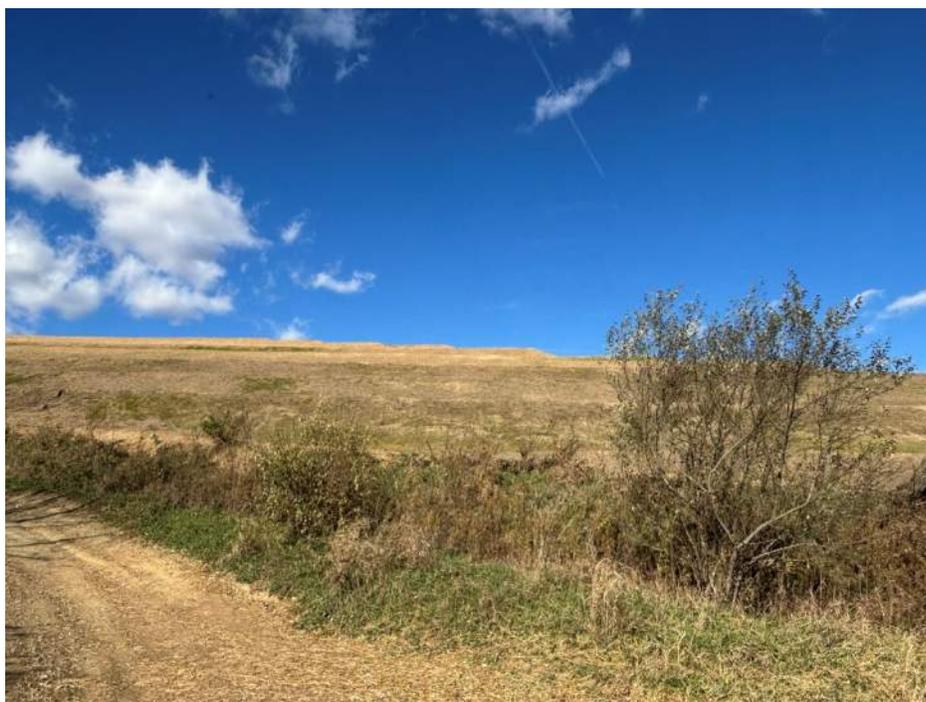
Photograph 4. Northwest view of the recently capped East Valley south facing benches.

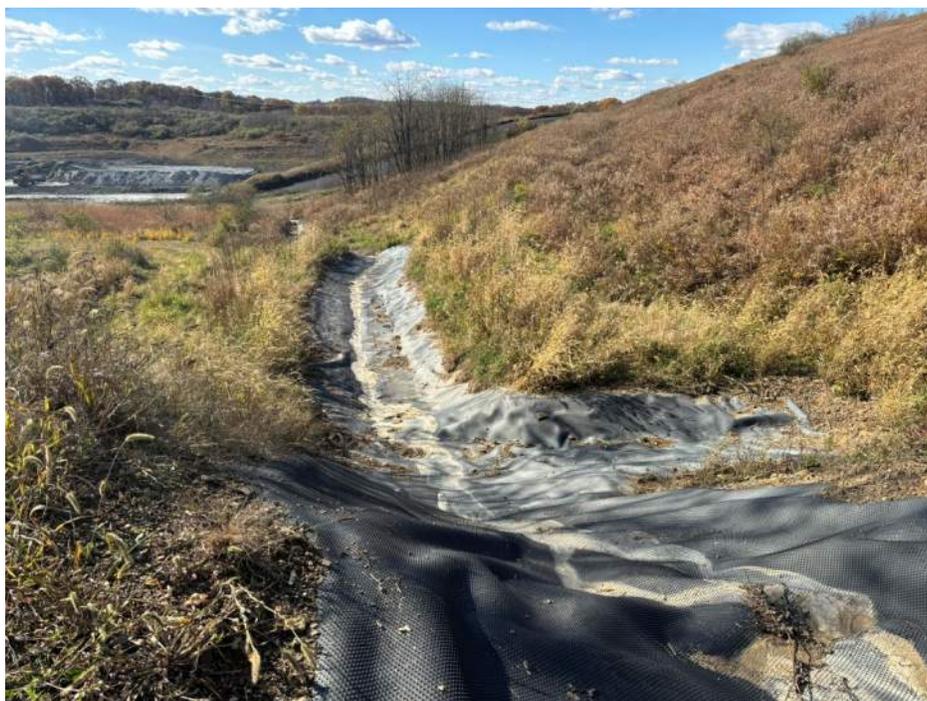
Weekly inspections: A review of weekly inspections has concluded that no significant deficiencies occurred at the facility. On the March 19th weekly inspection, an area of erosion internal to the Stage II and Stage III areas was discovered and remedial actions were taken to repair the erosion of the affected intermediate cover. Additional erosion and sedimentation controls were installed.

Photograph 5. Erosion repair of the affected intermediate cover area internal to Stage II and Stage III.

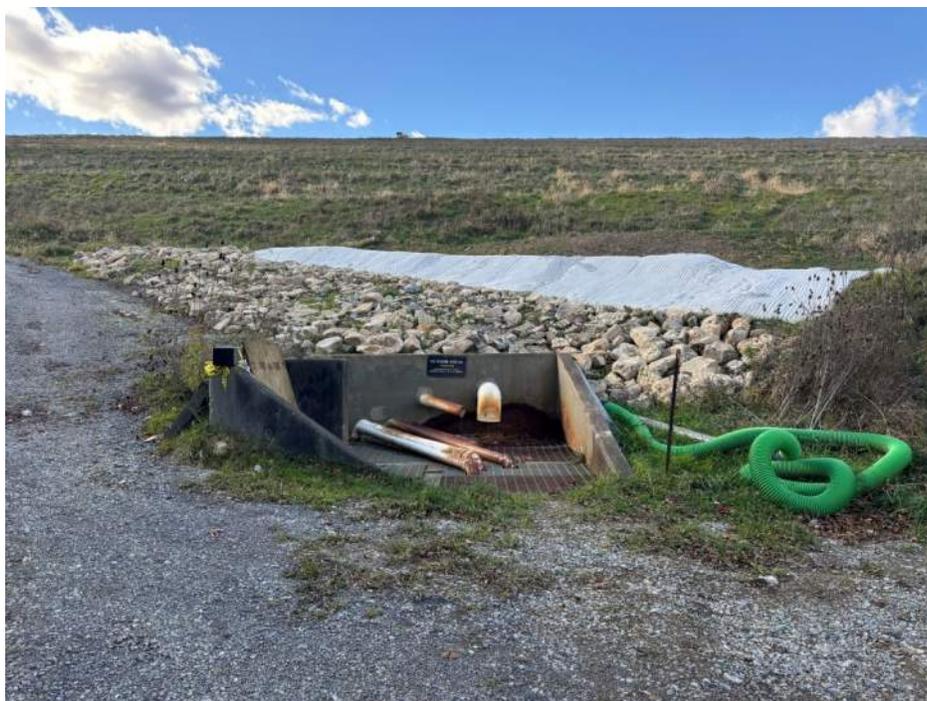
Photograph 6. East Valley Leachate Collection Box, view west.

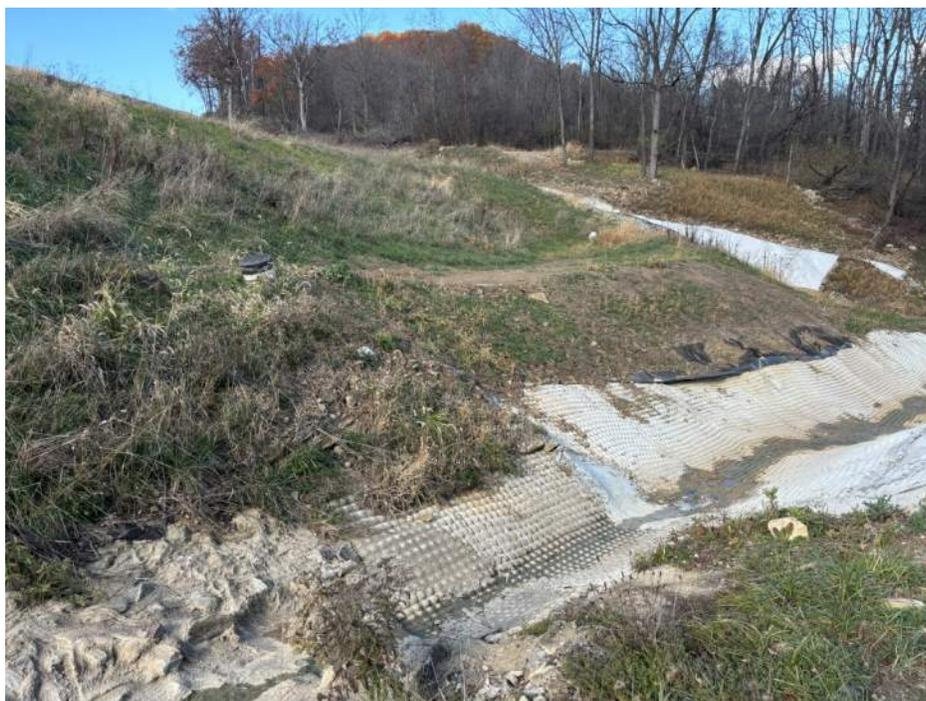
Photograph 7. Leachate Seep Collection Pipes and East Valley Collection Channel at toe area, view east.

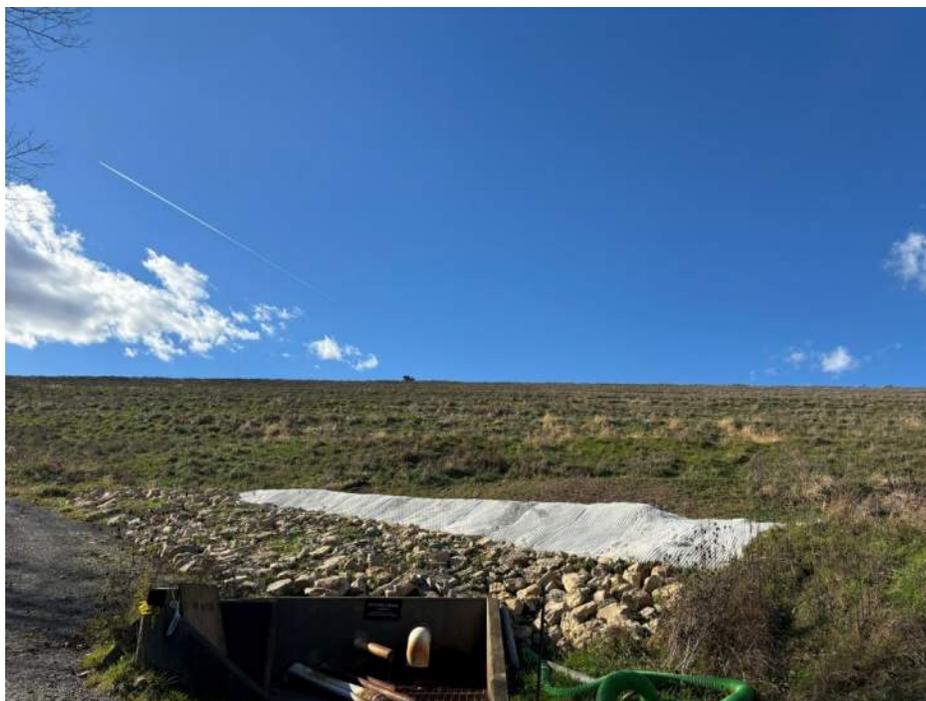
Photograph 8. East Valley Toe and recently capped east facing benches, view west.

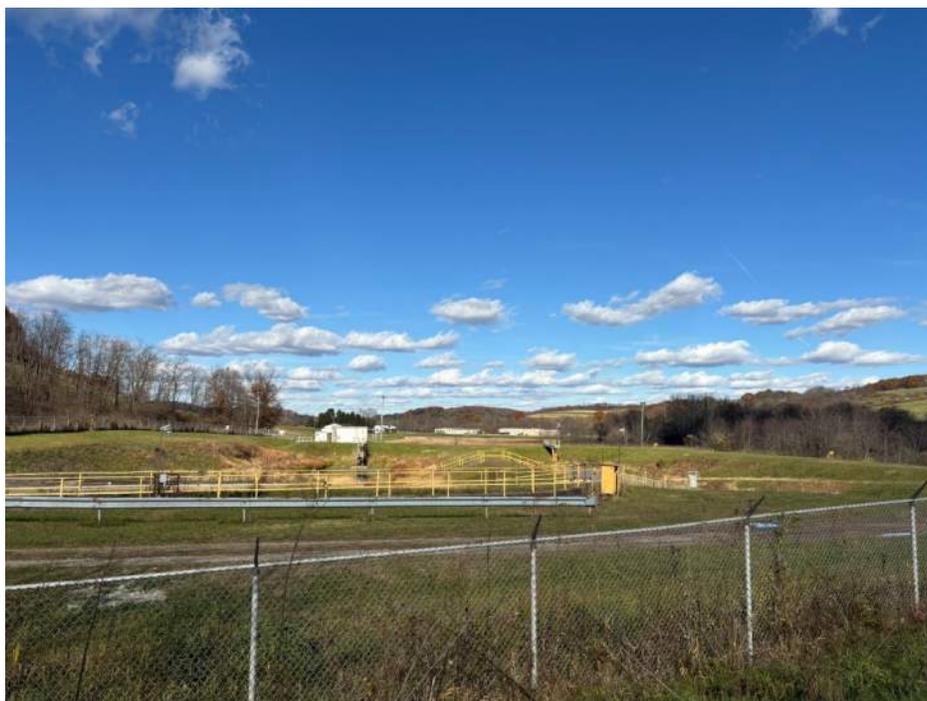
Photograph 9. View north of idled East Valley Equalization Ponds.

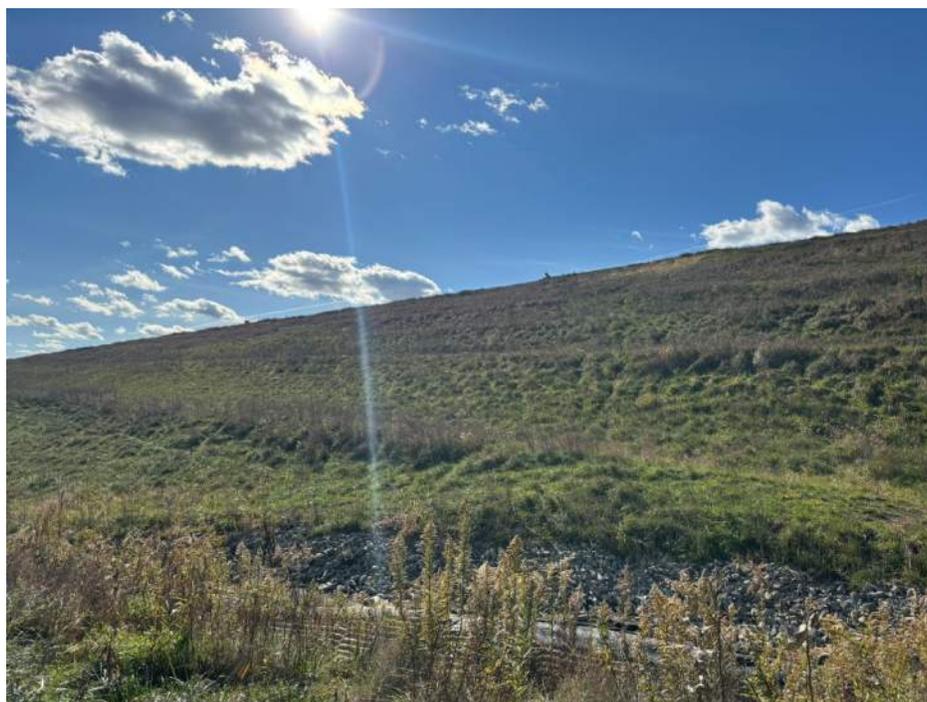
Photograph 10. Capped East Valley, east facing benches, view south.

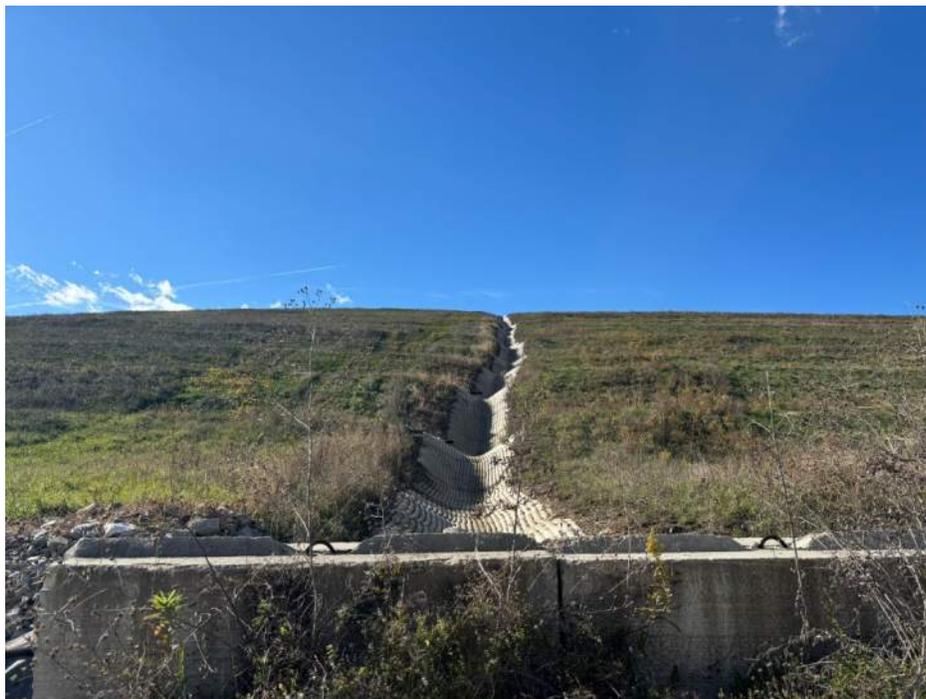
Photograph 11. Re-established East Valley collection channel from 2024 capping construction activities, view west.

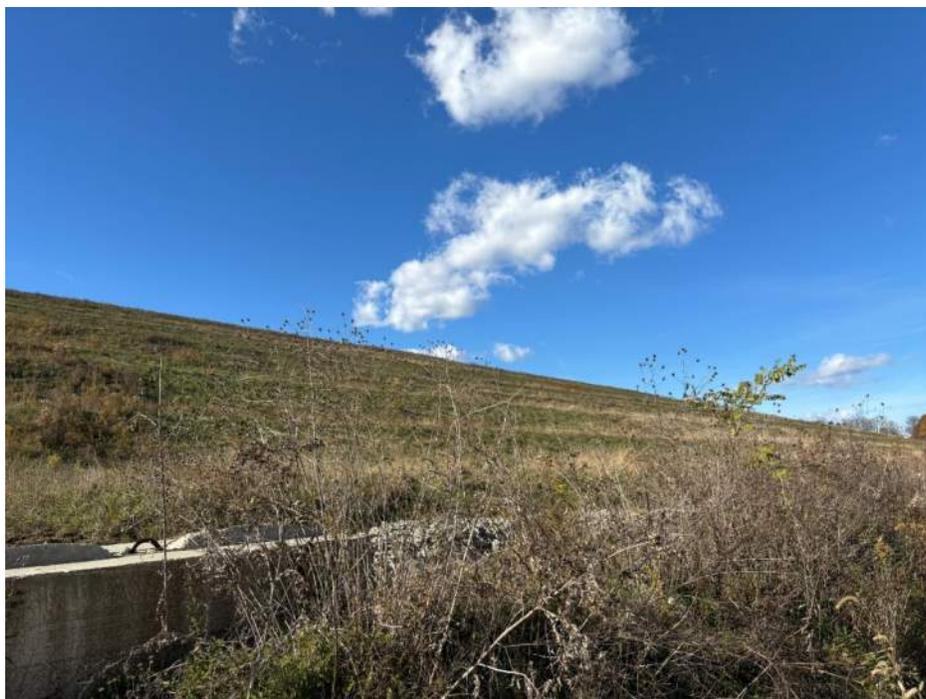
Photograph 12. Capped East Valley east facing benches and Stage I/II collection channel, view north.

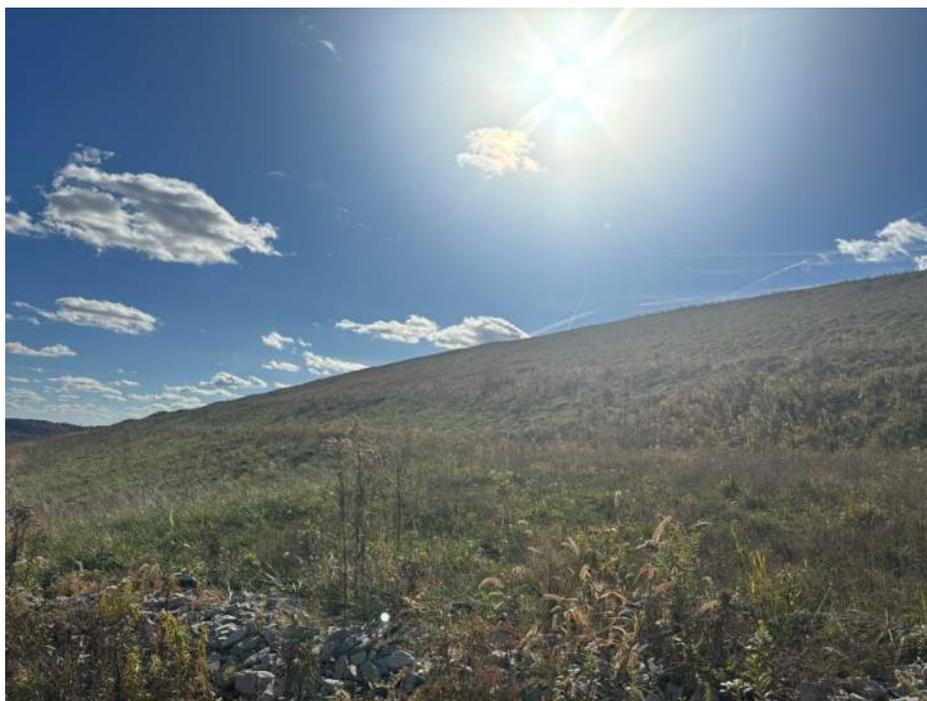
Photograph 13. Capped East Valley east facing benches, view south.

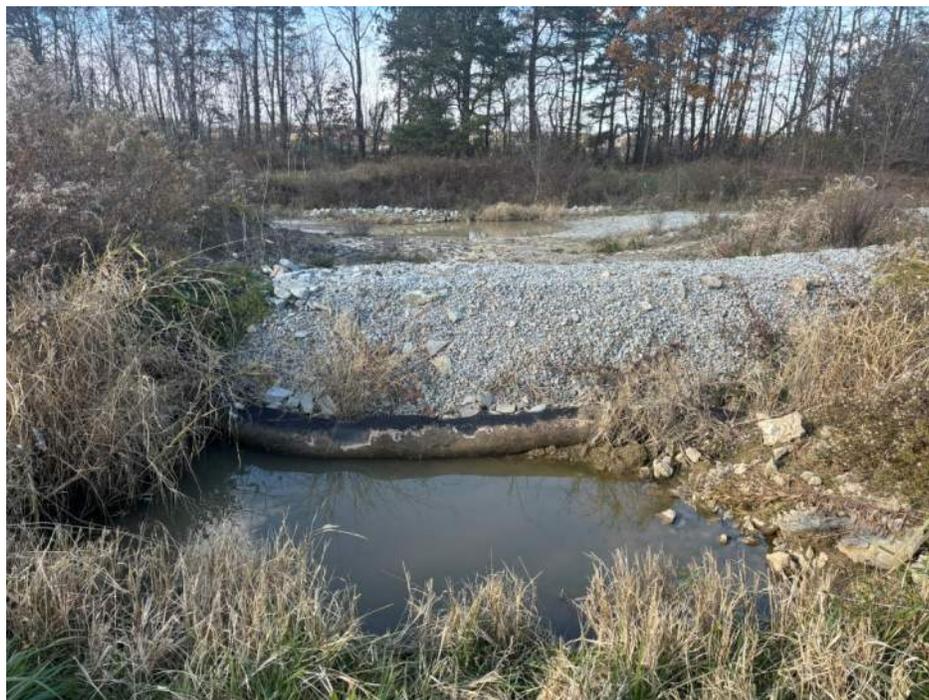
Photograph 14. Stage I/II revegetated top surface drainage swale, north end.

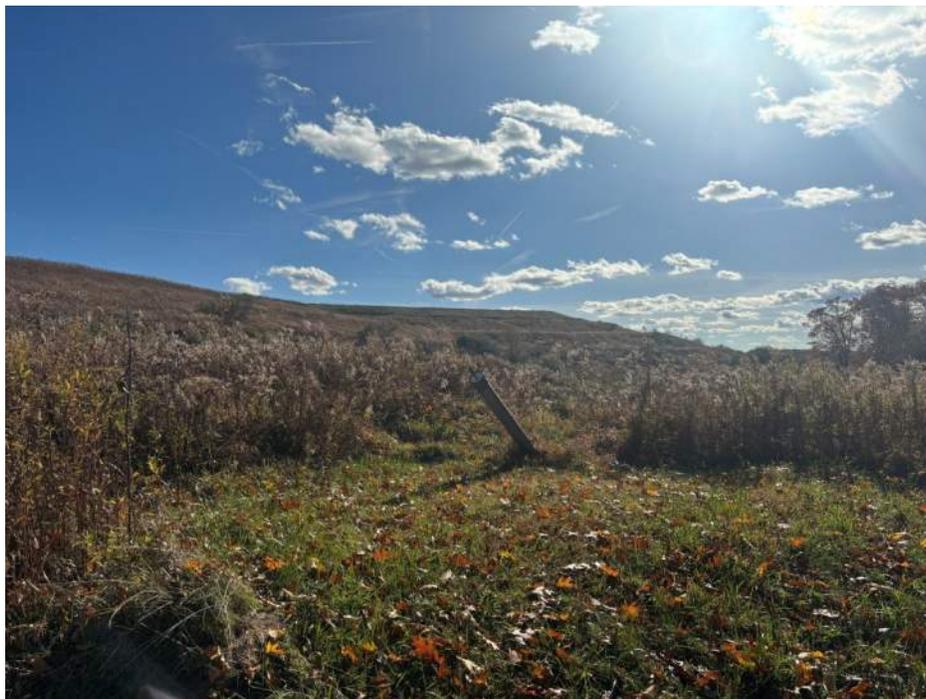
**Photograph 15. Foreground – Stage 1 west facing benches and leachate pipe cleanout.
Background – Stage III west facing benches.**

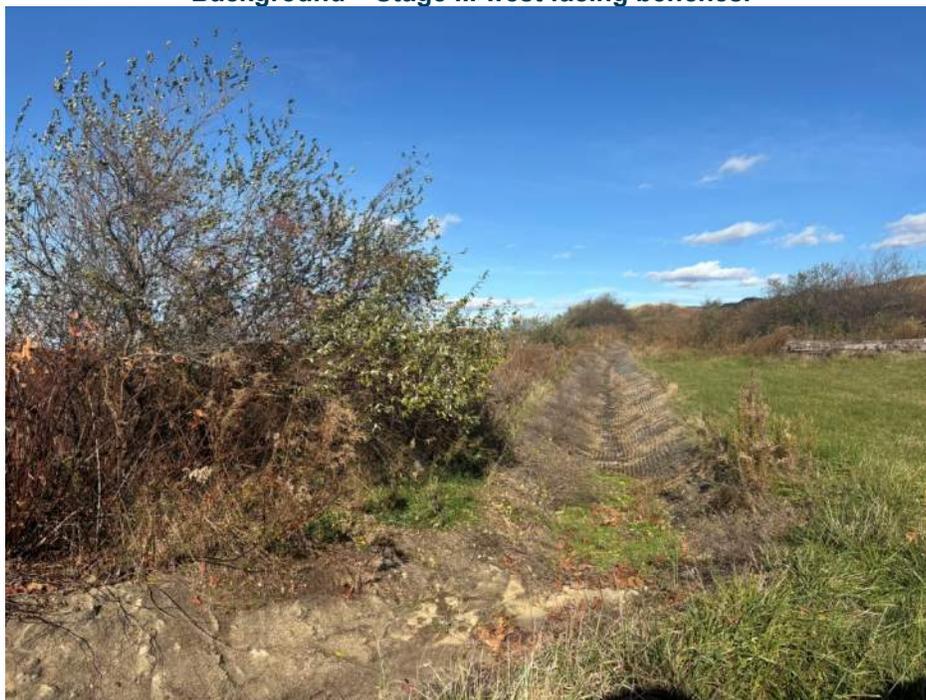
Photograph 16. West Valley Stage III Diversion Channel, view north.

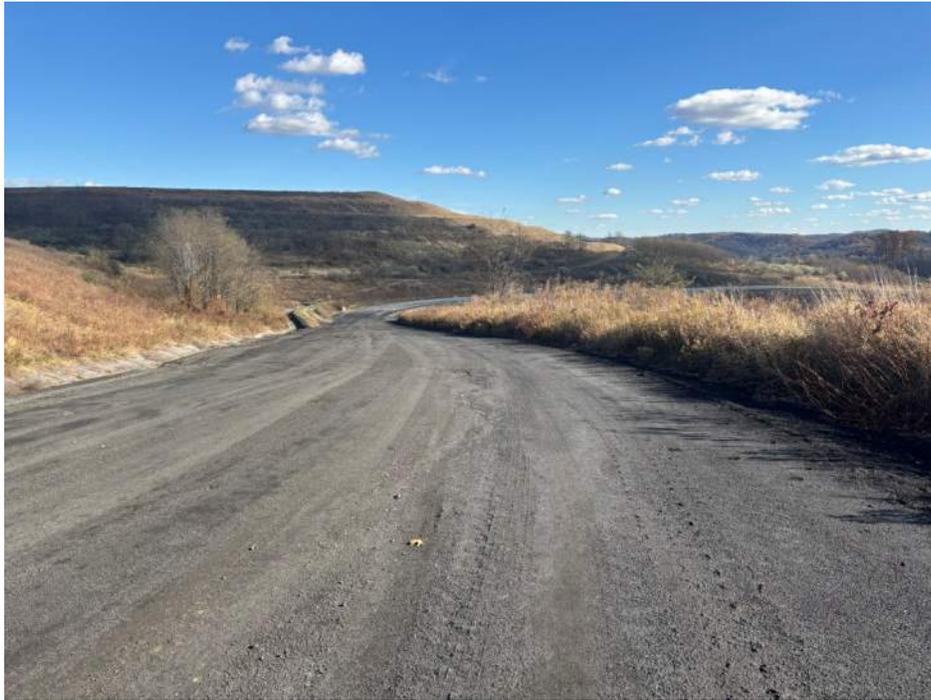
Photograph 17. Stage III Haul Road and view of the East Valley Benches, view southeast.

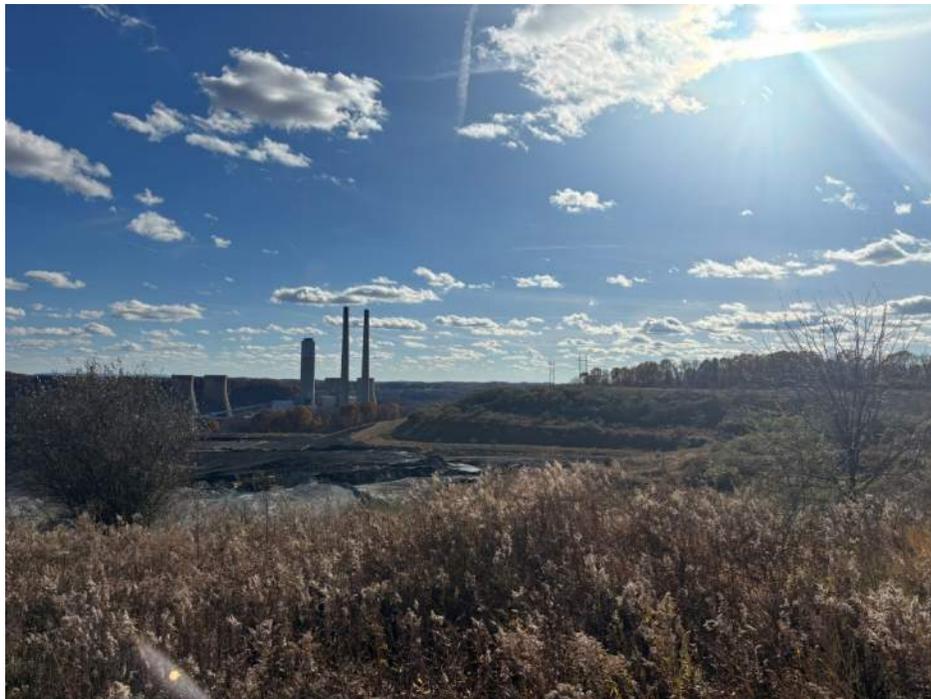
Photograph 18. West Valley Stage IV, view southwest.

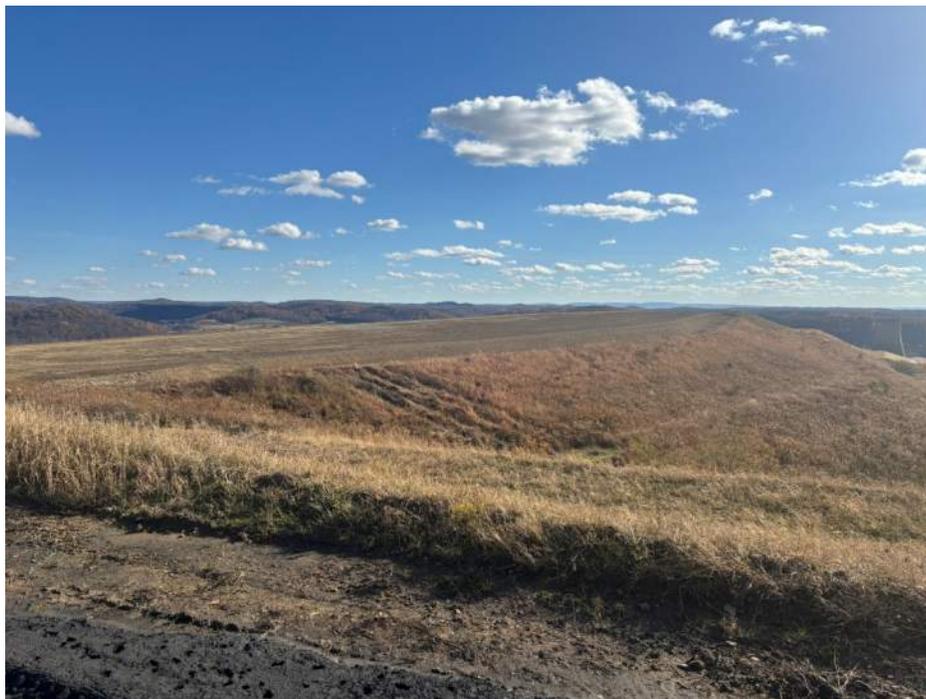
Photograph 19. East end of revegetated East Valley Stage II top.

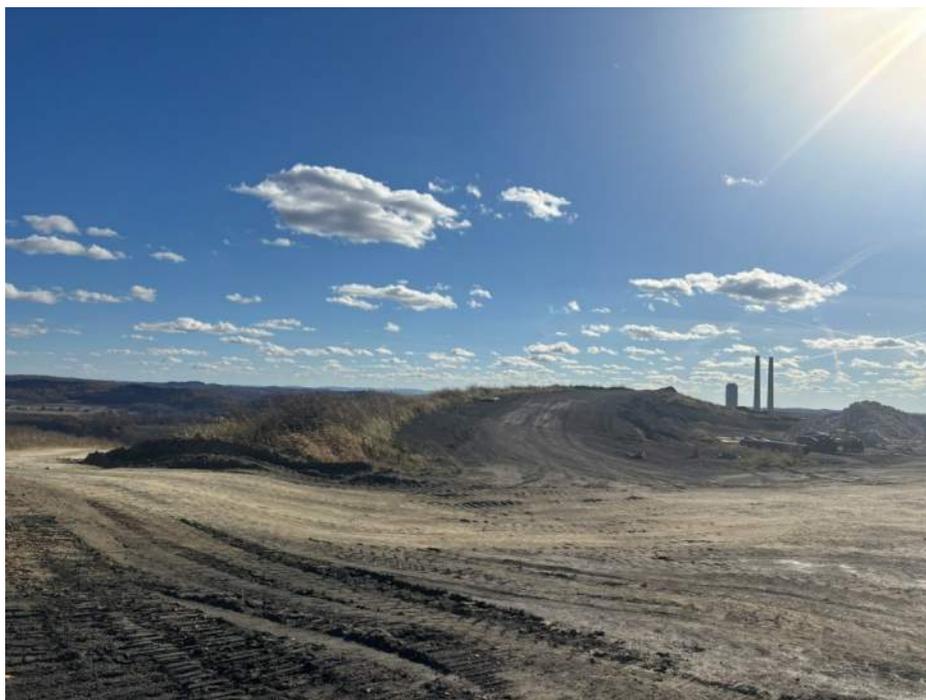
Photograph 20. Eastern side of active West Valley Stage III, view south.

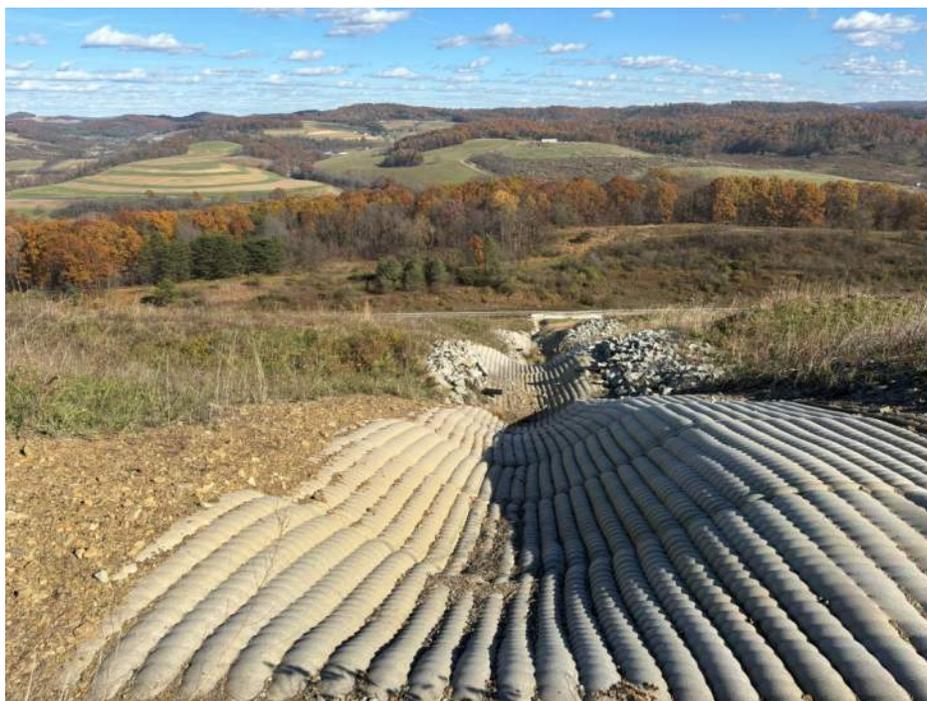
Photograph 21. East Valley Slope Drain, view east from Stage III top.

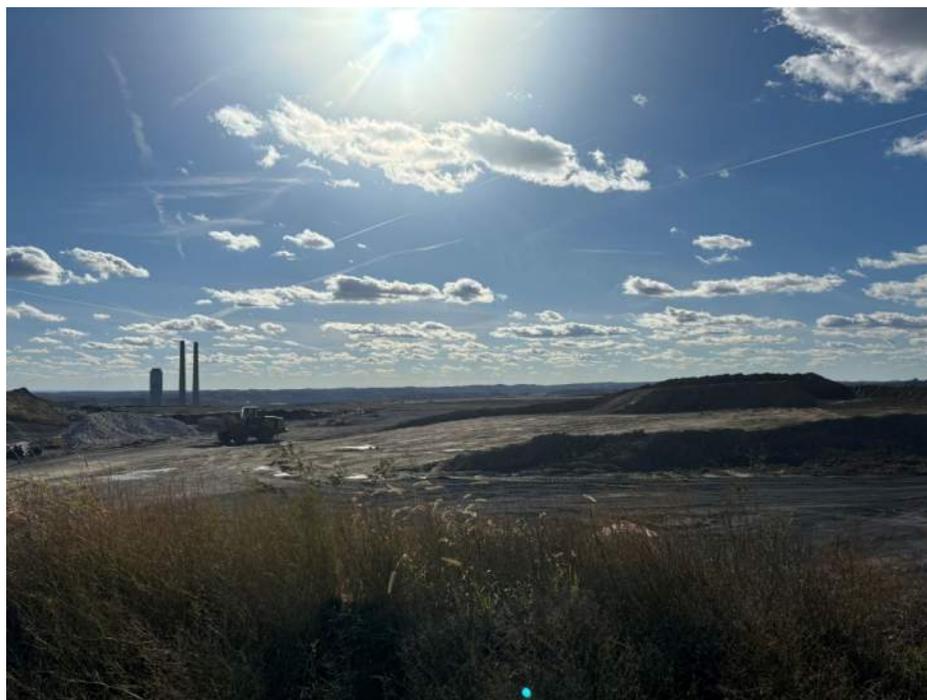
Photograph 22. Active top of West Valley Stage III.

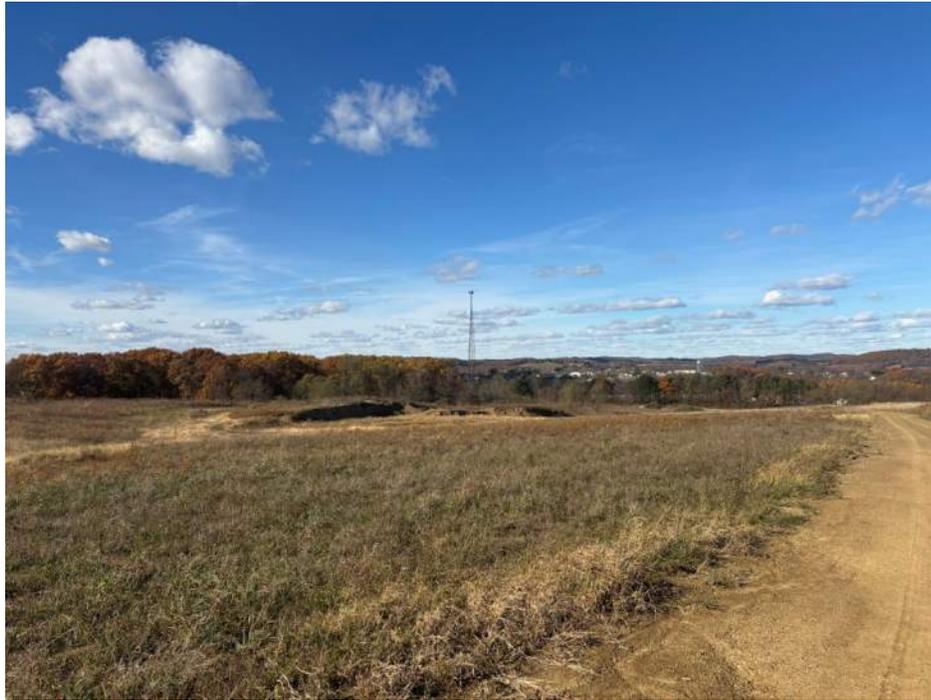
Photograph 23. North end of revegetated Stage III top.

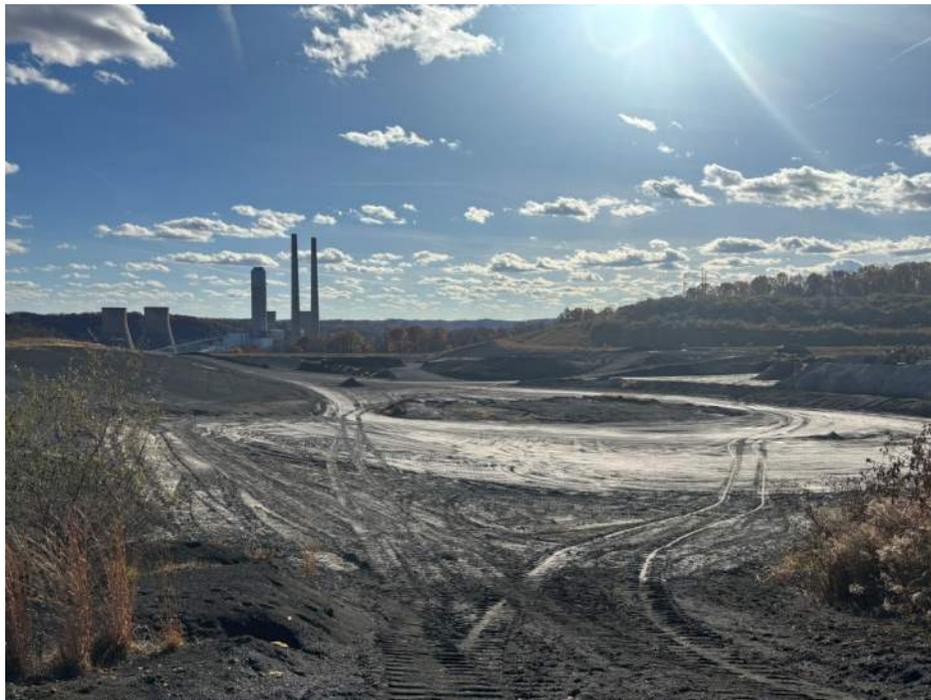
Photograph 24. Gypsum being loaded out of a stockpile in Stage IV for beneficial use.

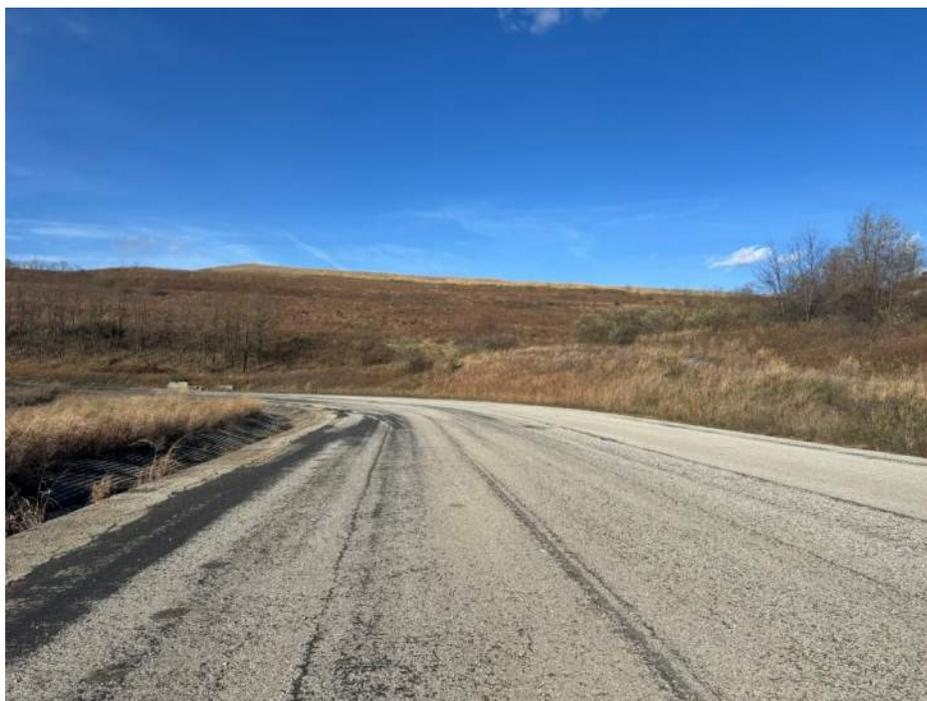
Photograph 25. West Valley Stage III haul road and benches.

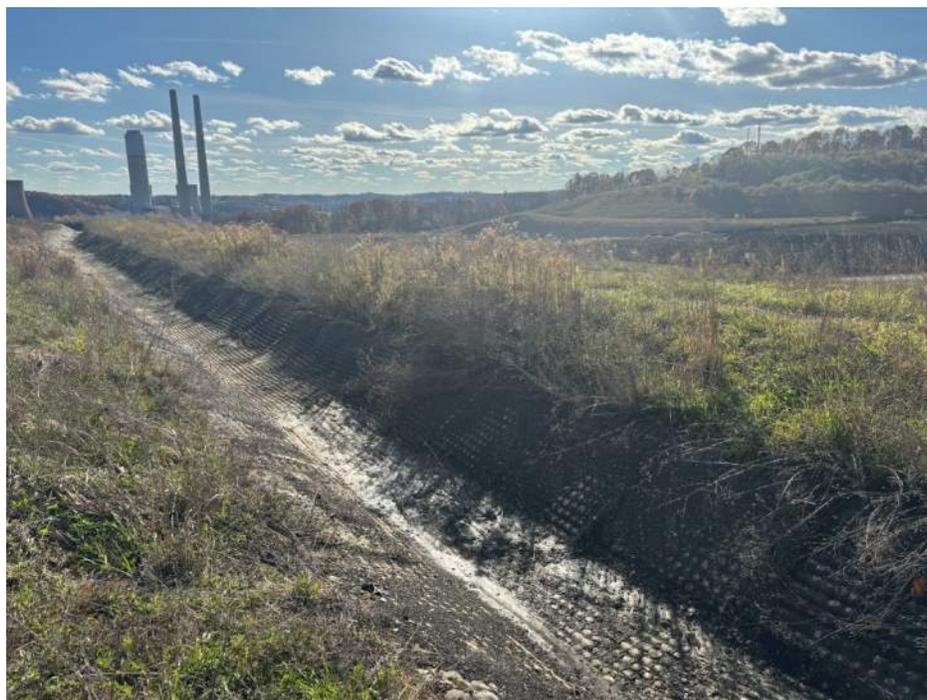
Photograph 26. West Valley Stage IV and haul road collection channel, view south.

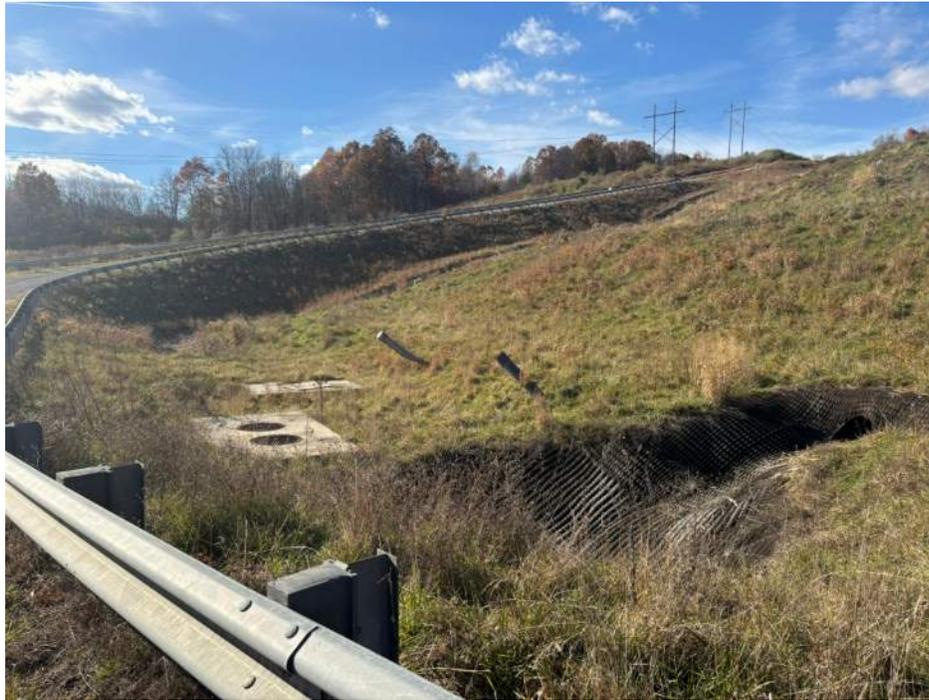
Photograph 27. View of the West Valley Stage IV toe access road, view west.
