Inspection Report

To: Nate Rozic (Keystone Generating Station)
From: Richard Southorn, P.E., P.G.
Re: Keystone Ash Disposal Site – Annual CCR Unit Inspection Report
Inspection Date: October 21, 2019
Report Date: January 16, 2020

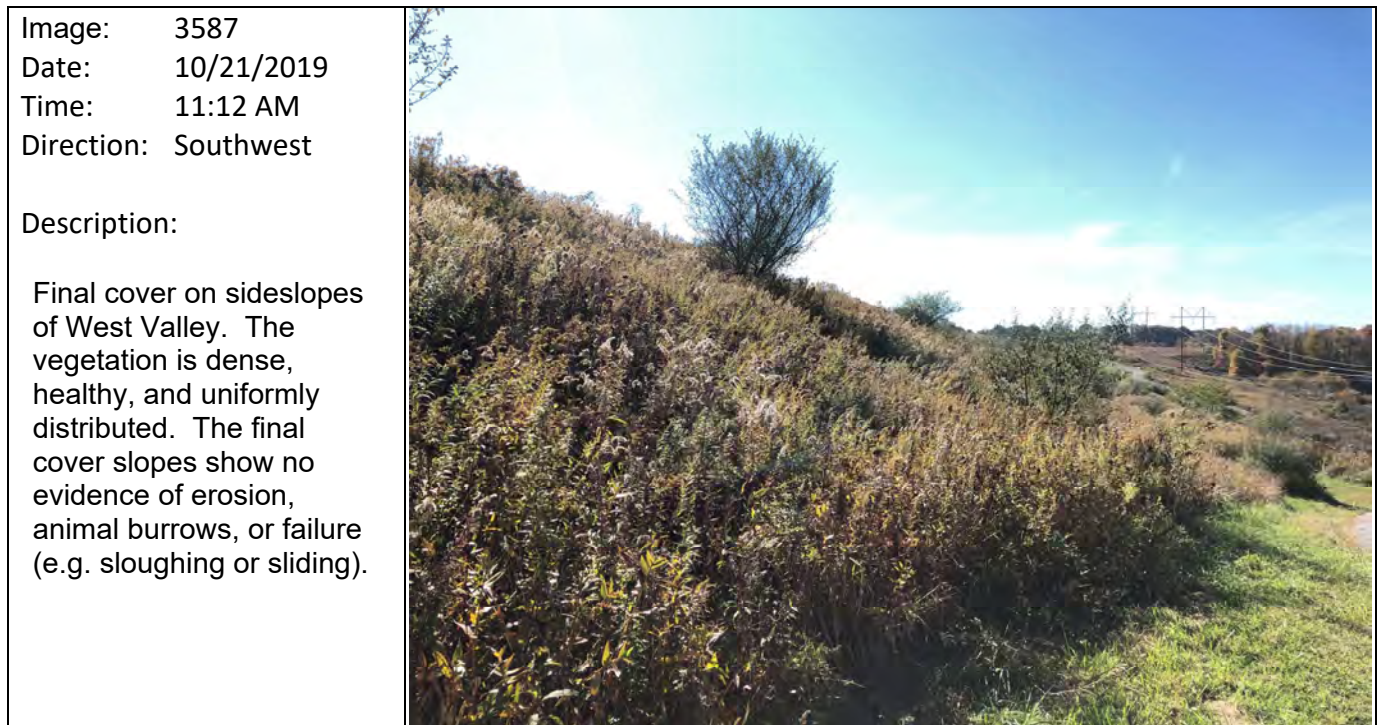
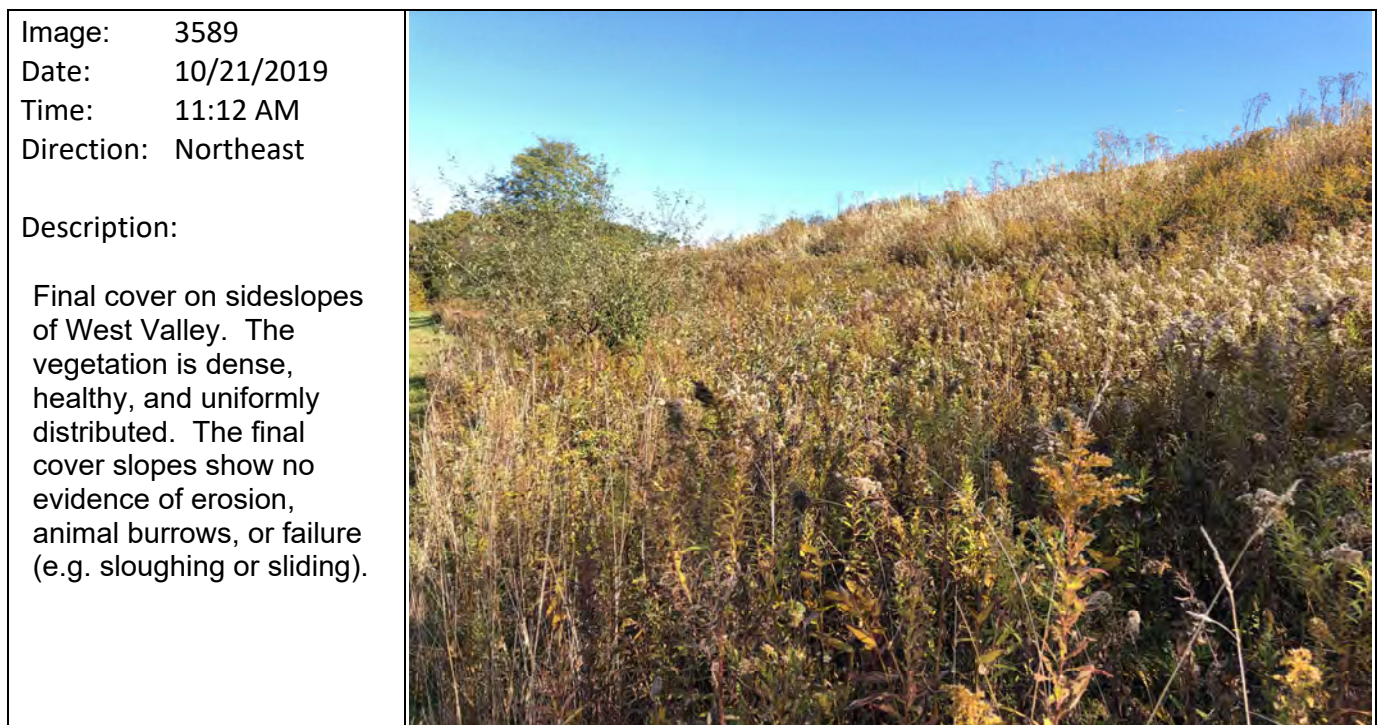
Image: 3593
Date: 10/21/2019
Time: 11:14 AM
Direction: Southwest

Final cover on sideslopes of West Valley. The vegetation is dense, healthy, and uniformly distributed. The final cover slopes show no evidence of erosion, animal burrows, or failure (e.g. sloughing or sliding).

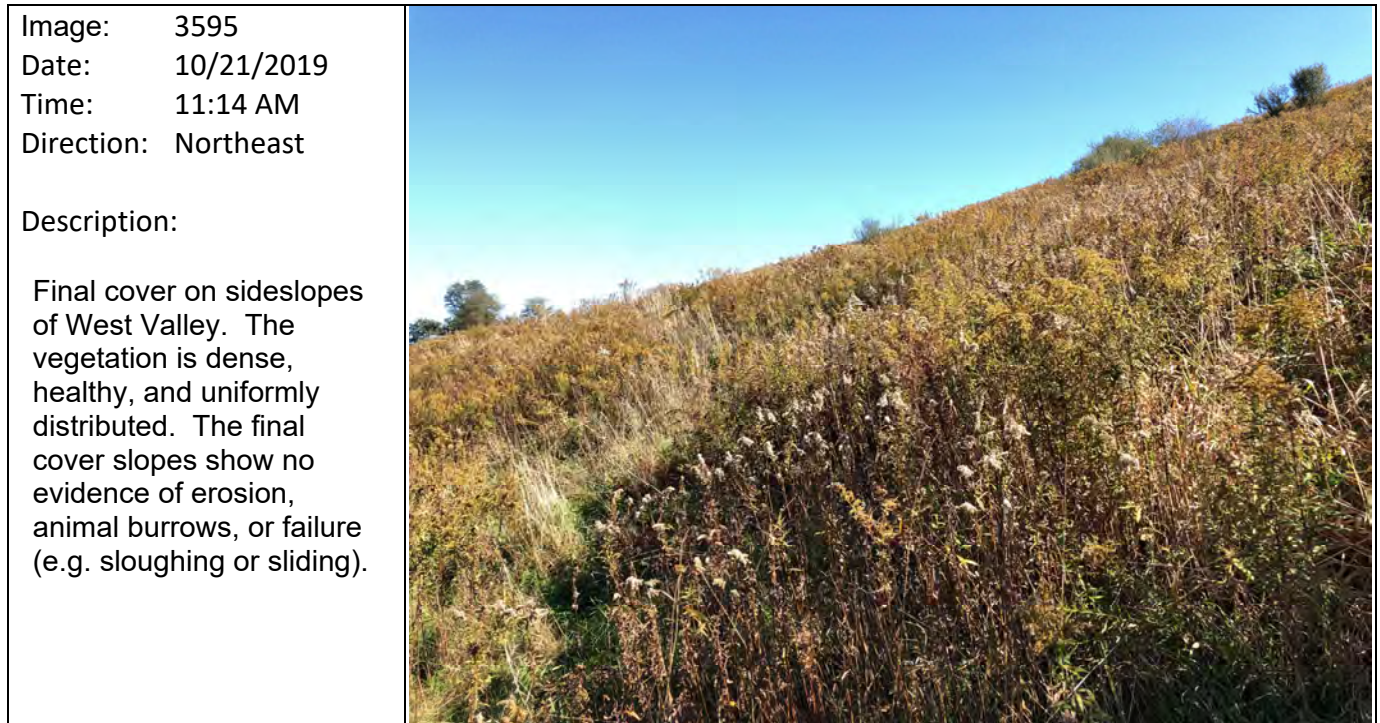
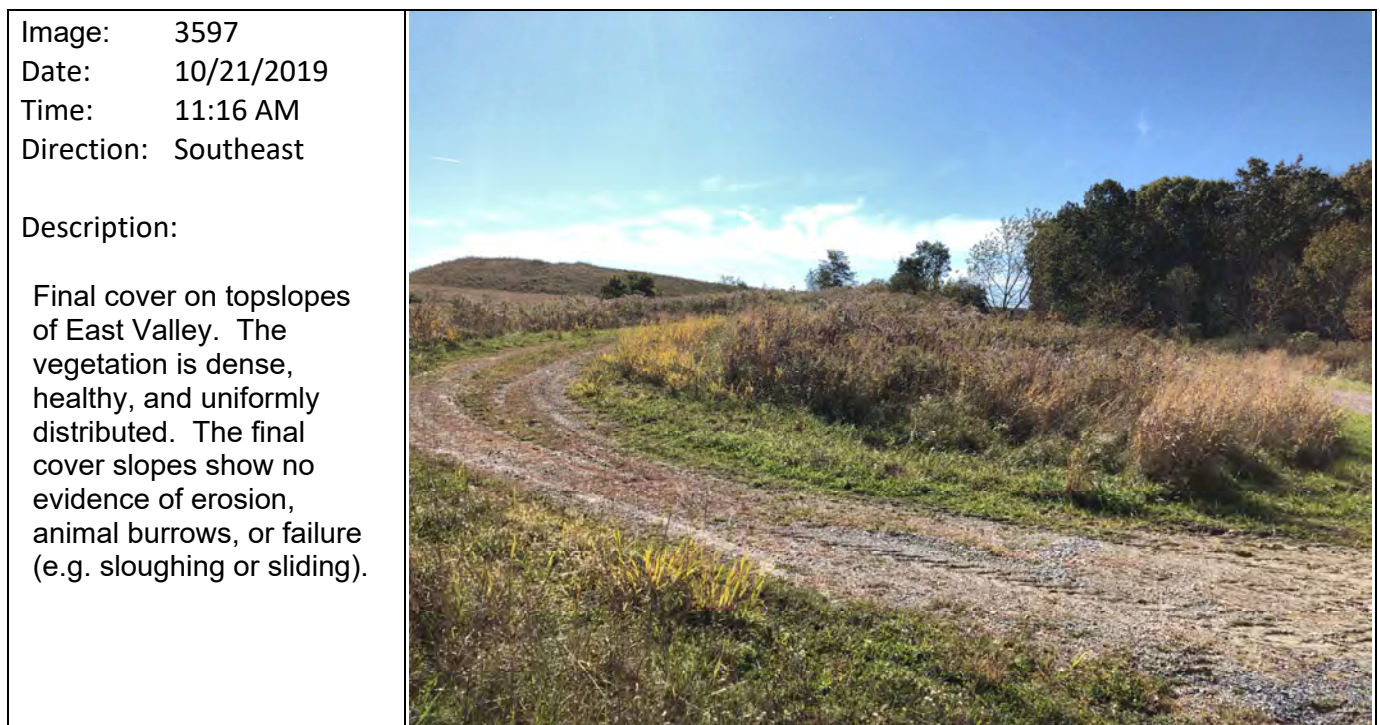
Image: 3599
Date: 10/21/2019
Time: 11:16 AM
Direction: Southeast

Final cover on topslopes of East Valley. The vegetation is dense, healthy, and uniformly distributed. The final cover slopes show no evidence of erosion, animal burrows, or failure (e.g. sloughing or sliding).

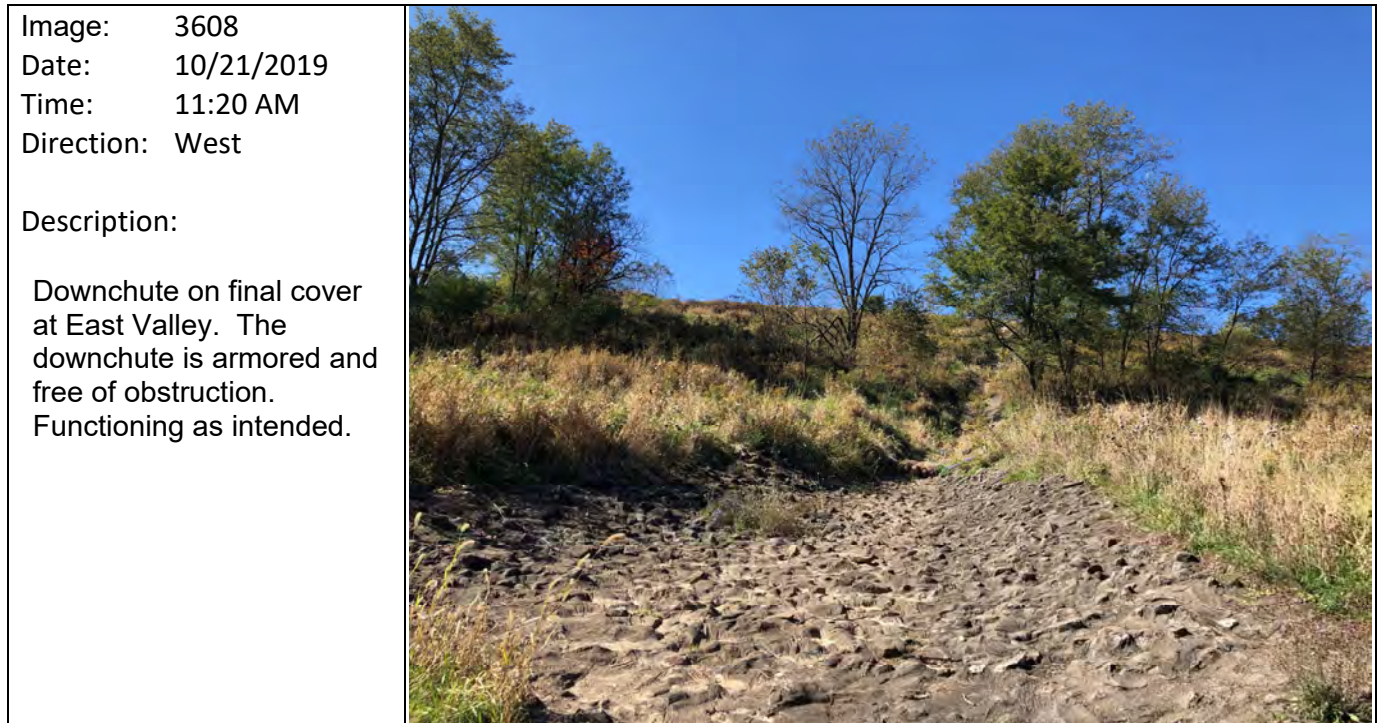
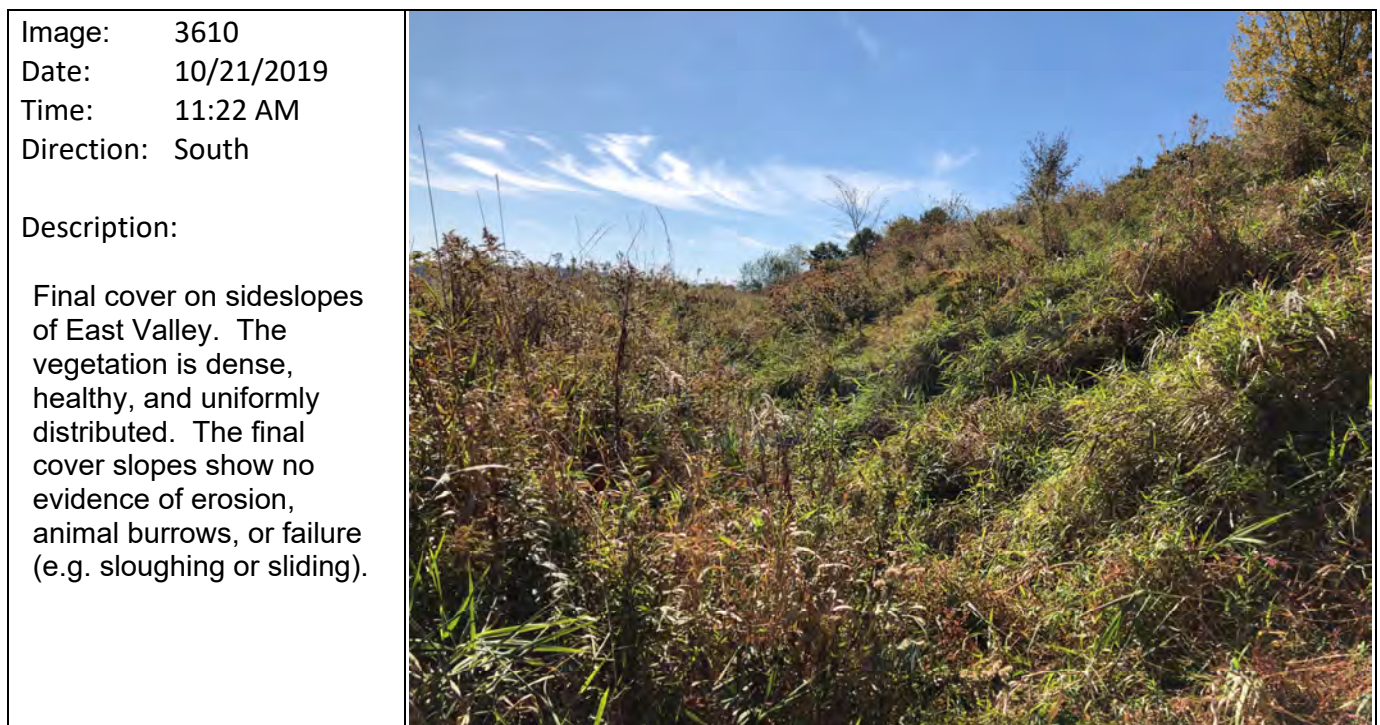
Final cover terrace on sideslopes of East Valley. The vegetation is dense, healthy, and uniformly distributed. The final cover slopes show no evidence of erosion, animal burrows, or failure (e.g. sloughing or sliding).

Woody vegetation on sideslopes of East Valley final cover. The final cover slopes show no evidence of erosion, animal burrows, or failure (e.g. sloughing or sliding).
